DOE/JPL
Distribution Category UC-6
Report #6

DEFECT STRUCTURE OF EFG SILICON RIBBON

December 1980

H. Strunk[†], B. Cunningham and D. Ast

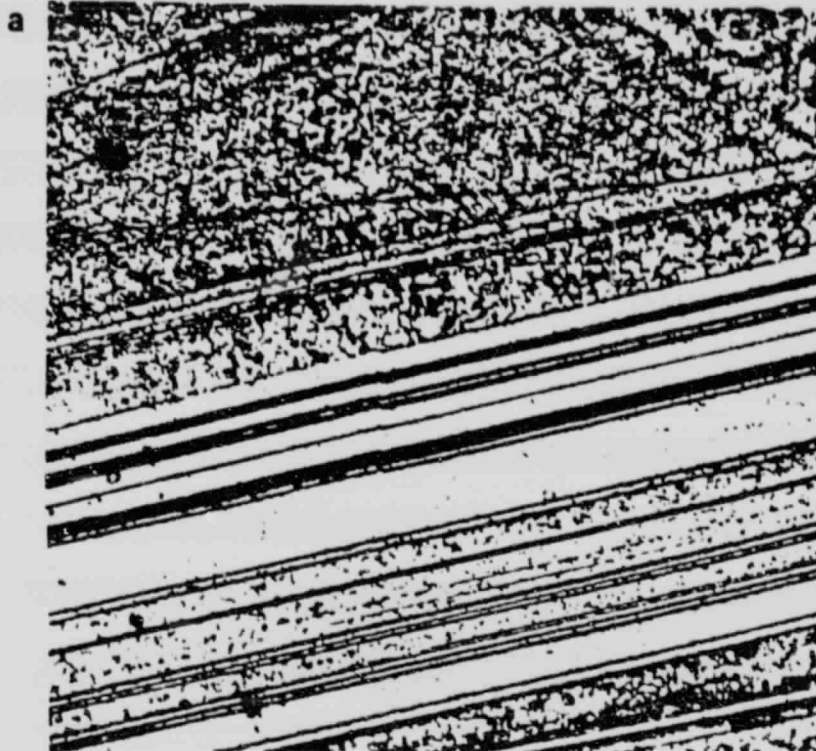
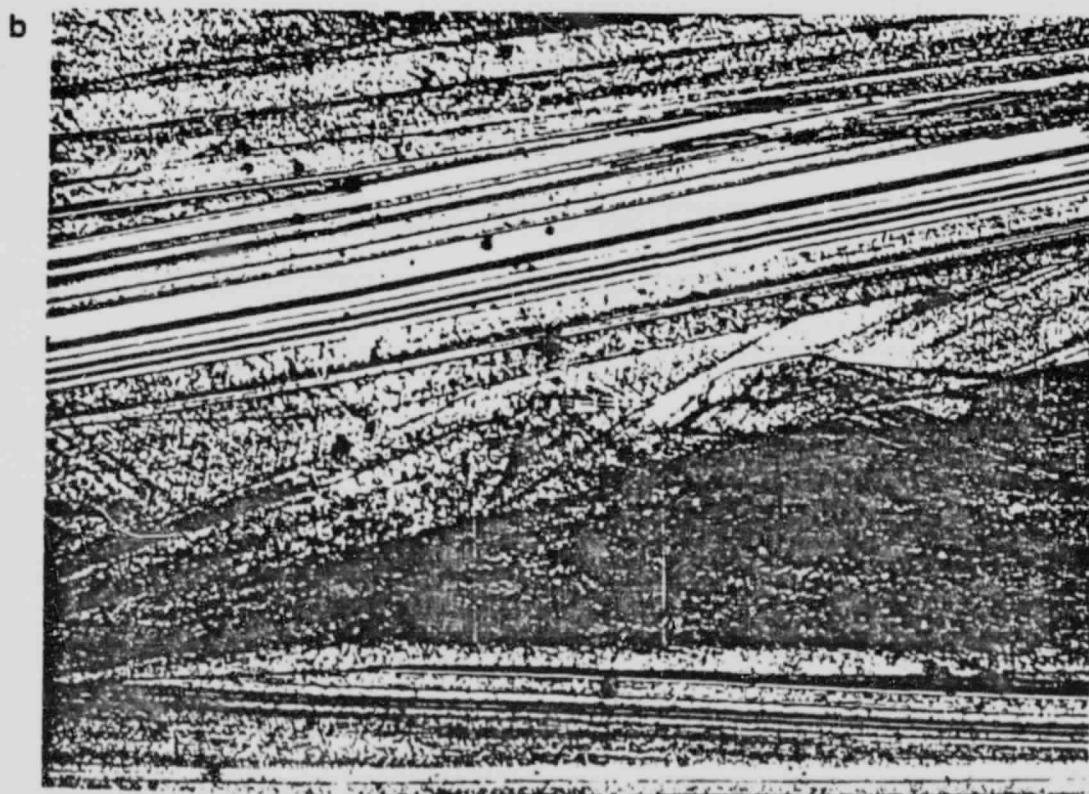
Figure. 1

1. Optical micrographs of etched ribbon surface Ribbon #2.
2. Optical micrograph of ribbon surface showing variation in grain orientations. Open circles mark areas analyzed by Laue X-ray and also orientations with respect to standard 001 stereographic projection (Courtesy of F. Stafford).

Similar features were observed in all of the EFG ribbons examined, the only difference being the scale of the defects (e.g. 'large' and 'small' grain). Figs. 1(a) and (b) show typical etch patterns, which have already been described (e.g. /7/to/10/). Only a brief description will therefore be given here, with emphasis on features which are interesting in connection with the correlation work reported in Section 5.

On a large scale the observed pattern is generally inhomogeneous, on a small scale, however, frequently homogeneous. Figure 1(a) shows an area of parallel striations, which are generally attributed to the presence of twin boundaries. (see Section 5 for a detailed discussion). At the top of Figure 1(a) is a region containing a high density of dislocation etch pits. It should be noted that the density of dislocations varies appreciably from region to region. Whereas Figure 1(a) represents the 'standard' defect structure (i.e. equilibrium structure', e.g. /11/) which is frequently discussed, Figure 1(b) shows an example of a more complicated pattern. Areas such as this were found on all of the ribbons and covered appreciable areas of the surface. The irregularity in Figure 1(b) is caused by reactions between grain and/or twin boundaries and by an inhomogeneous distribution of dislocations. In several regions the dislocation etch pits are aligned along crystallographic directions suggesting that the dislocations had been generated by plastic processes (See Section 5).

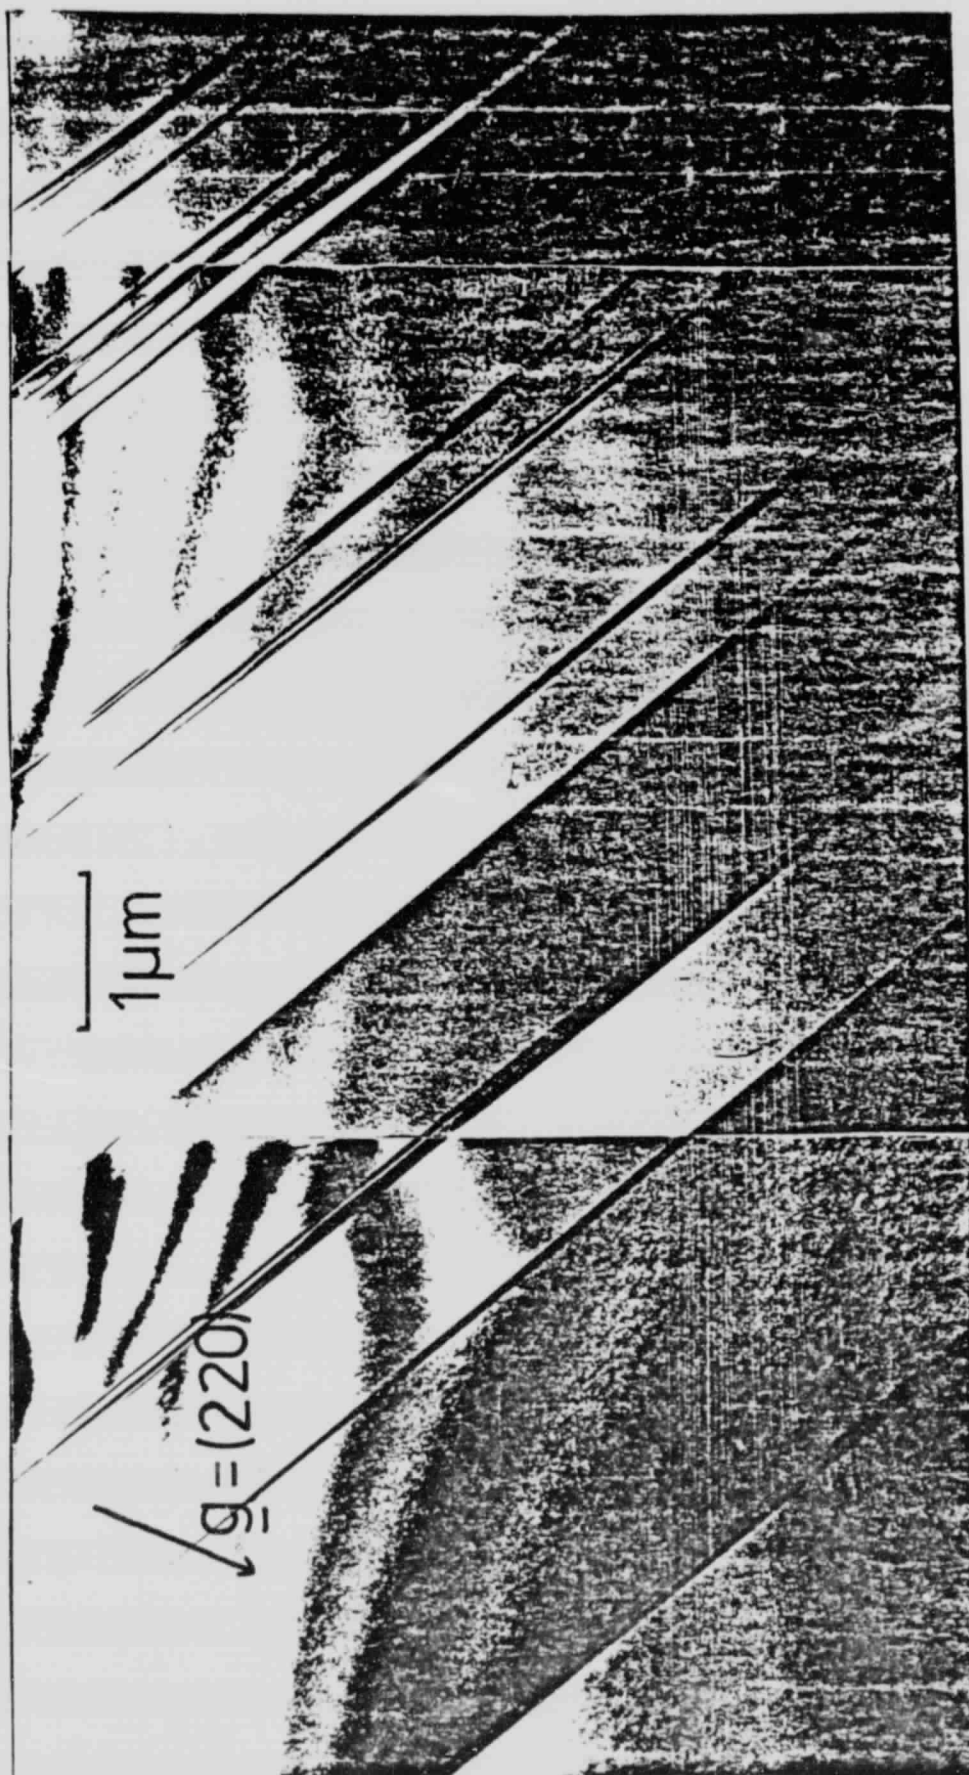
Figure. 6

6. TEM micrograph (125 kv) of microtwins in E.F.G. ribbon. Ribbon #1.
7. High resolution structural image of a microtwin five atomic layers thick. (125 kv).

Twins with a {111} habit plane occur with a high frequency and are therefore generally observed by TEM. A typical twinned structure is shown in Figure 6. The thicknesses of micro-twins may vary from a few layers of {111} planes up to tens of microns (which of course means single twin boundaries are observed in TEM). A micro-twin five layers thick is revealed by structural imaging in Figure 7. The 'small grain' ribbons contain a high density of microtwins (e.g. Figure 6) with thicknesses up to several 100 nm. 'Large grain' material contains isolated twin boundaries spaced several μm apart, resulting in a more proportionate distribution of 'twinned' and 'matrix' material.

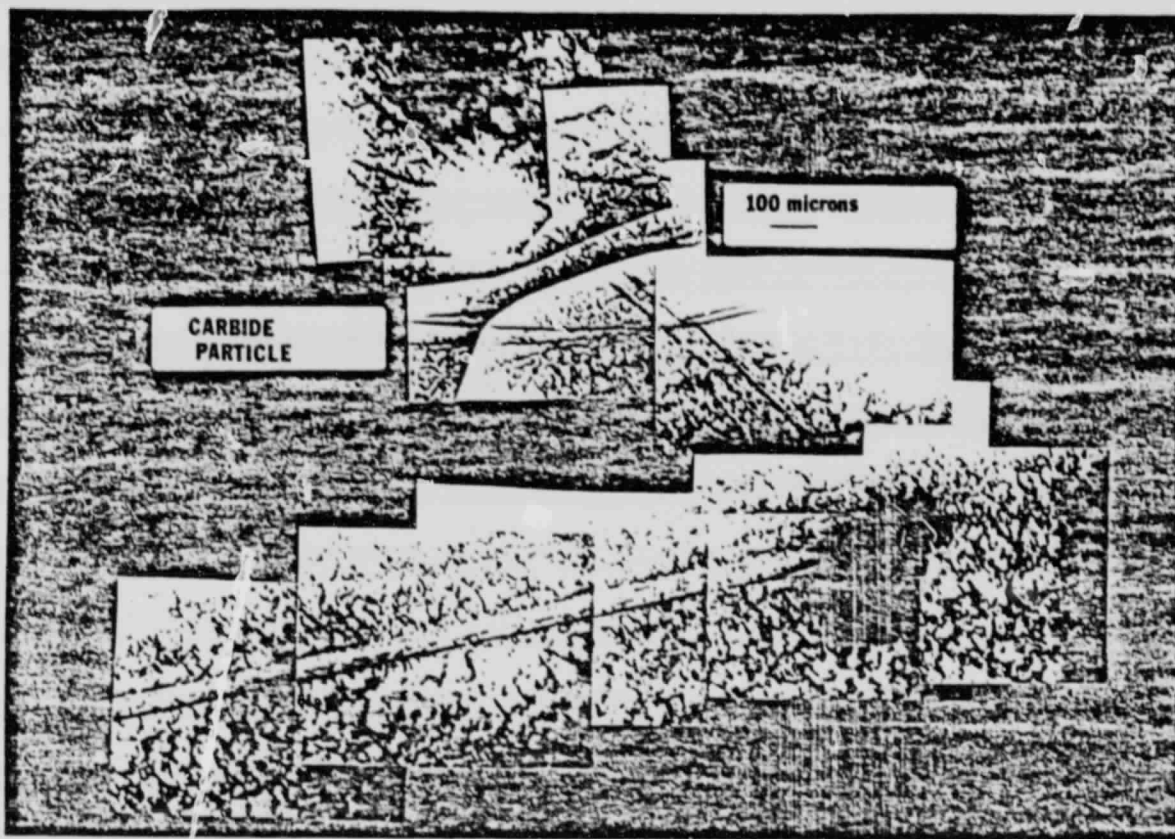
Figure. 8

8. EBIC micrograph showing contrast near a SiC particle. Ribbon #4.
9. a) Bright field HVEM image of a microtwin containing dislocations. b) Same area with twin out of contrast. c) EBIC micrograph from the same area. g = diffraction vector - Ribbon #4.

EBIC has been used to investigate the electrical activity of the defect structure nucleated at SiC particles. Figure 8 shows a typical arrangement with a high density of black dots, corresponding to dislocations, and a number of twin boundaries. Except for this high density of defects no other unusual effects were observed. This is particularly interesting since an excess of carbon may be expected near a SiC particle, thereby enhancing any carbon-induced impurity segregation. Such a segre-

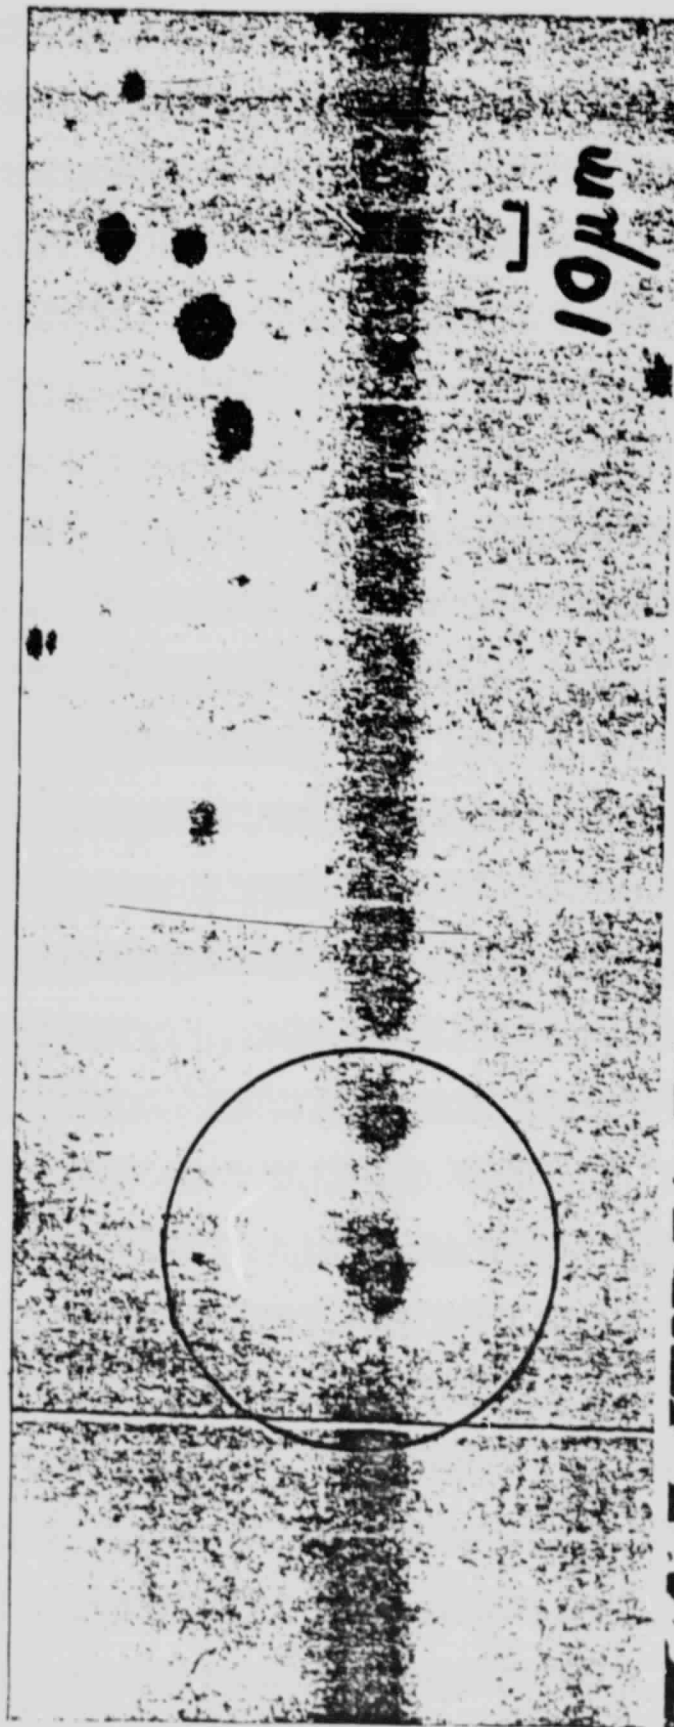
Figure. 10

10. a) EBIC micrograph showing dotted contrast. b) Optical micrograph of the same area showing interaction of microtwins. Ribbon #2.
11. a) Bright field HVEM micrograph of twin boundaries shown in Figure 10. b) Same area with one set of twin boundaries out of contrast.

Figure 10 (a) shows another example of dots in EBIC contrast. These dots, though similar to those shown in Figure 9 (c) are caused by a totally different structure. Figure 10 (b) is an etch pattern from the same area, showing that the observed contrast in Figure 10 (a) is due to the interaction of boundaries. The nature of the boundaries was determined by HVEM. As an example the area encircled in Figure 10 is shown in Figure 11. A three dimensional sketch of this area clarifying the relationships between the different areas is given in Figure 12. Analysis shows that T_1 is a microtwin $\sim 100\text{nm}$ thick, lying in the matrix M perpendicular to the growth surface. T_2 is in a different twin orientation to the matrix M with an inclined $\{111\}$ - habit plane. Thus the boundary between T_1 and T_2 joins two crystal grains with a misorientation caused by two non-parallel twinning operations. The geometric construction is depicted in Figure 13, projected along the $\langle 110 \rangle$ direction common to all three grains. Boundaries of this type have been termed 'second order twin joins' by Kohn /16/ and are $\Sigma 9$ boundaries in the CSL model /17/. In the present case the $\{111\}$ plane of T_1 matches a $\{115\}$ plane of T_2 . This unsymmetric configuration has been modelled by Kohn /18/, yet has not been observed so far to the author's knowledge. The dislocation model discussed by Hornstra /19/ could also be extended to describe this unsymmetric case, but would require a very high density such that the dislocation core regions would overlap. In Figure 11 (b) the specimen was tilted to show the boundaries of the microtwin T_1 . Dislocations that are contained in the $\{111\}/\{115\}$ boundary are clearly visible. These dislocations accommodate a small deviation from the $\{111\}/\{115\}$ orientation relationship and are commonly referred to as extrinsic boundary dislocations /20/. The Burgers vectors of these dislocations have not been analyzed.

The comparison of the HVEM micrographs (Figures 11 and 14) with the corresponding EBIC pattern (Figure 10) gives the following result: (1) The black dots in Figure 10 (a) correspond to the $\{111\}/\{11\bar{5}\}$ second order twin joins, which therefore represent efficient sites for minority carrier recombination. (11) The straight 30° and 90° partial dislocations show no contrast in EBIC (although etched in Figure 10 (b)) and thus are virtually electrically inactive.

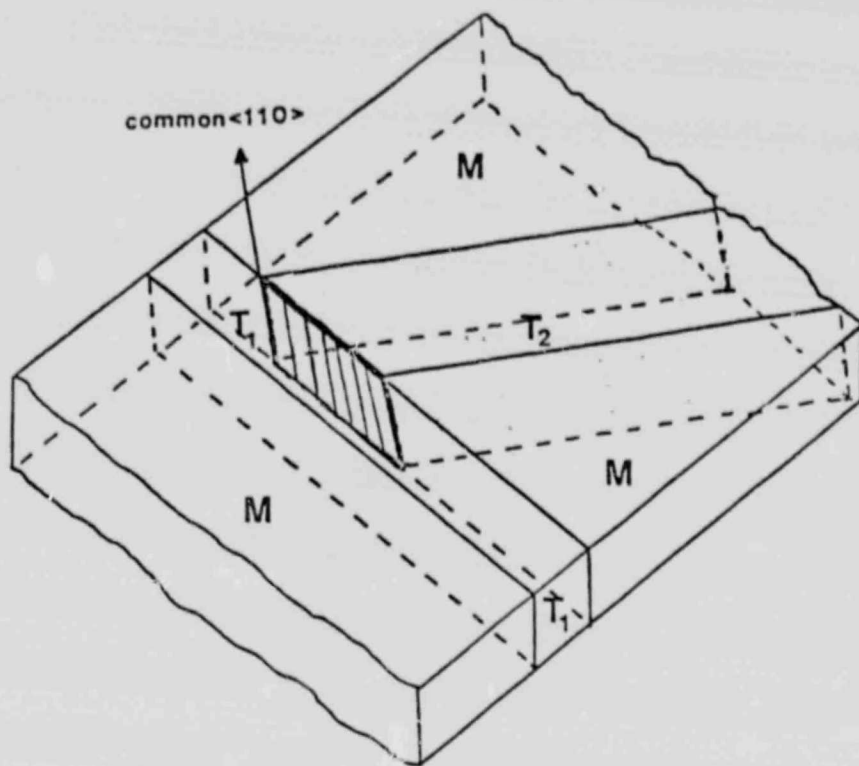
Figure. 12

12. Schematic sketch of the arrangement of twin boundaries shown in Figure 11.
13. Projection along the common $\langle 110 \rangle$ direction of twins indicated in Figure 12 showing the arrangement of atoms at the (111) (115) twin join.
