CARSON ALEXIOU CORPORATION

NASA AMES INFRARED DETECTOR ASSEMBLIES

FINAL REPORT

NAS 2-10136

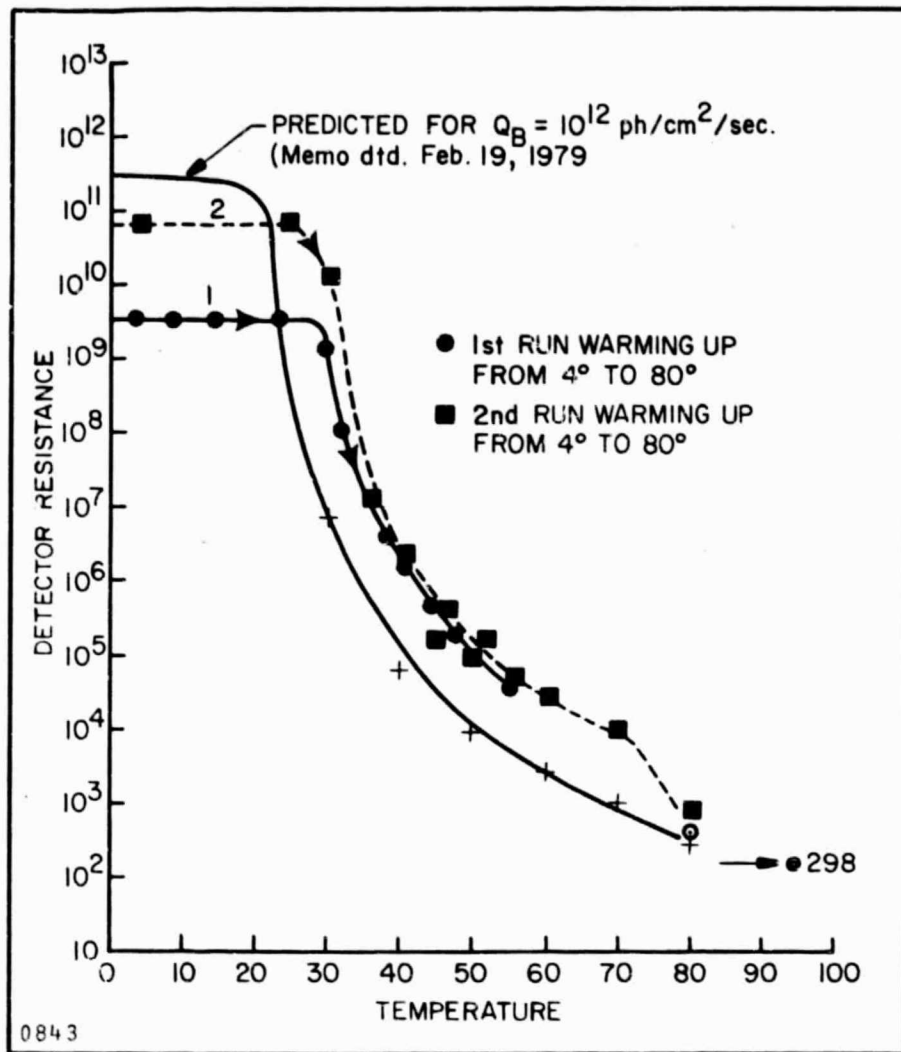
Figure 1. NASA Ames Detector Tests, 32-Channel CMOS MUX Worked over Range (tied thru $1 \times 10^{12} \Omega$ load resistor to slightly different bias) $10 \times 10 \times 40$ mil Al contacted detector

Detector resistance vs. temperature results were performed in May of 1979 and reported in that month's Progress Report. The detector resistance vs. temperature agreed approximately with theoretically predicted values. It was 200Ω at room temperature, reaching almost 1×10^{11} at 20-30°K as shown in Figure 1. These tests indicated approximately proper doping but did not prove that the detectors would necessarily work.

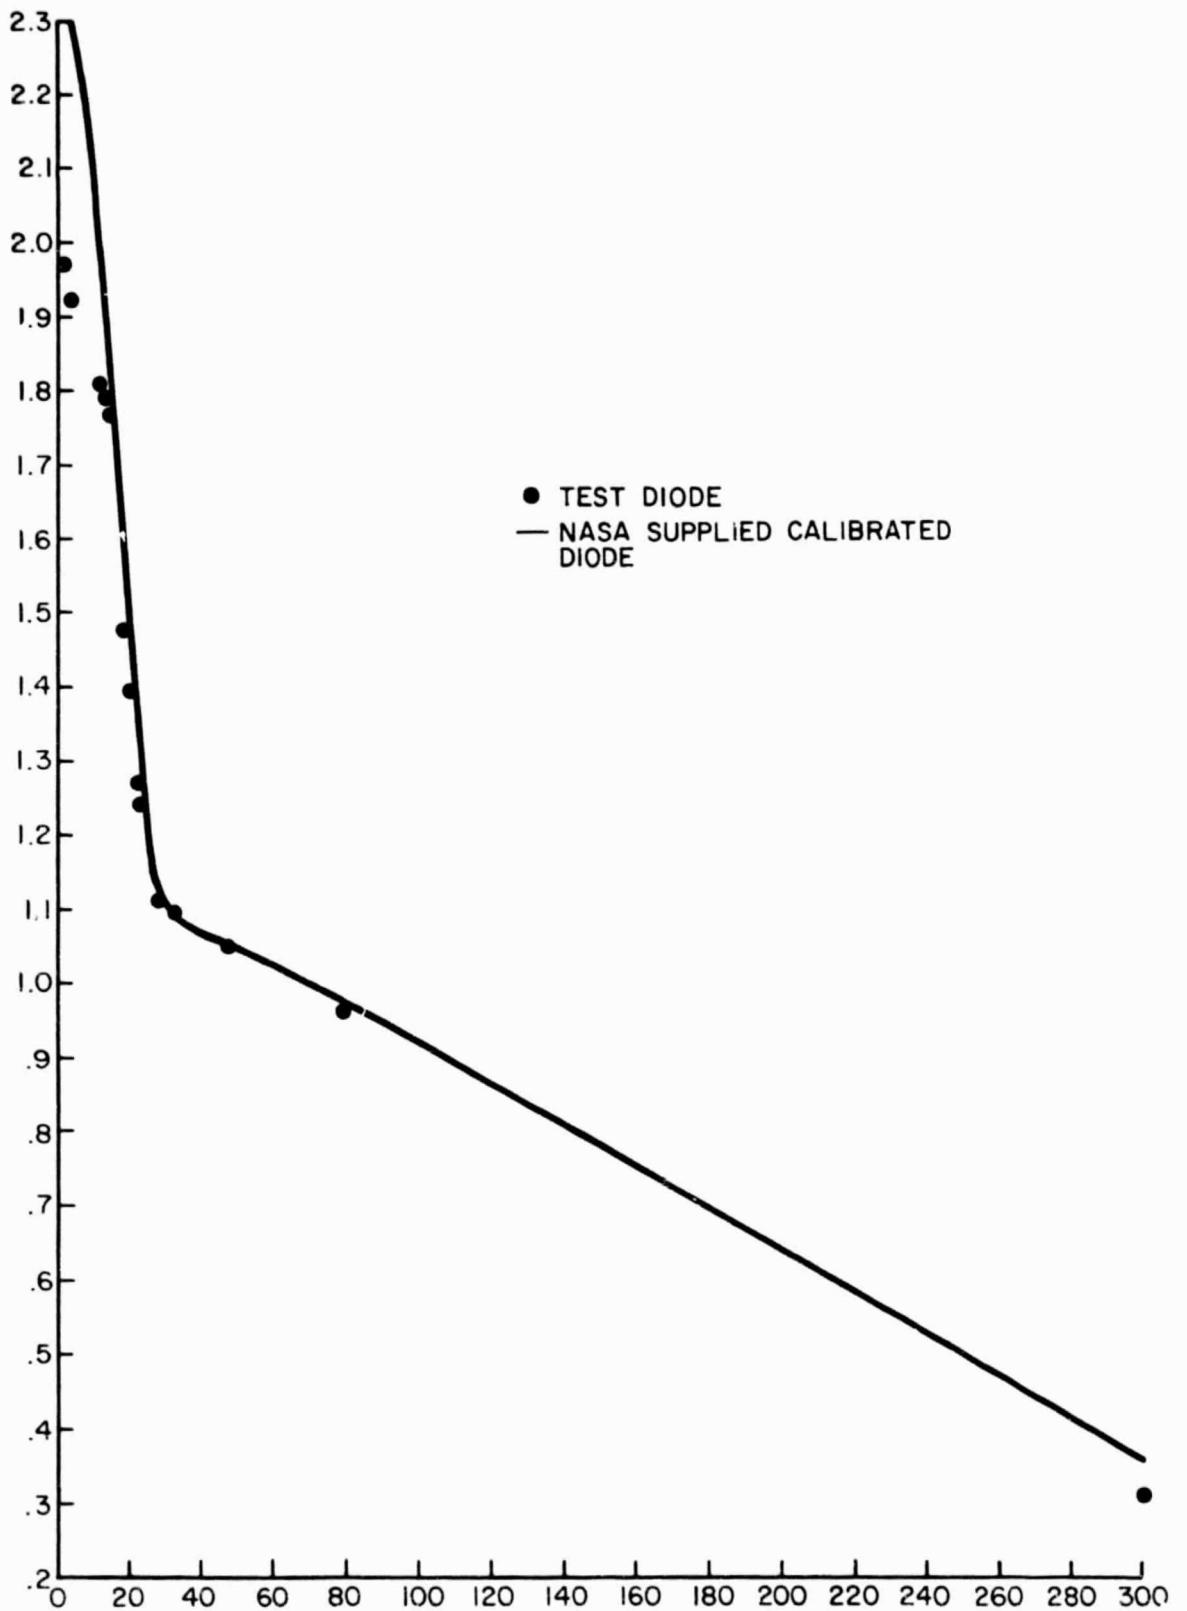
Figure 2. Temperature Diode Calibration

In preparation for testing the modules, the temperature diodes included with the modules were calibrated with the NASA-supplied calibrated temperature diode. The calibration results are shown in Figure 2 for the module diode used with the circuit shown in Figure 3.

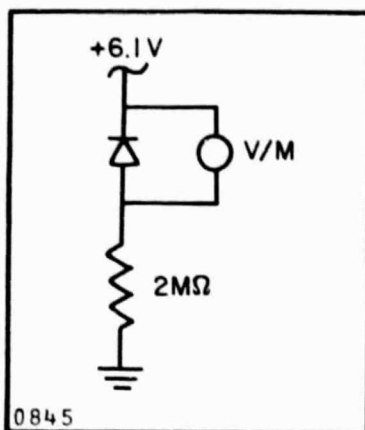
Figure 3. Temperature Sense Diode

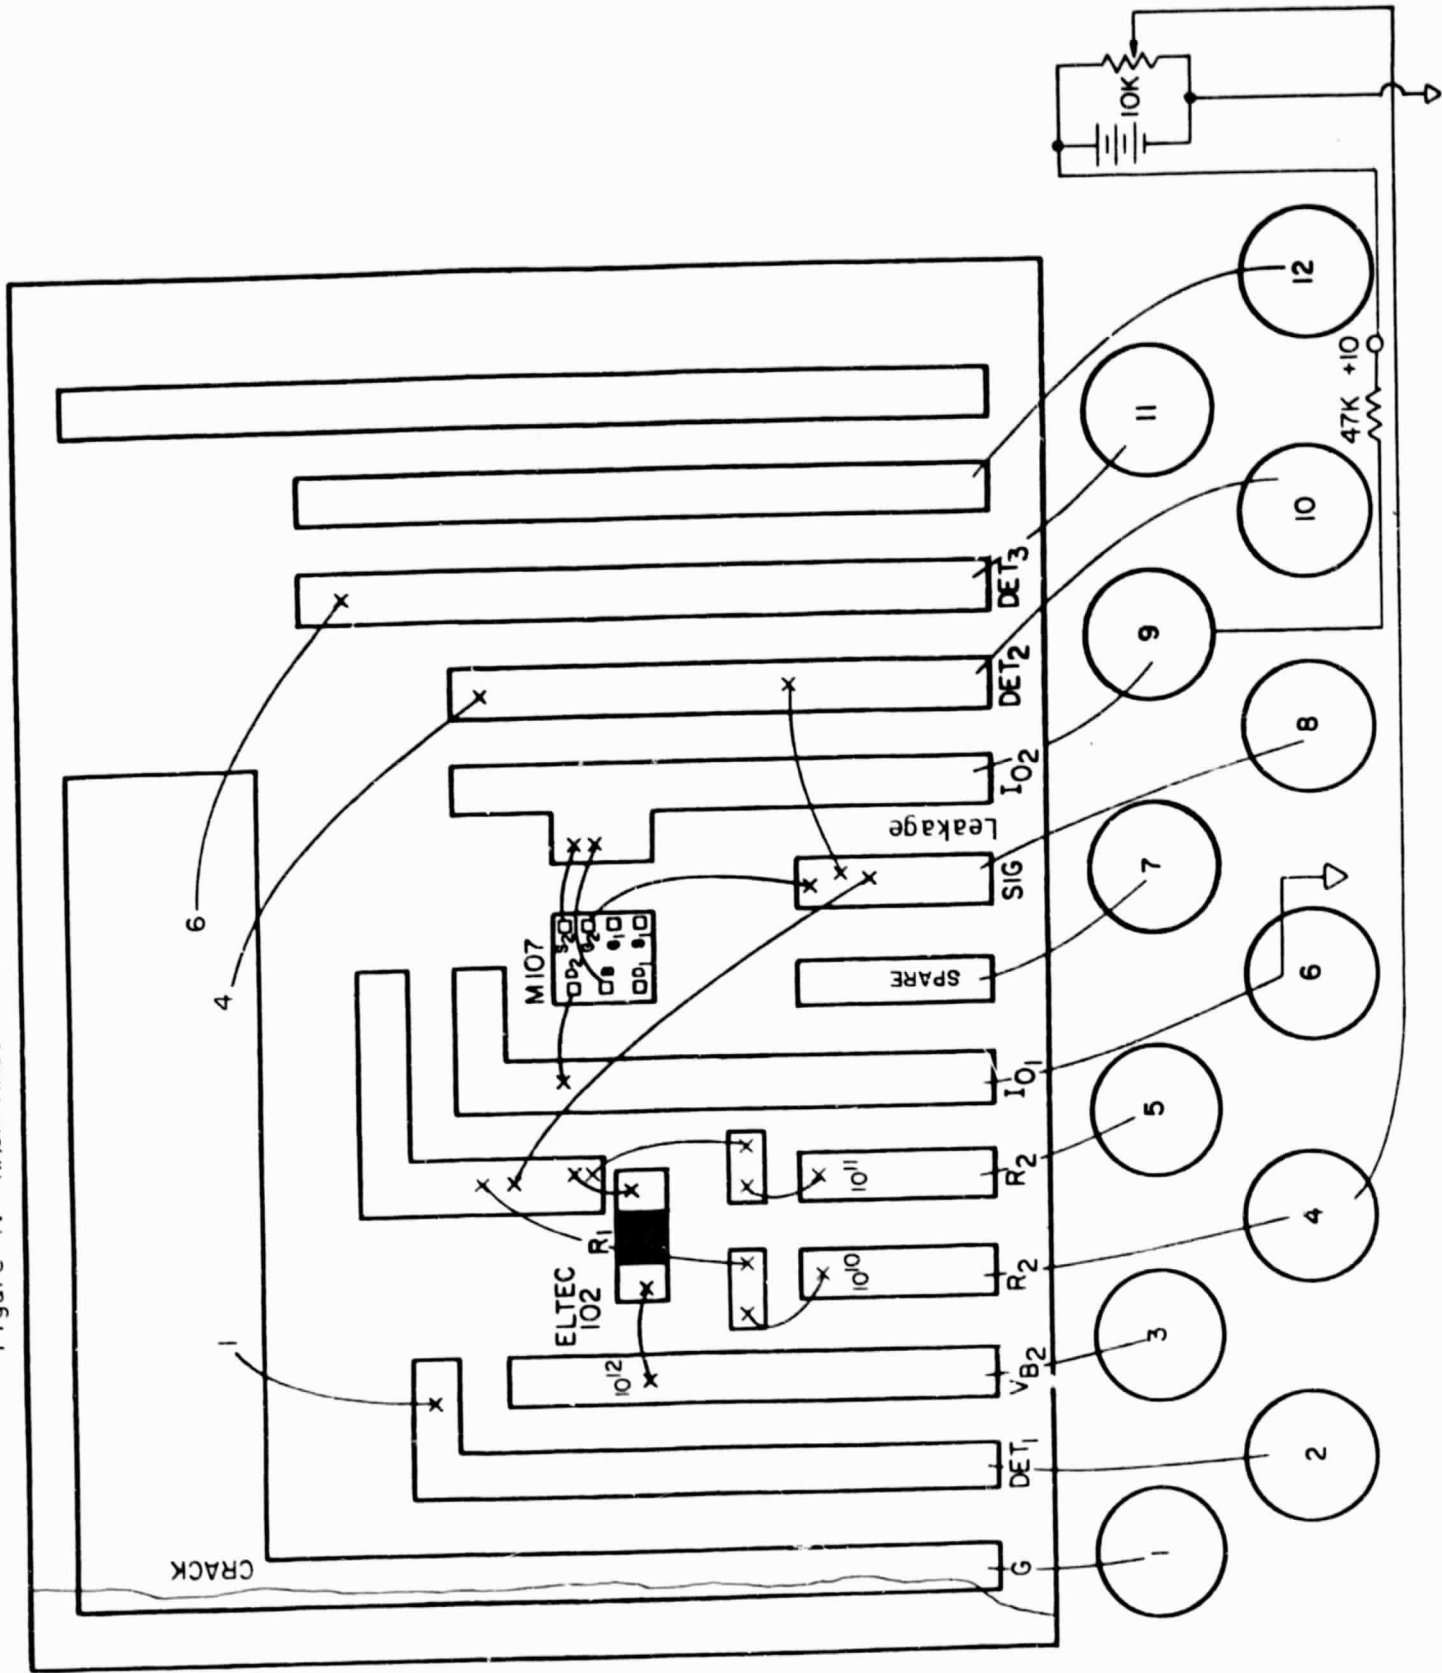
Figure 4. NASA Ames - Module #3

The schematic for module #3 with the M107 preamp is shown in Figure 4. On this module three load resistors are mounted such that for any test a 1×10^{10} , 1×10^{11} or $1 \times 10^{12} \Omega$ load resistor may be selected. Initially the M107 was tested warm with the $1 \times 10^{12} \Omega$ load resistor. However, the device failed to bias on correctly due probably to leakage currents. Next the $1 \times 10^{11} \Omega$ load resistor was tried. This resulted in marginal performance. The M107 could be biased on but control of the drain current was limited. Also the time constants involved were very long. This situation may or may not have improved with cryogenic operation. However, the decision was made to use the $1 \times 10^{10} \Omega$ load resistor because of the guaranteed correct bias control. The load resistance increased to 3×10^{10} cold. The noise was measured warm with the detector lead open. The results are shown in Figure 5. Low noise operation was indicated. The gain measurements both warm and cold (2°K) are shown in Figure 6. The initial test of the background was quite large

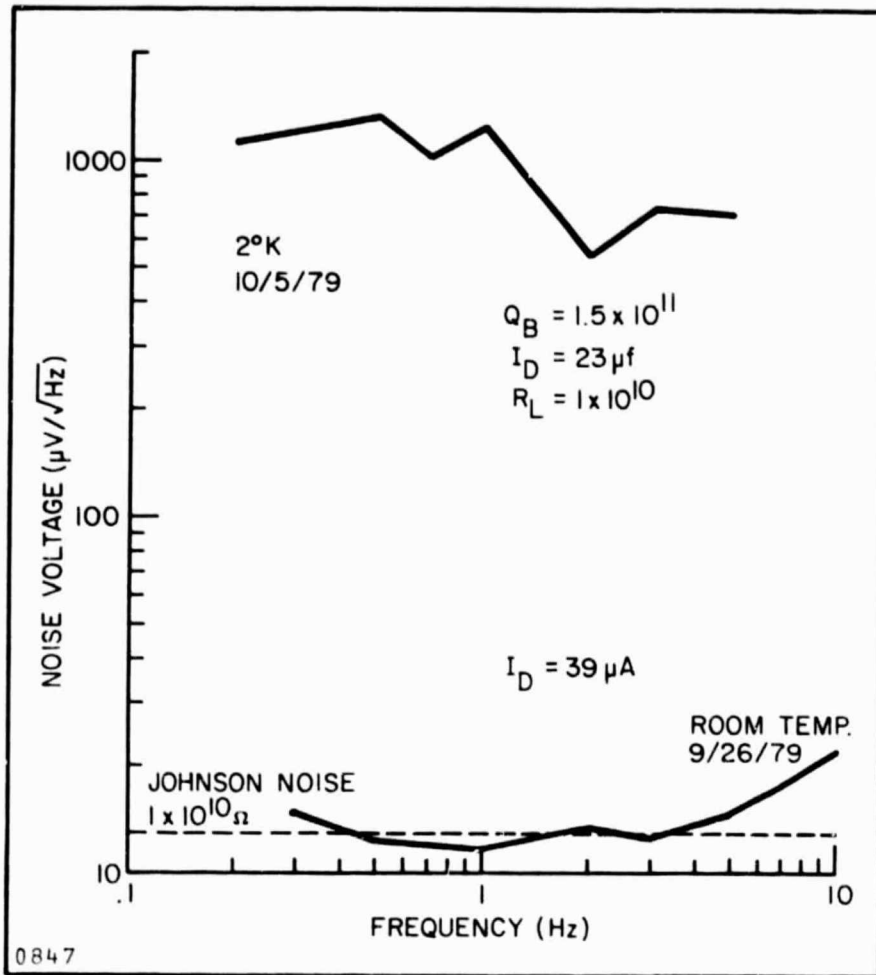
Figure 5. M107 #3 CMOS Preamp, Noise vs. Frequency

(3×10^{13} photons/cm²/sec.). The detector resistance, therefore, was assumed to be smaller than $1 \times 10^{10} \Omega$. The signal response from a chopped blackbody was measured to be 200 μ volts. In the second test the background was reduced to $\sim 1.5 \times 10^{11}$ photons/cm²/sec. and nearly two orders of magnitude increase in signal voltage response was observed as shown in Figure 7. During this test the noise voltage was also measured and shown in Figure 5. The

noise was quite high varying about $1 \text{ mV}/\sqrt{\text{Hz}}$. This is substantially larger than the Johnson noise of the detector load resistor combination or generation recombination noise and is additional detector noise. The detector bias was 7 volts and the detector resistance (cold) was $1.5 \times 10^{10} \Omega$.

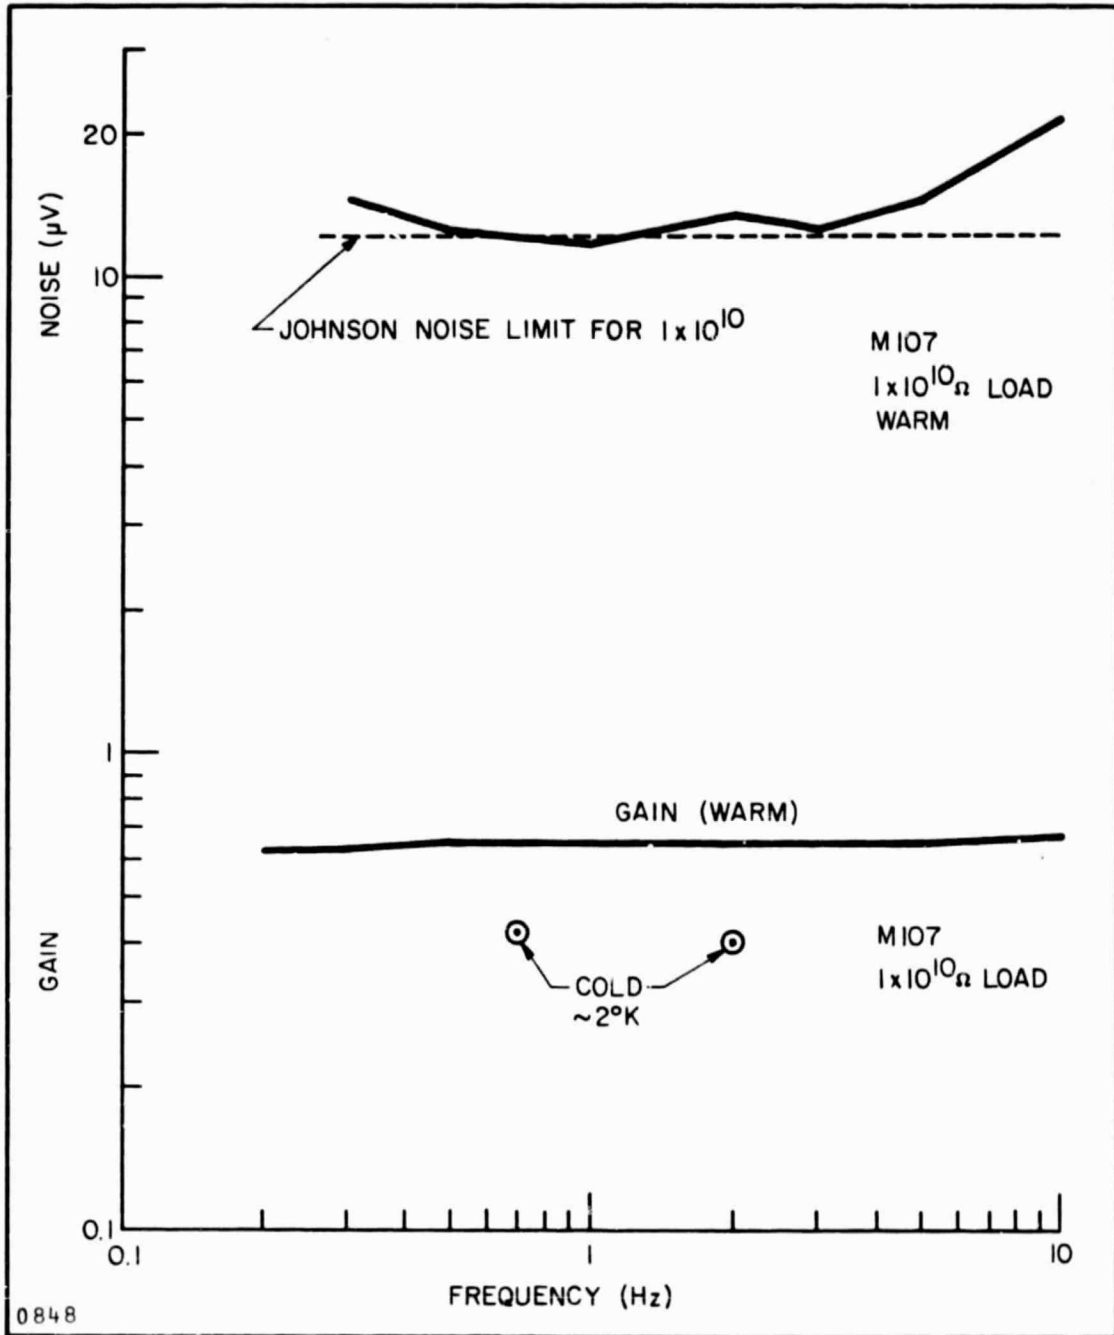
Figure 6. M107 #3 Module Gain

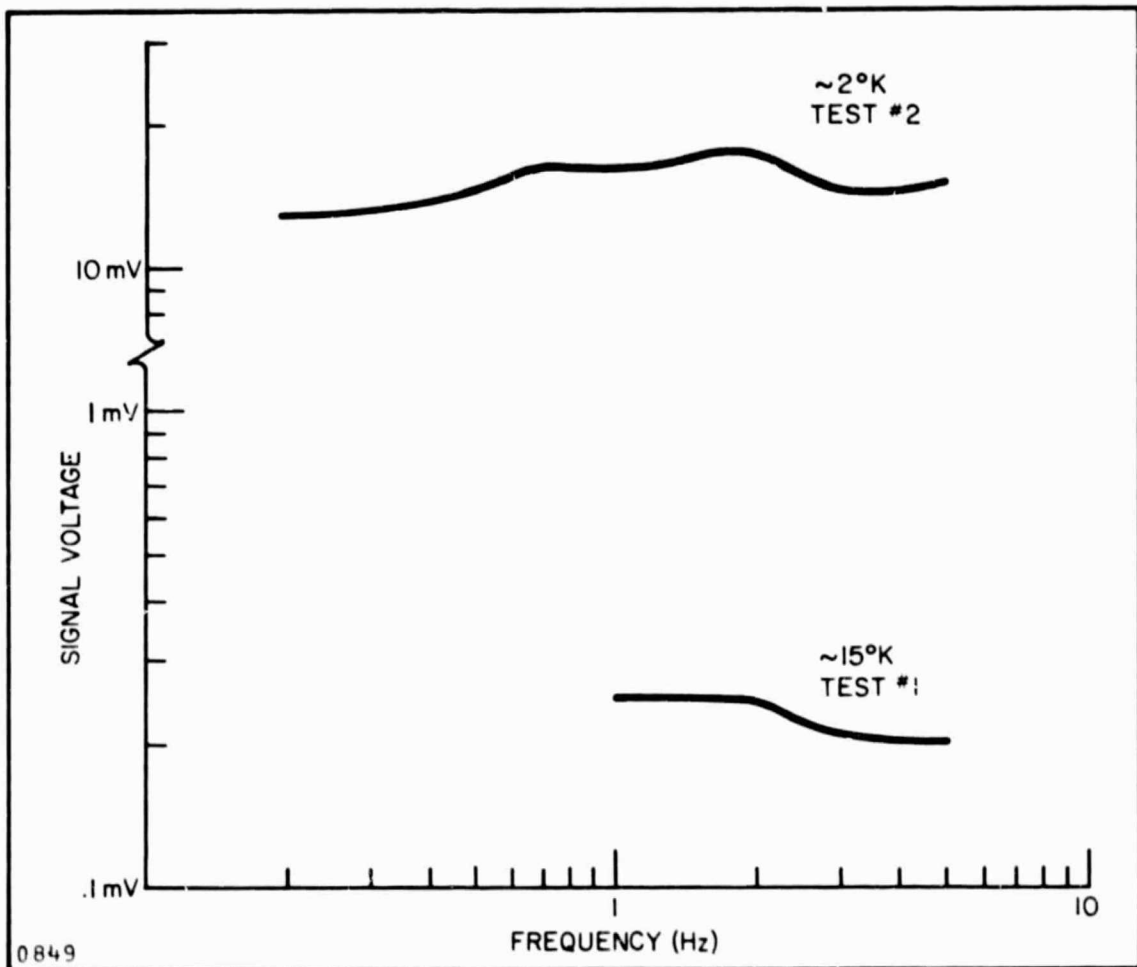
Figure 7. Signal Output Voltages

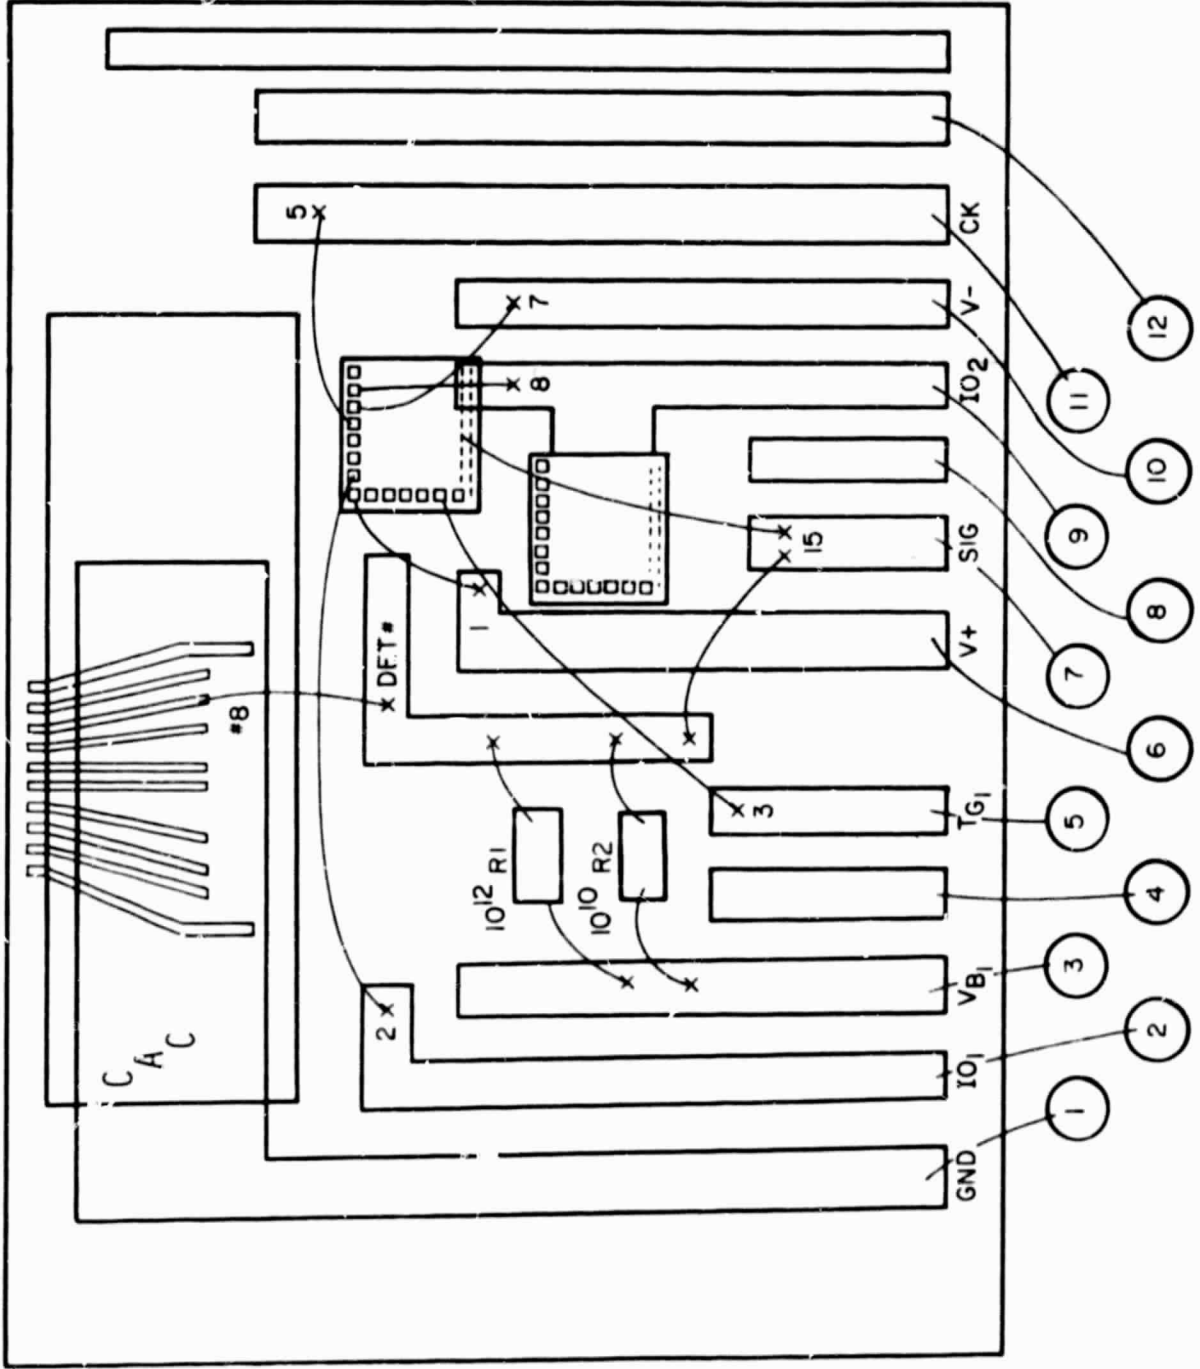
Figure 8. NASA Ames - Module #2

32 Channel Simulation

This module as shipped to NASA Ames contains two CMOS multiplexers, two resistors, and approximately 10 detectors (see Figure 8). Two resistors were connected in parallel at $1 \times 10^{12} \Omega$ and at $1 \times 10^{10} \Omega$ under the premise that after the tests were performed at high background in which the detectors were expected to be $1 \times 10^{10} \Omega$ the small resistor could be cut out leaving the $1 \times 10^{12} \Omega$ resistor for the low background test. The high background tests were performed at approximately 3×10^{13} photons/cm²/sec. One detector was connected to one input of the CMOS multiplexer (CMOS Channel #13). The

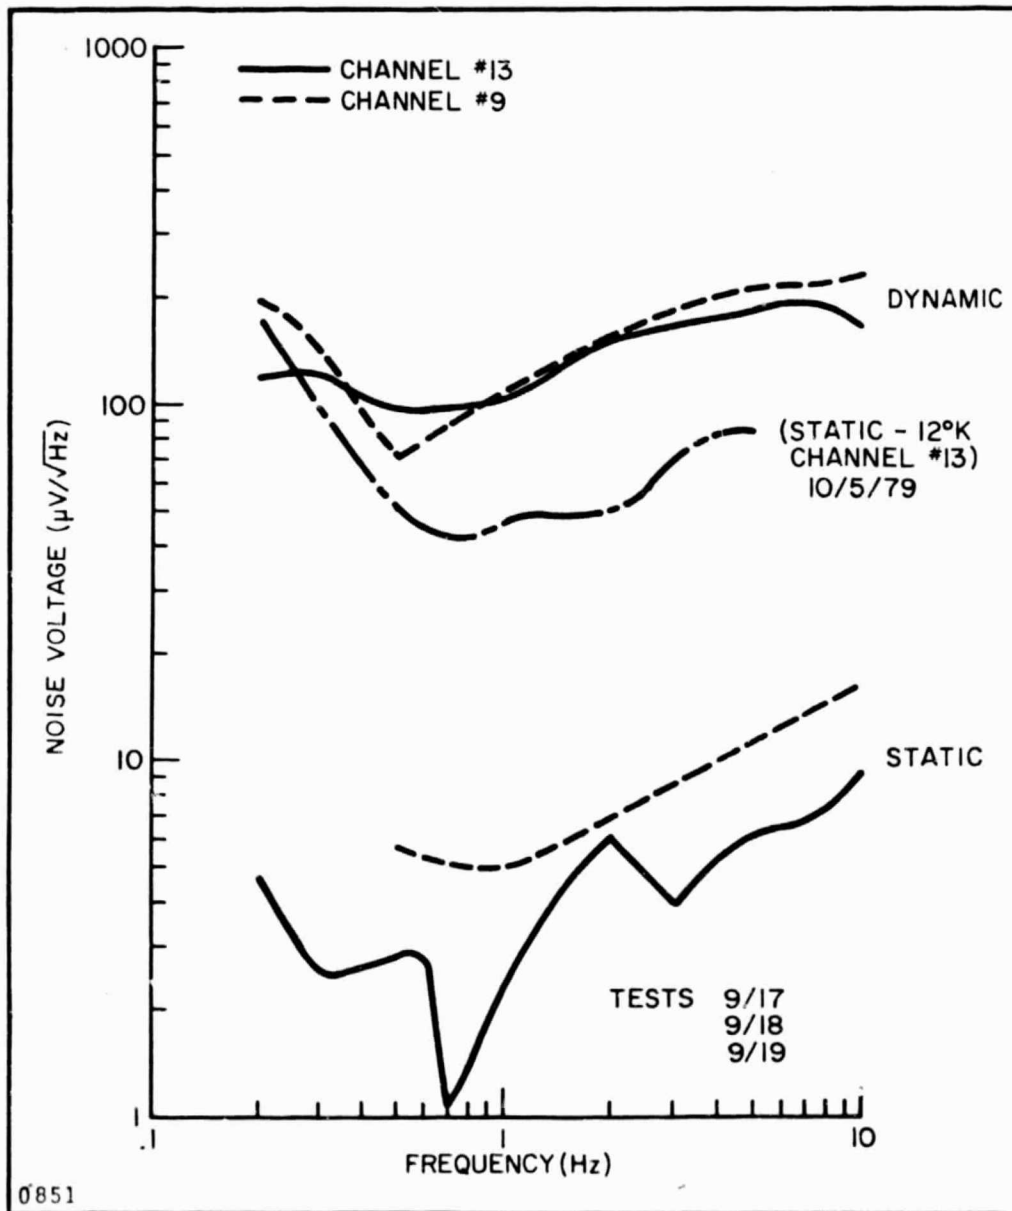
Figure 9. CMOS Multiplexer, Noise vs. Frequency

detector lead was left open for the initial warm noise tests because of the detectors low impedance at room temperature ($\sim 50\Omega$). Channel #13 was measured both dynamically (2.5 KHz clock rate) and statically (unlocked). Upon the initial cool-down Channel #13 apparently suffered static damage. The detector input was disconnected from Channel #13 and reconnected to Channel #9. Static and dynamic tests were performed warm. The results are shown in Figure 9. The Johnson noise of the warm load resistor is approximately $12.8 \mu\text{V} \sqrt{\text{Hz}}$.

The dynamic warm noise tests resulted in noise values around $150 \mu\text{V}/\sqrt{\text{Hz}}$. The gain of the multiplexer was not measured on this program unfortunately, however, it should lie between .7 and .8. Therefore, the gain corrected warm noise appears to be in the vicinity of $200 \mu\text{V}/\sqrt{\text{Hz}}$ or 16 times Johnson noise. The results of the static tests indicate noise levels of $4 \mu\text{V}/\sqrt{\text{Hz}}$ which is below theoretical Johnson noise because of low gain of the CMOS multiplexer.

and no photo gain. The poor detector performance was verified in that the detector would only respond slightly to a soldering iron. The static noise measurements from this test are also shown in Figure 9. With the detector in the circuit and at 12°K the noise voltage appears to be approximately 1 order of magnitude larger than previous static tests.

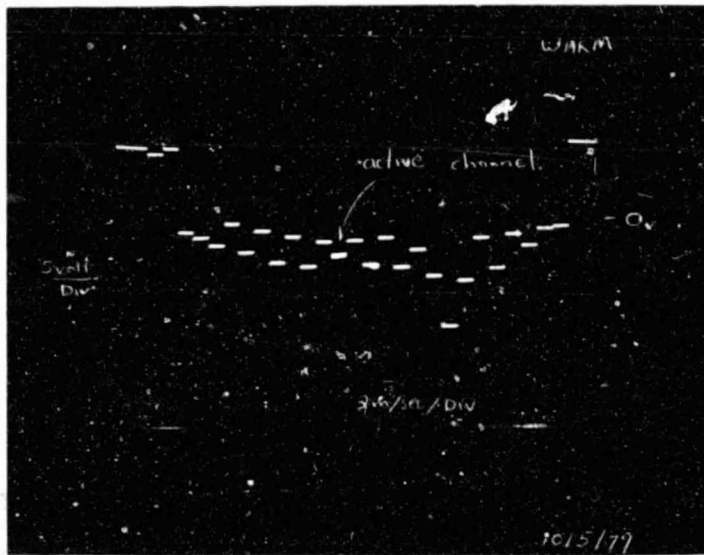
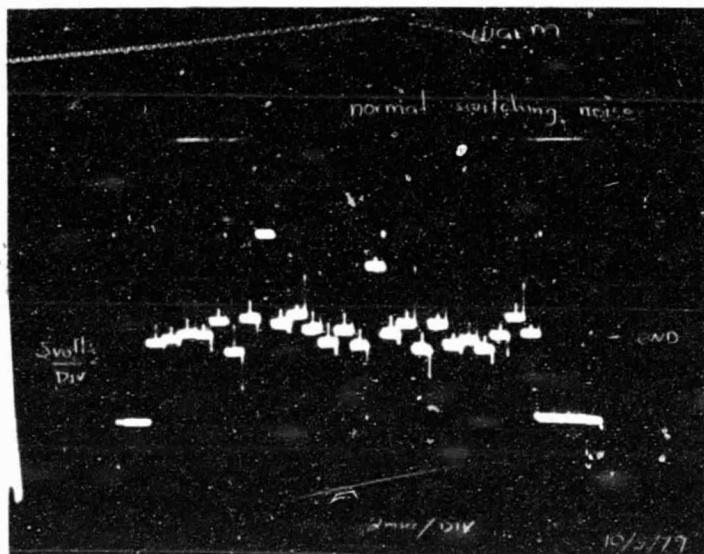
Normal Output Waveform of CMOS MUX at Room Temperature

Intensity Enhanced to Show Switching Noise of CMOS MUX - Room Temperature

Figure 10. CMOS MUX Waveforms

The normal waveforms of the CMOS multiplexer are shown in Figure 10. The "fixed pattern noise in Figure 10a is large due to the fact that 31 inputs of the CMOS are left open and only one is tied to a bias (detector and load resistor bias). In normal operation the active channel is biased to 0V thus allowing sufficient dynamic range both positive and negative. In Figure 10b the scope intensity is increased to highlight the switching spikes during dynamic operation. At 2.5 KHz the switching spikes contribute significant noise as seen in Figure 9. These spikes, however, do settle out quite fast as seen in the expanded time scale of the CMOS waveform in Figure 11a. The exact dependence of noise and gain on clock rate is unknown and should be investigated further. Also the measured noise should vary as a function of where the CMOS output is sampled in time; the closer to a switching spike, the noisier the results, obviously.

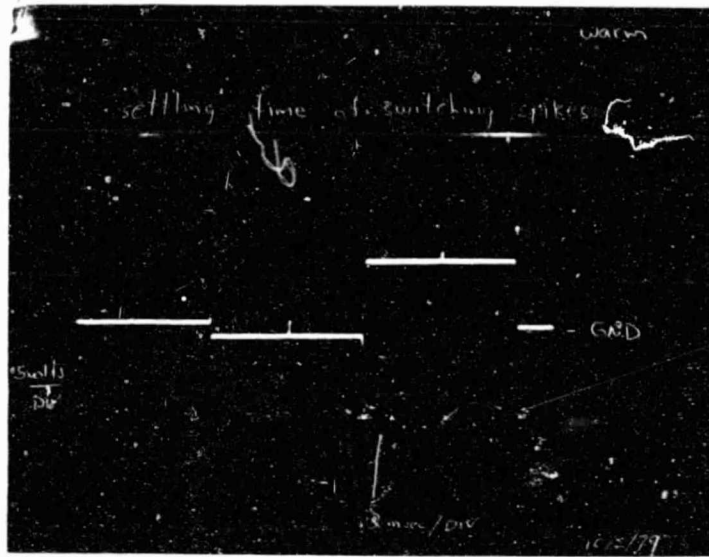
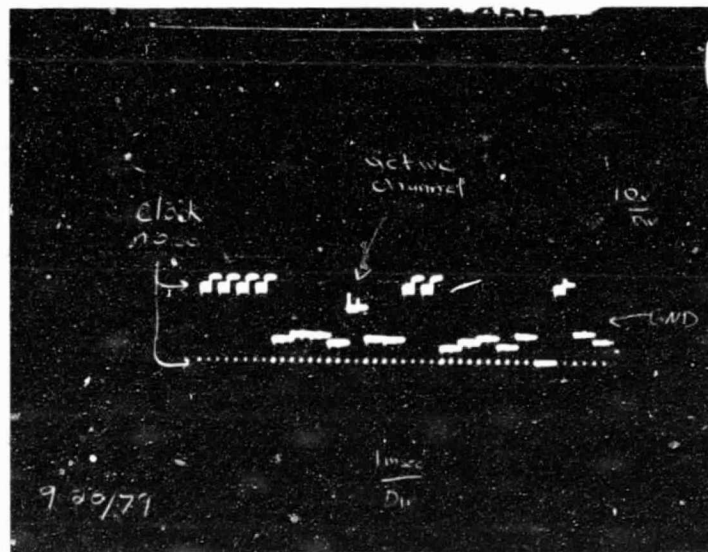
Expanded Time Scale to Show Settling Time of Normal CMOS MUX Switching Spikes - Room Temperature

Abnormal Switching Noise of CMOS MUX Channel #9 Active - Room Temperature

Figure 11. CMOS Multiplexer Waveforms

During rework of the module (Channel #13 to Channel #9 switch) additional degradation to the multiplexer occurred. This degradation appears as additional clock noise as seen in Figure 11b. Due to this degradation an additional CMOS multiplexer was attached to the module. Again Channel #13 was selected to be the active input channel (selected at random).

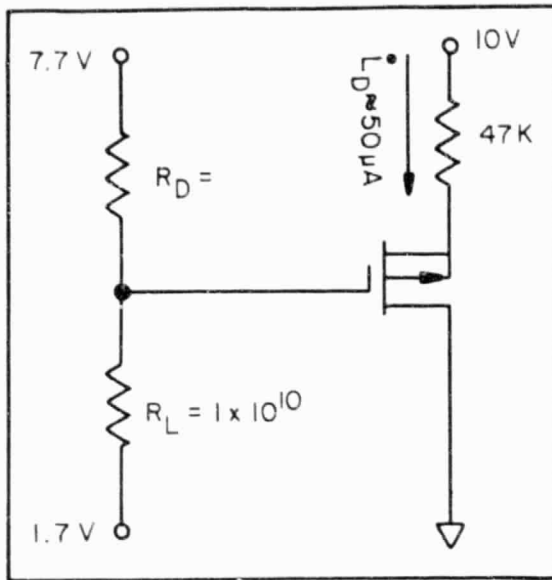
Figure 12. CMOS MUX Bias

This device was cooled for noise measurements at a more moderate background, $\sim 1.5 \times 10^{11}$ photons/cm²/sec. The bias circuit, voltages, and currents used at 12°K for the CMOS operation are shown in Figure 12. The bias circuit points out that the detector resistance in this case is very poor ($< 1 \times 10^9$) because the gate of the CMOS input appears to be at about 7.7 volts. Thus there is not bias across the detector

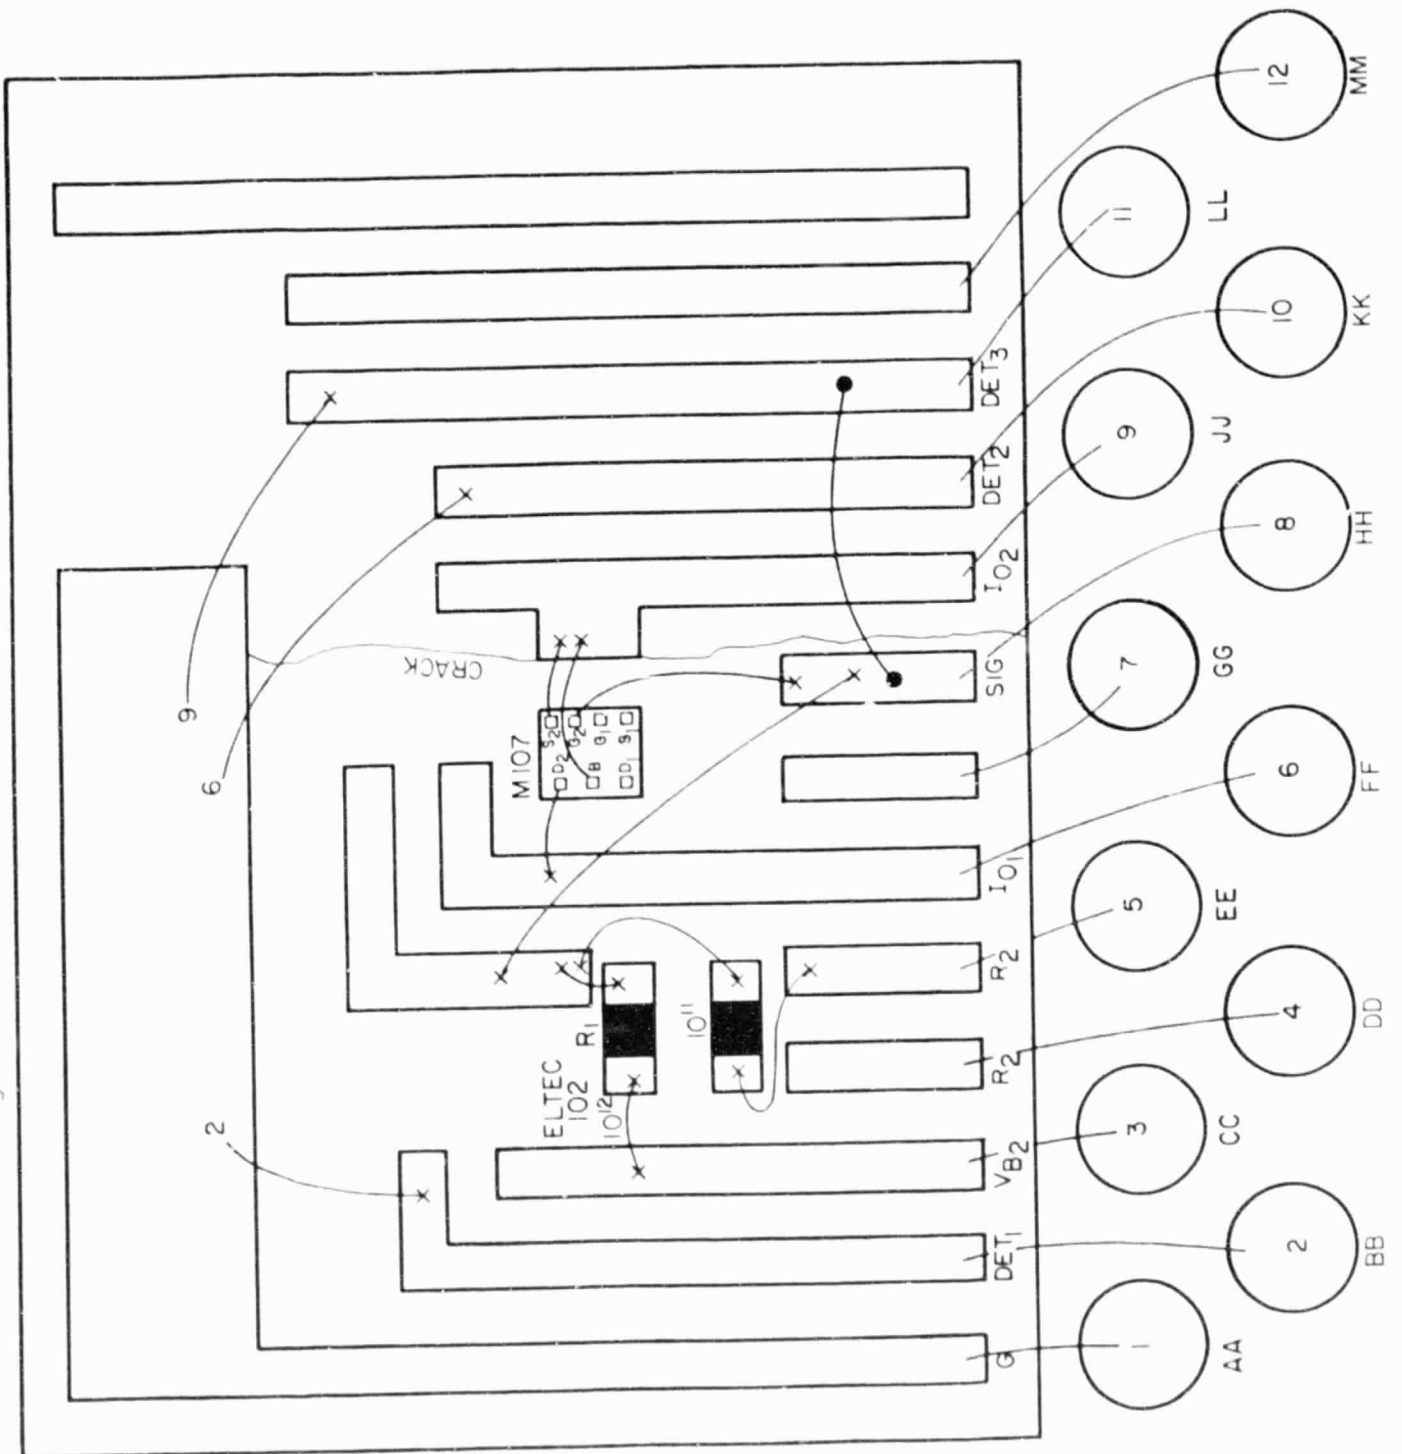
Figure 14. NASA Ames - Module #1

This module is untested, however, the CMOS chip has been cleaned since it was discovered that dust particles had settled on the chip. The CMOS preamps were received from the manufacturer in this condition, therefore it is hoped that the cleaning will improve the input impedance and allow load resistors in the 1×10^{11} to $1 \times 10^{12} \Omega$ range. A schematic of Module #1 is shown in Figure 14.

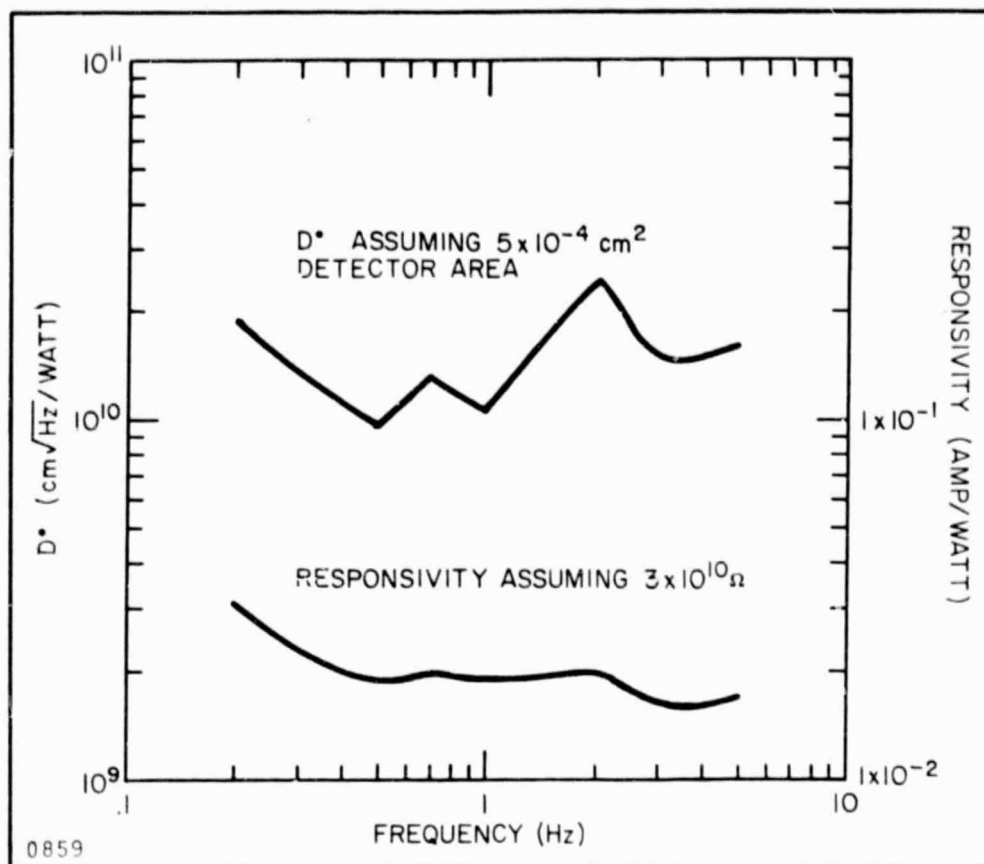
Figure 16. M107 #3 Radiometric Test

At 2°K the load resistor was assumed to be the limiting impedance (detector higher impedance) at $1 \times 10^{10} \Omega$. Responsivity is calculated to be in the range of 34 ma/watt to 60 ma/watt as shown in Figure 16. The corresponding D^* is in the range between 2×10^{10} and $5 \times 10^{10} \text{ cm } \sqrt{\text{Hz}}/\text{watt}$. The D^* BLIP for this experiment is approximately $2 \times 10^{13} \text{ cm } \sqrt{\text{Hz}}/\text{watt}$, or 3 orders of magnitude greater than measured (assuming a quantum efficiency of .5). The theoretical D^* associated with the Johnson noise from a $3 \times 10^{10} \Omega$ load resistor is

It appears that this detector is an order of magnitude low on responsivity and more than 3 orders of magnitude high in noise.
