DEGRADATION MECHANISMS IN ALUMINUM MATRIX COMPOSITES ALUMINA/ALUMINUM AND BORON/ALUMINUM

A thesis submitted to the Graduate Faculty of North Carolina State University at Raleigh in partial fulfillment of the requirements for the Degree of Doctor of Philosophy

DEPARTMENT OF MECHANICAL AND AEROSPACE ENGINEERING

FIVE BORON/ALUMINUM COMPOSITES: LONG-TERM THERMAL DEGRADATION AND ALLOYING CONSTITUENT EFFECTS¹

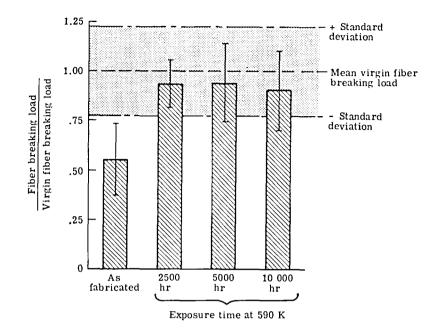
Figure 9.- $\alpha Al_{2}0_{3}$ fiber breaking loads after removal from composite specimens thermally exposed at 590 K.

Fibers chemically removed from the composite matrix were individually tensile tested. Mean values and standard deviations of the breaking loads from 10 tests at each condition are shown in figure 9. These data show that fiber strength lost during fabrication is nearly restored to its virgin strength by isothermal exposure. Apparently thermal exposure enhances the movement and annihilation of the vacancies formed during fabrication.

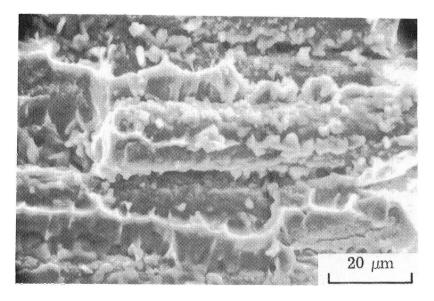
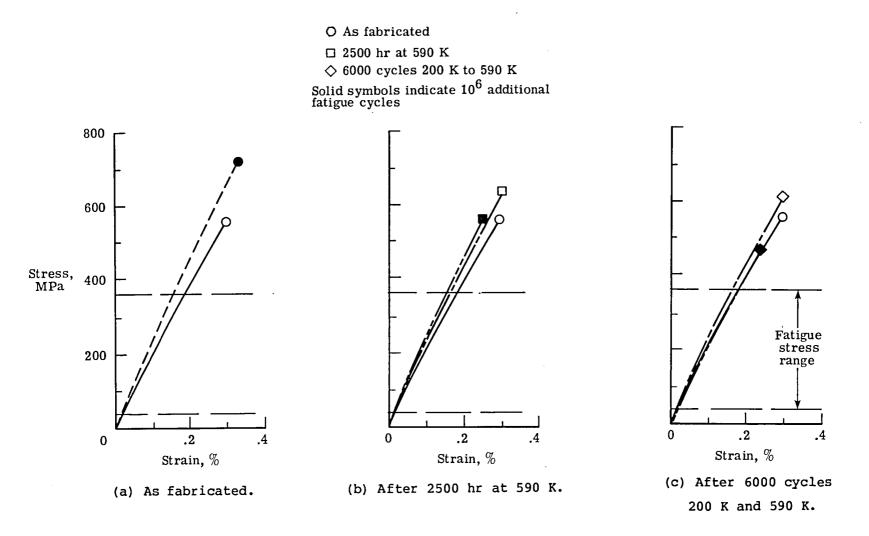
Figure 11.- Typical fracture surfaces of α Al₂0₃/Al composite specimens after 6000 thermal cycles between 200 K and 590 K.

Longitudinal and transverse tensile fractographs of the thermally cycled specimens are shown in figure 11. The longitudinal surface (fig. 11(a)) was rough and had matrix shear steps but very little bare fiber was exposed. Matrix material was still adhering to the fiber indicating that the interface was stronger than the matrix. The transverse fracture surface (fig. 11(b)) shows tear ridges between fibers and a dense population of small fragments of the matrix attached to the fibers. These fragments appear to be the result of accumulated crack damage in the matrix incurred during thermal cycling. The angularity of the fragments suggest brittle failure probably occurring at the low temperature as a result of stresses induced by the differential in thermal expansion between the matrix and fiber.

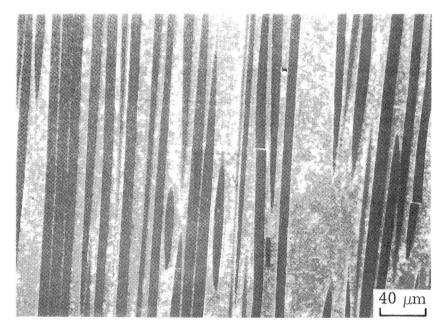
Figure 14.- Typical longitudinal tensile fracture surfaces of $\alpha Al_20_3/Al$ composite specimens after 10⁶ fatigue cycles.

Fractographs of the fatigue cycled specimens are shown in figure 14. Comparison of as-fabricated specimen failure surfaces with fatigue (fig. 14(a)) and without fatigue (fig. 2) shows an apparent work hardening of the matrix material. There is less ductile necking of the matrix and flatter more brittle failure of the fibers. The overall failure surface is flatter and there is no apparent fatigue-induced damage. These same observations are true when comparing specimens exposed for 2500 hours at 590 K with fatigue (fig. 14(b)) and without fatigue (fig. 7(a)) and specimens thermally cycled with fatigue (fig. 14(c)) and without fatigue (fig. 11(a)). The effect of fatigue cycling on the specimens is more readily seen in the polished and etched longitudinal cross sections shown in figure 15. As-fabricated specimens with and without fatigue (fig. 15(a)) are identical in appearance and show no indication of fatigue induced damage. Comparison of specimens exposed for 2500 hours at 590 K with and without fatigue (fig. 15(b)) does show fatigueinduced damage. The specimen with fatigue has cracking in the matrix and fibers not present prior to fatigue cycling. The thermally cycled specimen without fatigue (fig. 15(c)) has extensive cracking in the matrix and fibers induced by the thermal expansion mismatch, but the

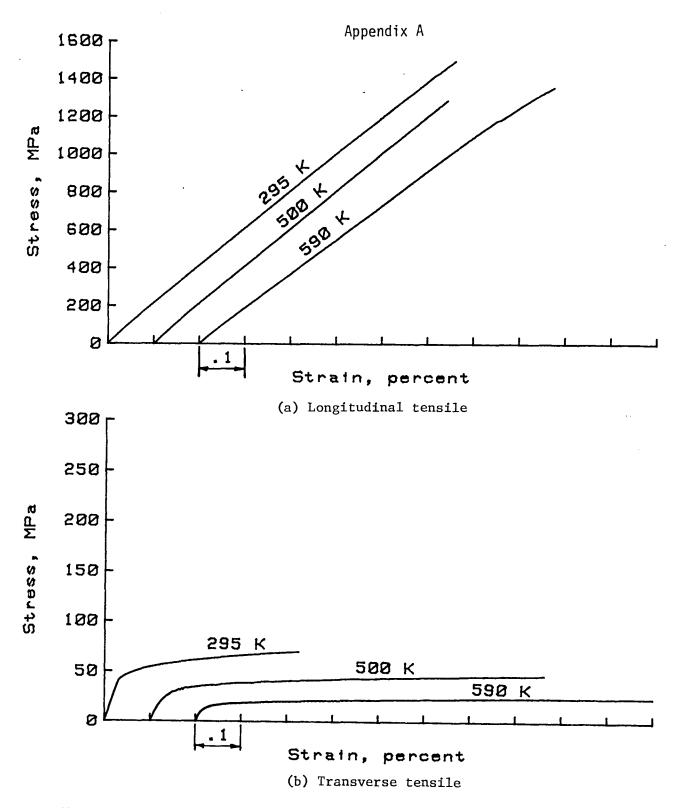
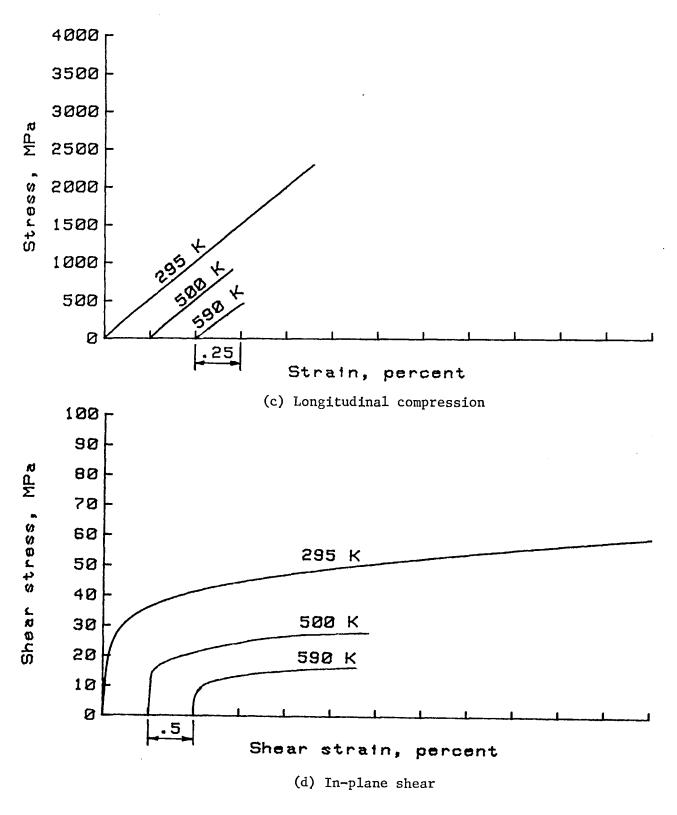
Figure A-1.- Typical elevated test temperature stress-strain curves for B/1100 A1 composite.

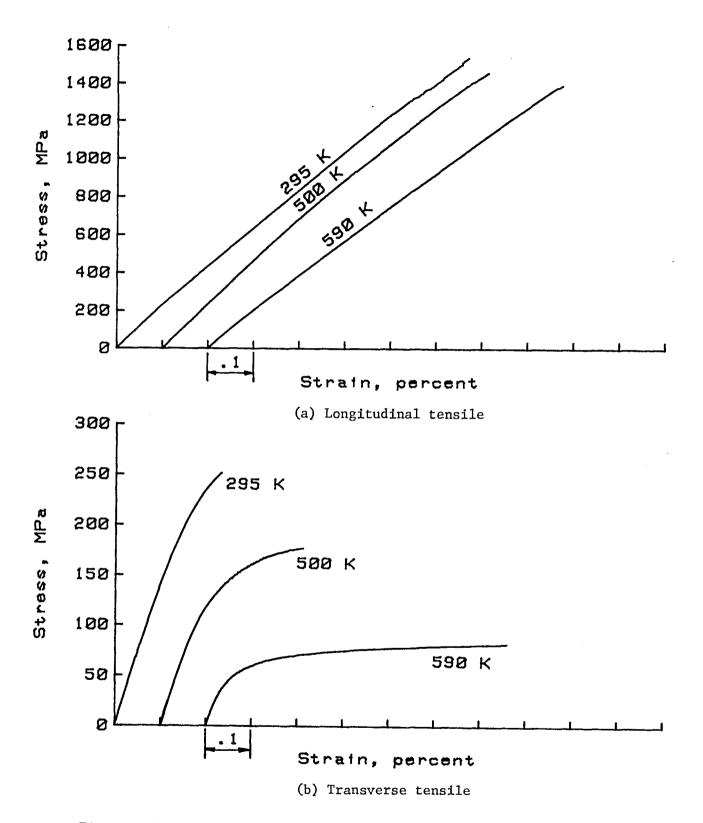
Figure A-2.- Typical elevated test temperature stress-strain curves for B/2024 Al composite.

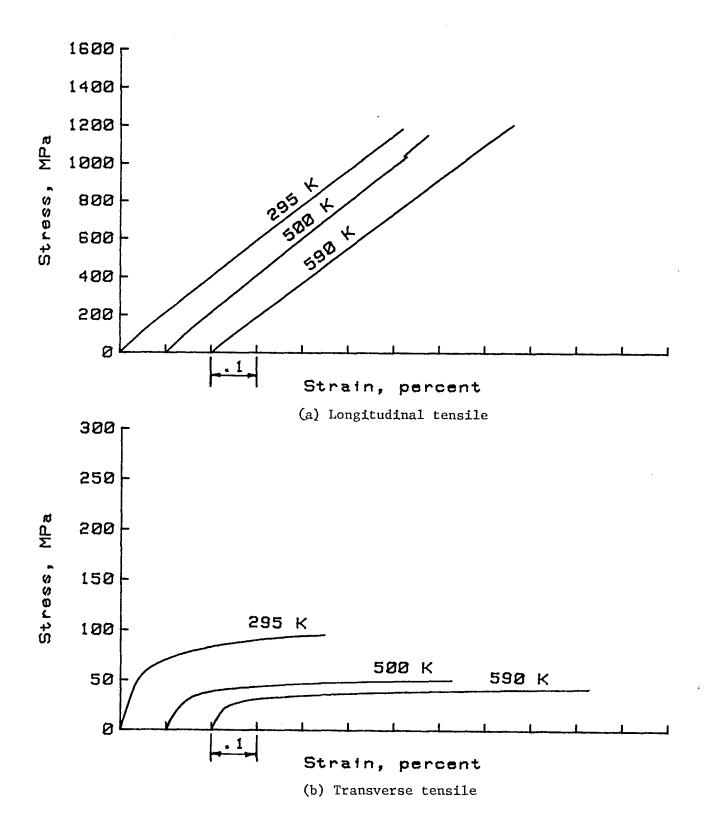
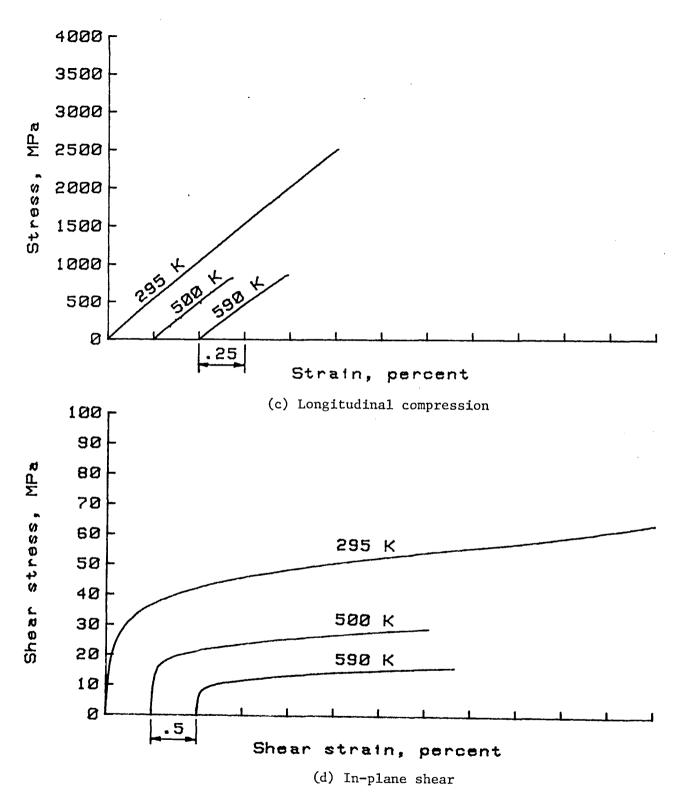
Figure A-3.- Typical elevated test temperature stress-strain curves for B/3003 A1 composite.

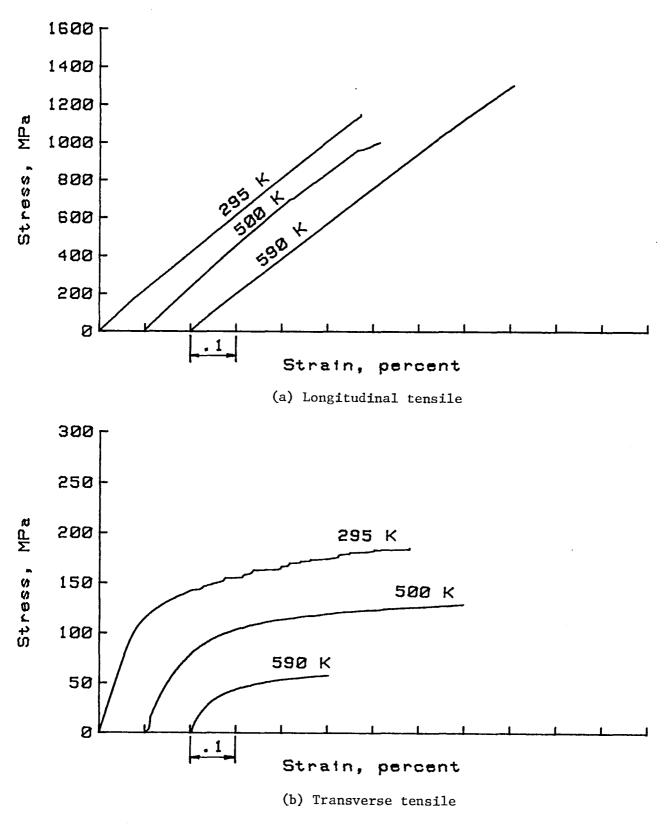
Figure A-4.- Typical elevated test temperature stress-strain curves for B/5052 Al composite.

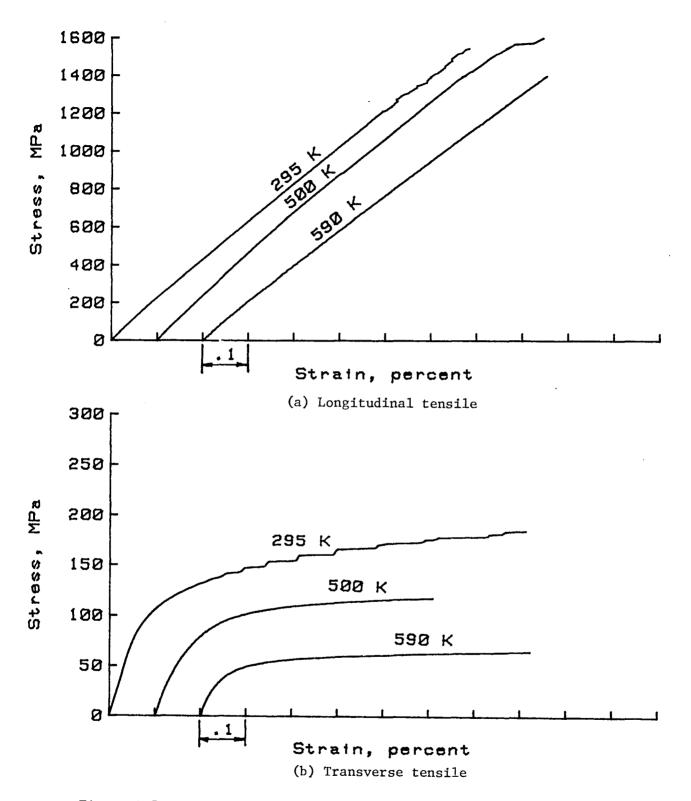
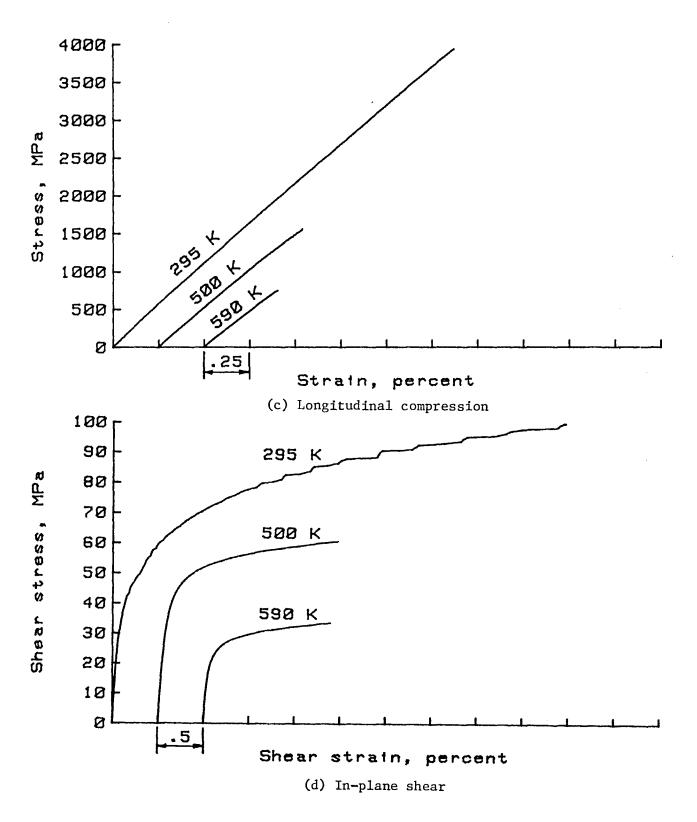
Figure A-5.- Typical elevated test temperature streee-strain curves for B/6061 Al composite.

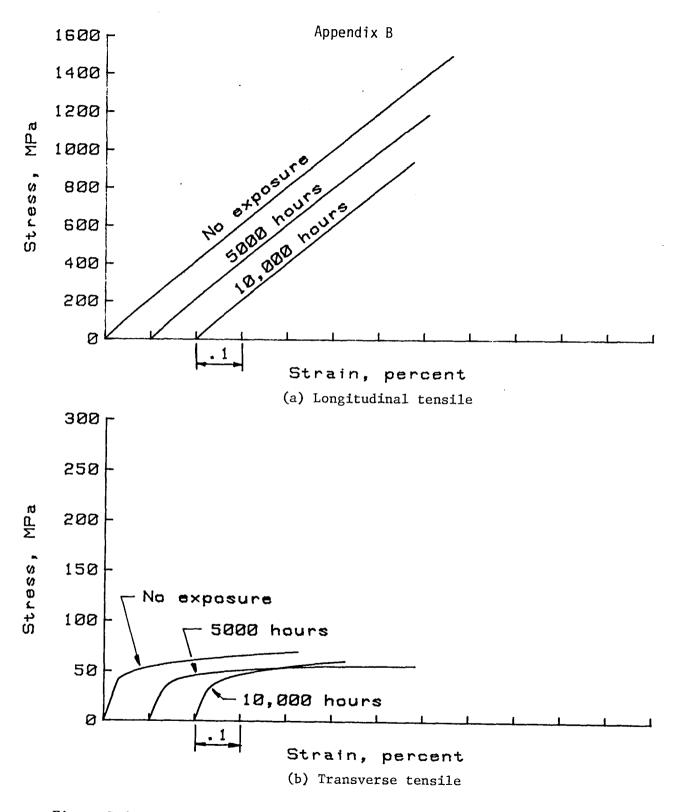
Figure B-1.- Typical room temperature stress-strain curves for B/1100 A1 composite material exposed at 500 K.

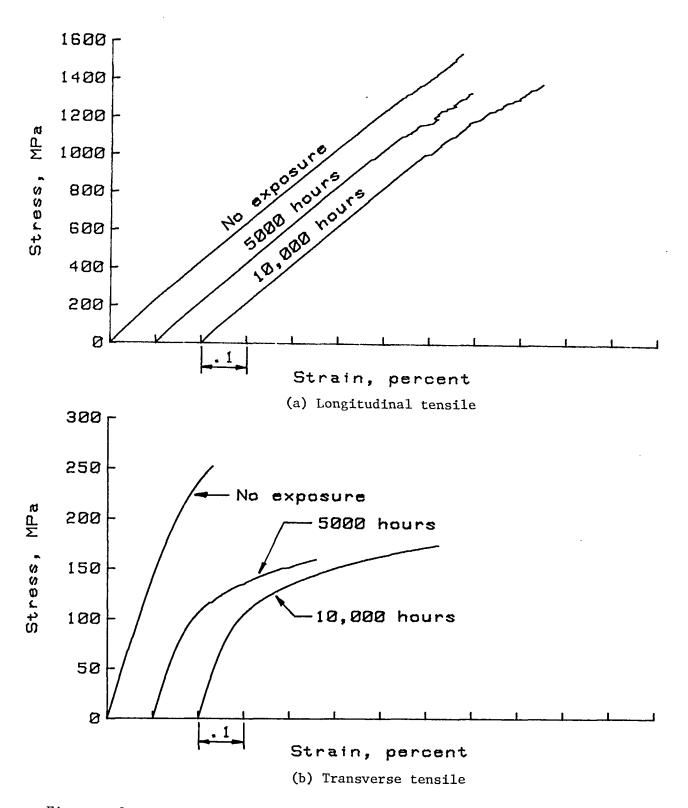
Figure B-2.- Typical room temperature stress-strain curves for B/2024 Al composite material exposed at 500 K.

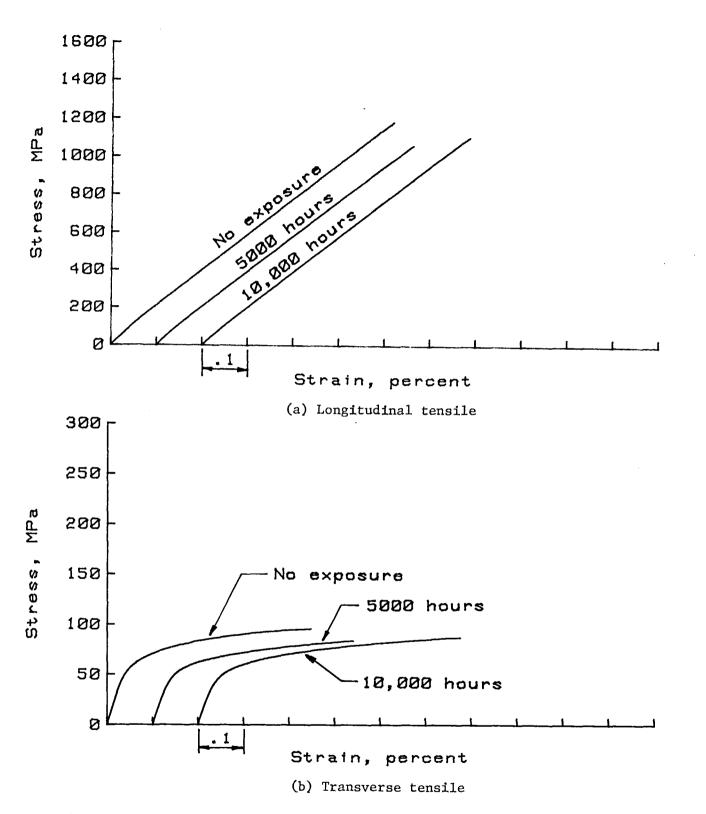
Figure B-3.- Typical room temperature stress-strain curves for B/3003 A1 composite material exposed at 500 K.

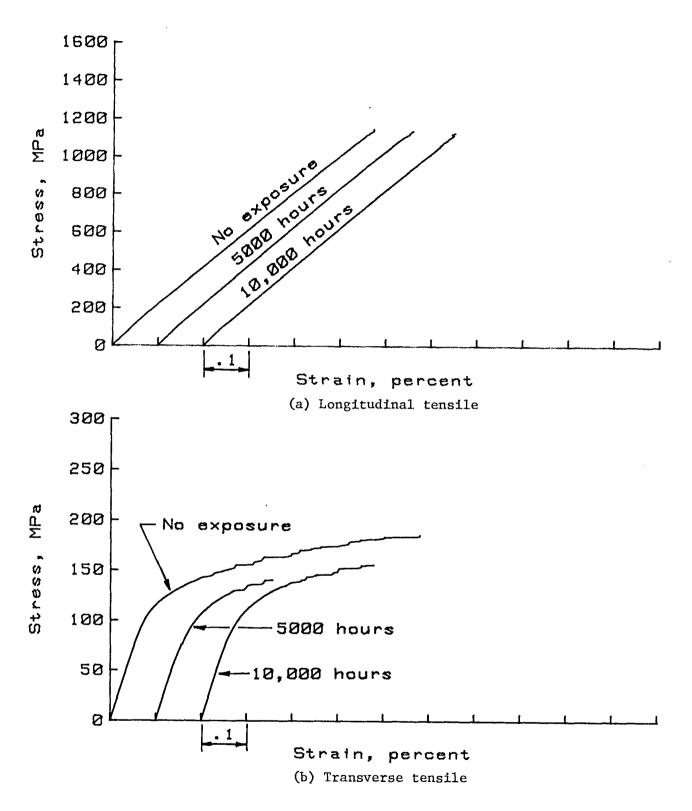
Figure B-4.- Typical room temperature stress-strain curves for B/5052 Al composite material exposed at 500 K.

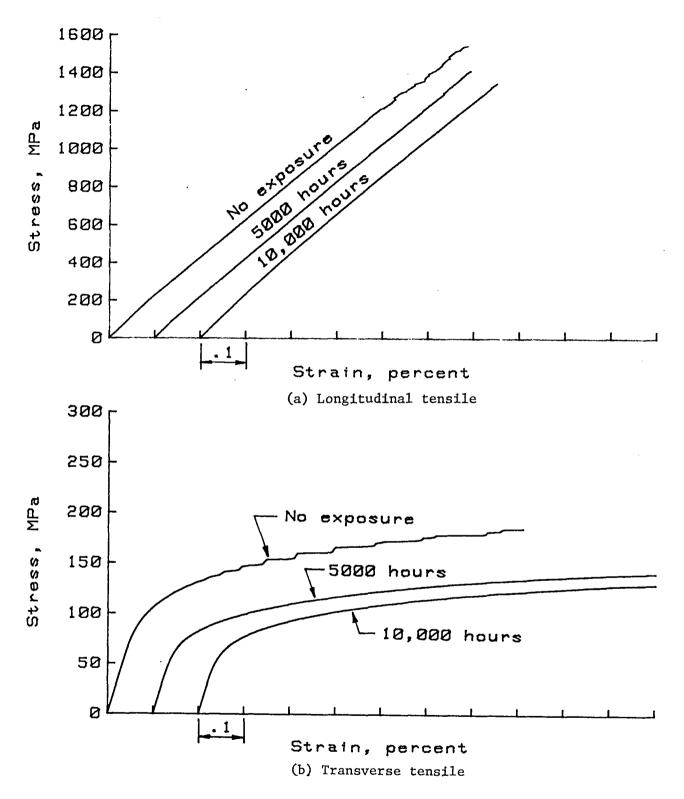
Figure B-5.- Typical room temperature stress-strain curves for B/6061 Al composite material exposed at 500 K.

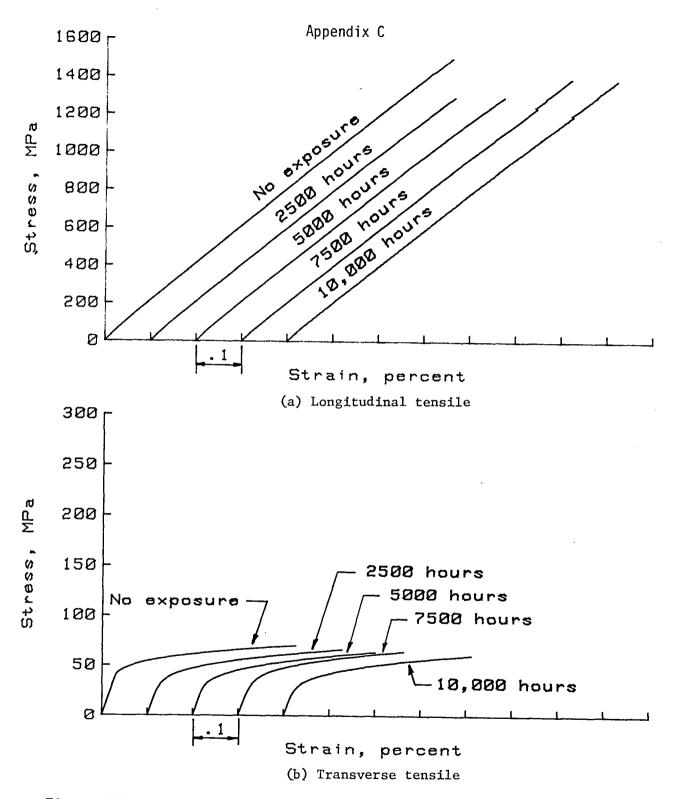
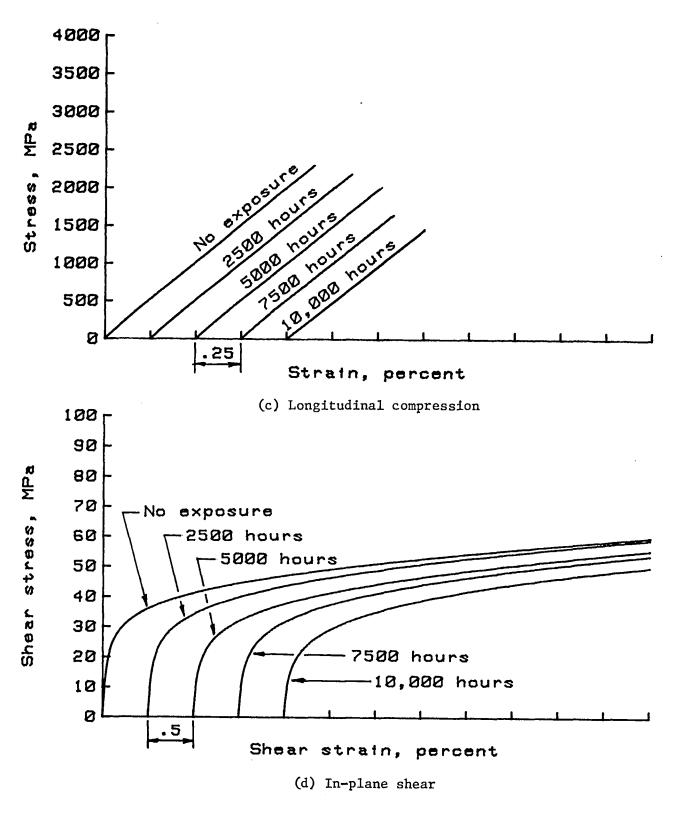
Figure C-1.- Typical room temperature stress-strain curves for B/1100 A1 composite material exposed at 590 K.

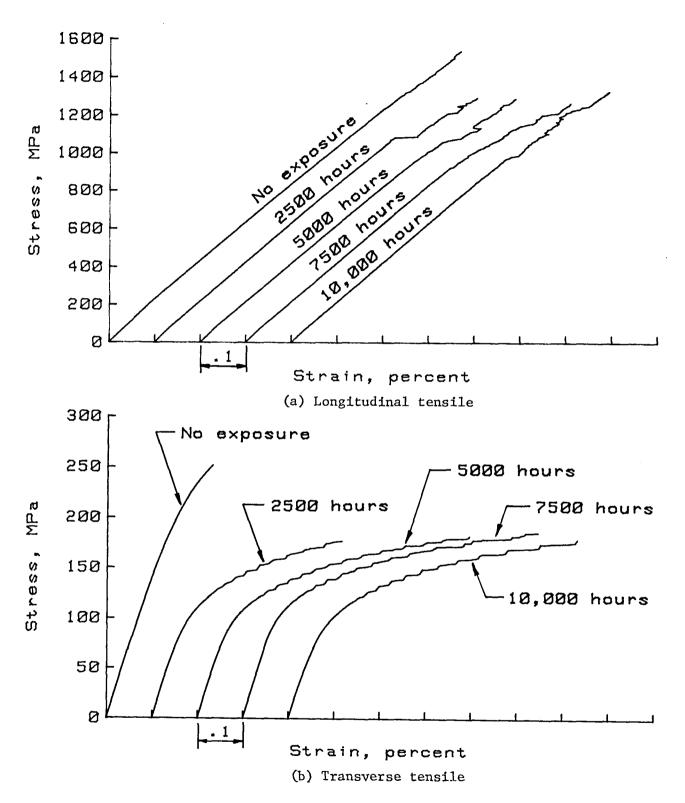
Figure C-2.- Typical room temperature stress-strain curves for B/2024 A1 composite material exposed at 590 K.

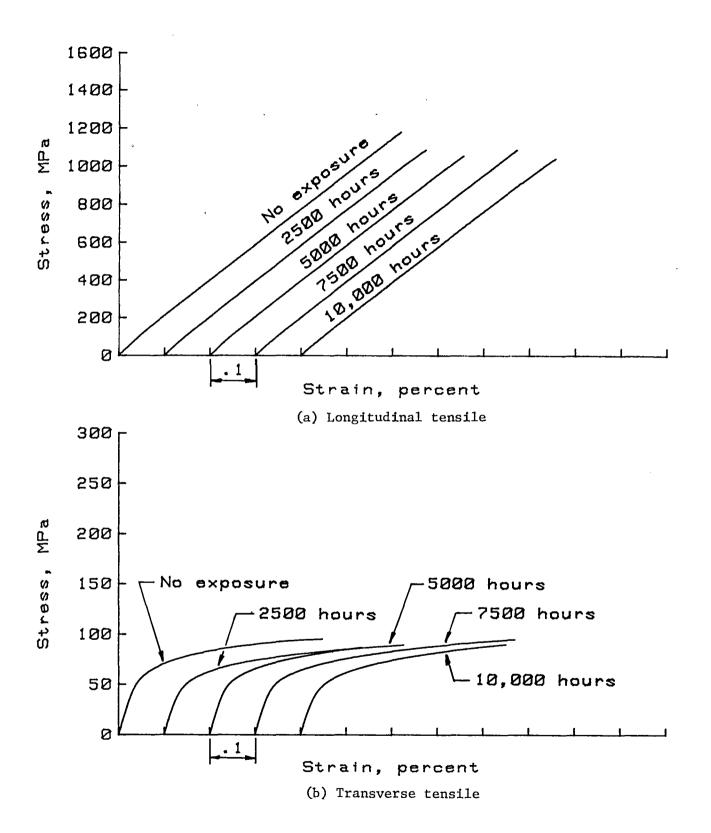
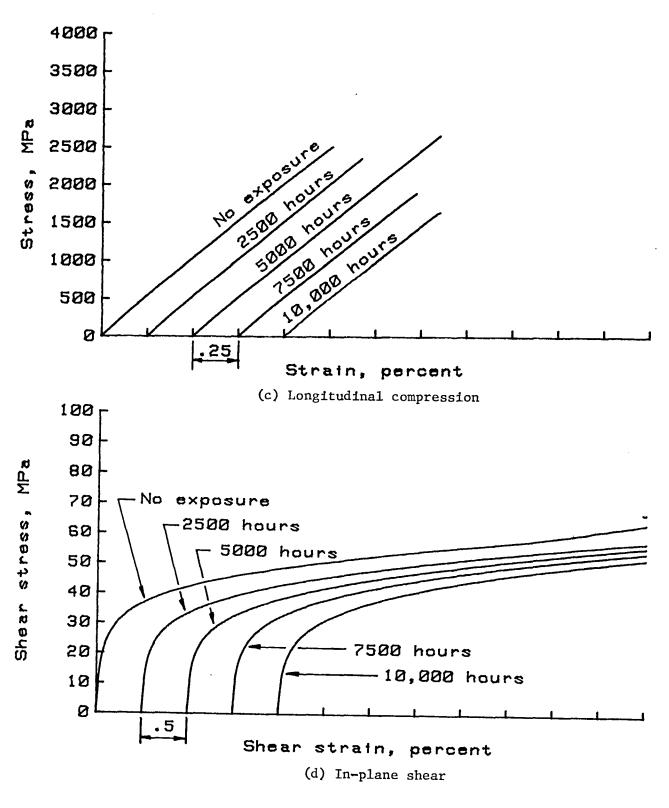
Figure C-3.- Typical room temperature stress-strain curves for B/3003 A1 composite material exposed at 590 K.

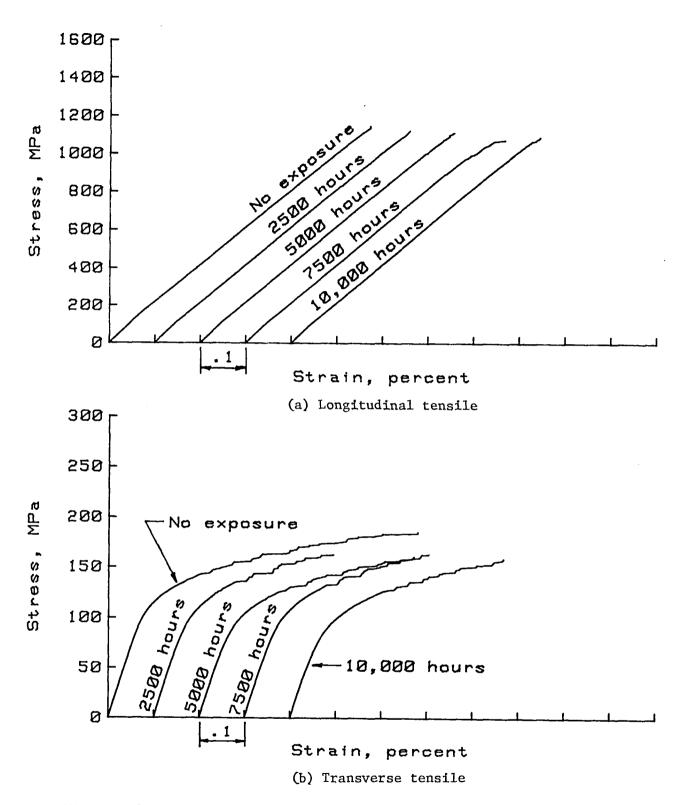
Figure C-4.- Typical room temperature stress-strain curves for B/5052 Al composite material exposed at 590 K.

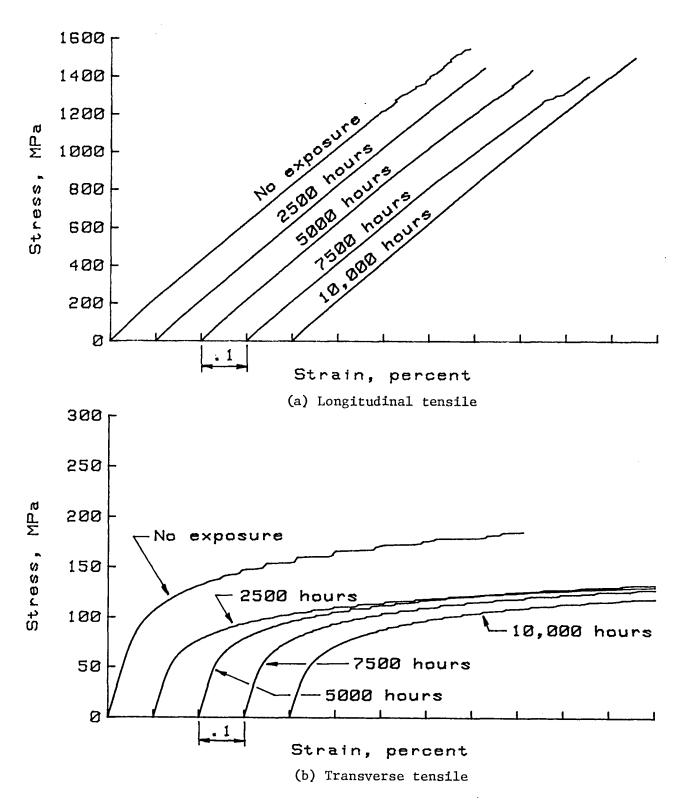
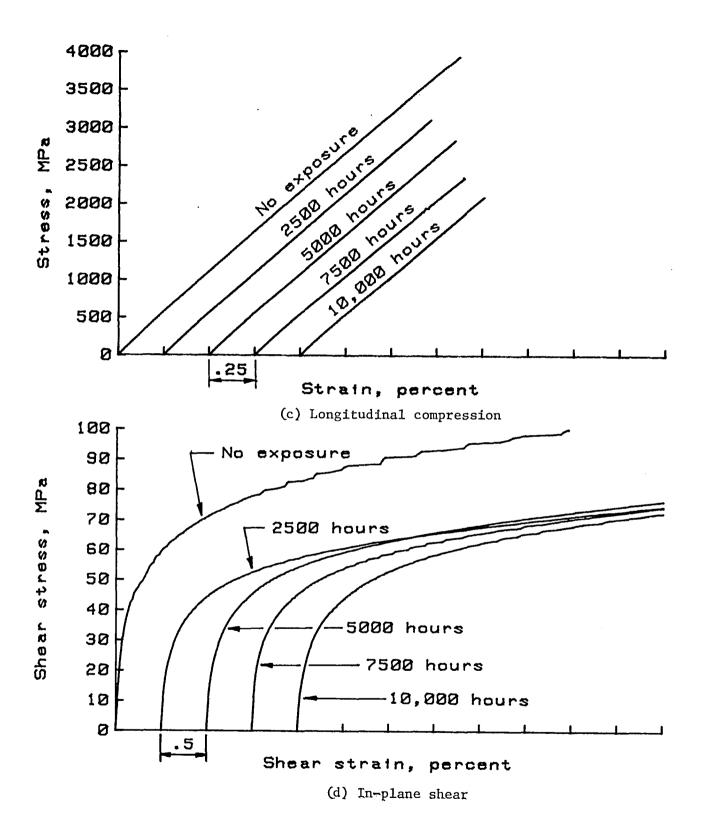
Figure C-5.- Typical room temperature stress-strain curves for B/6061 A1 composite material exposed at 590 K.

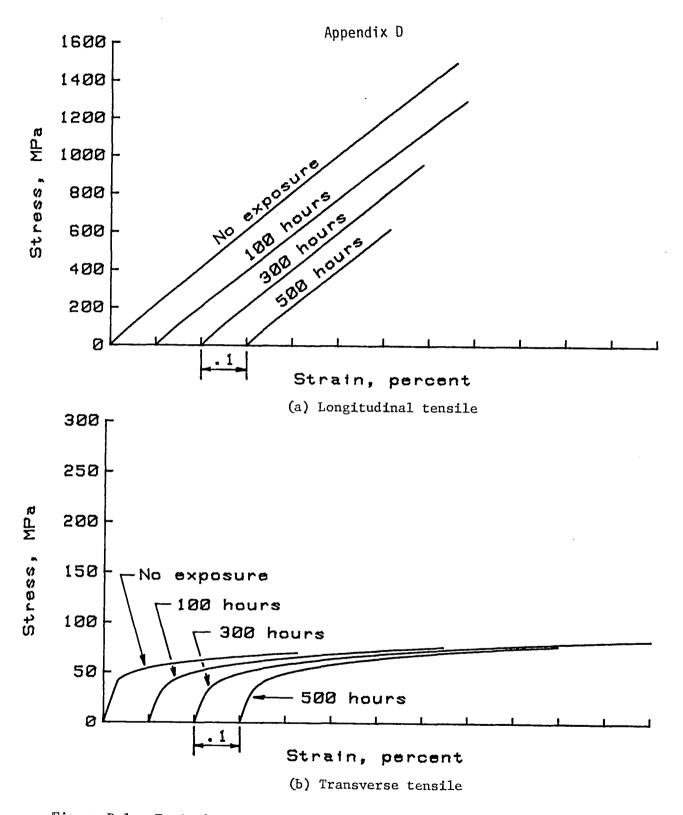
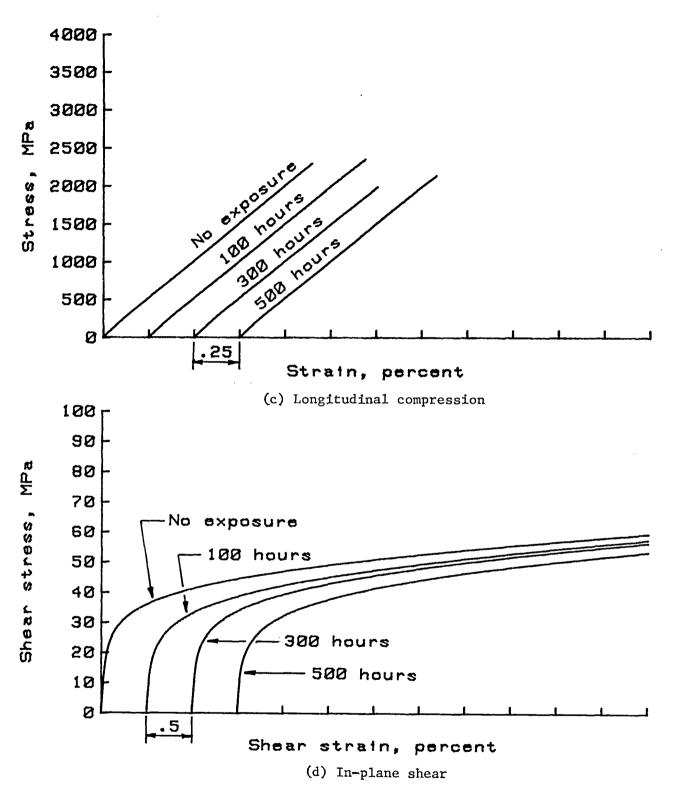
Figure D-1.- Typical room temperature stress-strain curves for B/1100 A1 composite material exposed at 730 K.

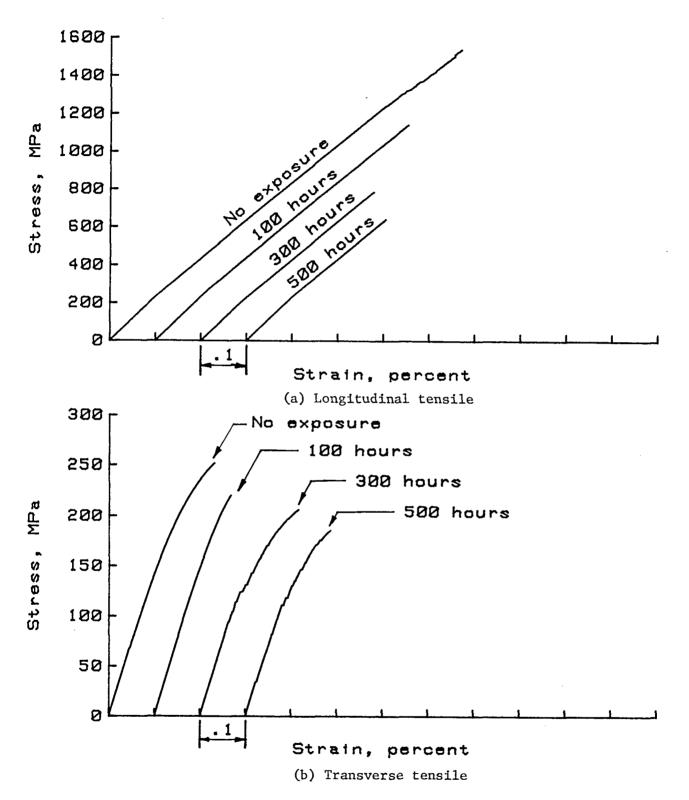
Figure D-2.- Typical room temperature stress-strain curves for B/2024 Al composite material exposed at 730 K.

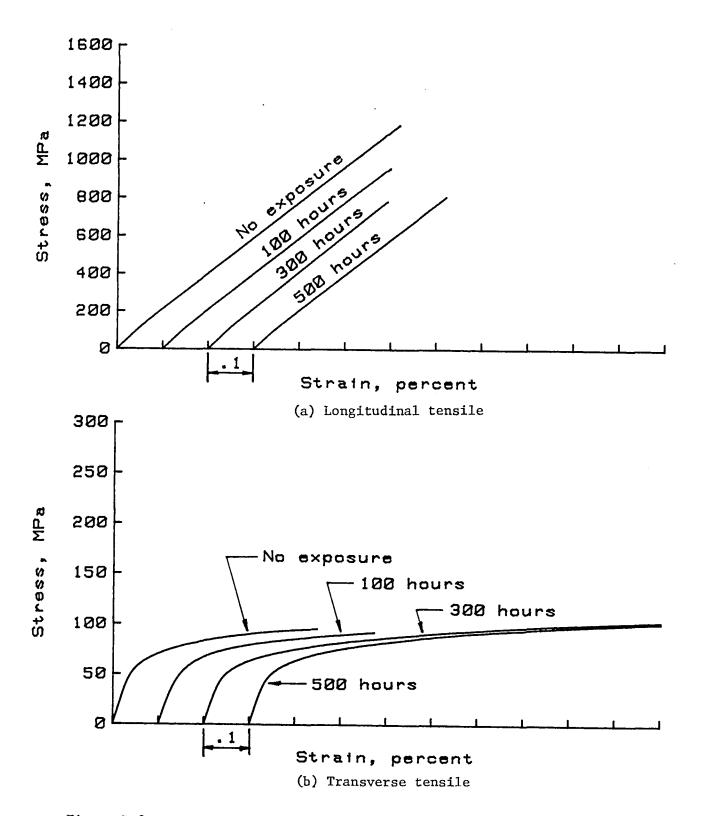
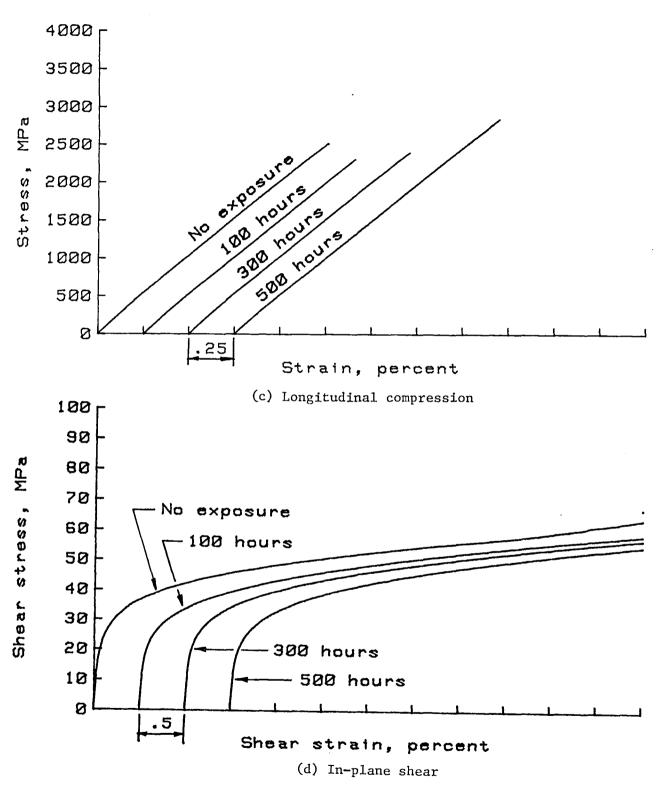
Figure D-3.- Typical room temperature stress-strain curves for B/3003 Al composite material exposed at 730 K.

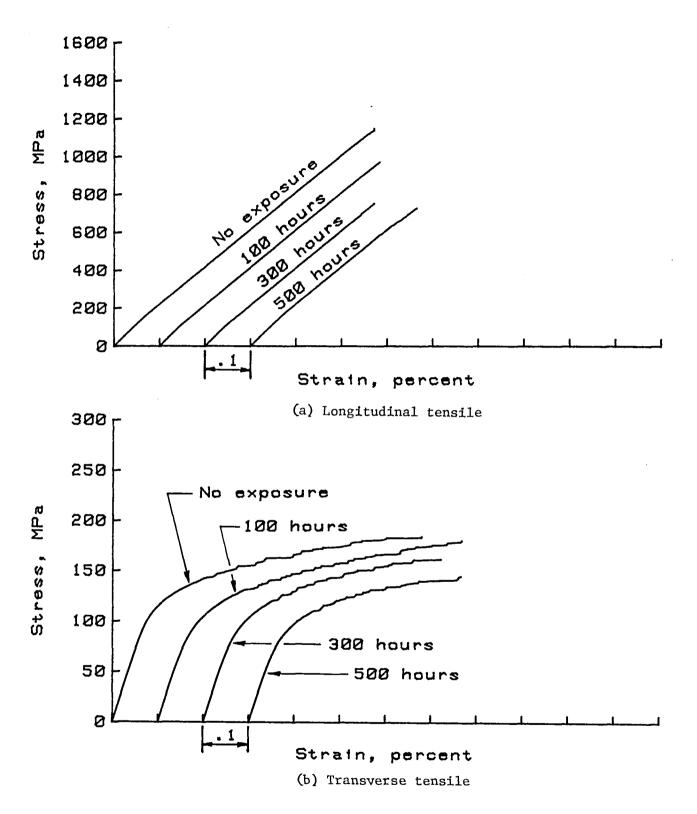
Figure D-4.- Typical room temperature stress-strain curves for B/5052 A1 composite material exposed at 730 K.

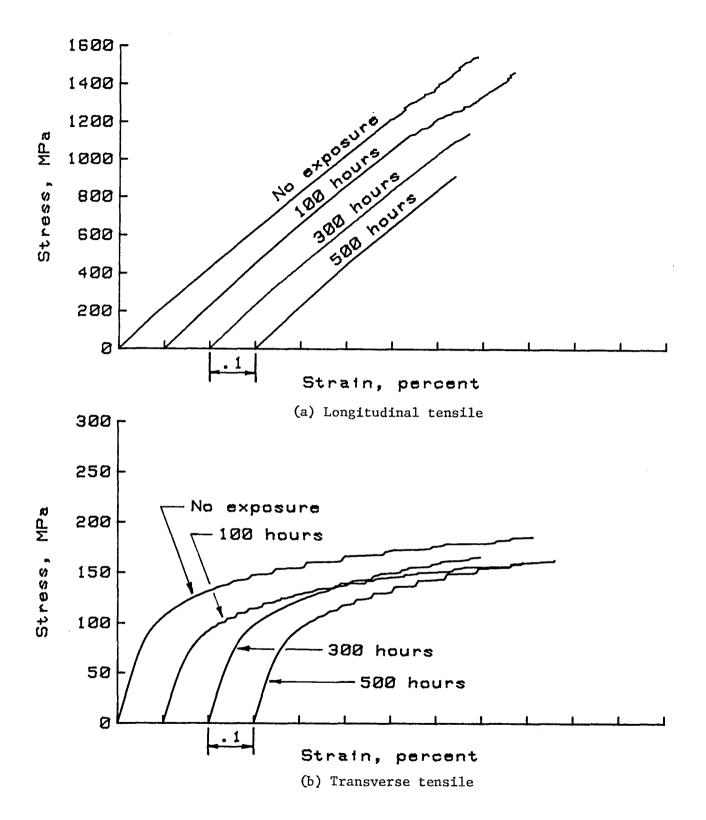
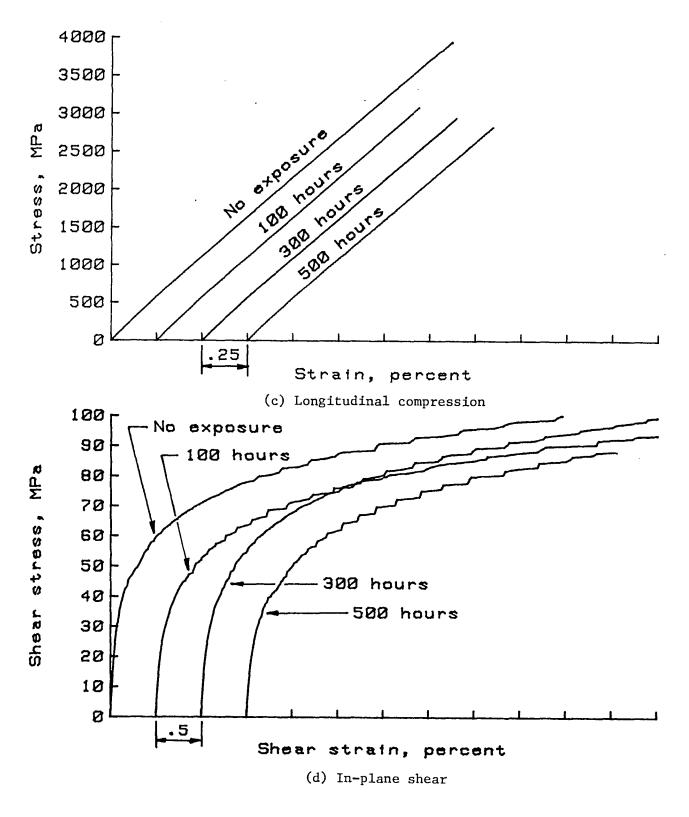
Figure D-5.- Typical room temperature stress-strain curves for B/6061 Al composite material exposed at 730 K.

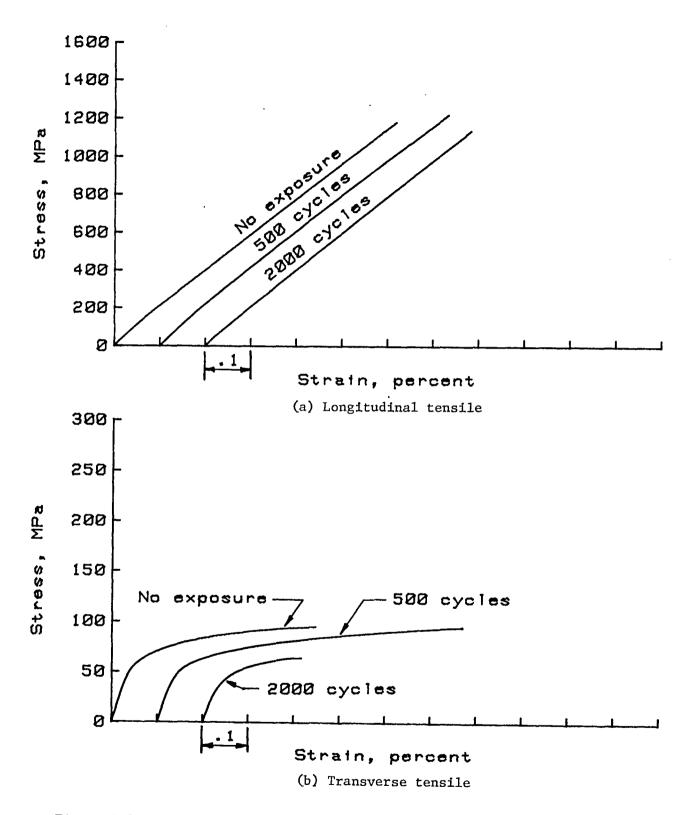
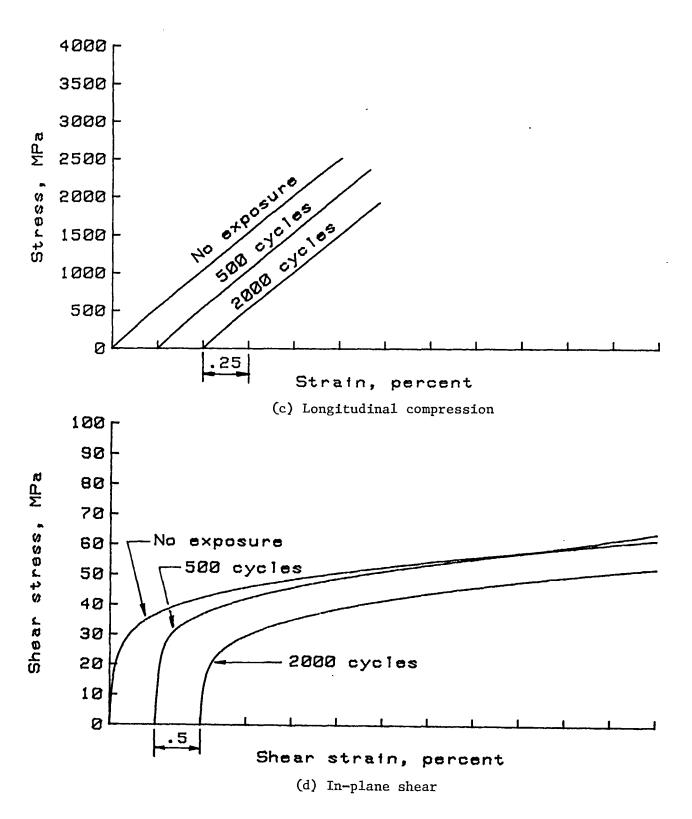
Figure E-3.- Typical room temperature stress-strain curves for B/3003 Al composite material thermally cycled between 200 K and 590 K.

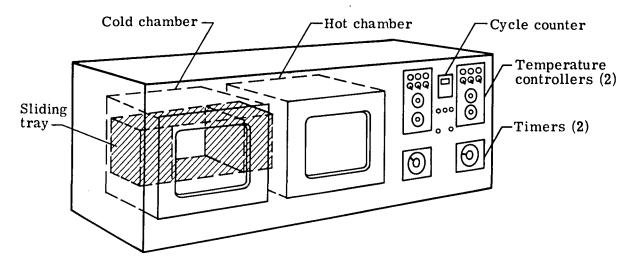
(a) Thermal cycling apparatus.

Figure 1.- Thermal cycling exposure.

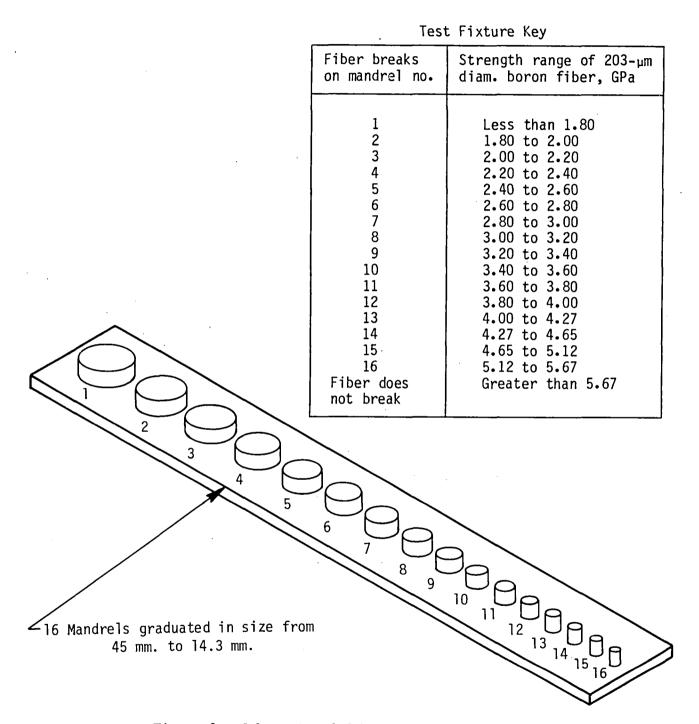
Figure 2.- Schematic of fiber bend-test fixture.

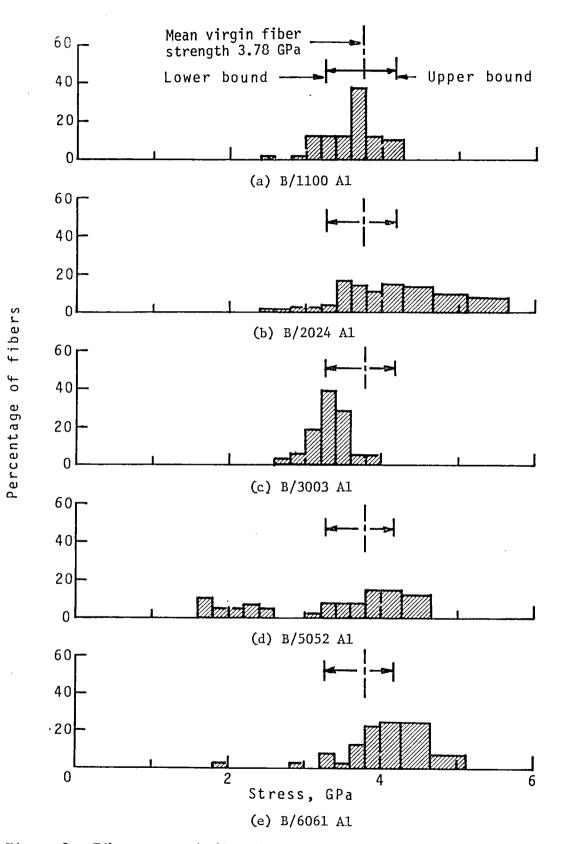
Figure 3.- Fiber strength distributions for as-fabricated composites.

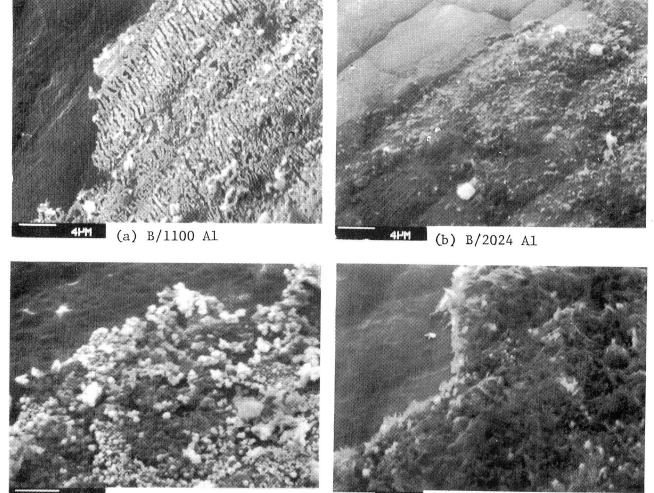
Figure 4.- Reaction layers on fibers removed from as-fabricated composite specimens.

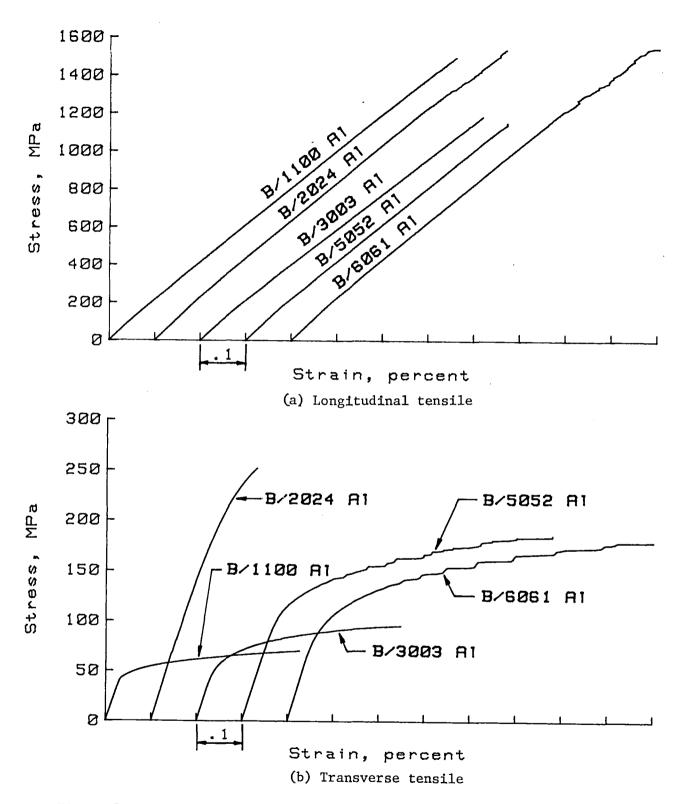
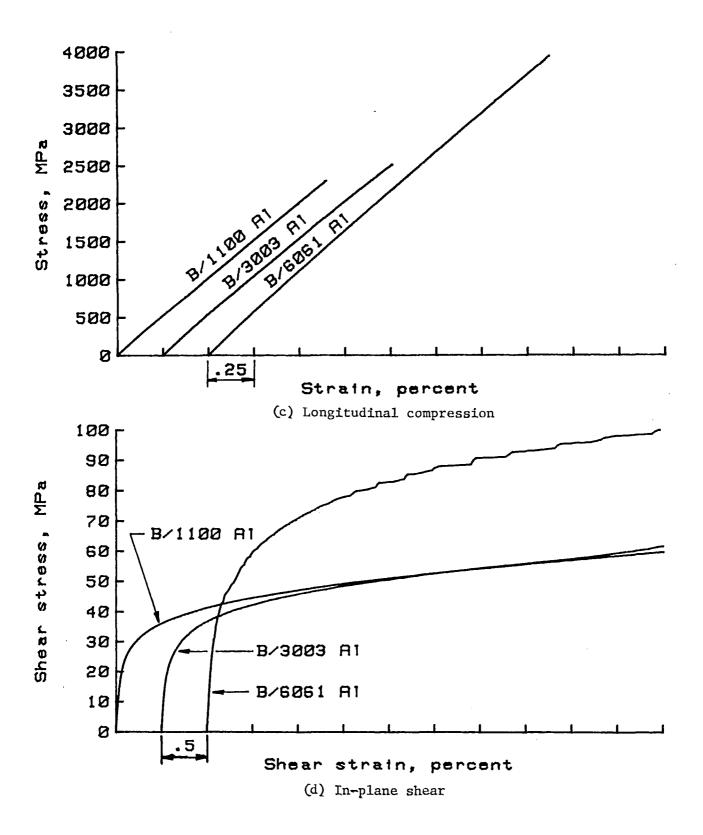
Figure 5.- Typical room temperature stress-strain curves for as-fabricated B/Al composites.

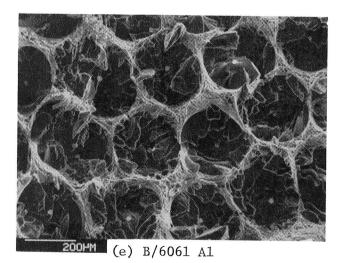
Figure 6.- Longitudinal fracture surfaces of as-fabricated specimens.

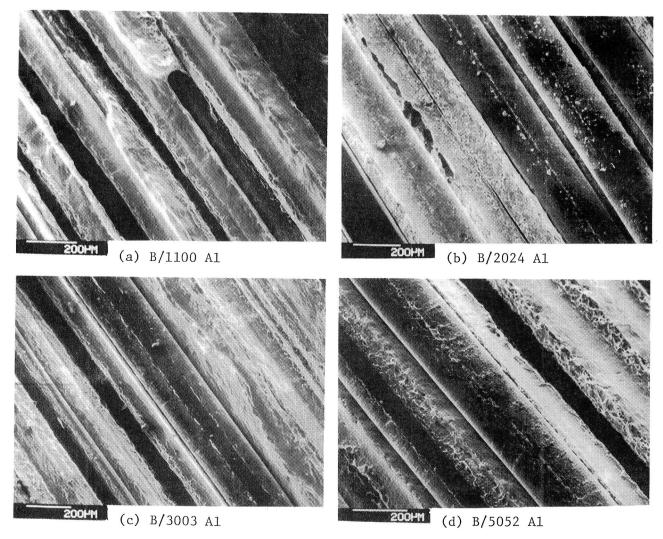
Figure 7.- Transverse fracture surfaces of as-fabricated specimens.
