DEGRADATION MECHANISMS IN ALUMINUM MATRIX COMPOSITES ALUMINA/ALUMINUM AND BORON/ALUMINUM

A thesis submitted to the Graduate Faculty of North Carolina State University at Raleigh in partial fulfillment of the requirements for the Degree of Doctor of Philosophy

DEPARTMENT OF MECHANICAL AND AEROSPACE ENGINEERING

FIVE BORON/ALUMINUM COMPOSITES: LONG-TERM THERMAL DEGRADATION AND ALLOYING CONSTITUENT EFFECTS¹

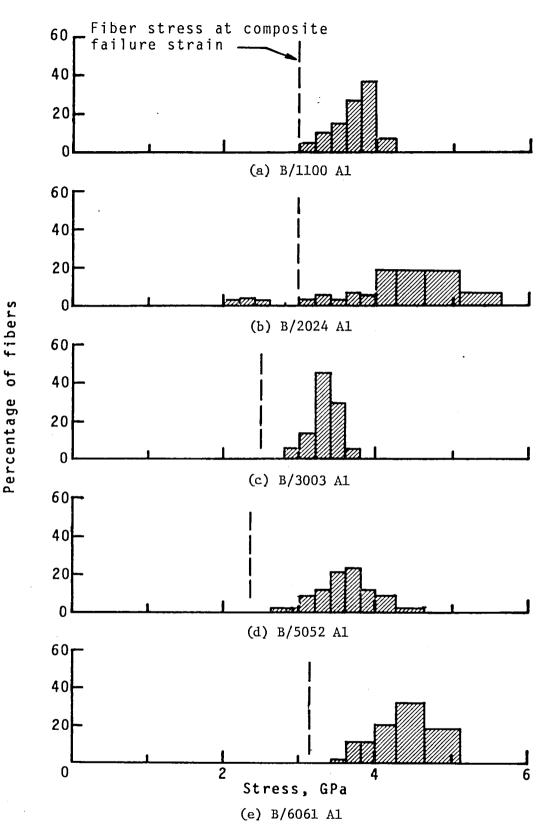
Figure 8.- Residual fiber strength distribution for as-fabricated composites after tensile testing.

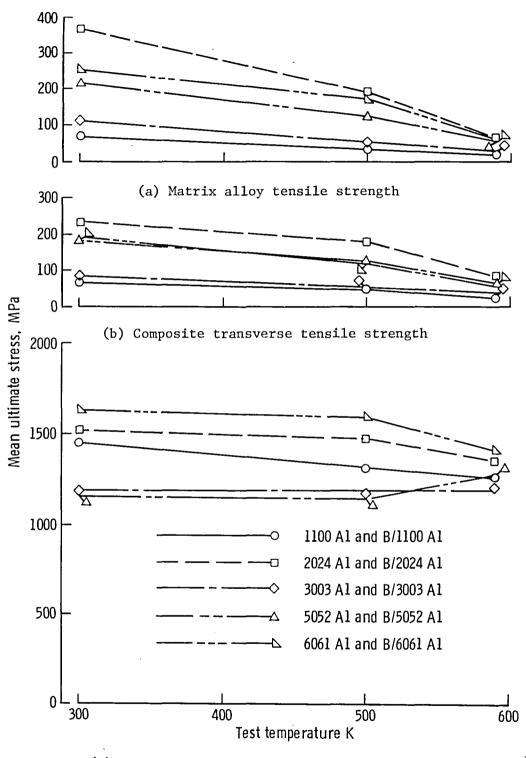
Figure 9.- Effect of elevated test temperature on the mean ultimate strengths of B/Al composites.

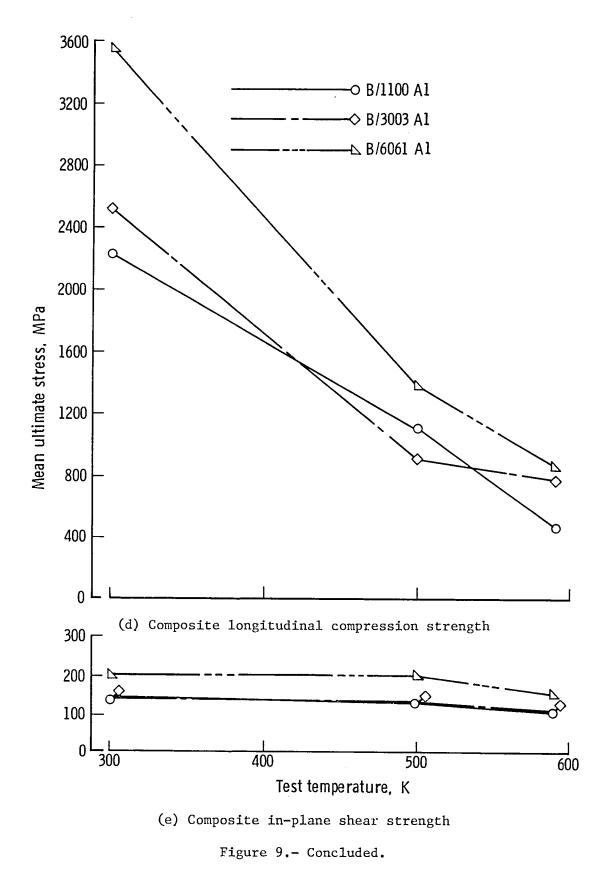
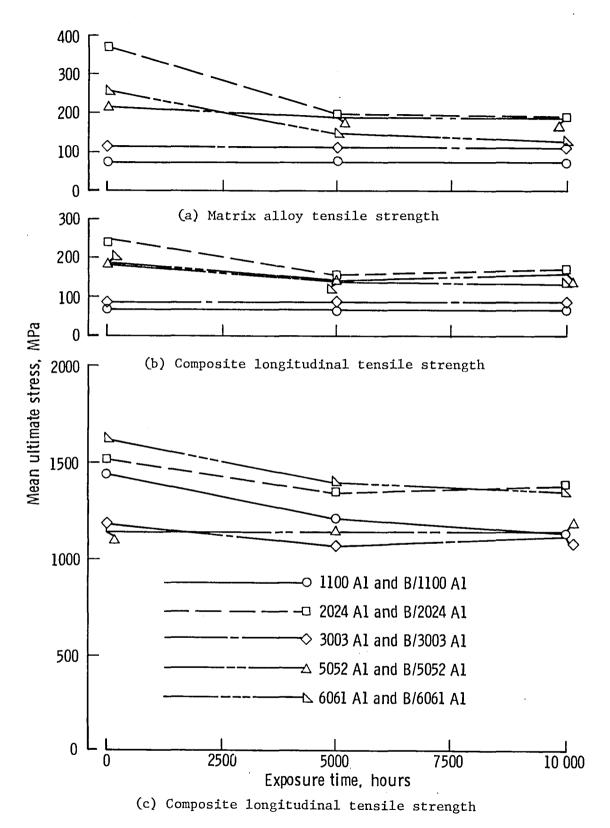
Figure 10.- Effect of isothermal exposure at 500 K on the ultimate stress of B/Al composites and their matrix alloys.

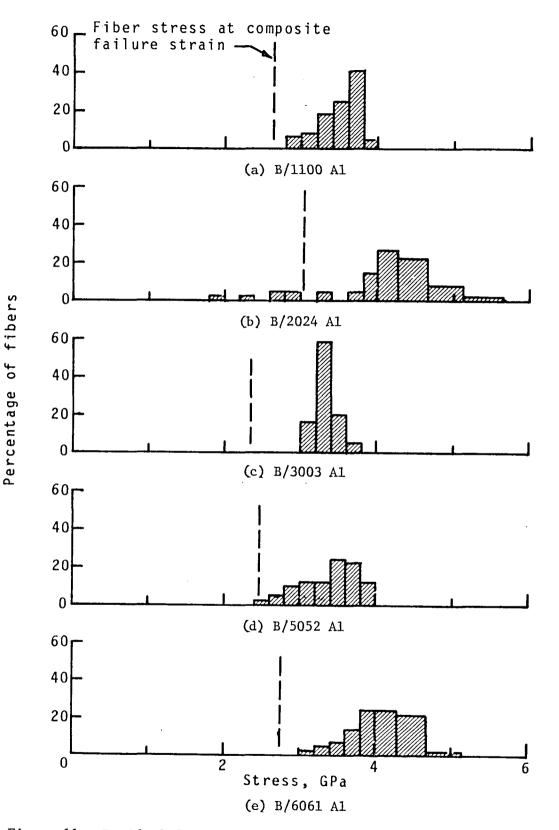
Figure 11.- Residual fiber strength distributions for composites after 10 000 hours exposure at 500 K and tensile testing.

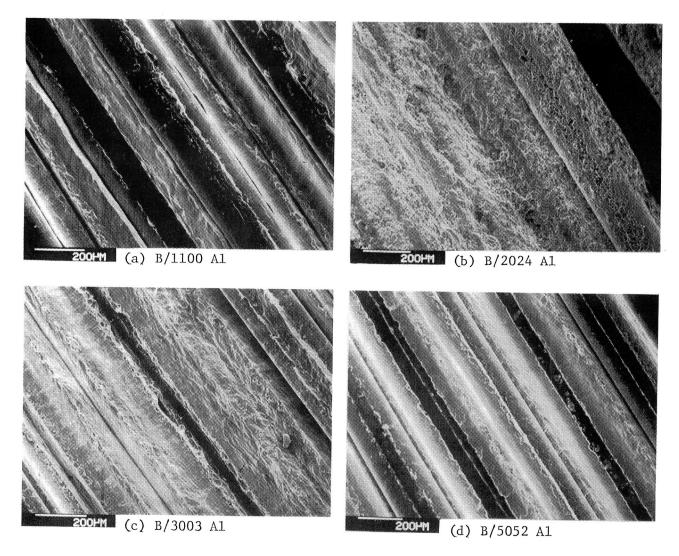
Figure 12.- Transverse fracture surfaces of specimens isothermally exposed for 10 000 hours at 500 K.

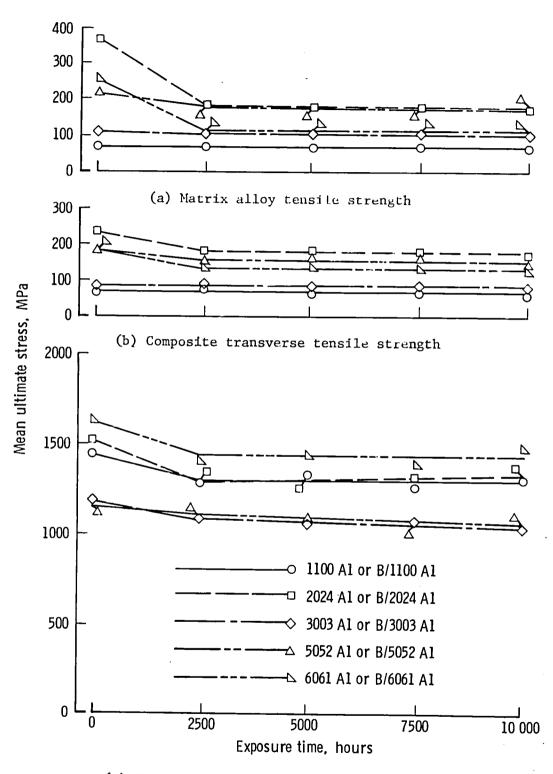
Figure 13.- Effect of isothermal exposure at 590 K on the ultimate stress of B/A1 composites and their matrix alloys.

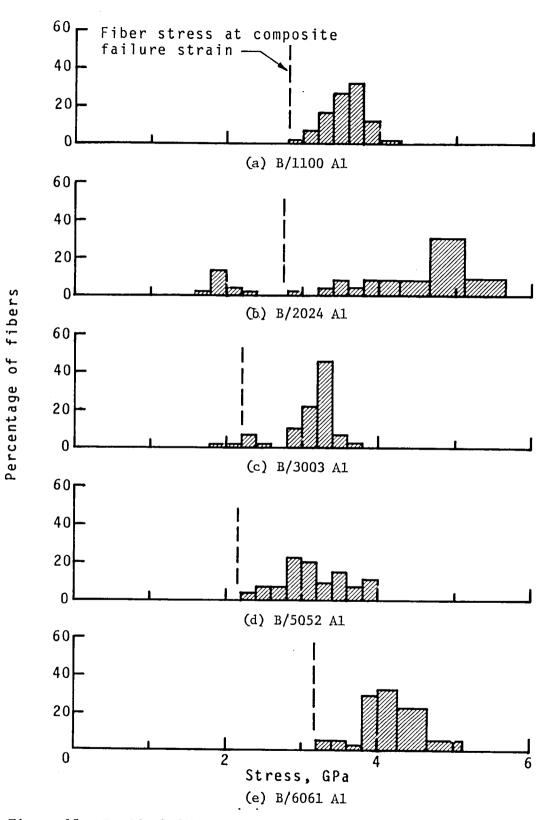
Figure 15.- Residual fiber strength distributions for composites after 10 000 hours exposure at 590 K and tensile testing.

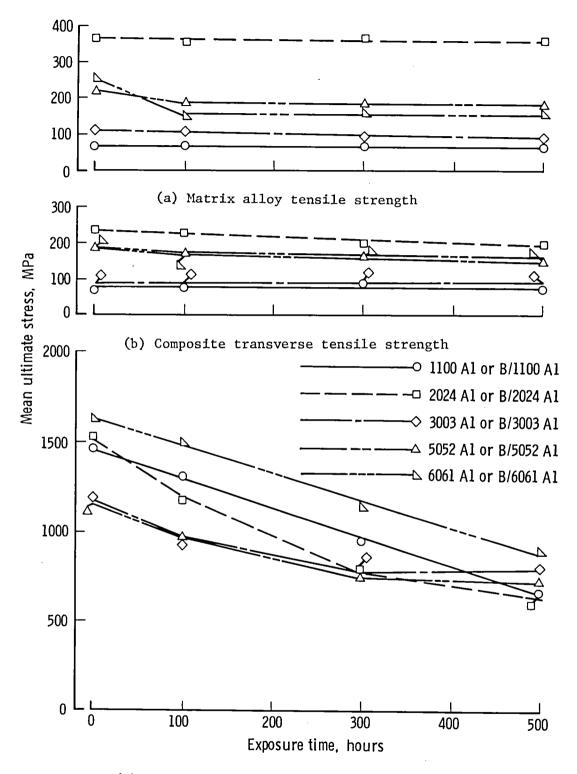
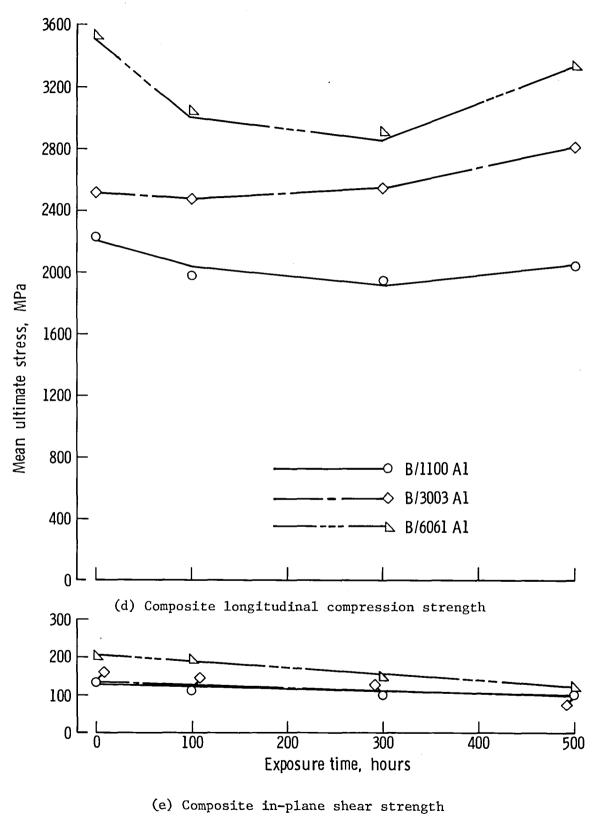
Figure 18.- Effect of isothermal exposure at 730 K on the ultimate stress of B/A1 composites and their matrix alloys.

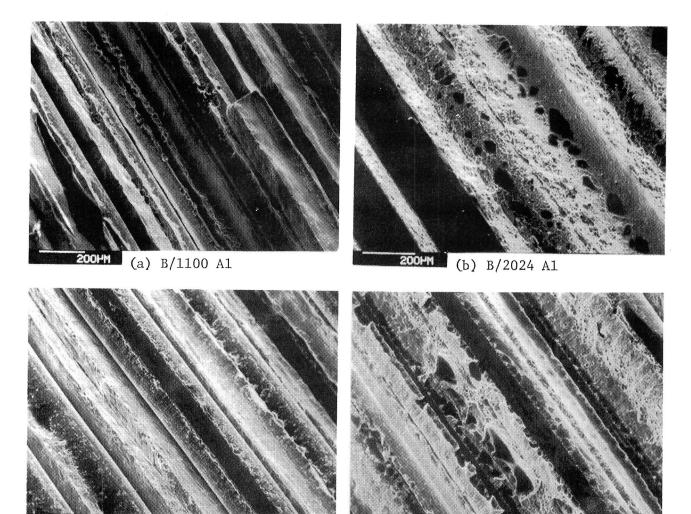
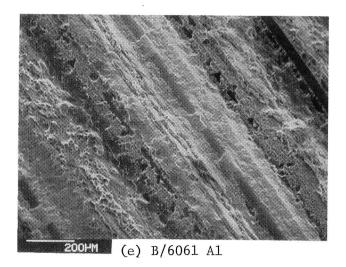
Figure 19.- Transverse fracture surfaces of specimens isothermally exposed for 500 hours at 730 K.

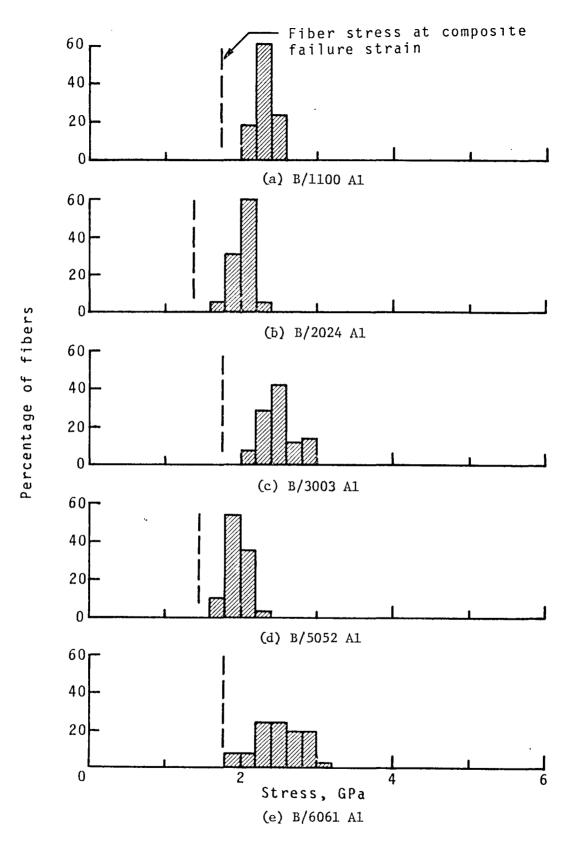
Figure 20.- Residual fiber strength distributions for composites after 500 hours exposure at 730 K and tensile testing.

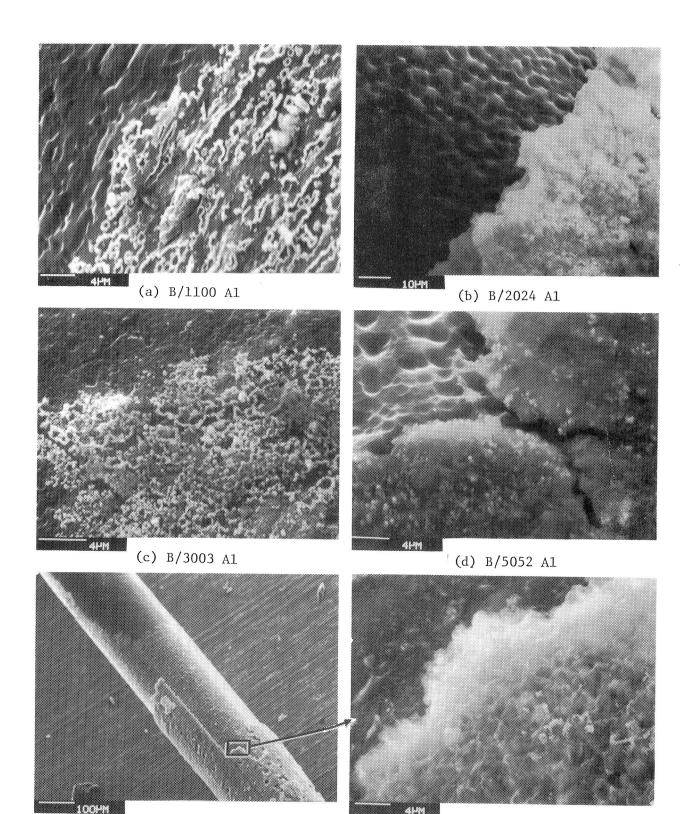
Figure 21.- Reaction layers on fibers removed from composite specimens after 500 hours exposure at 730 K.

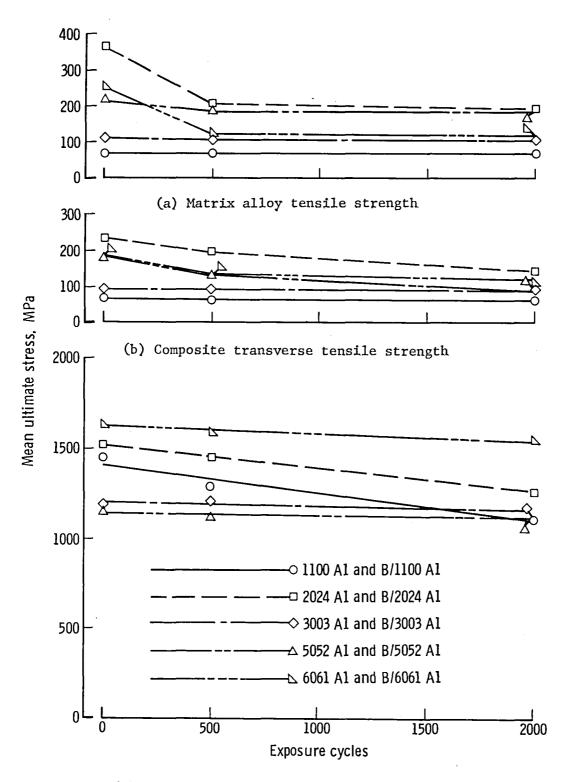
Figure 22.- Effect of thermal cycling between 200 K and 590 K on the ultimate tensile strength of B/Al composites and their matrix alloys.

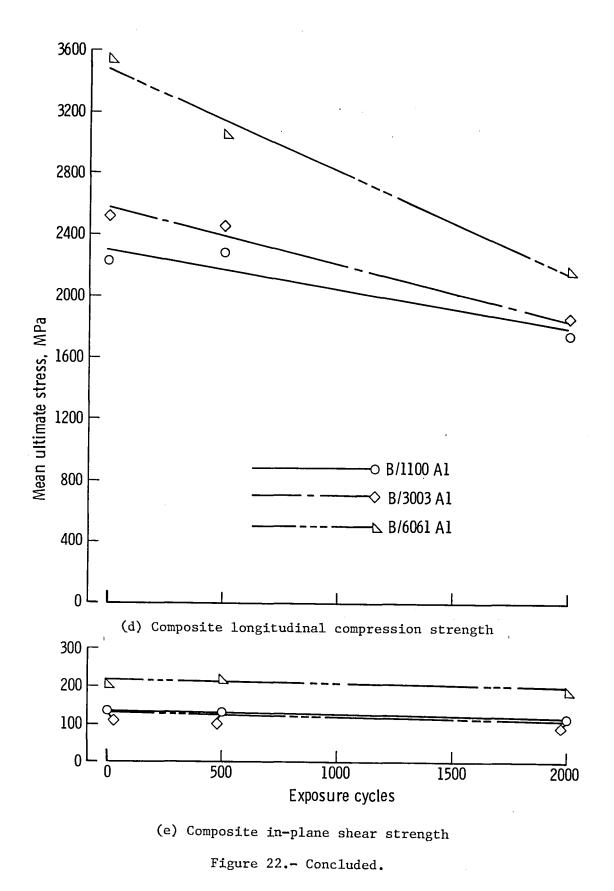
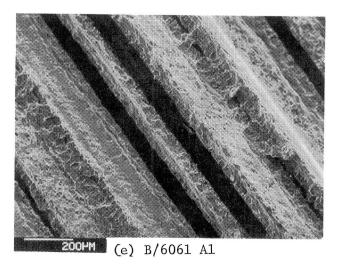
Figure 23.- Transverse fracture surfaces of specimens thermally cycled 2000 times between 200 K and 590 K.

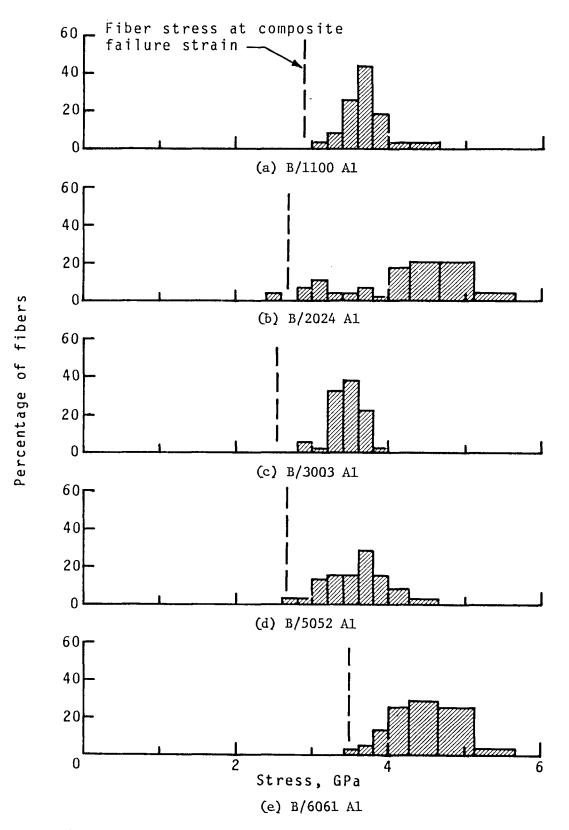
Figure 24.- Residual fiber strength distributions for composites after 2000 thermal cycles between 200 K and 590 K.
