NASA Technical Memorandum 84477

**THE EFFECT OF WATER VAPOR ON
FATIGUE CRACK GROWTH IN 7475-T651
ALUMINUM ALLOY PLATE**

DENNIS L. DICUS

MAY 1982

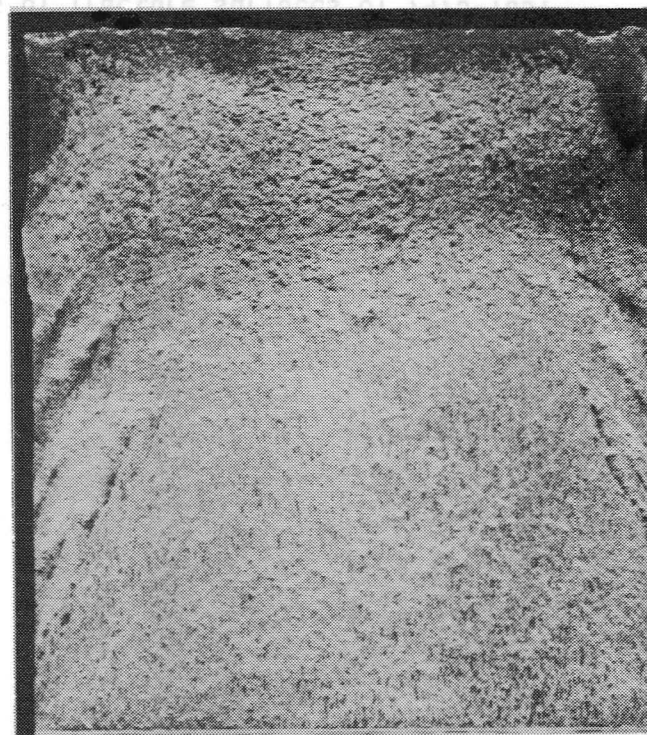
FIG. 9 - Optical macrographs of fracture surfaces of 7475-T651 specimens fatigued in vacuum.

Fracture surfaces of specimens fatigued in hard vacuum and at various water vapor pressures were characterized in an attempt to correlate fracture morphology with environmental interaction. Macroscopically, the fracture morphology of specimens tested in vacuum contrasted sharply with that of specimens tested in water vapor. As illustrated in Fig. 9, the fracture morphology of specimens tested in vacuum varied across the thickness of the

specimens. Compared to the mid-thickness region, the fracture surface near the edges was highly roughened or rumpled, having an undulated appearance. The roughened portions of the fracture surface appeared to have grown toward the center of the specimen with increasing ΔK . This change in morphology from the center to the edges indicates a change in fatigue crack propagation mode associated with a change of stress state along the crack front. In the mid-thickness region where the fracture plane was normal to the applied load axis, the crack propagated predominantly in the opening (tensile) mode. However, the highly roughened surface indicates that the crack propagated in a mixed opening/sliding (tensile/shear) mode in the near-edge regions.

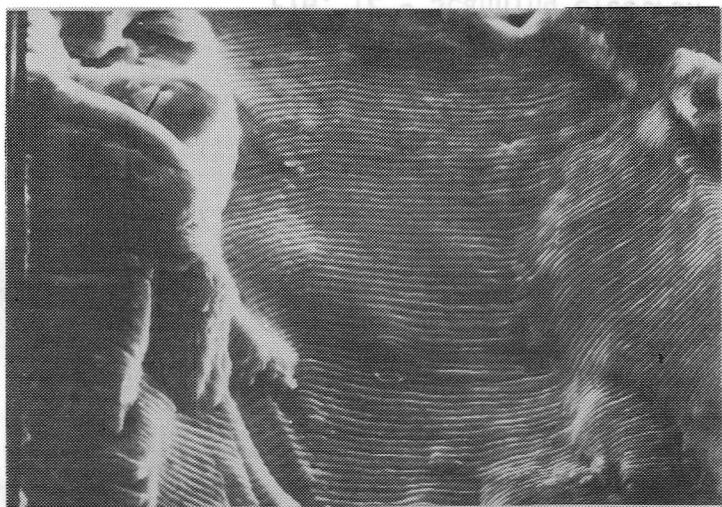
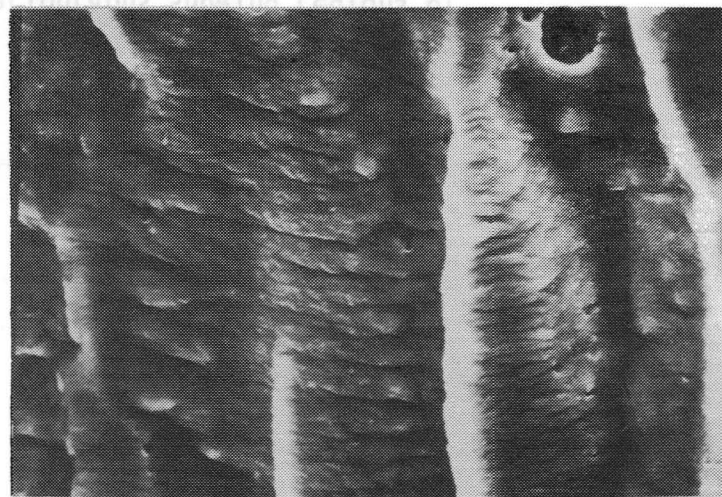
(a) 94 Pa water vapor. $\Delta K = 14 \text{ MN/m}^{3/2}$.

(b) Vacuum. $\Delta K = 15 \text{ MN/m}^{3/2}$.

FIG. 11 - Scanning electron fractorgraphs of fatigue striations formed on 7475-T651 specimens tested in water vapor and vacuum.

Fatigue striations were found on the fracture surfaces of specimens tested in vacuum and water vapor. However, the appearance of striations formed in vacuum and water vapor was quite different, and striations were much less prevalent on specimens tested in vacuum. Fatigue striations formed in water vapor (Fig. 11(a)) were classic in appearance, but striations formed in vacuum (Fig. 11(b)) were poorly defined and exhibited large, local variations in spacing. Measured striation spacings were compared to fatigue crack growth rates. In general, good agreement was found for specimens tested in water vapor, but large discrepancies were found for specimens tested in vacuum.
