# NASA Contractor Report - 166051

## F-111 NATURAL LAMINAR FLOW GLOVE FLIGHT TEST DATA ANALYSIS AND BOUNDARY LAYER STABILITY ANALYSIS

BOEING COMMERCIAL AIRPLANE COMPANY  
P.O. BOX 3707, SEATTLE, WASHINGTON 98124

CONTRACT NAS1-15325  
JANUARY 1984

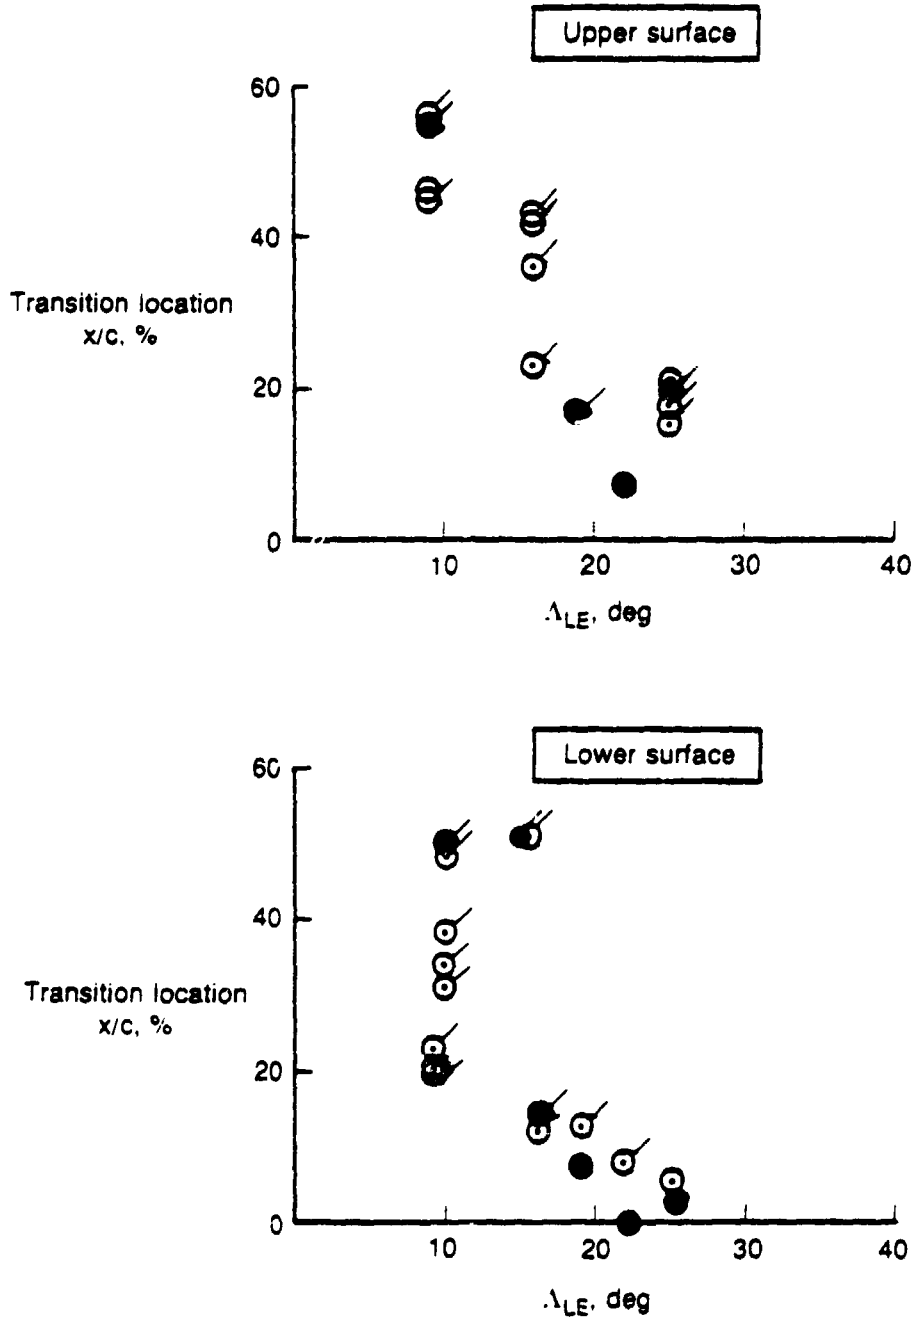
Figure 4. Transition Location Versus Sweep

\*For these cases, T-S amplification varies so rapidly near the transition point (due to adverse local pressure gradient) that reliable values cannot be given

- $Re_c = 23 \times 10^6$
- $Re_c = 28 \times 10^6$
- ⊙ Cases for which boundary layer stability was analyzed

A summary of the results for all 34 cases is given in Table 1. The extent of laminar flow was found to vary from 0% (case 7) to 56% (case 16). In general, the upper surface results at a given sweep angle show a greater extent of laminar flow than on the lower surface. The variation of transition location with sweep angle is shown in Figure 4. On the upper surface, the maximum extent of laminar flow varies from 56% chord at a sweep angle of 9 deg to 21% chord at a sweep angle of 25 deg. On the lower surface, the maximum extent of laminar flow varies from 51% chord at a sweep angle of 15 deg to 6% chord at a sweep angle of 25 deg. The lower surface cases that show transition at 31% chord or greater are from flight 146 and do not seem to follow the trend of the other lower surface cases. These were cases 26 through 34 and, as shown in Appendix C, the flight test results do not show anything unusual. However, as can be seen from Table 1, 10 of the 20 lower surface cases analyzed are from various data runs taken during flight 161. It is possible that the large extent of laminar flow for cases 26 through 34 is an indication that external disturbances (possibly insect contamination) may have affected the transition location for all cases from flight 161, but not for cases 26 through 34, which are from flight 146.

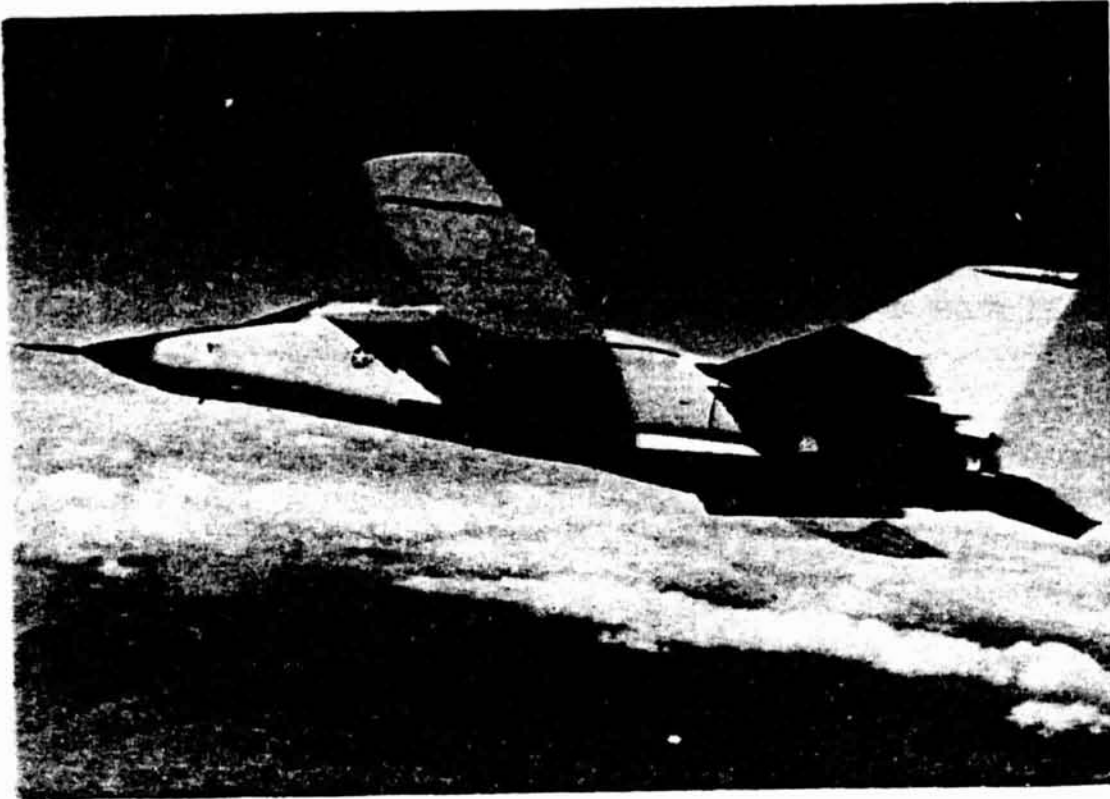
*Figure 33. F-111 in Flight Showing Wing-Inlet Relationship*

noise, especially at high Mach numbers, but the upper surface would be shielded from such noise. Engine noise could excite T-S disturbances, because such noise tends to have peak energy in the same frequency range as most highly amplified T-S disturbances (2000 to 8000 Hz). C-F disturbances probably would be affected less than T-S disturbances because their highest amplification usually occurs at lower frequencies. This might result in the type of envelope shown in Figure 32 for the lower surface, because T-S disturbances of large initial amplitude require much less amplification before causing transition than do the normally infinitesimal disturbances. Although the possibility of engine noise contamination on the lower surface is plausible, there was no apparent effect on transition location when the engine on the right-hand wing of the F-111 was throttled back for case 25. The results of case 25 thus raise doubts about this hypothesis.
