SOLAR CELL AND I.C. ASPECTS OF INGOT-TO-SLICE MECHANICAL PROCESSING

by Lawrence D. Dyer

ABSTRACT

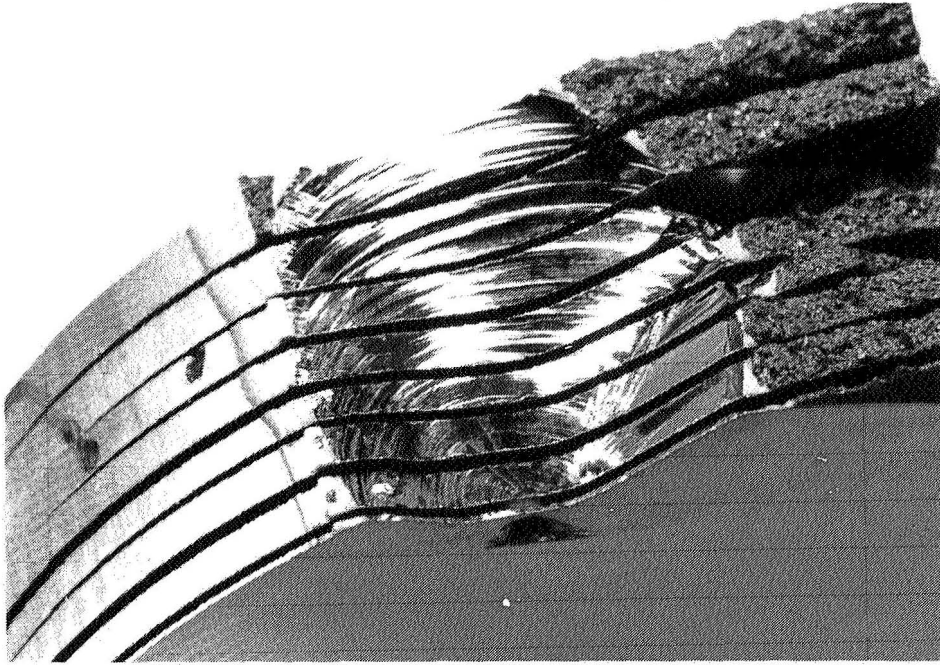
Cropping chips.--Figure 1 shows a fracture developed from using too much blade force in a cropping saw. Silicon can be lost immediately at this work station, or the defect may not show up until the slicing stage as shown in Figure 1. This problem can obviously be solved by limiting the force.

Fig. 1. Cropping chips on 100 mm silicon crystal, detected at wafering step.

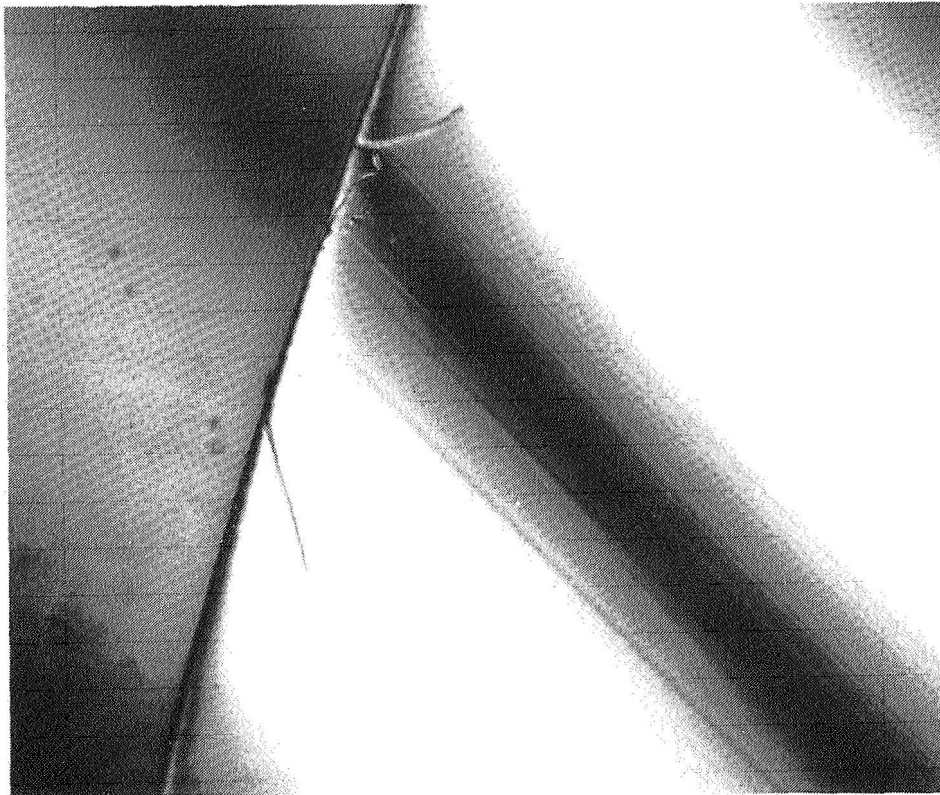
Grinding cracks.--Figure 2 shows grinding cracks made by a centerless-type crystal grinder some years ago. The defects were found at epitaxy, where they had caused slip. Figure 3 shows schematic diagram of slip generation from excessively deep cracks formed at the crystal grinding step. Figure 4 shows grinding cracks made by a center-type crystal grinder. Clearly there is a need to limit the severity of the grinding process to minimize such cracks. One means of limiting this is provided on the Siltec crystal grinder (10), i.e. by measuring the current drawn by the drive motor (11).

Fig. 2. Cracks produced by centerless crystal grinder and subsequent slip in epitaxial processing.

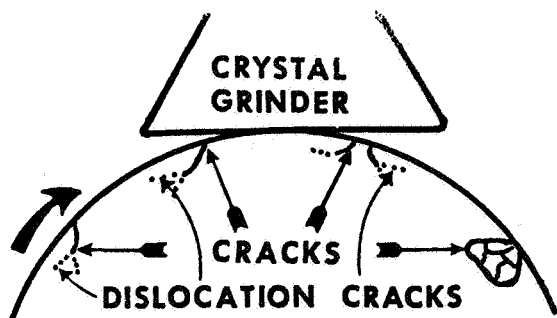
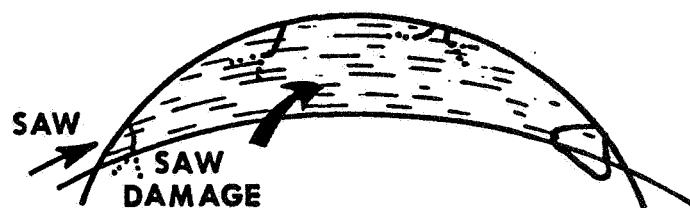
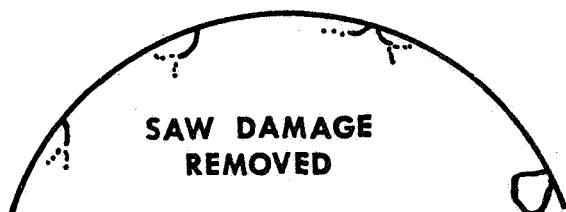
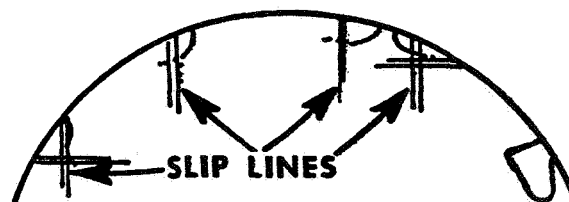
FIG. 3 SCHEMATIC OF SLIP GENERATION FROM EXCESSIVELY DEEP CRYSTAL GRIND CRACKS.

A. GRINDING OF SILICON INGOT CAUSES CRACKS AND DISLOCATION CRACKS.

B. SLICING PUTS IN SAW DAMAGE AND CHIPS OUT SOME GRINDING CAVITIES.

C. LAPPING, ETCHING AND POLISHING REMOVES SAW DAMAGE BUT NOT ALL OF THE GRINDING DAMAGE.

D. PROCESSING IN FURNACE OR EPI REACTOR GENERATES SLIPLINES.

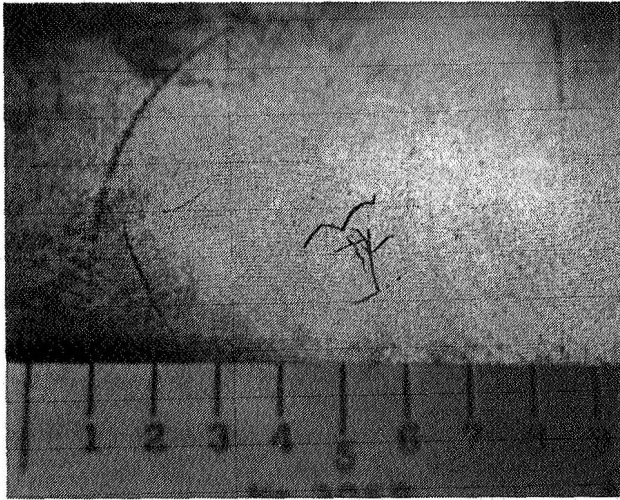
Fig. 4. Cracks produced by center-type crystal grinder.

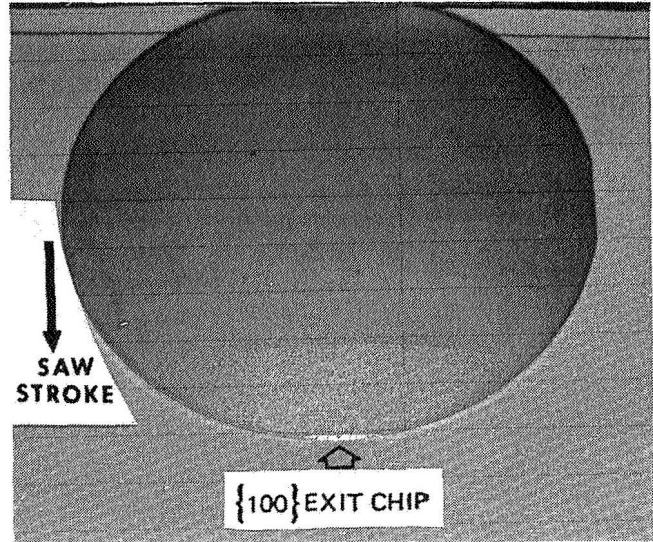
Exit Chips/Saw Fractures.--Figure 5 shows a saw exit chip on a silicon slice that was made with the I.D. saw. This defect is a cosmetic one for the semiconductor industry, but a slice cannot be sold with an exit chip, partly because of potential of generating increased particle counts in the wafer fabrication facility (12). In the solar wafer the exit chip can, if severe, constitute a "saw fracture"; in fact, it is probably the major limitation on lower slice thickness for solar-cut wafers (13). The causes of exit chips have been outlined previously (14); they fall basically into two categories--bending forces (13) and wedge forces (14). Since there are numerous ways to cause the exit chip, it remains a perennial problem.

Fig. 5. Saw exit chip.

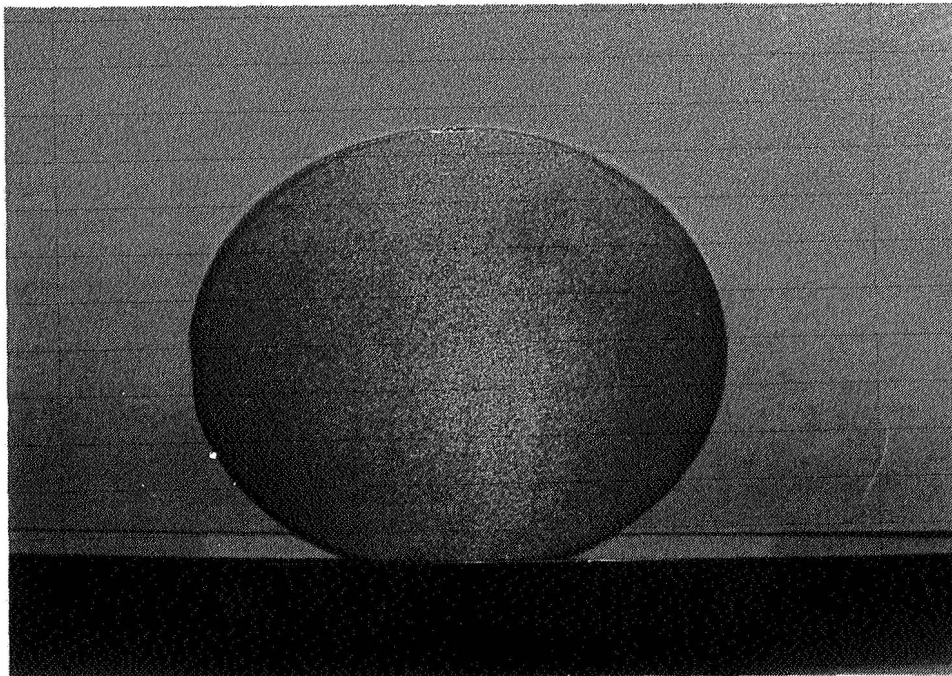
Deep Saw Damage ("Sparkle").--Figure 6 shows an area on a (100) sawed slice that reflects light preferentially at the same angle as the exit chip. This appearance is sometimes called "sparkle" and often accompanies the exit chip. The appearance is due to deeper-than-usual microcracks (14) that show up under the microscope as small, scattered facets. This collection of defects probably has one of the same causes as exit chips, but occurs earlier in the cut where the crystal still has enough breadth to resist complete crack propagation.

Fig. 6. Deep saw damage ("sparkle") on (100) silicon.

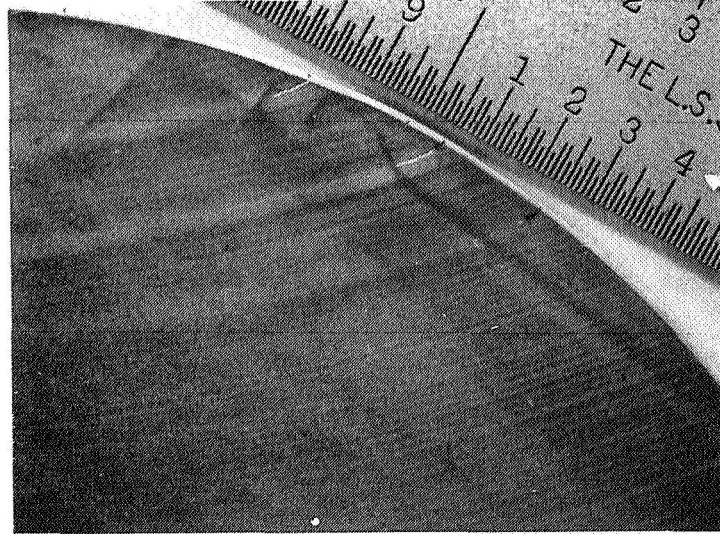
Saw Edge Fractures.--Figures 7 and 8 show a type of defect related to exit chips and which is cause for immediate rejection. It is a fracture that initiates at the edge and is associated with a depression in the slice caused by saw blade removal. It occurs more frequently in thin slices. Deep saw damage is often evident elsewhere on the slice. It occurs when the I.D. saw blade has lost some of its tension. On (100) slices, the cracks are parallel to saw marks; on (111) slices, they are usually

located at 30 +/- 10 degrees from the exit end. The mechanism postulated for this defect is that the blade becomes too flexible, all or in part, and is deviant before entering the cut. As it enters the cut, it applies a bending stress to the wafer at its edge. In the (111) case, the mounting strip protects the edge to +/- 20 deg. from the exit location. In the (100) case this protection is not enough because of the ease of making the exit chip-like fracture.

Fig. 7. Saw edge fractures--(111) silicon.

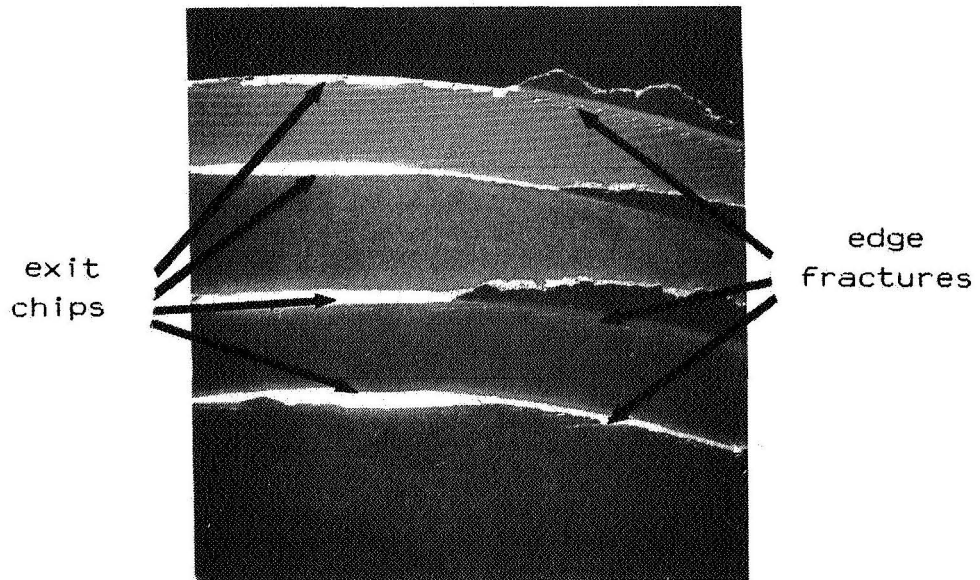
Fig. 8. Saw edge fractures--(100) silicon.

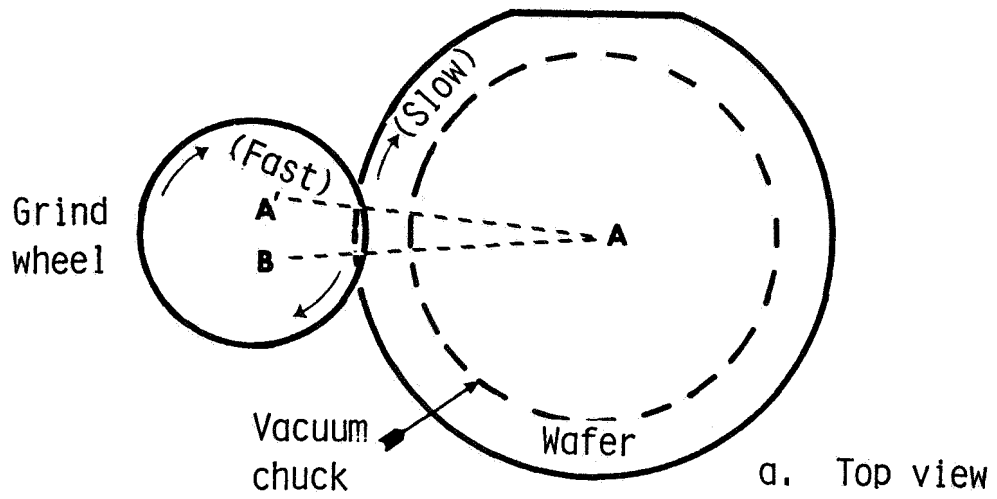
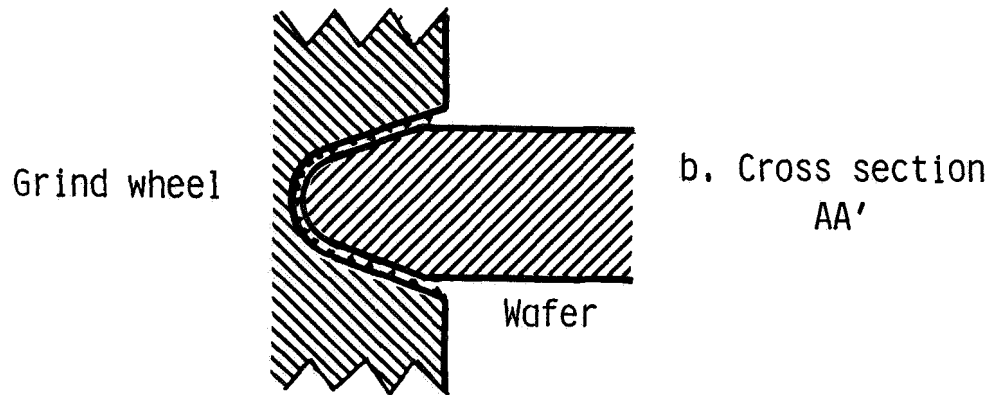
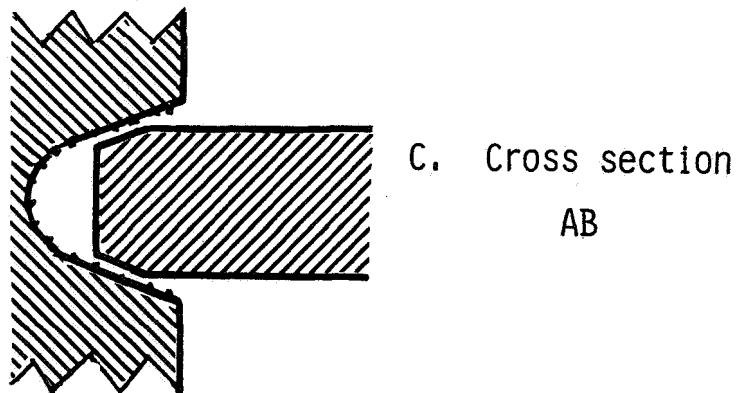
Crow's-Foot Fractures.--Figure 9 shows a schematic diagram of the edge grinding process. The wafer is held on a vacuum chuck and slowly rotated. A fast-spinning grind wheel having a groove of the desired shape is brought against the edge as shown in the cross-sections. Cooling medium is directed into the interface.

Fig. 9. Schematic Diagram of Edge Grinding Operation

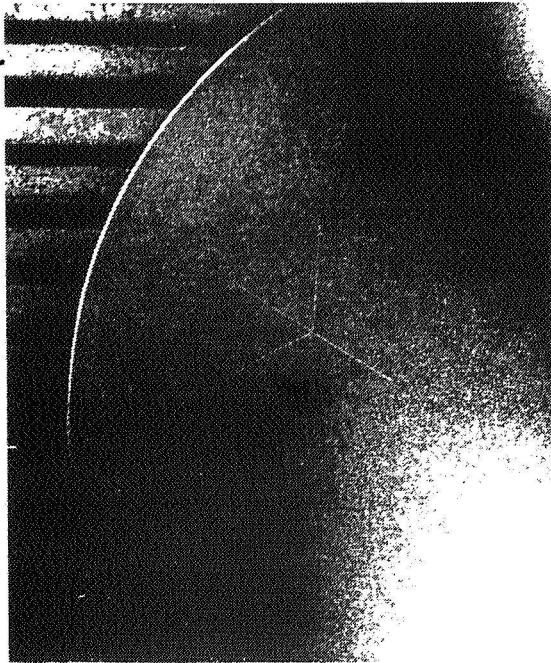
Figure 10 shows a typical crow's-foot fracture that occurred because of a 1.3-mil burr on a vacuum chuck in the edge-grind operation. Figure 11 shows the mechanism by which such fractures occur; an analysis was given previously (15). Thin slices are more susceptible to this type of fracture.

Fig. 10. Crow's-foot fracture from burr on vacuum chuck.

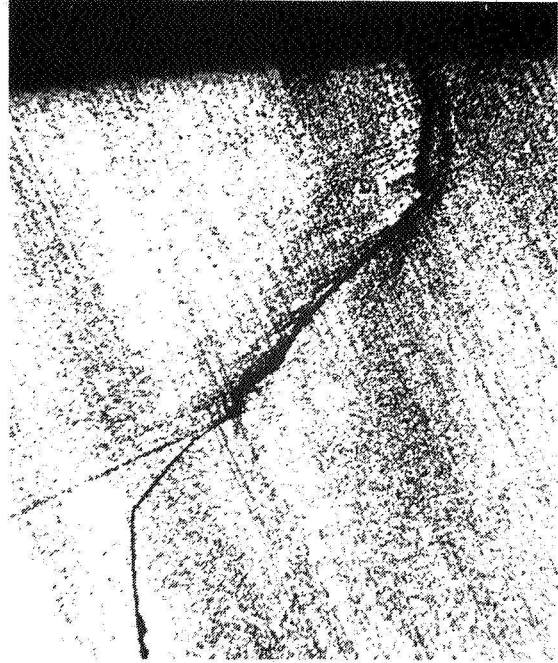
Edge Cracks from Heat Treating.--Sometimes an annealing operation is carried out to stabilize resistivity. Figure 12 shows a crack formed at a slice heat treat operation. These cracks can form either from the impact of transfer into the boats or from boat slots that pinch the slice edges. In the instance of Figure 12, the temperature was high enough for dislocation generation. Such defects can also occur during fabrication of wafers into devices.

Fig. 12. Edge crack from heat-treating silicon slice in quartz boat.

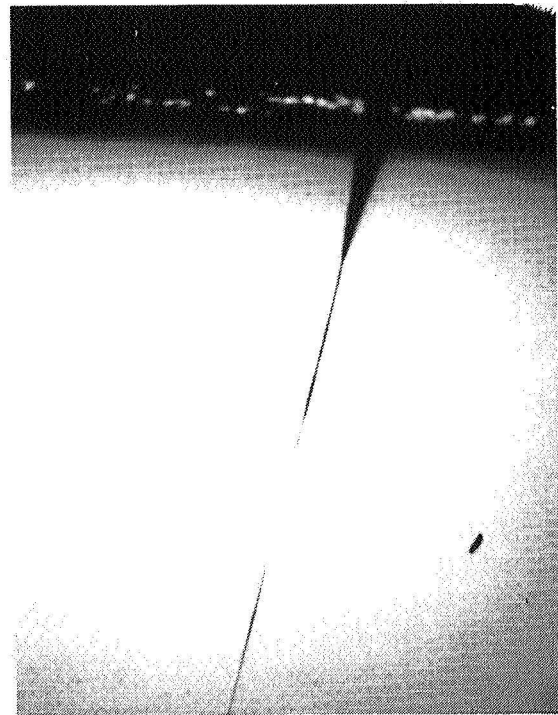
Edge Cracks at Polish.--Figures 13-14 show edge cracks that developed during the polish operation. These are characterized by nearly radial development and by polish cloth bevelling. They are envisioned to form in response to the tangential stresses that occur when the slice friction is too high and the slice edge is relatively cool.

Fig. 14. Edge crack at polish.

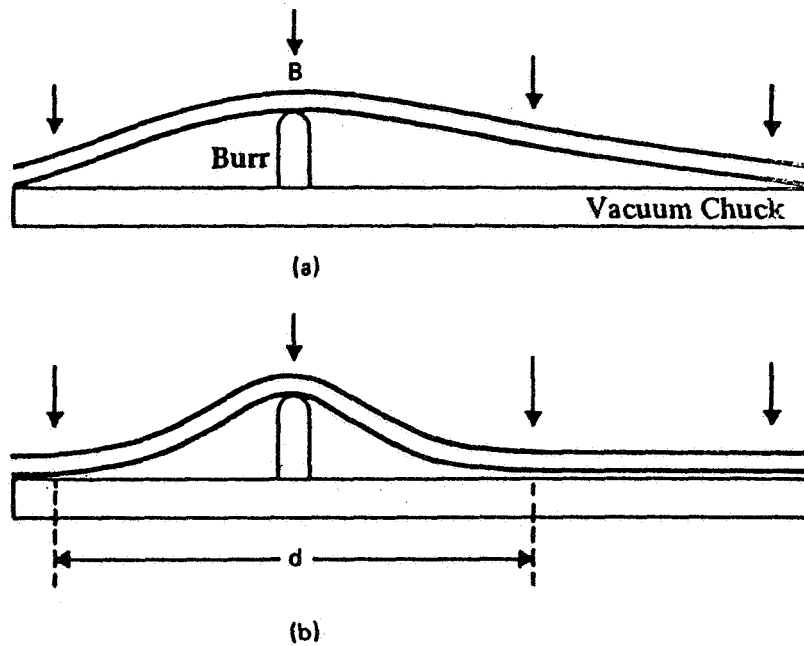
Fig. 11. MECHANISM OF BURR-INDUCED FRACTURE ON VACUUM CHUCK

- (a). Slice is bent over burr: max tensile stress at B. Weak vacuum
- (b). Strong vacuum flattens outer regions against plate and increases curvature and stress at 'B'.
- (c). (Not shown). Crack starts near "B" but stops as reverse curvature area is reached. (Within "d").

Another operation in which crow's-foot fractures originate is lapping. Note that the mechanism is different from Fig.11; the edge-grind fracture occurs because of bending stresses, the lap fracture is thought to arise from wedging by abrasive particles (16).

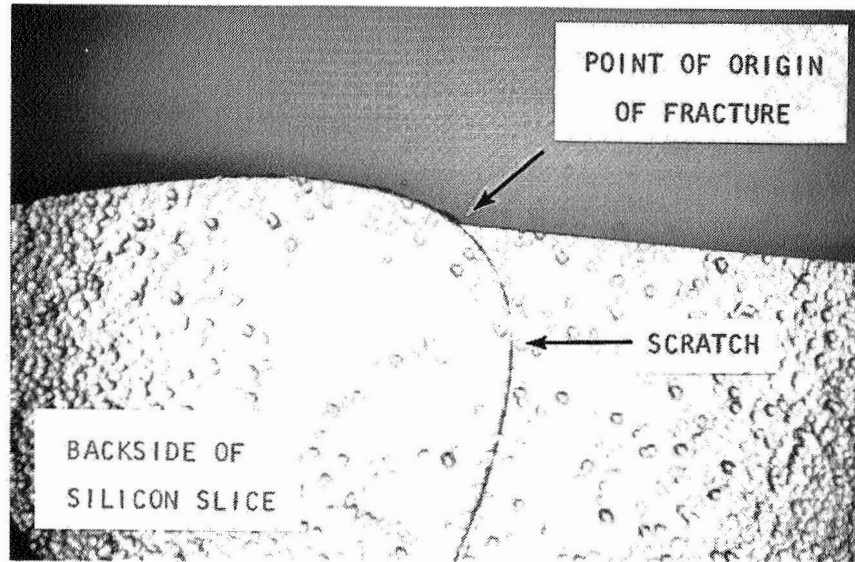
Scratches.--Figures 15 and 16 show backside scratches that caused wafer breakages in furnace operations. The fracture origin (9) in each case coincided with the point of tangency of the scratch. This breakage is postulated to occur as follows: Furnace operations cause wafers to undergo transient stresses that bow the wafer one way or the other. If a scratch is located on the convex side of the wafer, it is subject to tensile stress which can exceed the crack propagation stress for the scratch. Such scratches must be avoided in wafer processing not only for the survival of the individual slice, but for avoiding the loss of many other devices from particles generated in the fracture process.

Fig. 15. Scratch leading to
furnace breakage. 30X

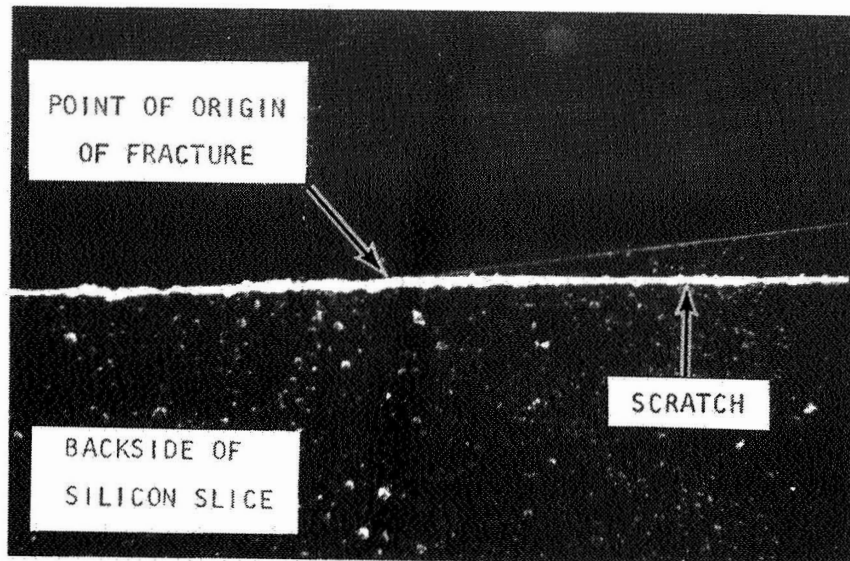
Fig. 16. Scratch leading to
furnace breakage. 30X
