# Comparison of Measured and Calculated Temperatures for a Mach 8 Hypersonic Wing Test Structure

Robert D. Quinn and Roger A. Fields

March 1986

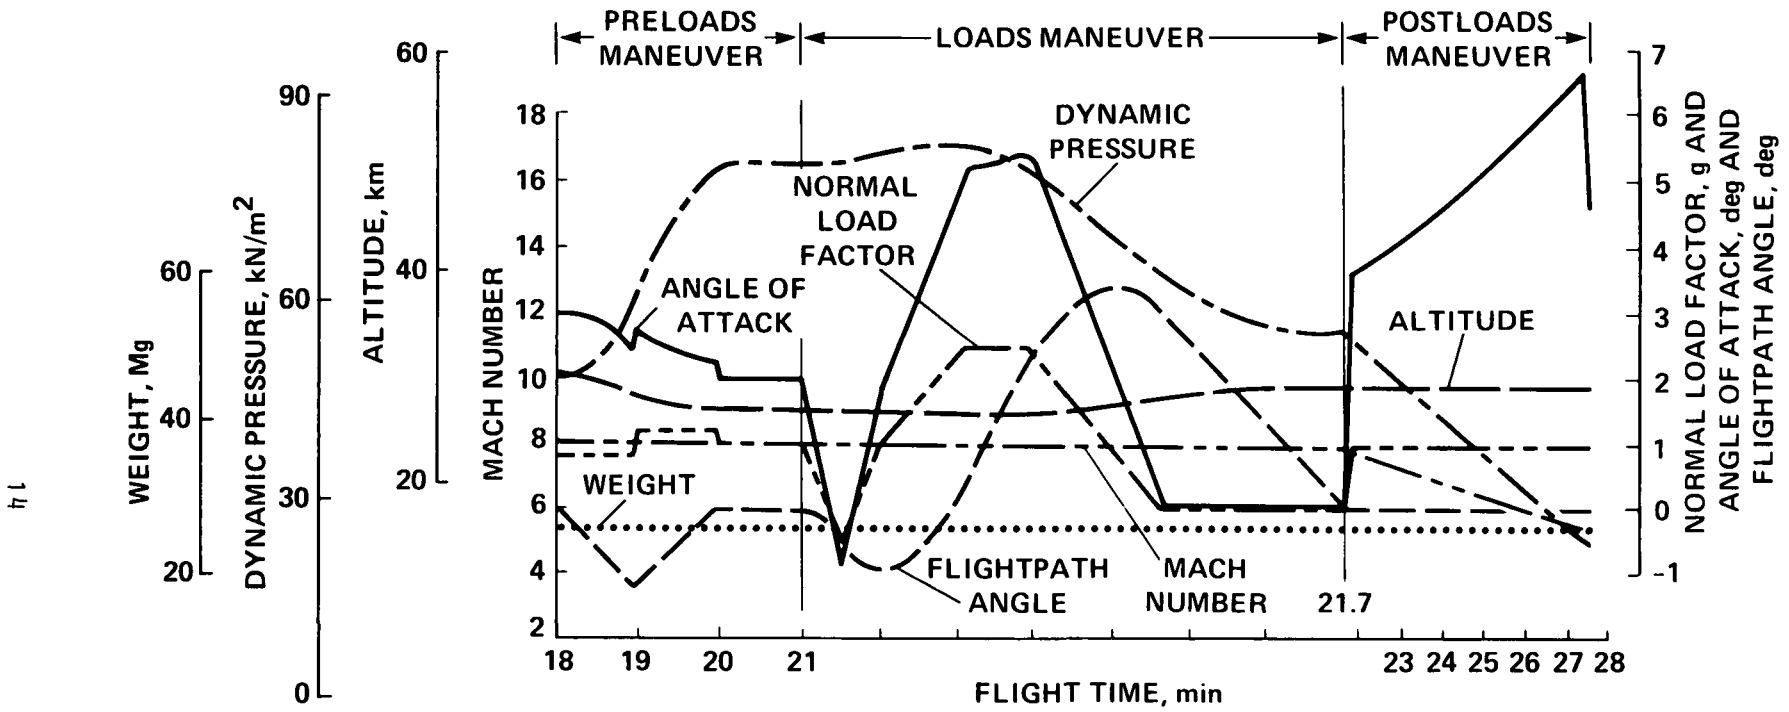
Figure 3.- Time history for a loads maneuver of the hypersonic research airplane.

A major design consideration was the pushover-pullup loads maneuver shown by the dashed line profile in figure 2. This maneuver is initiated at Mach 8 at an altitude of 27.4 km, and consists of a  $-0.5\text{-g}$  pushover, a  $2.5\text{-g}$  pullup, and a return to the nominal research mission descent profile. A more specific time history for this loads maneuver is shown in figure 3. Preload and postload maneuvers precede and follow the actual loads maneuver, providing transitions to and from the nominal flight profile. The entire loads maneuver took 42 sec, with a maximum dynamic pressure of  $83.78\text{ kN/m}^2$  obtained during this time.

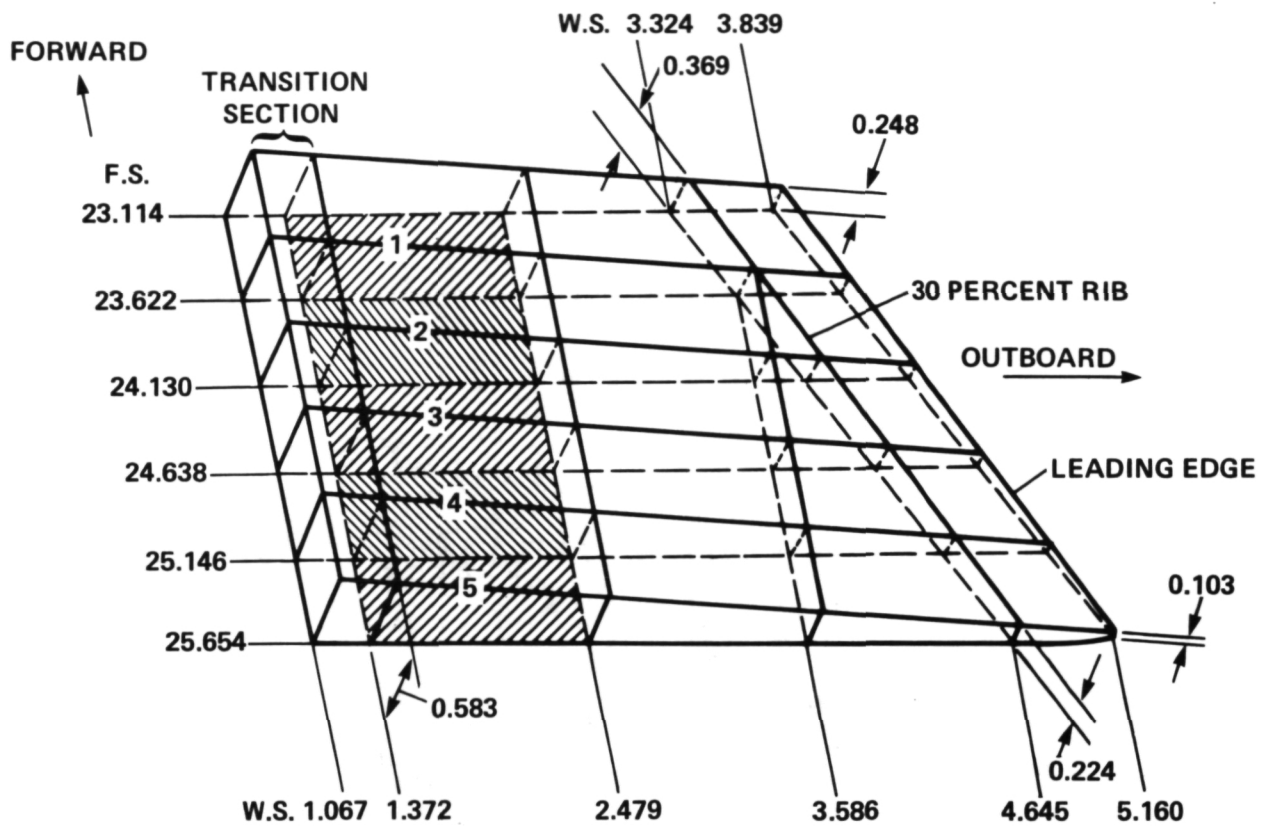
Figure 4.- Hypersonic wing test structure dimensions. The most critically loaded panels are shaded and numbered 1 to 5 going aft. Fuselage stations (F.S.), wing stations (W.S.), and dimensions in meters.

Figure 4 shows the general dimensions and shape of the HWTS with a transition section. The wing is cantilevered from wing station (W.S.) 1.067. The wing was tested inverted, so the compressively loaded surface of the actual vehicle would be on the lower surface of the test structure. (In the remainder of this report, "upper surface" refers to that nearest the sky and "lower surface" to that nearest the ground in the test setup.) Although not part of the aircraft design, the transition section was included to provide a buffer between the support structure and the test portion of the wing. The five most critically compression-loaded panels are the lower root panels, shaded in figure 4 and numbered 1 through 5 from fore to aft.

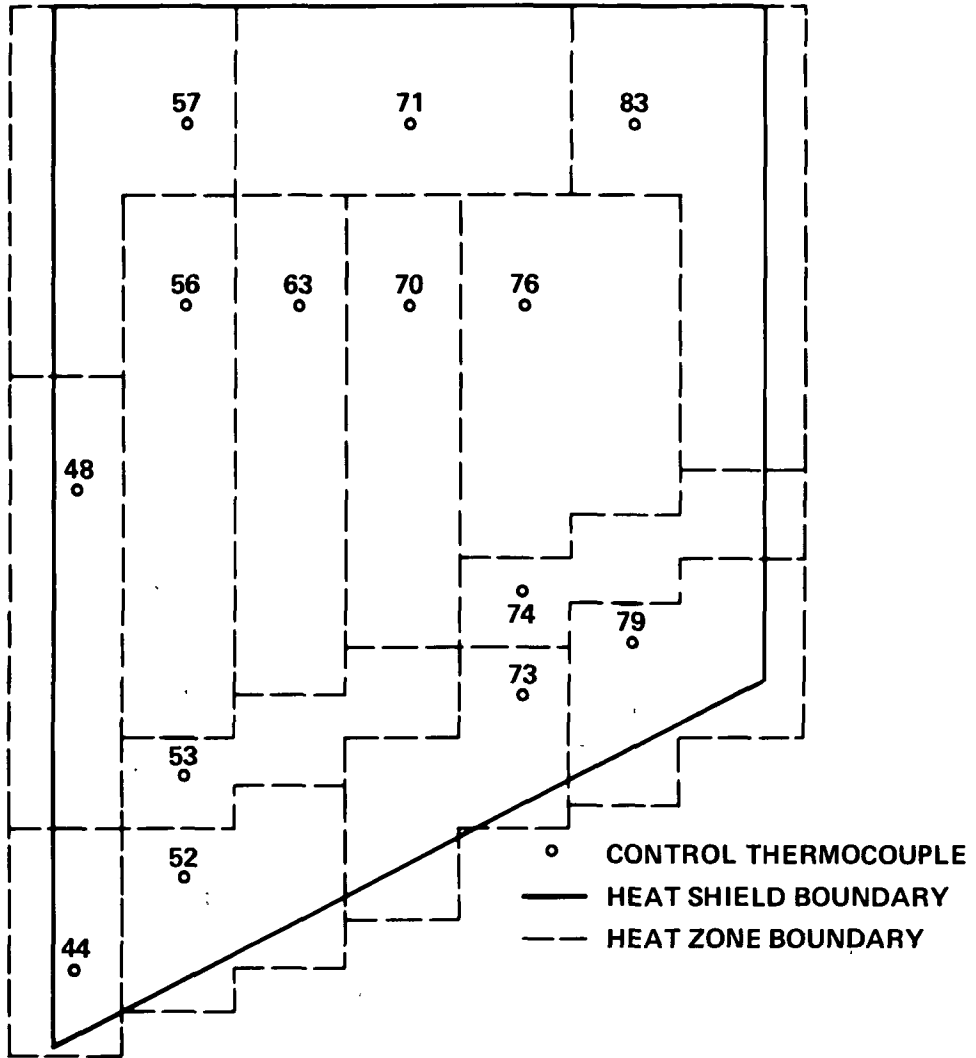
(b) Upper surface heater.

Figure 20.- Concluded.
