QUANTITATIVE FLAW CHARACTERIZATION WITH SCANNING LASER ACOUSTIC MICROSCOPY

Edward R. Generazio and Don J. Roth
National Aeronautics and Space Administration
Lewis Research Center
Cleveland, Ohio 44135

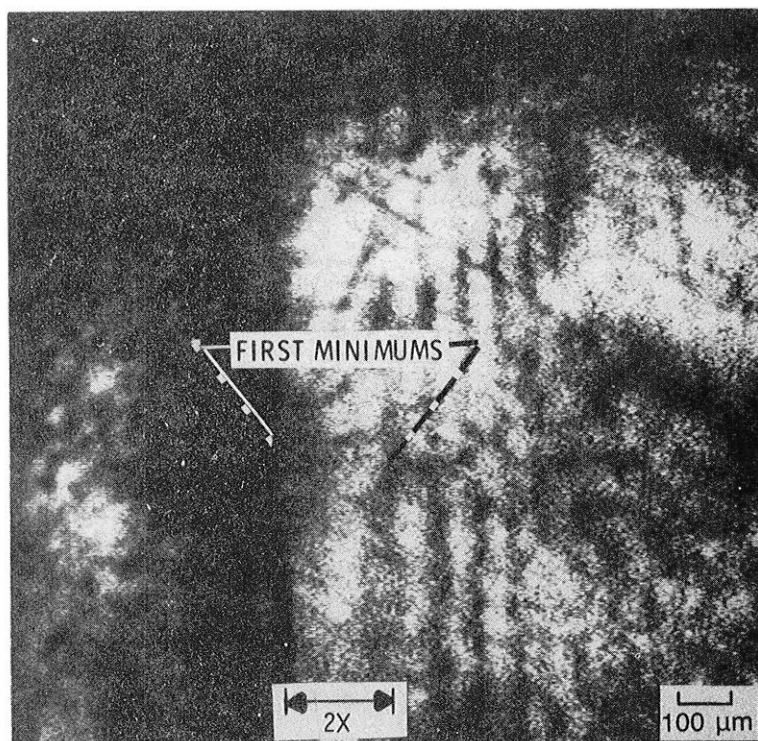
Figure 14. - Acoustic image of wire embedded in polymethylmethacrylate slab (Fig. 12).

The acoustic image for the wire embedded in polymethylmethacrylate is shown in figure 14. The image resembles the Fourier transform of a line function shown in figure 9(c). The first minimums are indicated in the figure and the distance $2x$ between them is 232 μm . Combining the distance between the minimums with the depth of the wire and equation (5) yielded an experimental value of 7.02° for the angular distance between the first minimum and the center of the void. This value agrees well with the theoretical value of 7.48° obtained from equation (4).

The acoustical Fourier transforms (figs. 13 and 14) are not identical to their corresponding digital two-dimensional Fourier transforms (figs. 10(b) and 9(c)). The discrepancies are due to three theoretical conditions that are not satisfied by the experimental configuration. First, neither the wire nor the void is a two-dimensional object. Hence the standard theoretical development for two-dimensional apertures does not apply. The wire defect was purposely flattened on one side in an effort to achieve an experimental system that was nearly two dimensional. A similar polymethylmethacrylate sample was produced in which a cylindrical wire was embedded. The diffraction pattern on the left side of the central maximum was not observed on the acoustic image. Only by flattening one side of the wire was the full diffraction pattern observable. This result can be extended to the case of the void. For the void the diffraction pattern on the left side of the central maximum (fig. 14) was most likely not observed because of the dimensionality of the defect and the experimental configuration. Second, the acoustic image is formed on an image plane that is not perpendicular to the direction of sound propagation. The obliqueness of this image plane must be incorporated into the diffraction theory. Third, the experimental configuration used did not result in true Fraunhofer conditions. For the sample dimensions and sound wavelengths shown herein, the diffraction patterns were observed in the transition region between Fresnel and Fraunhofer zones. As a result the phase cancellation at the minimums was incomplete and the minimums were displaced.
