**NASA  
Technical  
Memorandum**

NASA TM - 100361

**A NONCONTACTING SCANNING PHOTOELECTRON  
EMISSION TECHNIQUE FOR BONDING SURFACE  
CLEANLINESS INSPECTION**

February 1989

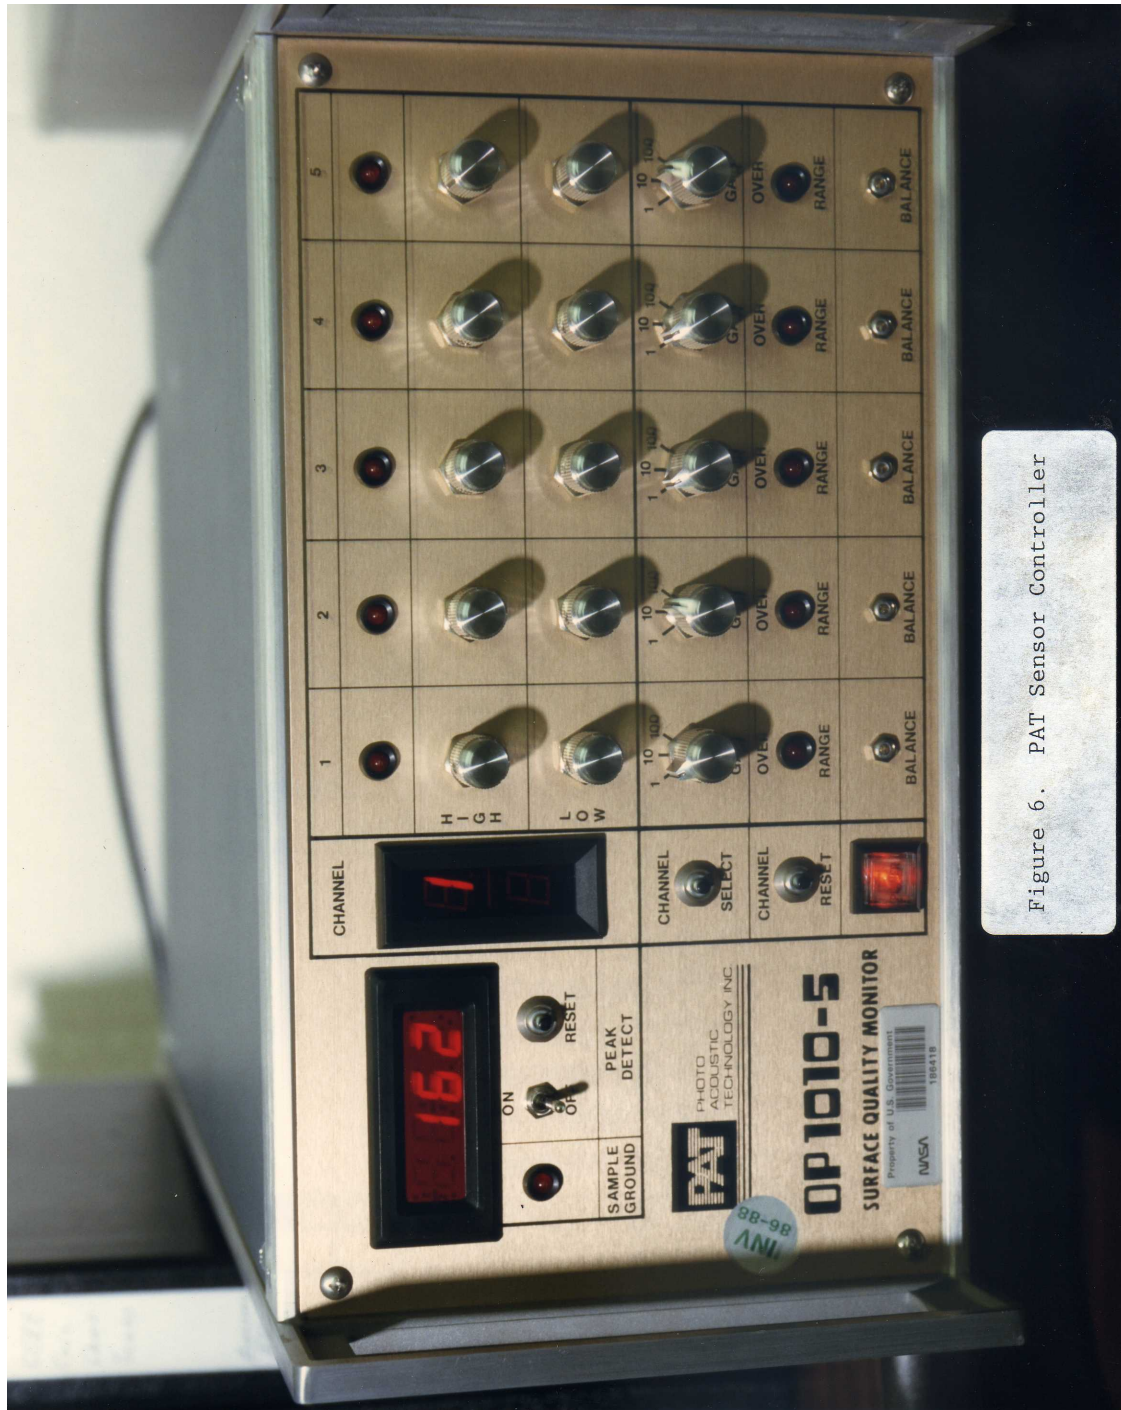
Figure 6. PAT Sensor Controller

Figure 6. PAT sensor controller.

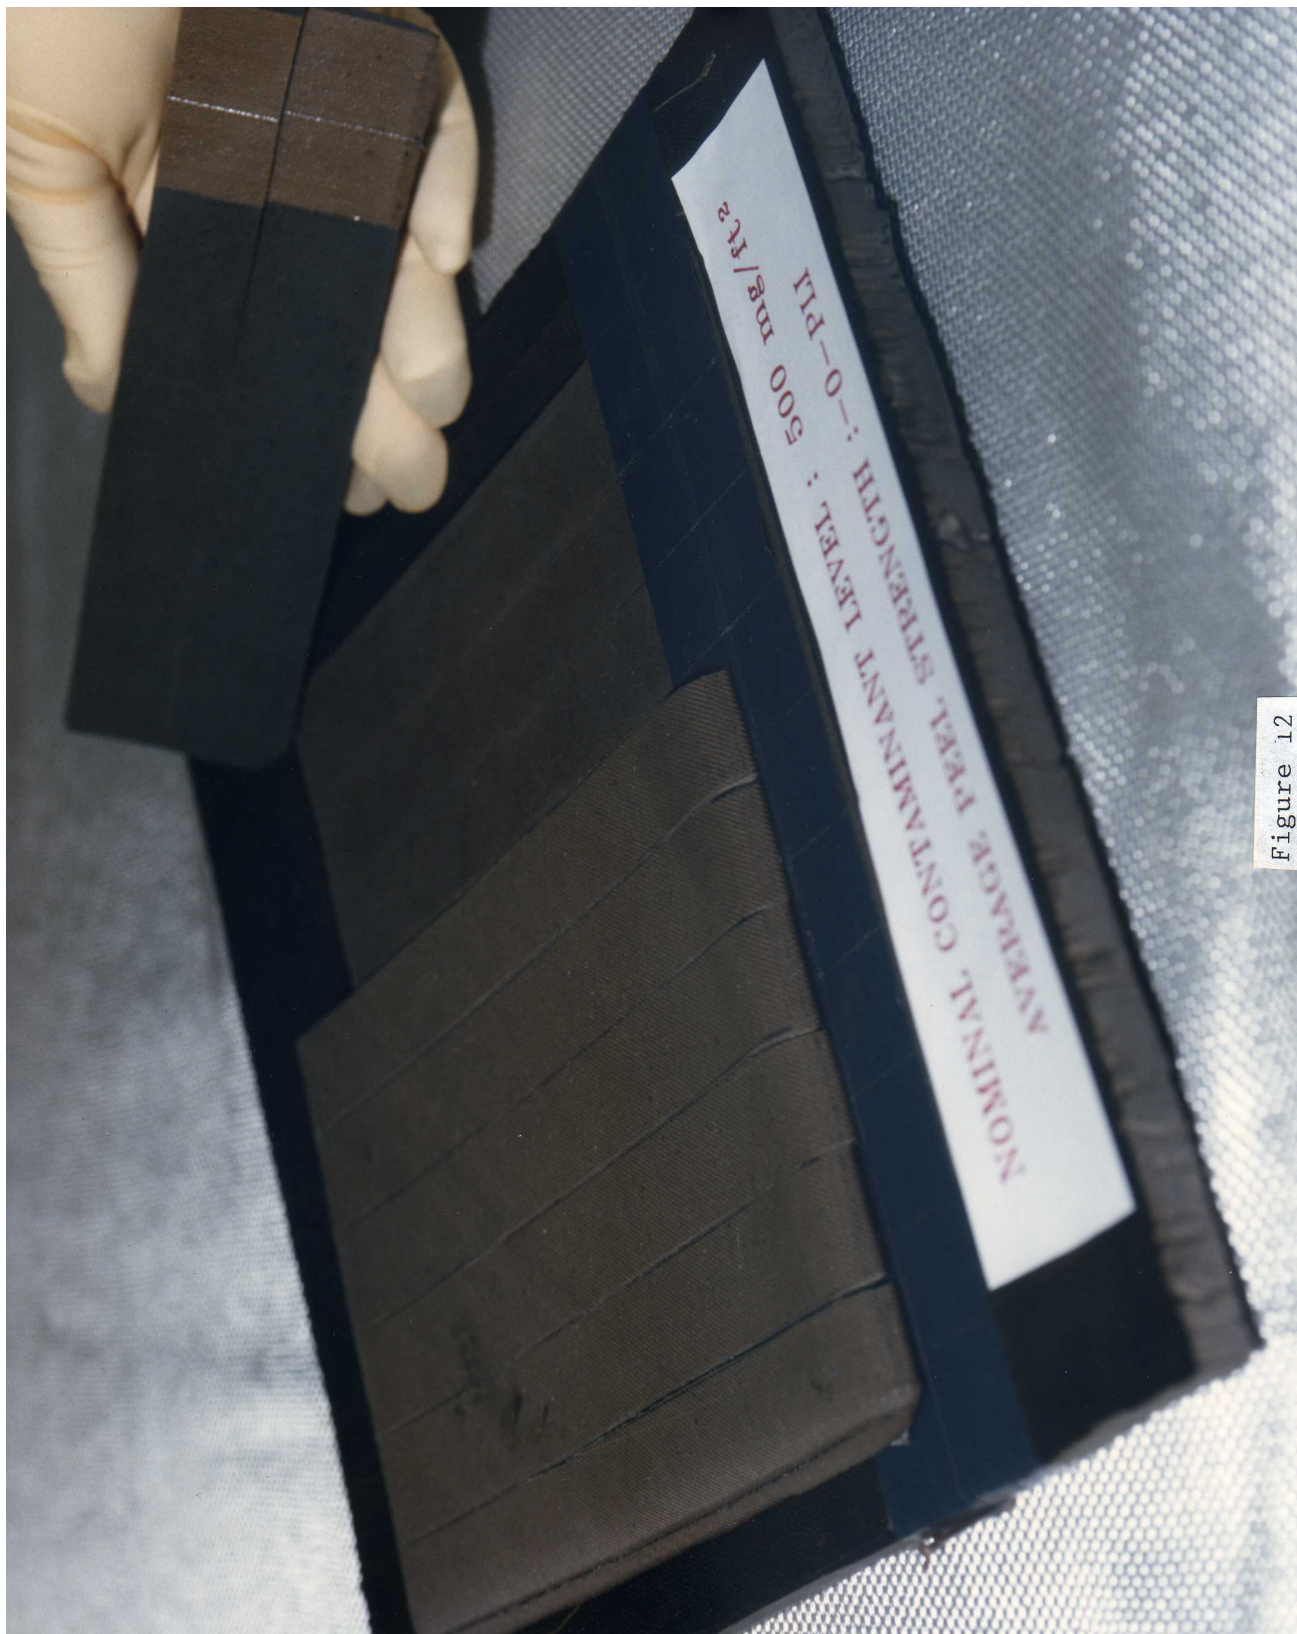
Figure 12

Figure 12. 500 mg/ft<sup>2</sup> strength specimen.

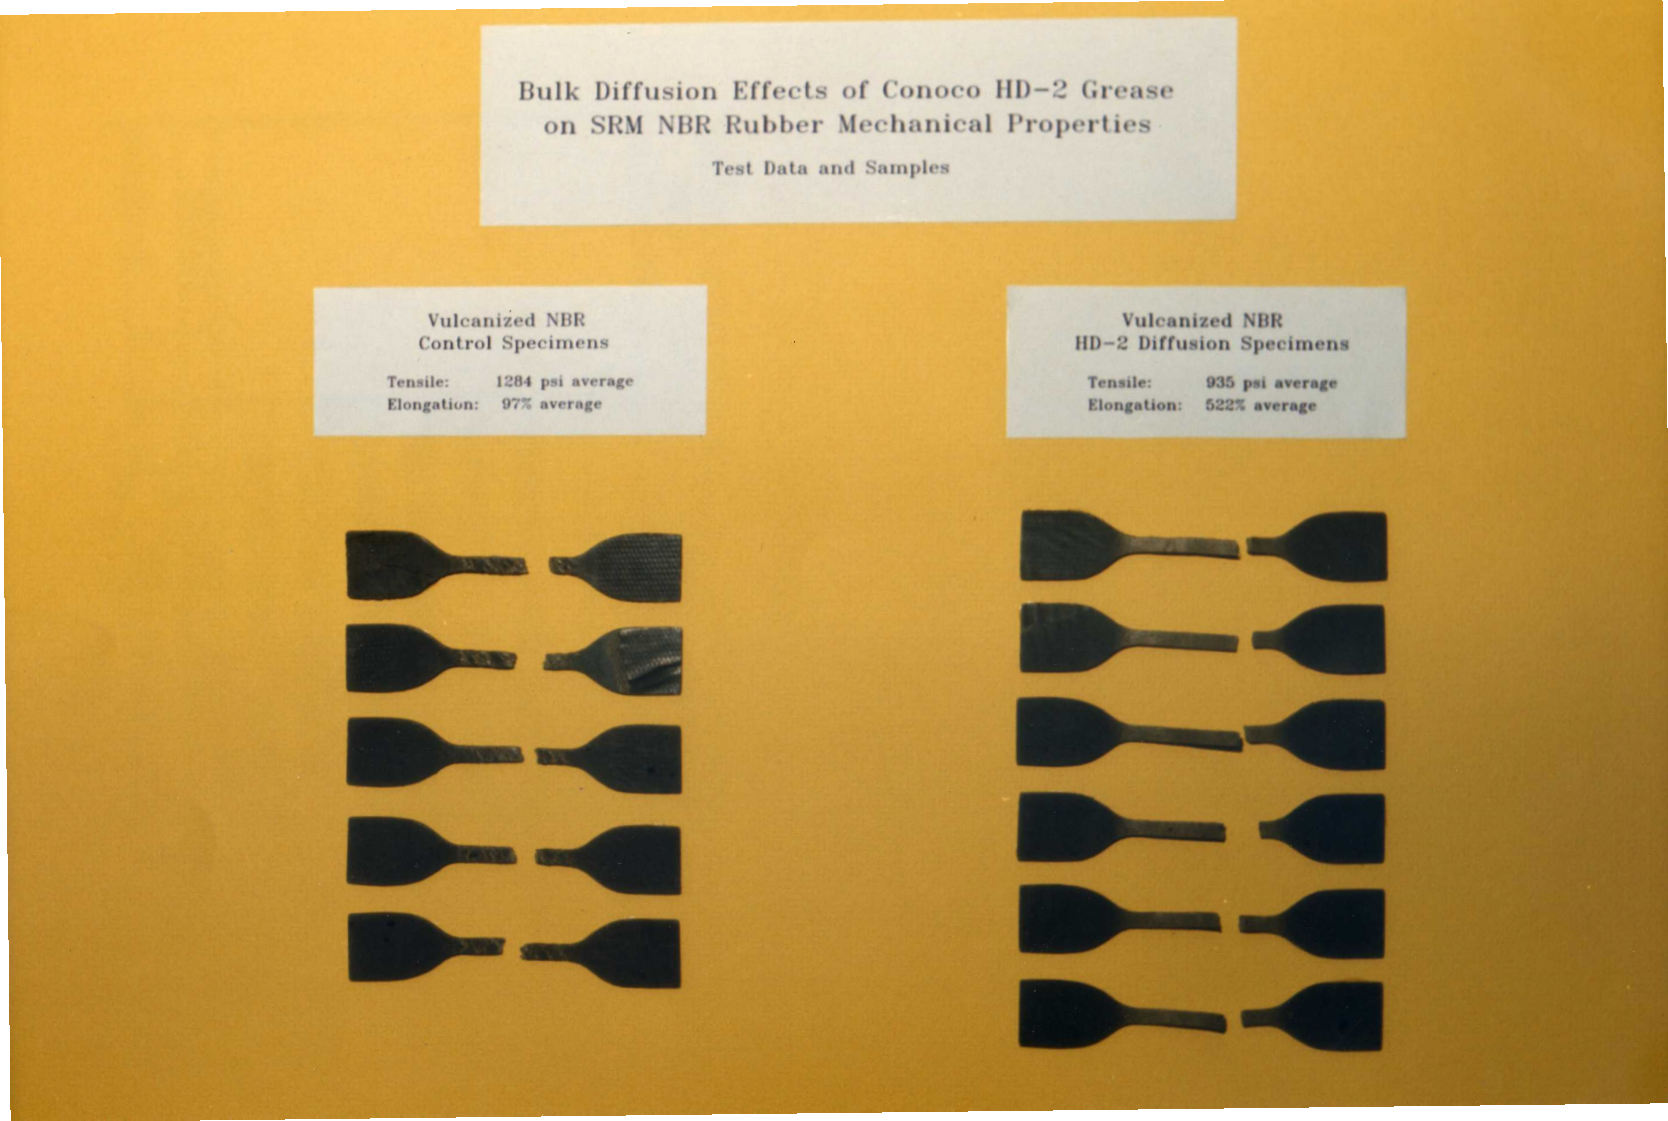
Figure 18. Bulk diffusion effects on Conoco HD-2 grease on SRM NBR rubber mechanical properties.

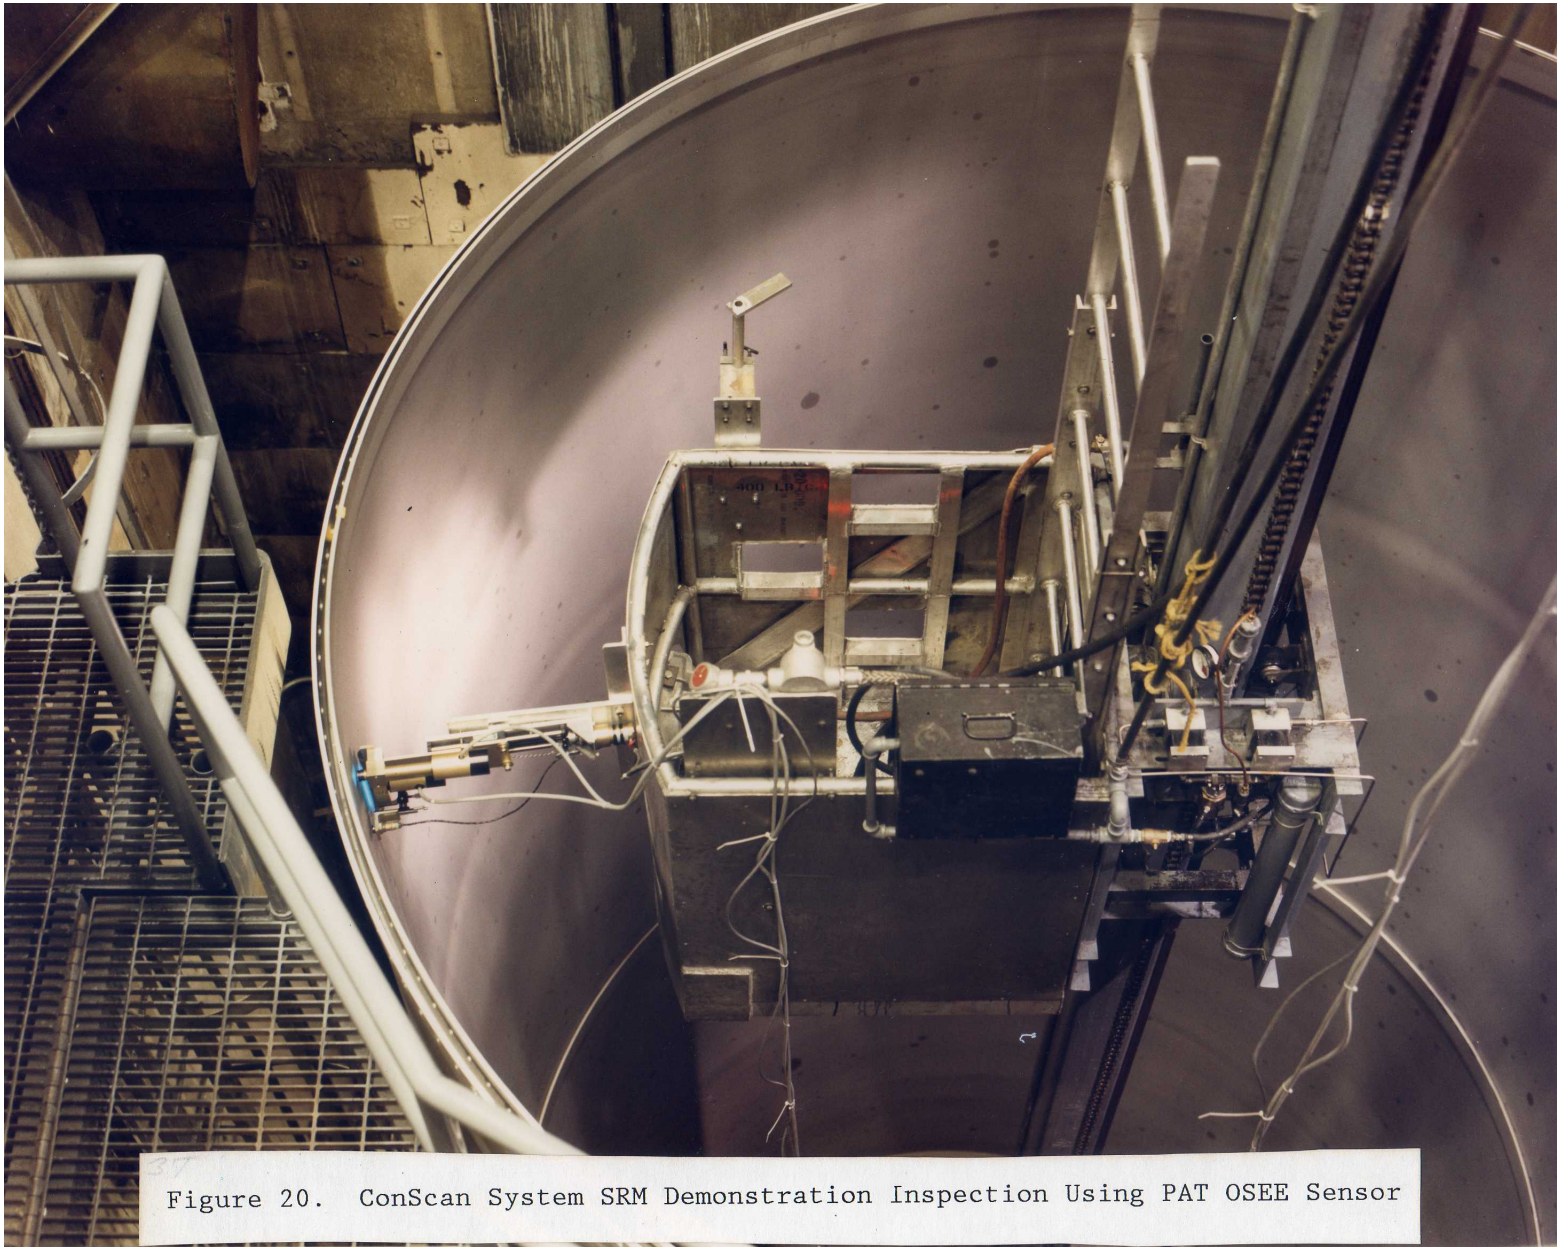
Figure 20. ConScan System SRM Demonstration Inspection Using PAT OSEE Sensor

Figure 20. ConScan system SRM demonstration inspection using PAT OSEE sensor.

With the establishment of the SRM case cleanliness requirements for HD-2 grease (the principal case contaminant) and the calibration of the OSEE technique for verifying the requirements, a full scale demonstration of the prototype ConScan system described earlier was performed at the MTI SRM manufacturing facility in Utah. Figure 20 shows the installation of the sensor and associated position controller on the hydraulically operated cage and the location of the sensor relative to the casting segment which was mounted on a turntable. The data system is shown in Figure 21.

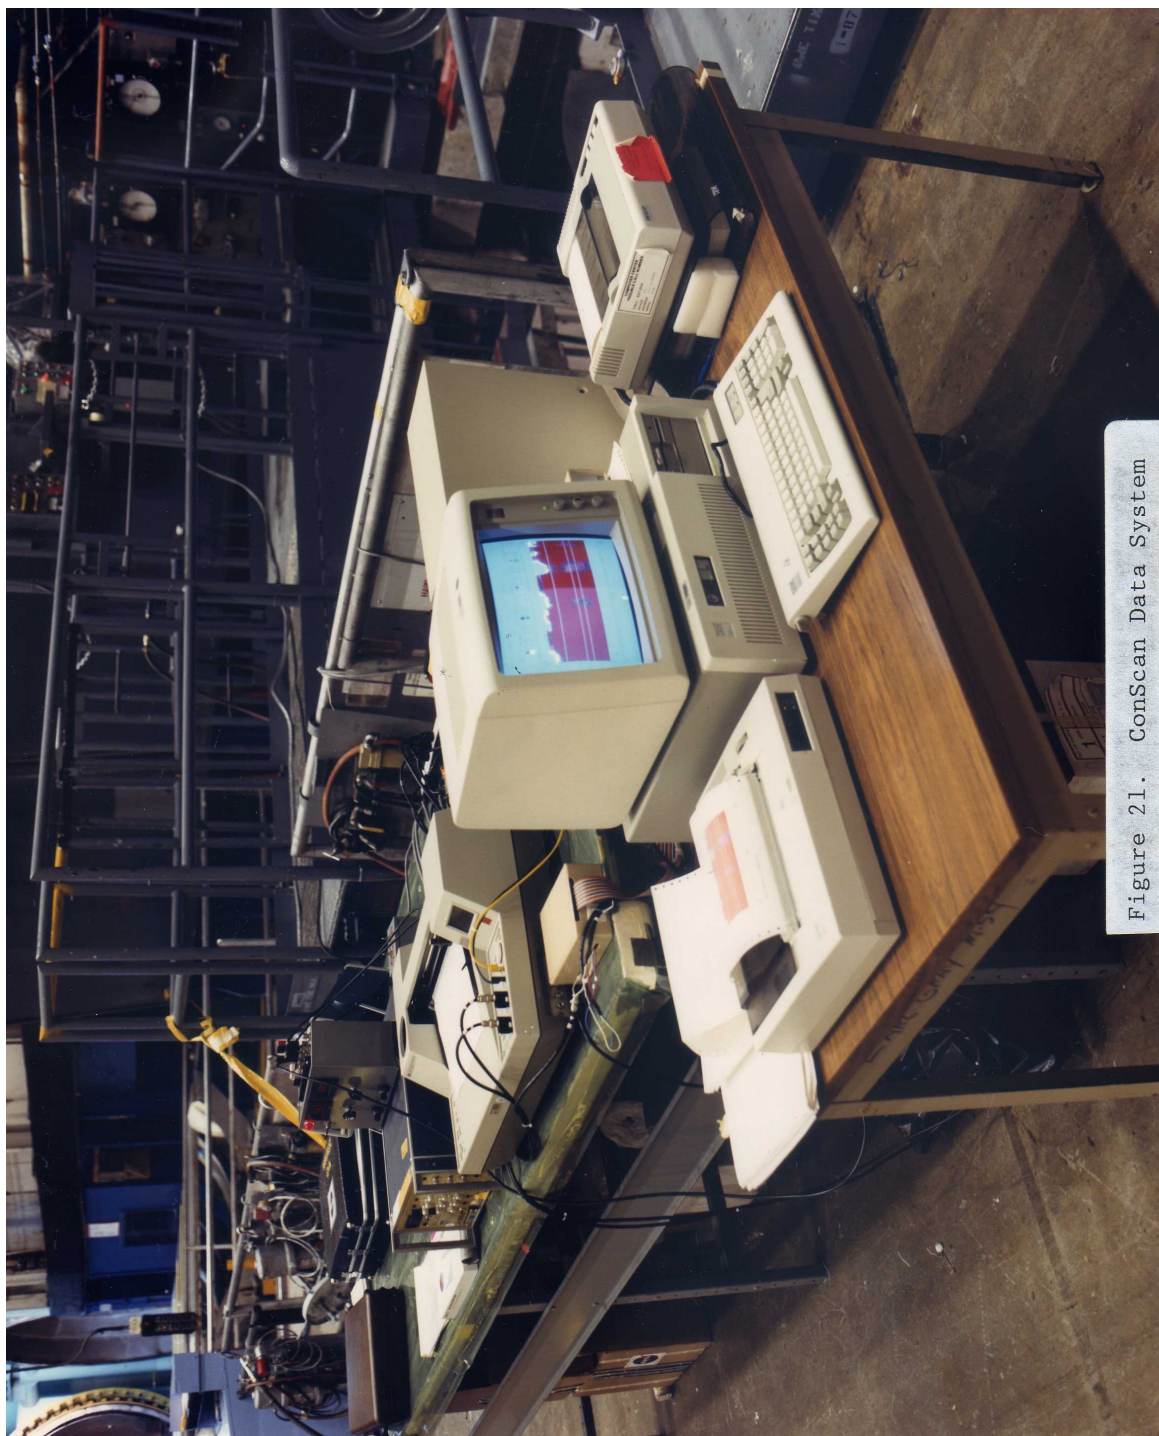
Figure 21. ConScan Data System

Figure 21. ConScan data system.

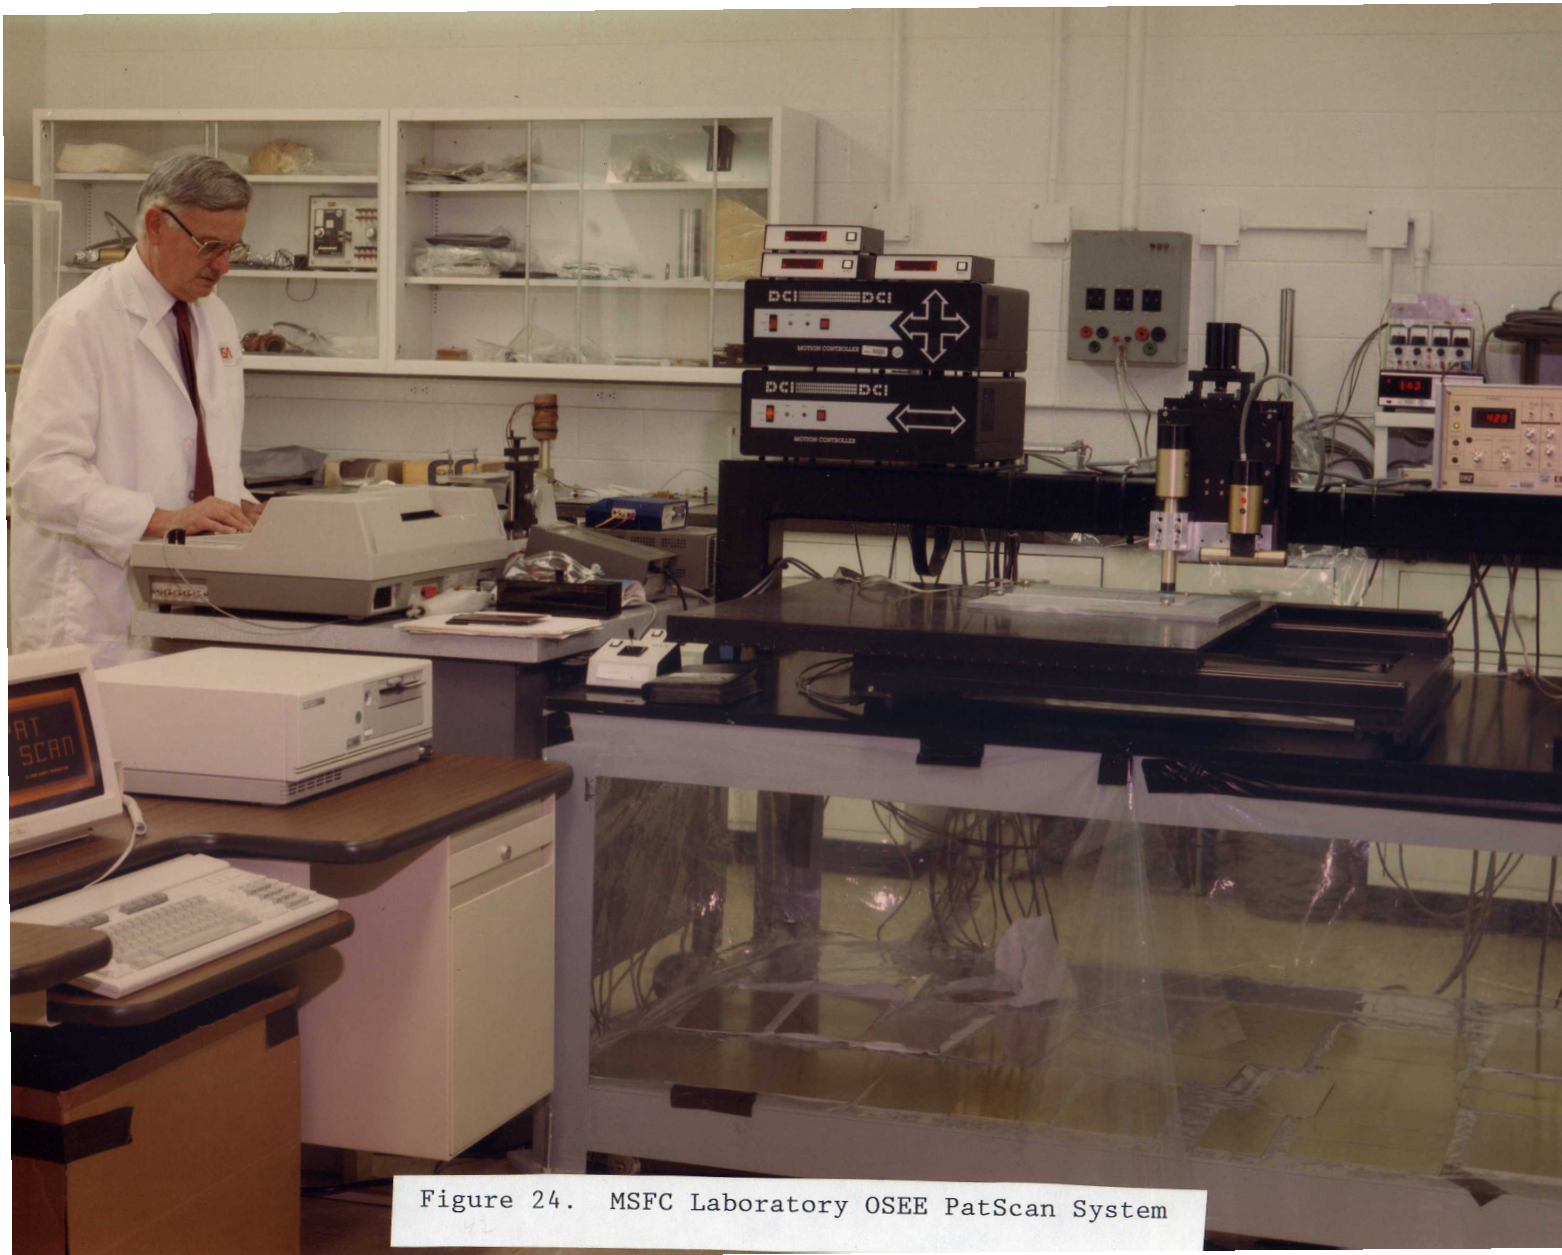
Figure 24. MSFC Laboratory OSEE PatScan System

Figure 24. MSFC Laboratory OSEE PatScan system.

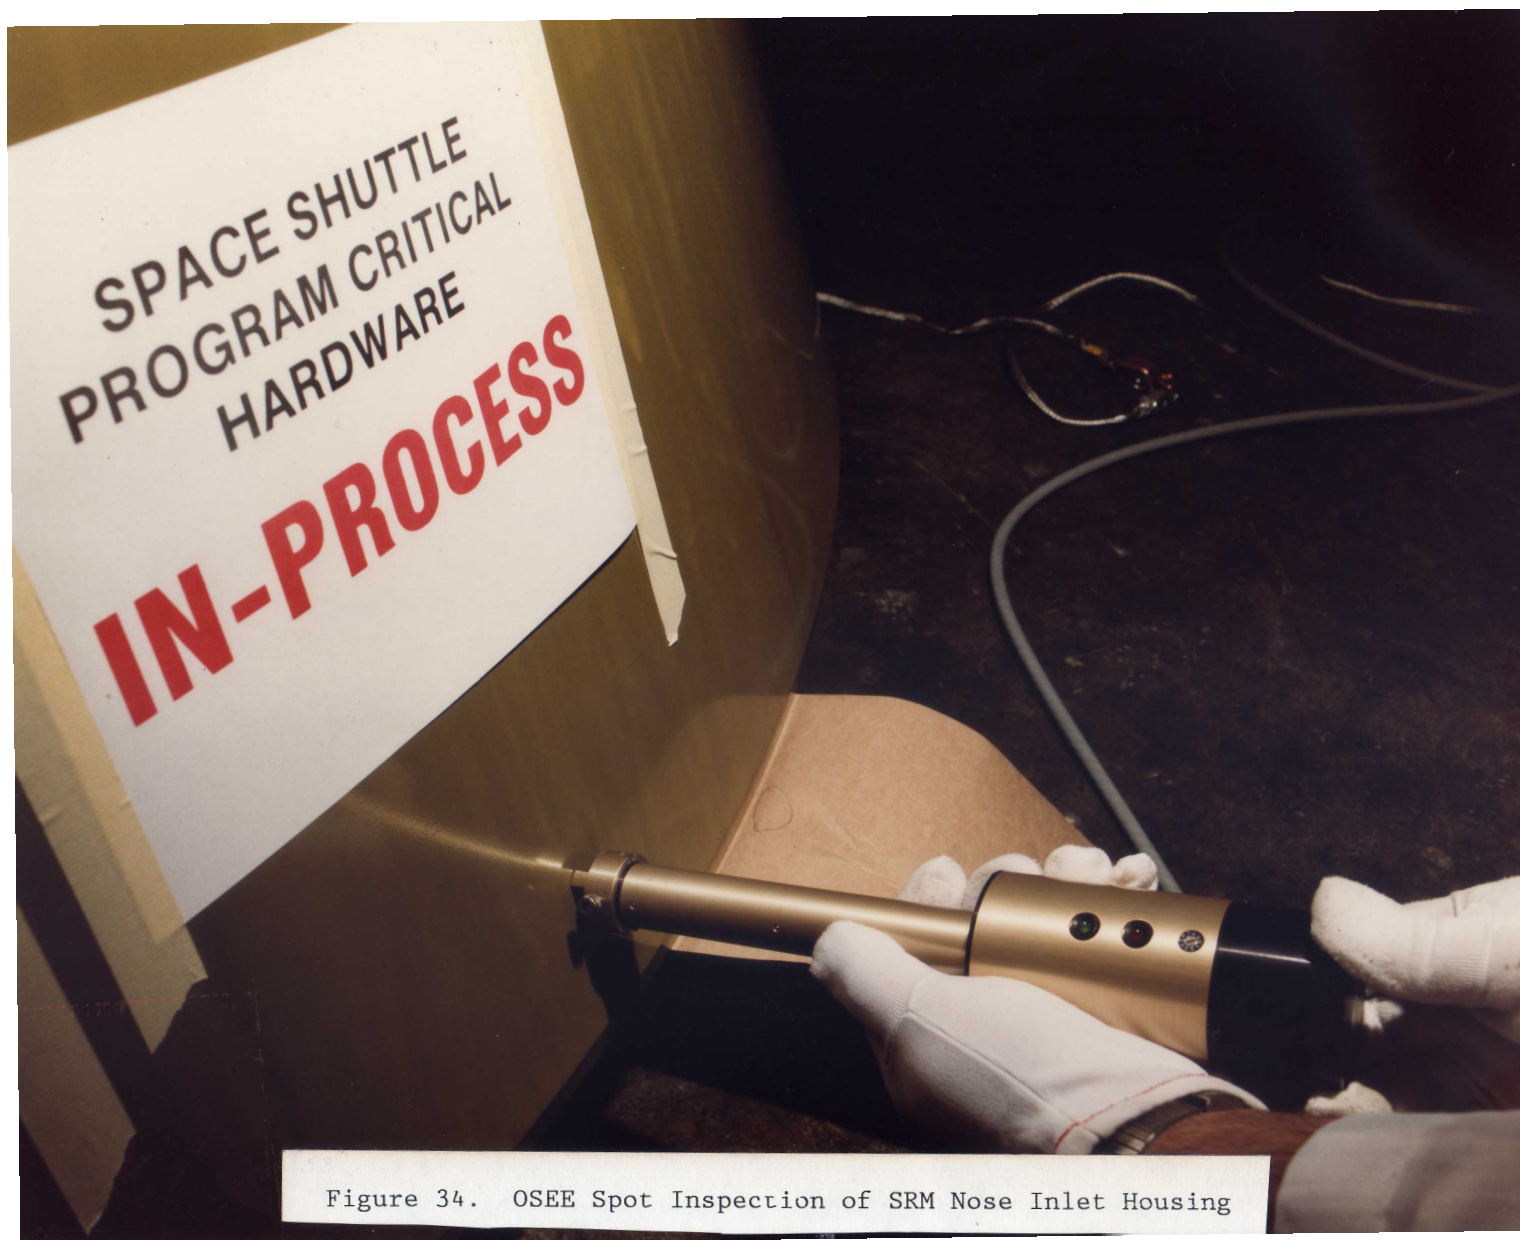
Figure 34. OSEE Spot Inspection of SRM Nose Inlet Housing

Figure 34. OSEE spot inspection of SRM nose inlet housing.

Some measurements on full-scale SRM nozzle parts have been made. However, due to the present lack of an automated scanning capability, only spot inspections were made. The use of the OSEE sensor on an SRM nose inlet housing is shown in Figure 34. In this application, a clean standoff with a non-photoemitting coating is used to maintain the sensor-to-surface spacing. Since spot inspections by hand are time consuming and the probability of missing a contaminated area is high, automated scanning of the total bonding surface is highly desirable. Figures 35 and 36 show a gantry robot and the robot arm with an OSEE sensor being used to scan a 10-ft diameter test article mounted on a turntable. This system is under development for the automated scanning of the large SRM nozzle parts.
