Advanced Turbine Technology

ATTAP

1988 Annual Report

Allison
Gas Turbine Division
General Motors Corporation
P.O. Box 420
Indianapolis, Indiana 46206-0420

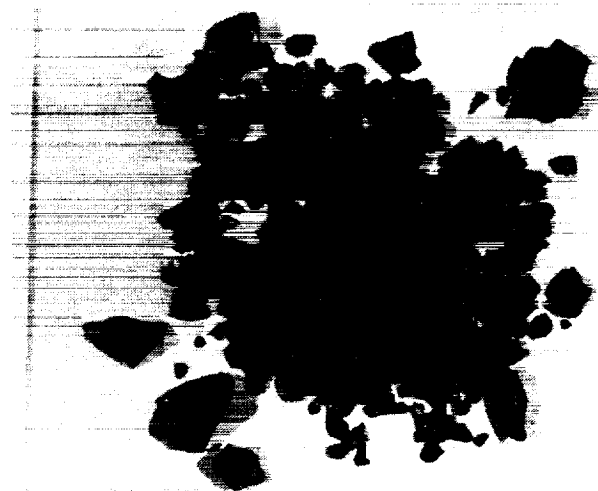
TE89-4619

Figure 52. Remnants of S/N 2, BU22 gasifier turbine rotor.

Gasifier Turbine Rotor (P/N AA101477, S/N FX52308, Carborundum SiC, Total Part Time: 23:43 Hours). The SiC rotor fractured from the stub shaft and was shattered, as shown in Figure 52. A fracture origin could not be identified in these fragments. However, the stub shaft fracture surface was not damaged and a fracture origin was identified, as shown in Figure 53. Moving away from the origin (normal to the surface), the crack front changed direction and headed toward the hub of the rotor, probably branching at the middle of the rotor shaft. Two opposing gouges noted on the zircon insulation ring indicated that the rotor initially fractured at the stub shaft.

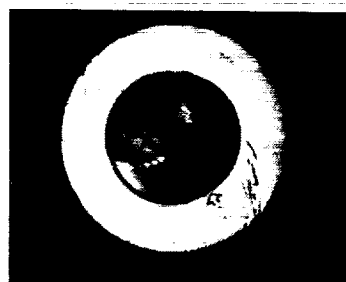
TE89-4620

Figure 53. Broken gasifier rotor stub shaft with fracture origin indicated by arrows. Insulator and kennametal rings gouged (left), crack front propagation direction change (right).

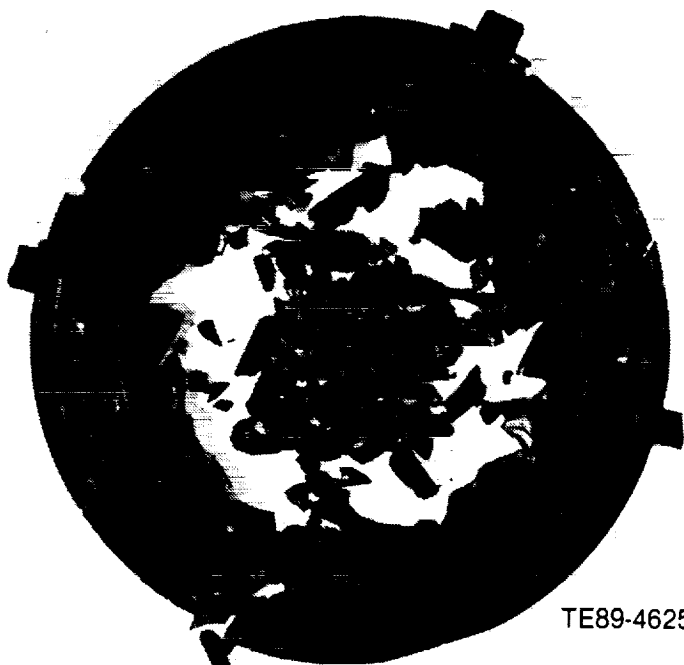
TE89-4625

Figure 58. Partially reconstructed gasifier outer backplate.

Gasifier Outer Backplate (P/N AA101165D, S/N FX52944, Carborundum SiC, Total Part Time: 5:54 Hours). The outer backplate shattered into numerous pieces. Figure 58 shows the partially reconstructed backplate. All major cracks initiated at the i.d. Crack origins were not observed at the cross key slots as observed in the previous engine failure (S/N 1, BU26).

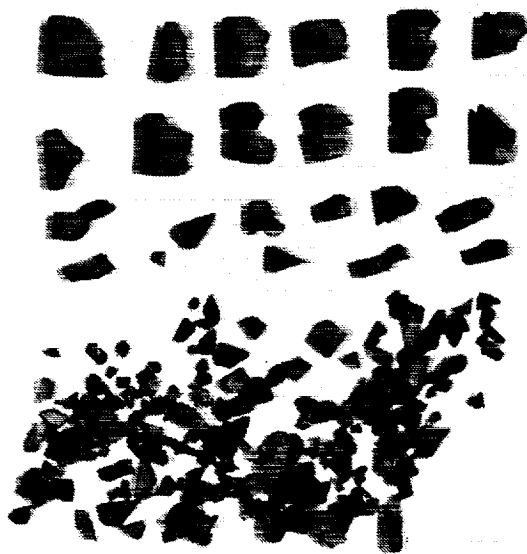
TE89-4626

Figure 59. Partially reconstructed gasifier vanes (left) and gouging impact damage on one vane (right).

Gasifier Vanes (P/N AA101374-4, GTE AY6 Si_3N_4 , Total Part Time: 5:54 Hours). Figure 59 shows the remains of 18 gasifier turbine vanes. Deep gouges and rub marks were observed on the suction surface of the vanes.

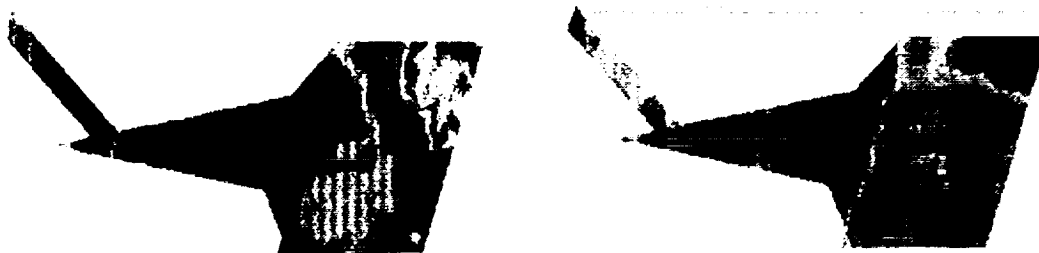
TE89-4660

Figure 68. Shear rate start-up conditions (left) and optimum conditions (right).

The shear rate during filling is a function of section thickness and flow front velocity. The maximum shear rate was reduced by 67% under optimized conditions (see Figure 68).

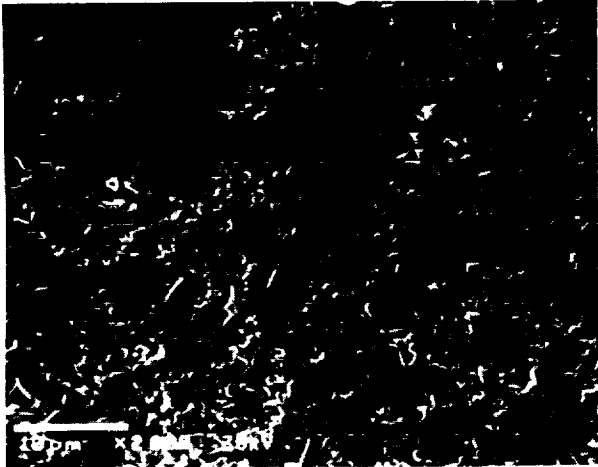
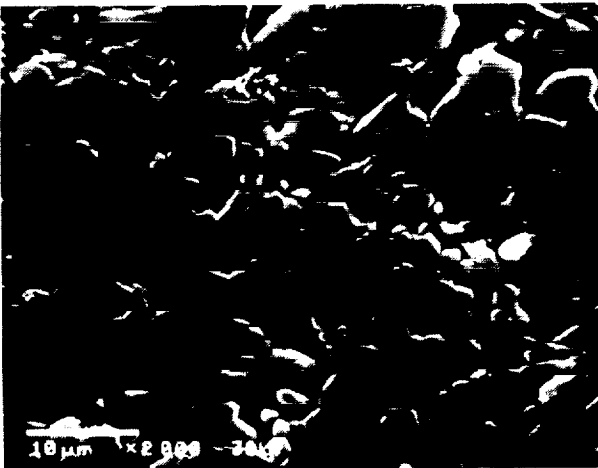
1750°C, 150 min

1750°C, 500 min

The fracture toughness of each billet was measured by the controlled surface flaw technique with an average of five samples. The results are shown in Figure 80. At both temperatures, fracture toughness increased approximately 20% with an increase in time from 150 to 500 minutes. The limit to which fracture toughness can be increased by grain growth is uncertain. Figure 80 shows that at 1750°C (3182°F), fracture toughness values still appear to be increasing after the 500 minute hot press cycle. To determine if the fracture toughness could be increased further by growing Si_3N_4 grains, a billet was hot pressed at 1750°C for 1500 minutes (25 hr). The results are plotted in Figure 81 and show that the extended hot

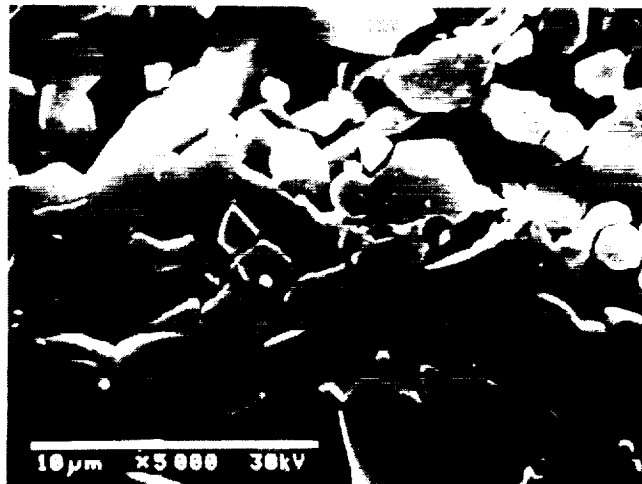
b) Desirable hot-pressed microstructure

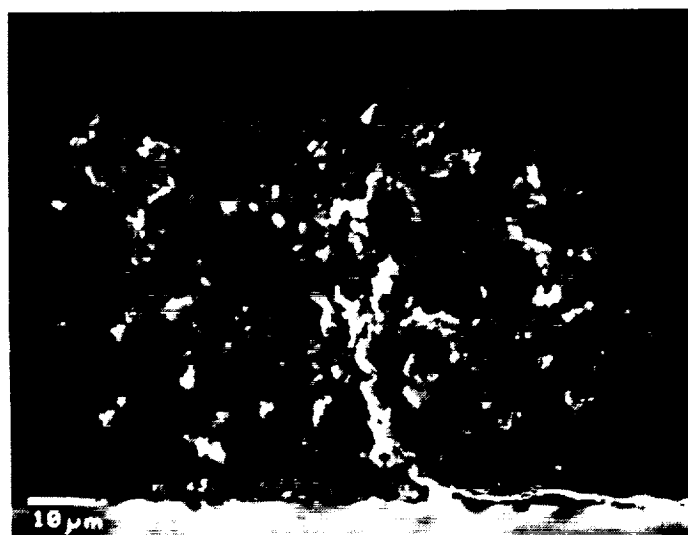
TE89-4636

b) Low density region

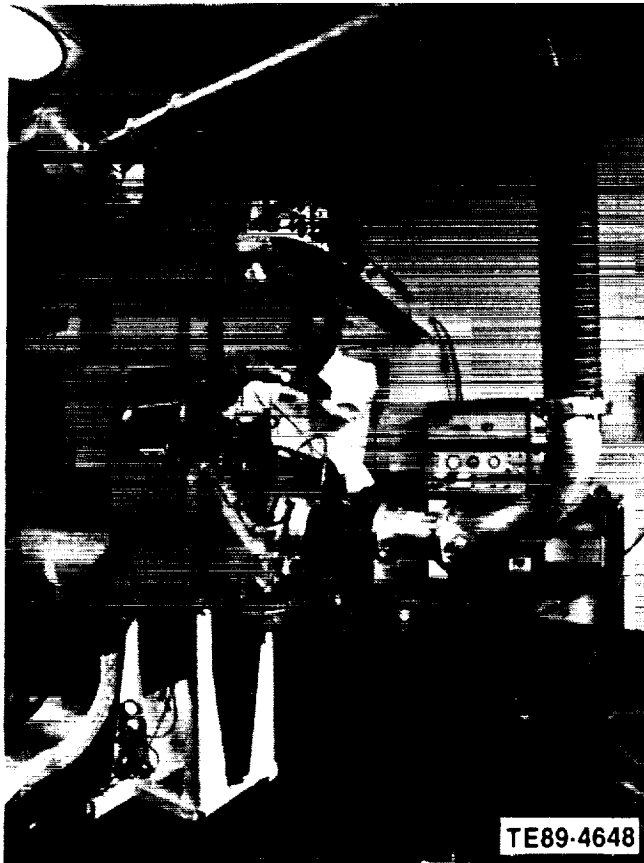
Figure 95. AGT-5 hot gasifier test rig on stand.

Design, procurement, build, and installation in the test cell was completed in late 1988. Figures 95 and 96 show the new AGT-5 hot gasifier rig in the final stages of installation in the test cell.

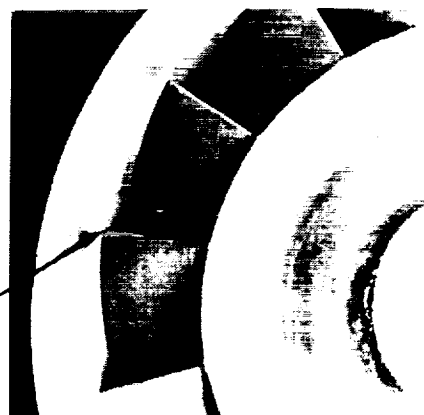
TE89-4652

Hard carbon
in dome

Combustion liner
local
deterioration

Small chip
in rotor

Figure 99. Foreign object survivability--ceramic turbine rotor.
