**NASA
Technical
Memorandum**

NASA TM- 100393

COMPENDIUM OF FRACTURE MECHANICS PROBLEMS

By R. Stallworth, C. Wilson, and C. Meyers

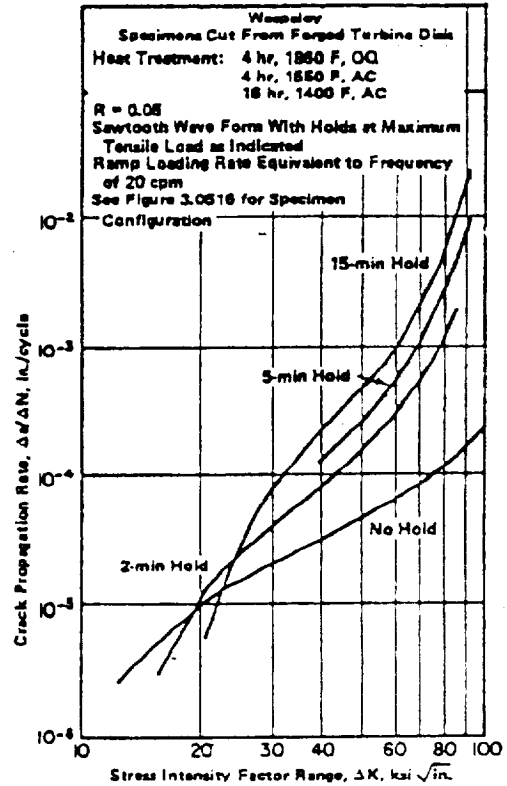
FIGURE 3.05115. EFFECT OF HOLD TIME ON CRACK PROPAGATION RATES FOR WASPALOY AT 1200 F (60)

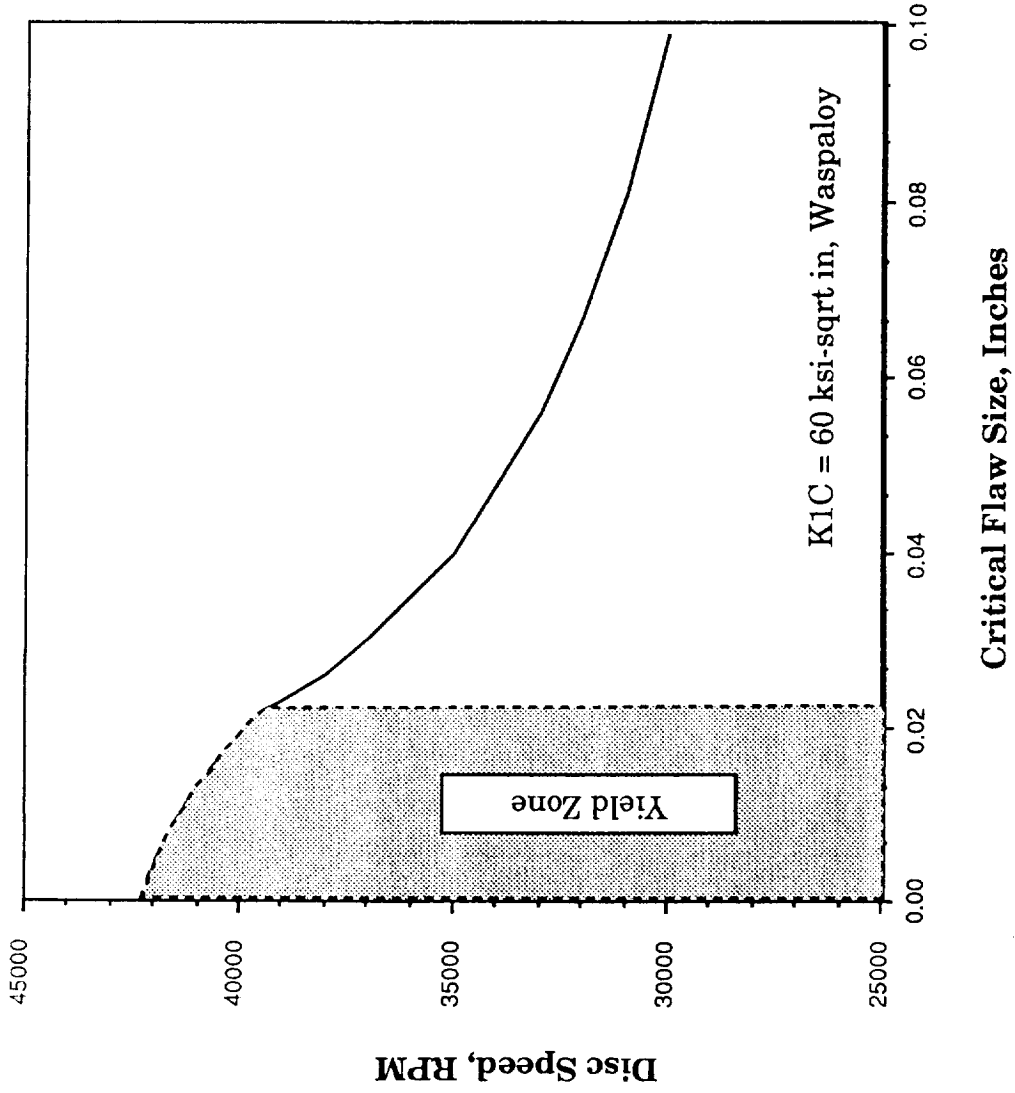
Corner Crack at Curvic Coupling Bolt Hole ($a/c=1$)

Figure 24. HPOTP disk burst speed.

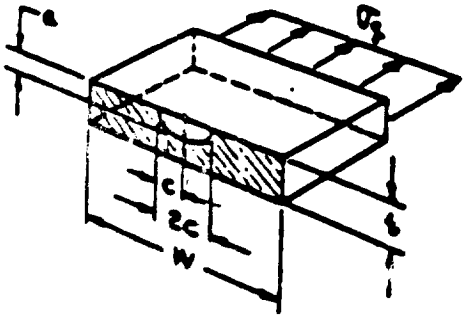
Description	Stress Adjustment Factors		Variable Correction Factors
	(1)	(2)	
<p><u>Case 1</u></p> <p>Center Panel Part Through Crack</p>

σ_{max} for bending	σ_{min} for bending	$VAF = f(a)$ $YCF = f(c)$

Figure 28. HST NASA/FLAGRO center panel part-through crack geometry model.

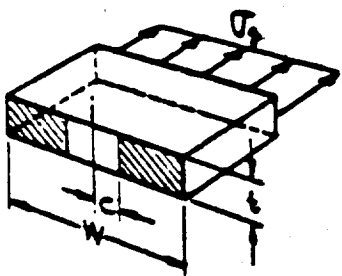
Description	Stress Adjustment Factors		Variable Correction Factors
	(1)	(2)	
<p><u>Case 1</u></p> <p>Center Through Crack</p>

Not Available	Not Available	$YCF = f(c)$

Figure 29. HST NASA/FLAGRO center panel through crack geometry model.
