NASA
Technical Memorandum 105668

Full-Scale Transmission Testing to Evaluate Advanced Lubricants

Prepared for the
Sixth International Power Transmission and Gearing Conference
sponsored by the American Society of Mechanical Engineers
Phoenix, Arizona, September 13-16, 1992

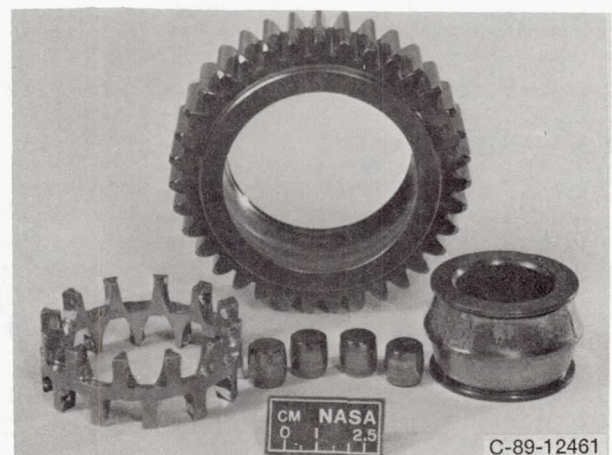
FIG. 4.—Planet bearing fatigue failure during test 5.

Planet bearing failures. For MIL-L-23699 lubricant brand A, three planet bearing fatigue failures occurred. The first occurred on one of the original planet gears of the transmission during test 5 (Fig. 4). The failure was a fatigue spall on the inner race. This component acquired 66 hr of run time at operating conditions of

117-percent torque and 121 °C (250 °F) oil inlet temperature from tests 3 and 5. The second and third planet bearing fatigue failures occurred at these operating conditions. One occurred after 59 hr of test 5, and the other after 75 hr of test 6. The failures of all three bearings were similar. The spalls covered both rows of each bearing and about one-third of their circumferences. The large amount of spalling indicates some run time occurred after initial spalling. All failures were detected from the conventional chip detector on the OH-58A transmission.

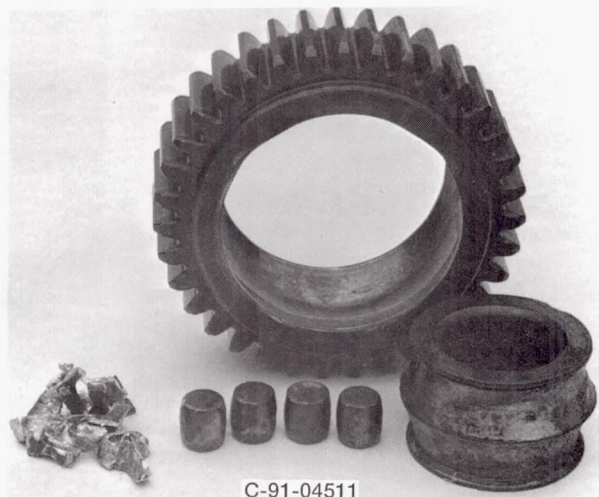
FIG. 5.—Planet bearing cage failure during test 9.

For MIL-L-23699 lubricant brand B, one planet bearing cage failure was produced after 91 hr of test 9 (Fig. 5). This failure was catastrophic in that the cage for one of the planet bearings was completely destroyed and the rollers and raceways showed excessive scoring and distress. This failure was detected by a sudden increase in component temperatures and vibration.
