NASA
Technical
Paper
3226

**Effect of Temperature
and Gap Opening Rate
on the Resiliency of
Candidate Solid Rocket
Booster O-Ring Materials**

Cynthia L. Lach
*Langley Research Center
Hampton, Virginia*

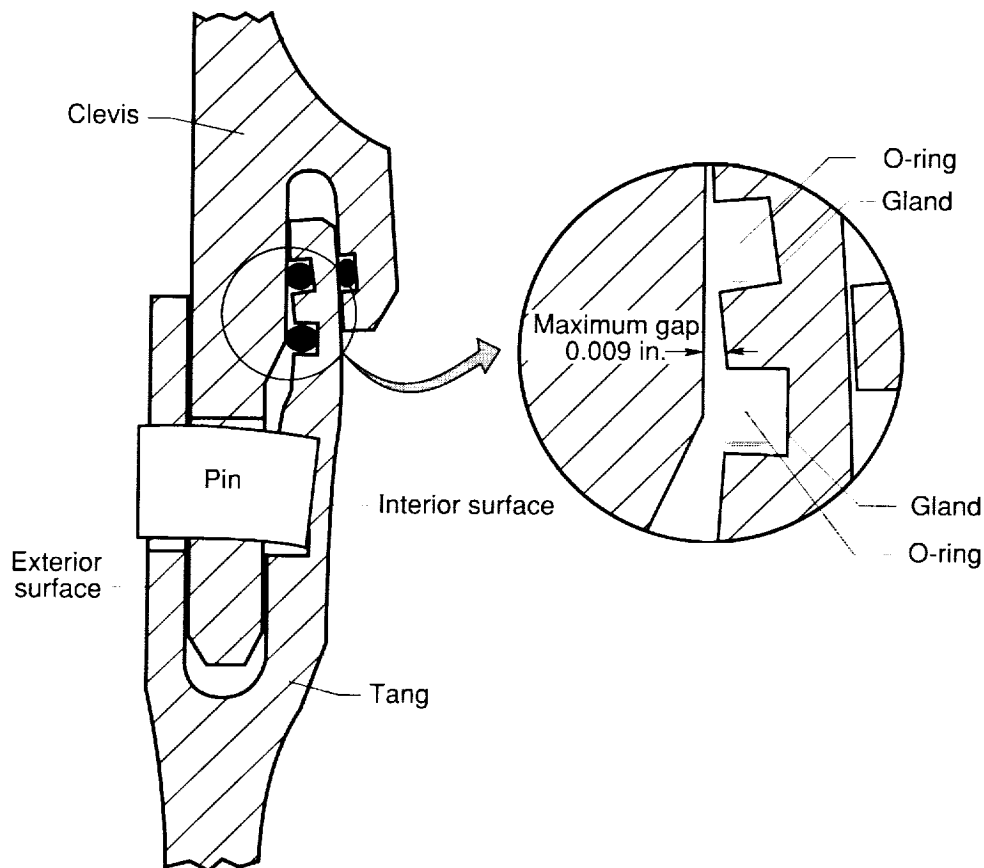
Figure 2. Schematic of redesigned field joint showing location of maximum gap opening during internal SRB pressurization.

The two main sources of SRB joint structural deflections are the dynamic external tank (ET)/SRB attach strut loads during Shuttle launch and the internal pressurization of the SRB during ignition. The structural deflections associated with the attach strut are caused by the constraint of the SRB during Shuttle main motor ignition. These constraint loads are stored within the assembled structure and released immediately after Shuttle launch. An analysis of previous flight data revealed that the structural vibrations caused by the attach strut loads produce maximum joint gap deflections of 0.001 in. at 3 Hz (private communication from Frank Bugg of NASA Marshall Space Flight Center, January 1987). The second source of deflection is the internal motor pressurization of the SRB. The 3σ case of the head end SRB motor pressure would result in a maximum internal pressure of 1015 psi. This pressure will create a maximum gap opening (delta gap) of 0.009 in. between the clevis and the tang of the redesigned field joint as shown in figure 2 (ref. 3).

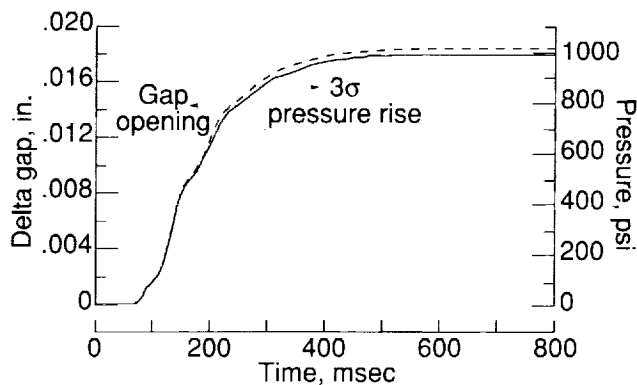
Figure 5. Displacement history and 3σ pressure rise for field joint deflection test.

A computer generated the nonlinear displacement gap opening that simulated twice the maximum gap opening curve resulting from the 3σ pressurization of the SRB field joint. Figure 5 shows the computer-generated displacement gap opening and the resulting gap opening displacement of the fixture mounted in the servo-hydraulic machine. The vibrational contributions to the delta gap opening were added onto the end of the computer-generated displacement gap opening (at 600 msec) to determine the effect of the vibrations due to the ET/SRB attach strut loads.

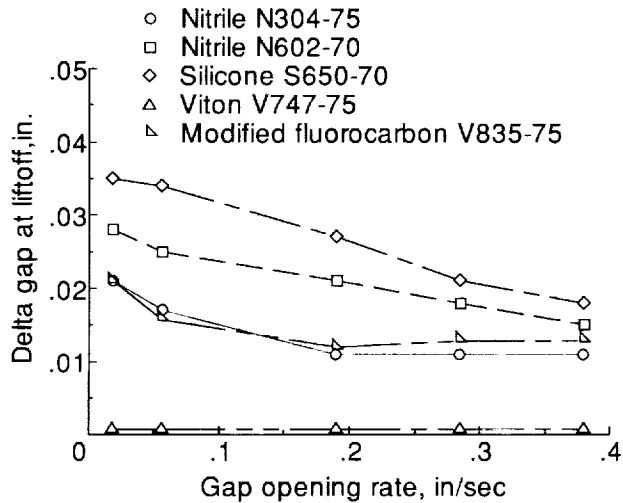
Figure 11. Resiliency behavior of candidate O-ring materials at 20°F.

Figures 6-11 show the resiliency behavior of the five candidate materials at temperatures from 70°F to 20°F in decreasing intervals of 10°F . Each figure has the delta gap at liftoff (the displacement at which

Figures 6-11 show the resiliency behavior of the five candidate materials at temperatures from 70°F to 20°F in decreasing intervals of 10°F. The ability of the O-ring to track the gap opening displacement (resiliency) decreased at lower temperatures and higher gap opening rates. Silicone S650-70 exhibited the best resiliency over the entire temperature range and was only mildly affected by the lower temperatures. In contrast, the resiliency of Viton V747-75 was severely reduced with decreasing temperature, particularly at the lowest temperature of 20°F, where the Viton O-ring lifted off immediately, regardless of the gap opening rate. Since the 20°F

test temperature was much closer to the glass transition temperature of Viton V747-75 than that of the other candidate materials tested, the largest effect was expected for Viton, which was shown to be much stiffer at the lower temperatures (ref. 7) (see table I). The thermal ranking of the candidate O-ring materials was in accordance with the results from tests performed at Marshall Space Flight Center (ref. 8).

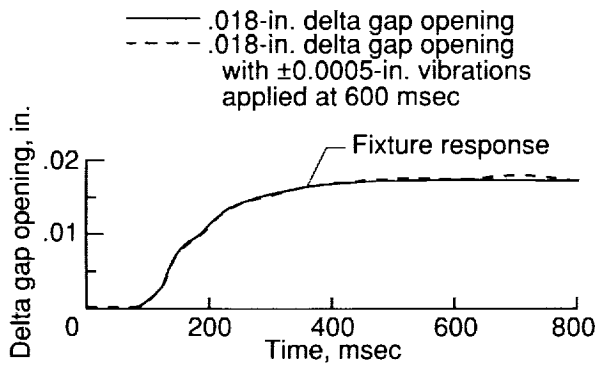
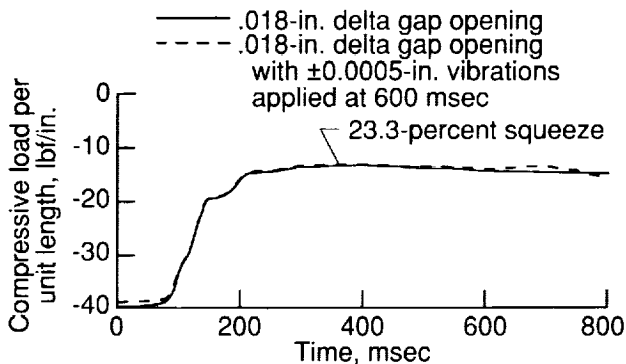
(a) Displacement response of fixture to programmed delta gap openings.

(b) Compressive load trace.

Figure 12. Results from simulated SRB field joint deflection test for V747-75 at 75°F.

Typical results from an SRB field joint deflection test are shown in figure 12. Figure 12(a) shows the displacement (delta gap opening) of the fixture within the 600-msec time frame of the computer-generated displacement gap opening. The 3-Hz, ± 0.0005 -in. vibrations were added at 600 msec at the end of the displacement gap opening. The fixture

response followed the computer-generated displacement gap opening very closely, with a maximum error in delta gap opening of 0.001 in. The error in the final delta gap opening of 0.018 in. was much smaller. An example of the resiliency response of Viton V747-75 at 75°F is shown in figure 12(b). The compressive load per unit length is plotted against the 600-msec time frame corresponding to the computer-generated displacement gap opening. Viton maintained contact throughout the computer-generated displacement gap opening and the computer-generated displacement gap opening with the vibrational contributions added at 600 msec, as shown by the compressive load curve in figure 12(b). Note that the resulting compressive load curve follows every change in slope of the computer-generated displacement gap opening.

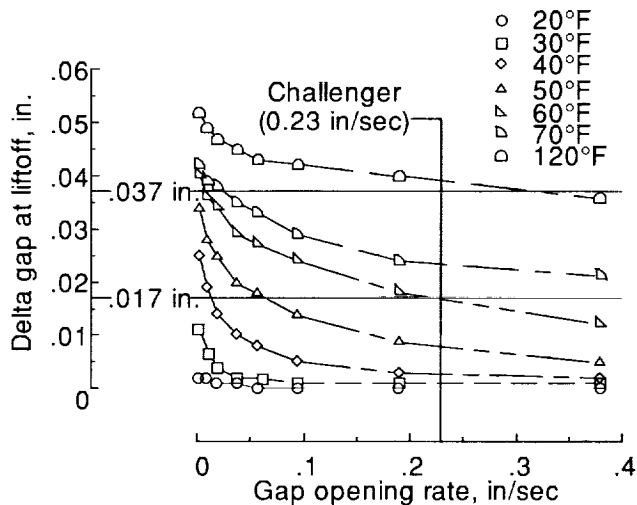
Figure 13. Viton response at Challenger's joint deflection and gap opening rate.

In order to characterize the full resiliency behavior of Viton V747-75, additional testing was performed that included a test temperature of 120°F and gap opening rates less than 0.1 in./sec. The results are shown in figures 13 and 14. Figure 13 shows that the resiliency of the Viton V747-75, which was used on the Challenger flight, was adversely affected by cold temperatures, particularly in the range of expected gap opening rates for the original field joint (0.23 in./sec) (ref. 9). Various structural analyses of the original SRB field joint showed that the average gap or relative displacement between tang and inner clevis arm ranged from 0.017 to 0.037 in. (refs. 1, 10, and 11). For the original SRB field joint, the estimated maximum gap opening rate of 0.23 in./sec was calculated from data provided in reference 11. At the mean joint launch temperature of Challenger, 28°F, the Viton V747-75 O-ring was unable to track the delta gap opening (0.017-0.037 in.) at the prescribed rate of 0.023 in./sec, nor could it track the maximum displacement requirement of 0.018 in. at a gap opening rate of 0.019 in./sec as required for the redesigned joint (see fig. 14). This investigation also confirms the Presidential Commission findings on the Challenger accident (ref. 1).

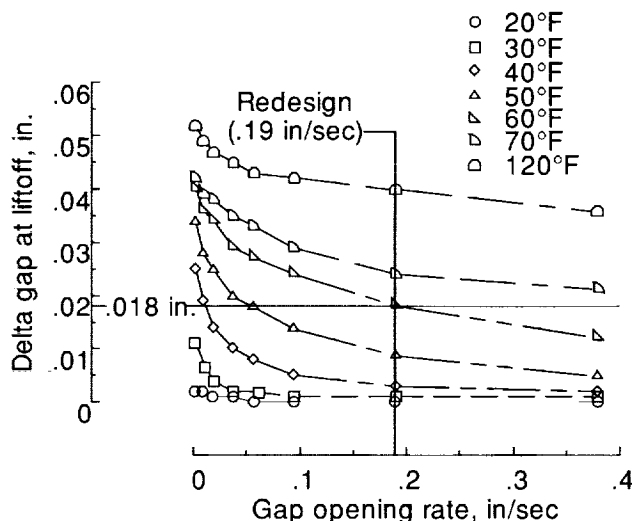
Figure 14. Viton response at redesign joint deflection and gap opening rate.

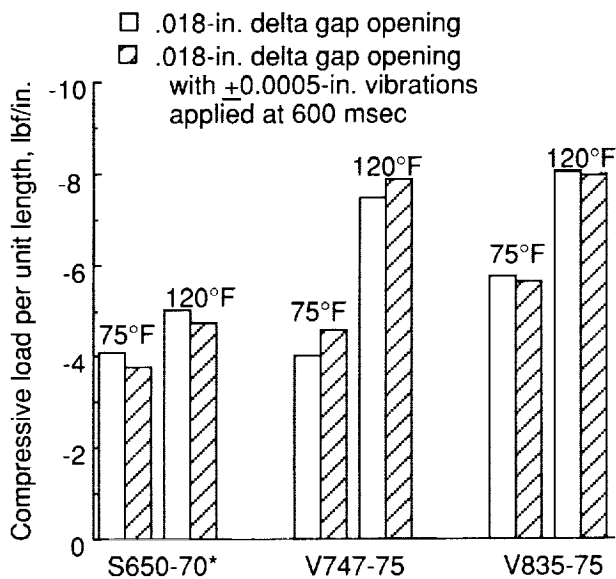
Figure 15. Residual load values of candidate materials at 16.2-percent squeeze at 75°F and 120°F.

Figures 15 and 16 show the results of the tests simulating structural deflections of the SRB field joint. The most significant feature of the results is that the compressive load on the O-ring did not drop to zero during the simulation, indicating that the O-ring successfully tracked the delta gap opening and maintained contact with the sealing surface. For all materials, initial squeezes, and temperatures tested, the O-ring tracked the required gap opening of 0.018 in. without pressure assistance during the critical 600-msec interval.

In addition to verifying that the O-ring materials could track the delta gap, it was of interest to assess the effects of the test variables on the minimum residual loads on the O-rings at the maximum gap. The magnitude of the residual load is a measure of the sealing capability of the O-ring; the higher the load the better the seal. Figures 15 and 16 show the effects of O-ring material, temperature, and vibrations on the residual loads for initial squeezes of 16.2 and 23.3 percent, respectively. The trends for the two squeezes were very similar, but the higher initial squeeze resulted in higher residual loads. The modified fluorocarbon V835-75 exhibited the highest residual loads at all test conditions, and the silicone S650-70* exhibited the lowest loads.

The higher residual loads for all materials at 120°F in comparison to those at 75°F (figs. 15 and 16) are most probably caused by thermal expansion. The difference was largest for modified

Figures 15 and 16 also indicate that the effects of vibration on residual load are minimal for all the materials in each test condition. Although the 3-Hz, ±0.0005-in. vibrations generally decreased the residual loads, the added vibrations did not result in the O-rings losing contact with the sealing surface at any time. The silicone S650-70*, having the lowest dynamic storage modulus of all the candidate materials, showed the greatest loss in residual load with the vibrations added.

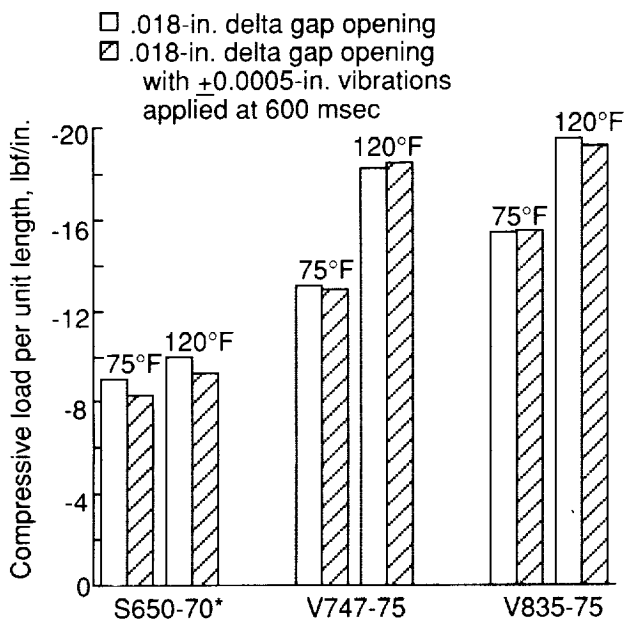
Figure 16. Residual load values of candidate materials at 23.3-percent squeeze at 75°F and 120°F.
