(NASA-Case-LAR-14581-1-SB) METHOD  
AND APPARATUS FOR EVALUATING  
MULTILAYER OBJECTS FOR  
IMPERFECTIONS Patent Application  
(NASA) 15 p

# METHOD AND APPARATUS FOR EVALUATING MULTILAYER OBJECTS FOR IMPERFECTIONS

PATENT APPLICATION

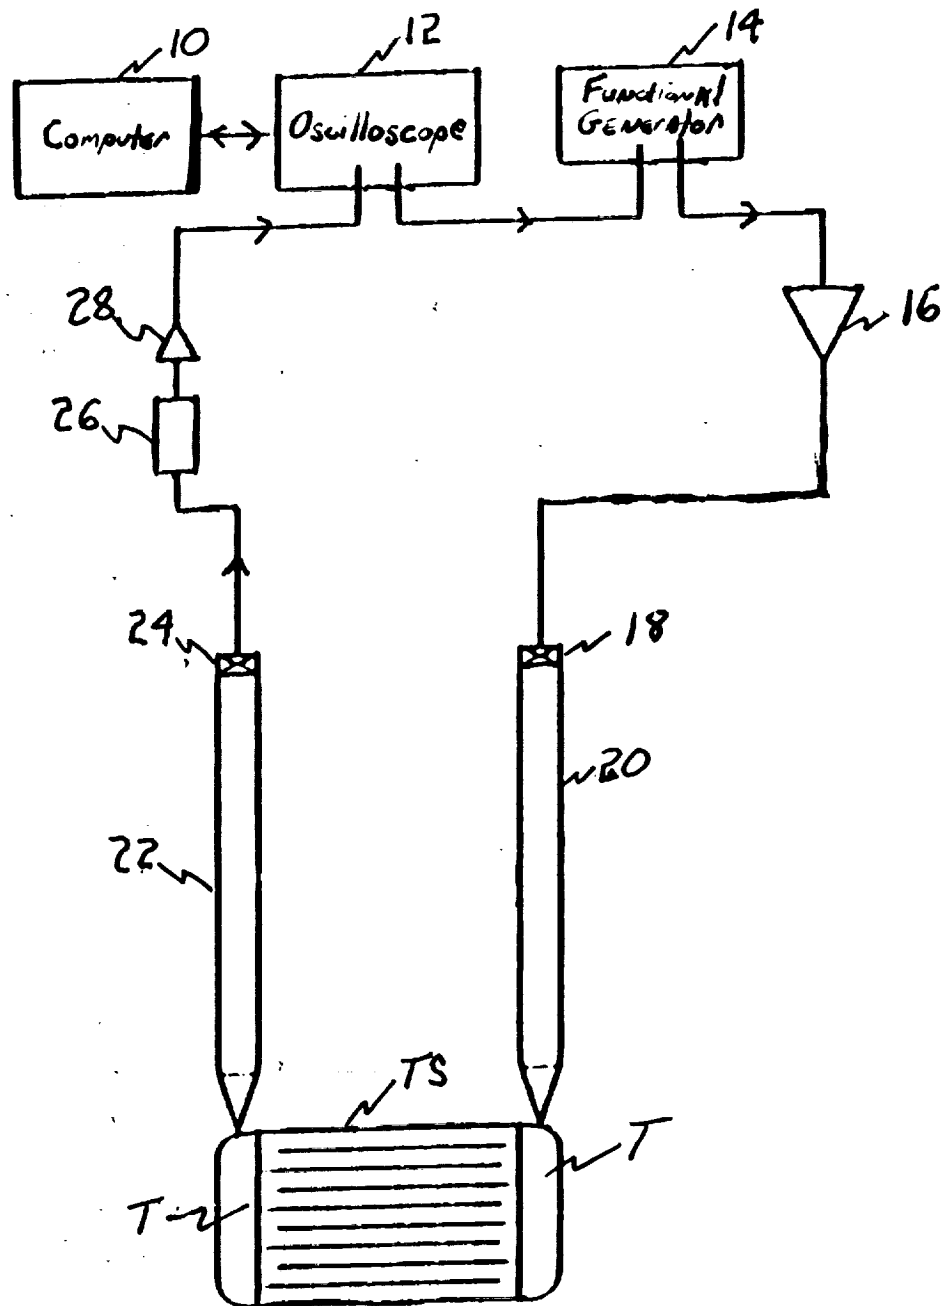
Fig. 1

FIG. 1 is a schematic of an apparatus for evaluating a multilayer object for imperfections according to the present invention;

Referring to FIG. 1, a schematic diagram is shown of the apparatus used in the present invention. A computer 10 is provided which is connected to and controls an oscilloscope 12, preferably a digital oscilloscope such as the LeCroy  
25       9400A which is commercially available from LeCroy Corporation. A line out from the oscilloscope is connected to a function generator 14 for generating a radio frequency (RF) pulse which is amplified by RF power amplifier 16. For example, the computer can command that a RF pulse with a center frequency of 1 MHz be generated. The frequency chosen is dependent upon the material  
30       properties and structural dimensions of the test specimen TS.

The amplified RF pulse is applied to the multilayer test specimen TS, which may be a multilayer ceramic chip capacitor (MLCC). The pulse is applied by a transmitting transducer 18 which is acoustically coupled to the TS via a first tapered buffer rod 20. Buffer rod 20 is uniformly cylindrical from a first end  
5 coupled to the transducer 18 throughout its body. The opposite end is tapered to a fine point in order to produce a sharp acoustic contact by reducing the interface area between this pointed end and the TS. The resulting acoustic wave propagates across the TS and is picked up by a second tapered buffer rod 22. Second tapered buffer rod 22 is similar in shape to first rod 20. By  
10 way of example, both rods may be copper and have an untapered diameter of approximately 700 $\mu$ m.

A receiving transducer 24 is coupled to the untapered end of second buffer rod 22, detects the propagated acoustic wave, and converts it into an electrical signal which is transmitted to a low pass filter 26 and then amplified  
15 by amplifier 28. The amplified electrical signal is then supplied to the oscilloscope 12. Oscilloscope 12 permits a visual display of the received acoustic signal and transmits this data along with temporal data to the computer 10 as discussed in greater detail below with reference to FIGS. 2-5. This permits the evaluation of the MLCC, as discussed below.

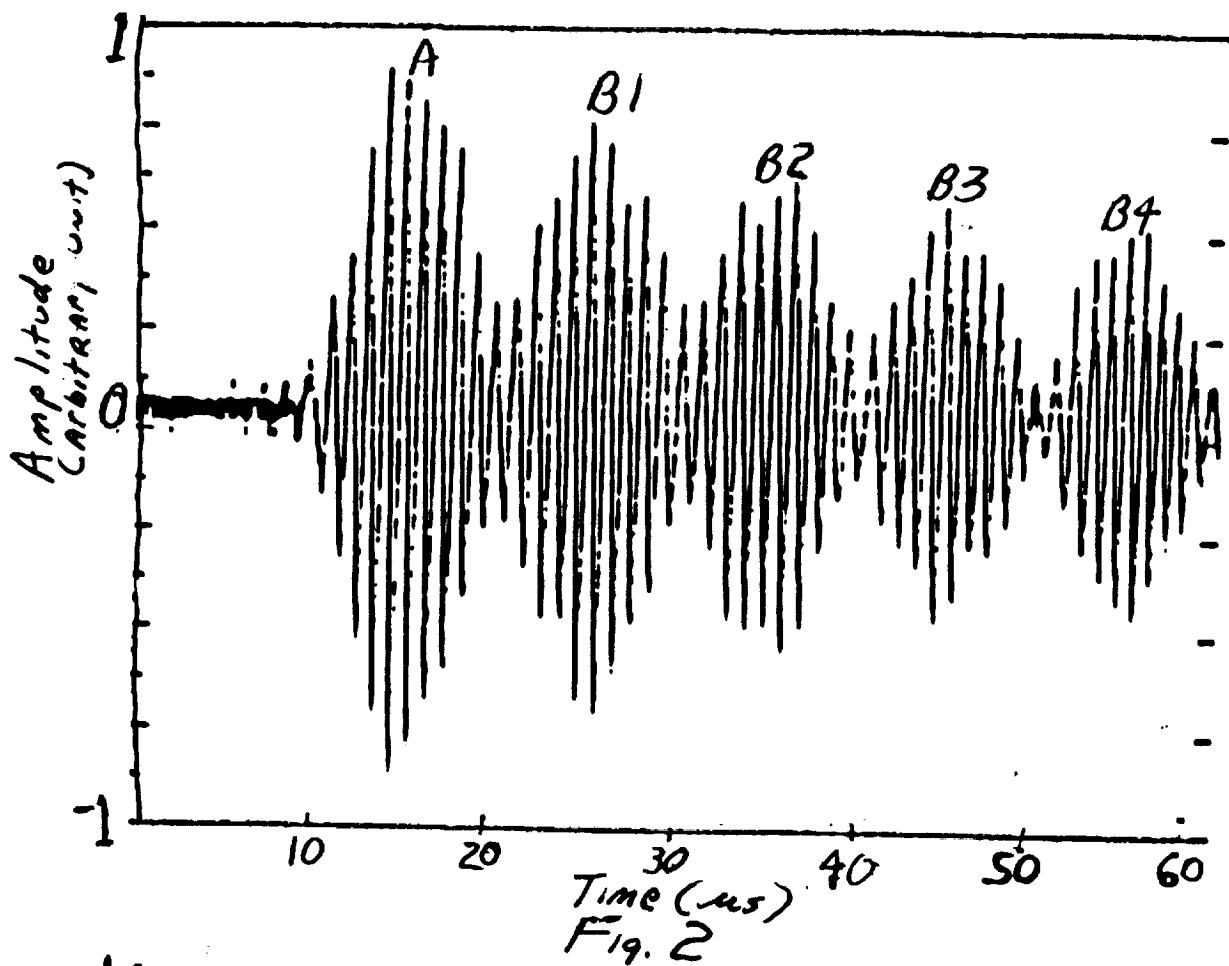
5        FIG. 2 is a graph of pulse echo signal groups taken over time for an undamaged multilayer chip capacitor;

The MLCC was determined to be relatively defect free prior to testing based on known manufacturing quality and microscopic inspection. FIG. 2 depicts pulse echo signals versus time for the same type of "good", i.e., relatively defect free, capacitor. The C-3216-CH-1H102K MLCC has typical dimensions of 3.2 mm x 1.6 mm x 0.85 mm. The buffer rod points were placed at the length ends so that the pulse traveled a typical length of 3.2 mm.

Both Table 1 and FIG. 2 clearly show a waveform consisting of an initial transmitted pulse (A in FIG. 2) followed by a series of undistorted echoes spaced at equal intervals ( $B_i$  in FIG. 2) for a "good" MLCC. This information is digitally transmitted to the computer 10, where it is stored for subsequent analysis. Based on the time between subsequent echoes (approximately 10 $\mu$ s) and the known path length (6.4 mm), the velocity of sound in the capacitor is determined by the computer or manually to be 640 m/sec.

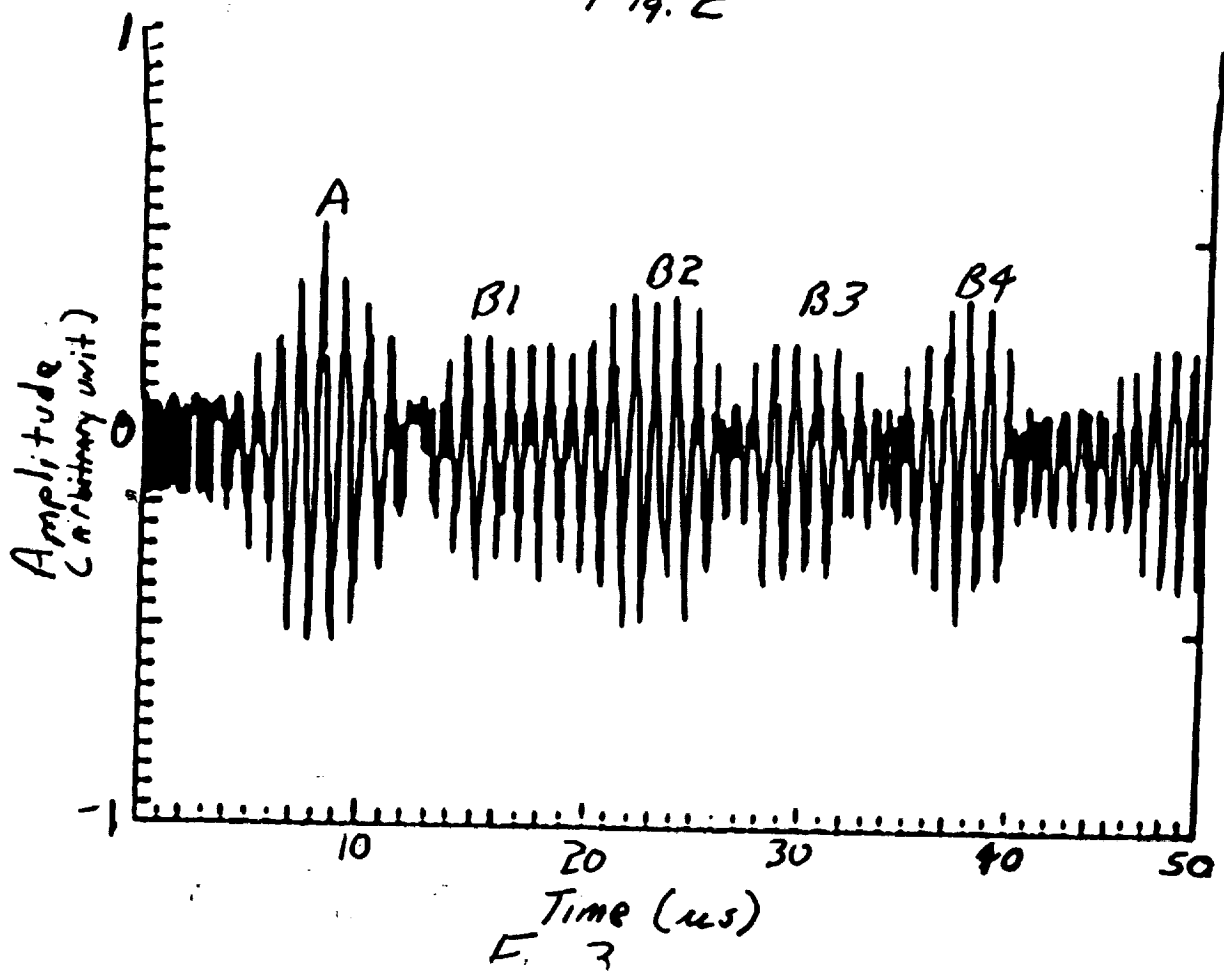
FIG. 3 is a graph of pulse signal groups taken over time for a damaged multilayer chip capacitor;

applying 1.7 kV of RF power across the terminal T in the acoustic propagation direction resulting in microcracks indicative of parametric or catastrophic failure. The microcracks were observed with a microscope. The damaged capacitor was then evaluated according to the method described above. FIG. 3 depicts the acoustic pulse echoes versus time for the damaged capacitor. Unlike the results of FIG. 2, FIG. 3 shows distorted echo trains which are unevenly spaced. Accordingly, the acoustic profile of a MLCC indicates the presence of damaging imperfections such as delaminations, voids, and microcracks. This acoustic profile can be evaluated as a function of time, i.e., computer sampled pulse groups or computer sampled peak amplitudes of each group which occur approximately periodically (equal intervals of time) indicates an acceptably undamaged MLCC whereas unequal intervals indicate an unacceptably damaged MLCC. Alternatively, the acoustic profile can be evaluated as discussed below in reference to FIGS. 4 and 5.

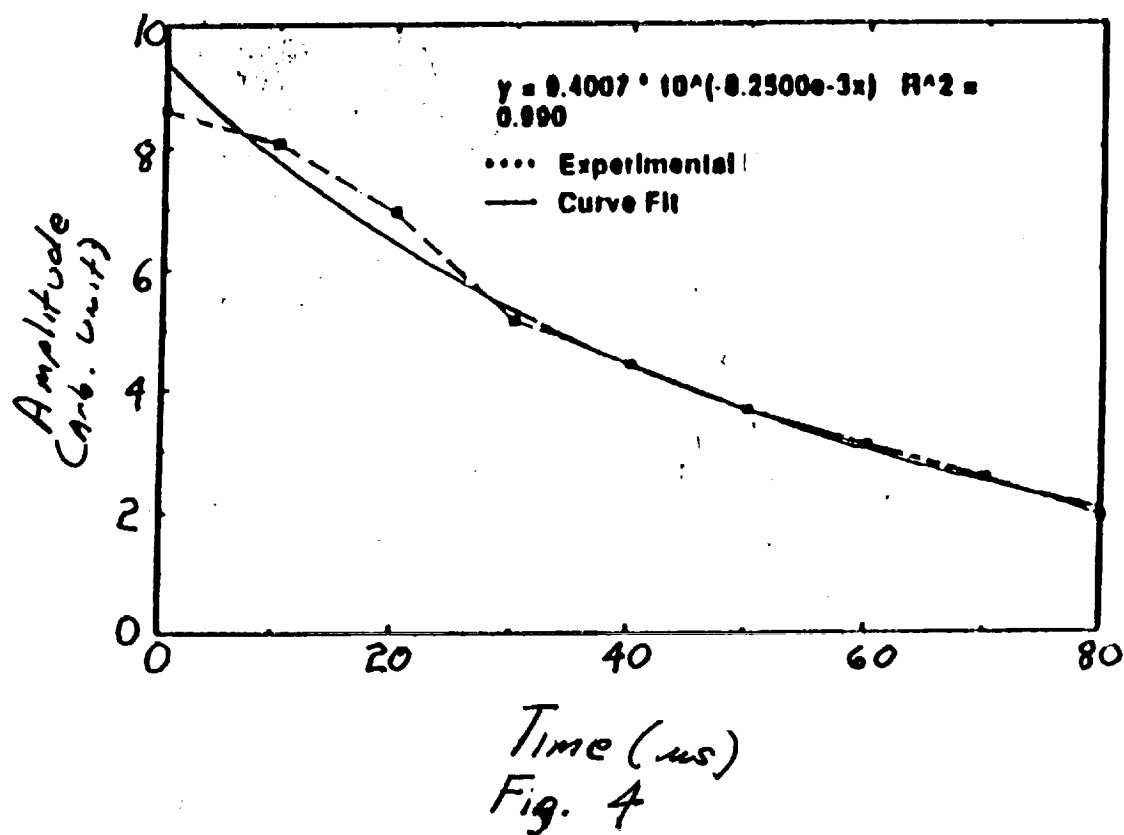
10       FIG. 4 is a graph of experimentally obtained peak amplitudes for each signal group in FIG. 2 and a model exponential curve;

FIG. 4 shows the amplitude of the acoustic signal versus time for the undamaged "good" MLCC. Specifically, the peak amplitudes of each distinct wave envelope or group of FIG. 2 is sampled by the computer, plotted as a data point and connected to other data points via a dashed line. A model exponential curve fit, represented by a solid line, is applied to the experimental data curve via the computer executing a conventional curve fitting program. The data in this case closely follows the exponential curve fit. Thus, it is seen that the amplitude of the acoustic signal for the "good" MLCC decreases over time. Similarly, FIG. 5 depicts the experimental amplitude peaks versus time for the MLCC test results of FIG. 3 connected via a dashed line. Once again, a model exponential curve fit is applied to the data points. The experimental data clearly does not follow the exponential due to damage caused by the applied RF power. Accordingly, the presence of distorted wave trains and deviation of peak amplitude from an exponential curve fit indicates a damaged MLCC.

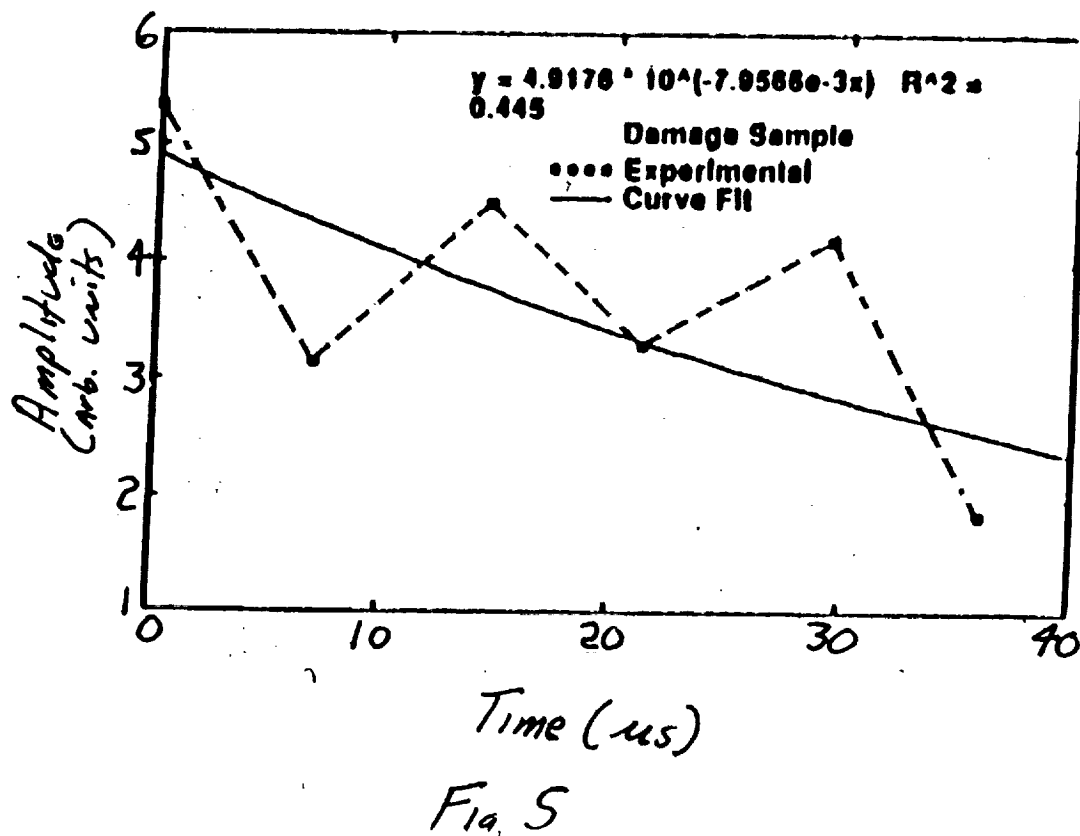
FIG. 5 is a graph of experimentally derived peak amplitudes for each signal group in FIG. 3 and a model exponential curve;

exponential indicates a relatively undamaged MLCC and a deviation from the curve fit indicates the converse. The percentage of fit indicative of a relatively undamaged state is of course application specific. A fit of approximately 80-90% has been found to be a good indication of an acceptable undamaged state and a deviation of 10-20% to indicate an unacceptable damaged state.

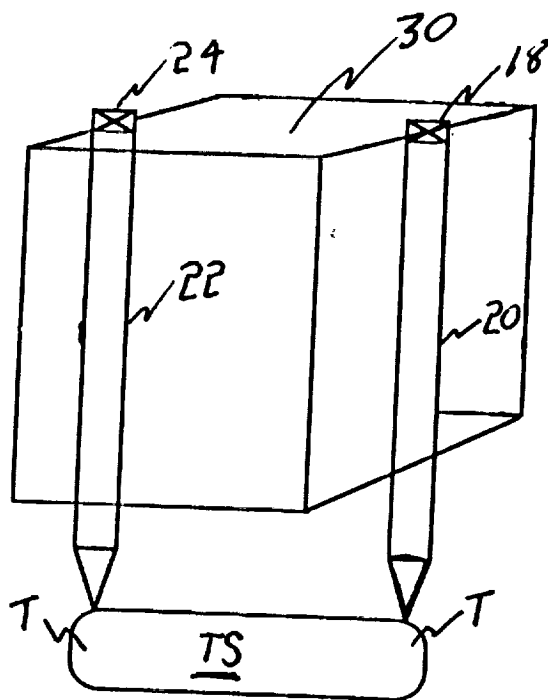
Fig. 6

FIG. 6 is a perspective of an embodiment of a transducer/waveguide combination used in the present invention;

FIG. 6 shows the use of a spacing device 30 which maintains the physical, electrical, and acoustic separation of the tapered ends of the buffer rods 20 and 22 respectively coupled to transmitting and receiving transducers 18 and 24. Spacing device 30 is depicted as a box-like structure wherein the buffer rods are attached to perpendicular faces of the structure. The buffer rods should be spaced so as to contact the terminal ends T of the MLCC test specimen TS. Of course, various alternative holding devices could be employed, e.g., an adjustable spacer located between the buffer rods.

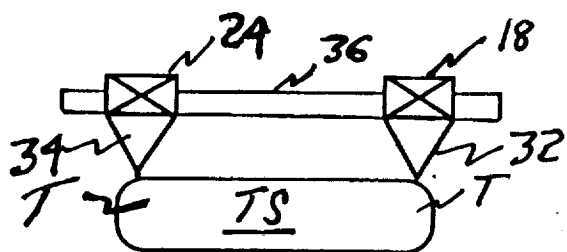
Fig. 7

15       FIG. 7 is a side view of another embodiment of a transducer/waveguide combination; and

FIG. 7 depicts an embodiment wherein the buffer rods are replaced with buffer cones 32 and 34. The transmitting and receiving transducers 18 and 24 are respectively coupled to the bases of cones 32 and 34.
