# ENVIRONMENTAL EFFECTS ON LUNAR ASTRONOMICAL OBSERVATORIES

Stewart W. Johnson<sup>1</sup>, G. Jeffrey Taylor<sup>2</sup>, and John P. Wetzel<sup>1</sup>

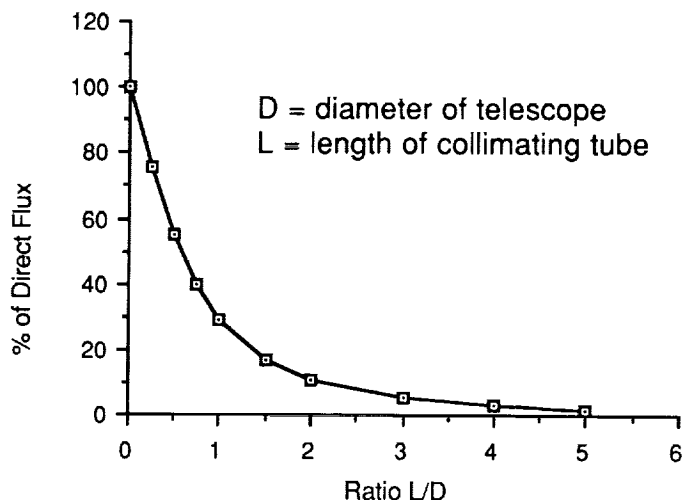
Fig. 1. Plot of the percent of direct flux of micrometeorites reaching a telescope surface of diameter  $D$  as a function of the length  $L$  of a collimating tube.

These fluxes are clearly high enough to damage telescope mirrors, but they apply to  $2\pi$  geometry. A telescope shielded within a collimator would be exposed to a lower flux. For example, a telescope mirror 1 m across located at the base of a 1-m tube would be exposed to only 29% of the direct flux. A tube 3 m long would decrease the flux to 5% of the values listed in Table 1. Figure 1 demonstrates quantitatively how the direct flux is decreased by using a collimator tube for shielding. Even long tubes, however, still allow substantial numbers of micrometeorites to strike an unprotected surface, and there is an additional source of impact-derived debris due to secondary impact events caused by ejecta of primary events. These not only make craters, but also commonly cause deposition of accretionary spatter (Zook, 1978).

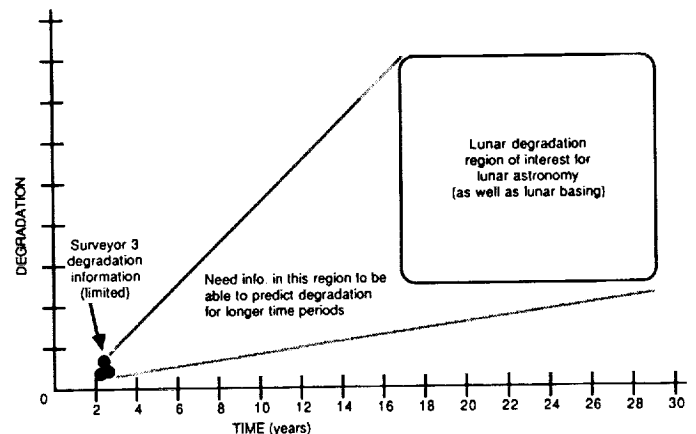
Fig. 2. Schematic representation of the information needed to investigate degradation on the lunar surface over a long period of time.

over a long period of time. For example, revisiting and studying the materials and equipment from the Apollo sites will allow us to acquire information about lunar degradation in the 30-year time range.
