OPTICAL CHARACTERIZATION OF LDEF CONTAMINANT FILM

EXTENDED ABSTRACT

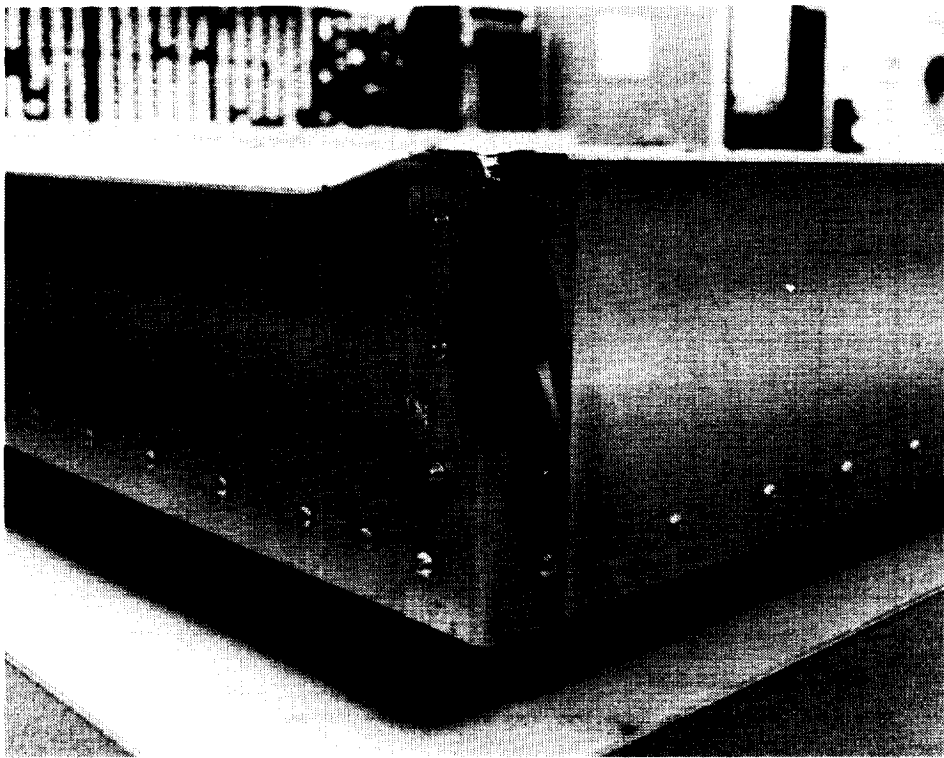
Figure 1a. Molecular film deposit below the mounting flange of experimental tray located at D10. Edge between Rows 9 and 10 pictured. RAM flow, left to right.

The film is thickest on surfaces facing toward the exterior, i.e. the tray corner, as can be seen by comparing the lee and wake aspects of the rivets. The patterns appear to be aligned not with the velocity vector but with the corner of the tray suggesting that flux to the surface is due to scattered atomic oxygen rather than direct ram impingement. The role of scattered flux is further supported by more faint plume patterns (unfortunately not readily visible from the photograph in Figure 1) on the sides of the tray. The angle of these plumes is strongly aligned with the ram direction but the outline of the deposit implies that incident atoms are scattered by collisions with the edges of the opening resulting in a directed, but diffuse, flux of atomic oxygen to the surface.

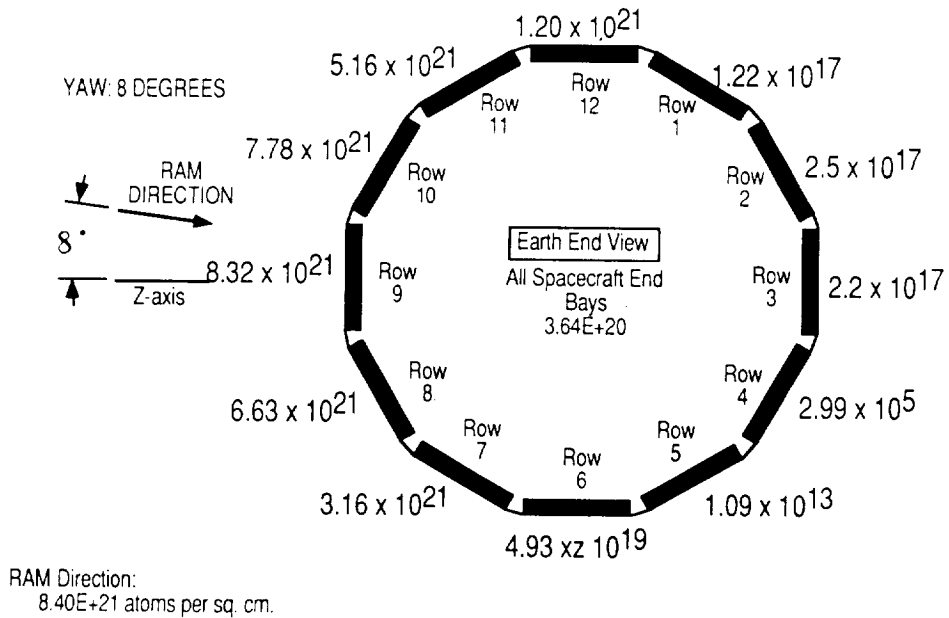
Figure 1b. Calculated distribution of atomic oxygen fluence on each of the LDEF surfaces. Note Rows 10 and 4.

[†] Atomic oxygen fluence distribution diagram from: Kinard, W.H., Martin, G.D, "LDEF Space Environments Overview," pg 54, Proceedings of the First LDEF Post-Retrieval Symposium, NASA CP-3134, 1992.

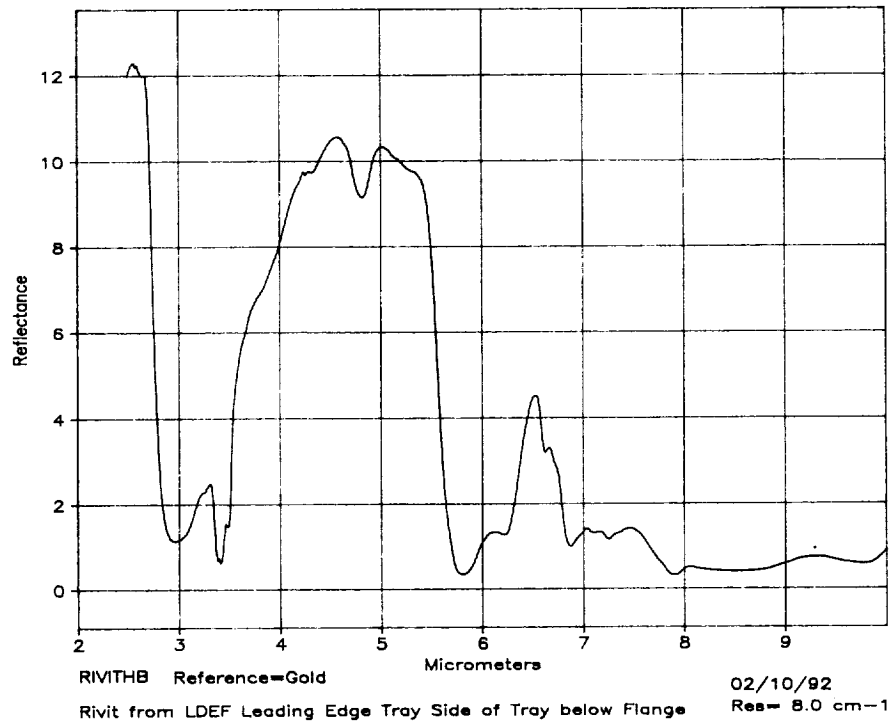
Figure 2a

Spectral reflectance measurements in the 2 to 10 micron (4000 to 1000 wavenumbers) spectral range are presented for the film in the "as deposited" condition and for the free standing film in Figures 2a and 2b. The material was analyzed by FTIR (Fourier Transform Infrared) microspectroscopy using gold as the reference standard. The "as deposited" specimen was on an aluminum rivet taken from beneath the tray flange while the free film was obtained by chipping some of the material from the rivet. The transmission spectrum over the 2 to 10 micron range for the free film is presented in Figure 3. This spectrum appears to be essentially the same as that presented by Crutcher et.al. (ref.2) for films formed at vent sites which faced into the ram direction and suggested to originate from urethanes and silicones used on the LDEF. Banks et.al. (ref.4) state that silicones, when exposed to atomic oxygen, release polymeric scission fragments which deposit on surfaces and form a glassy, dark contaminant layer upon further atomic oxygen exposure and solar irradiation.

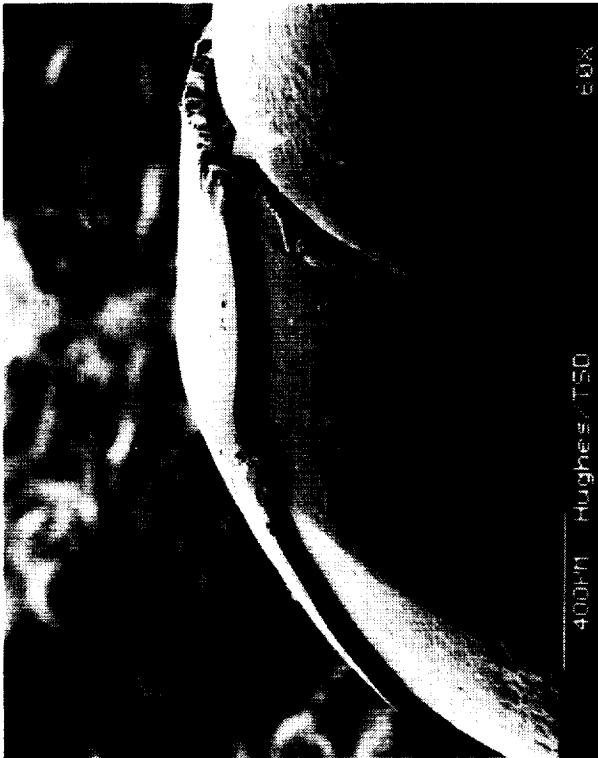
(a)

Figure 4. Molecular film deposit on D10 tray

- 4a. Molecular film on tray rivet.
- 4b. Layering of film indicating cyclic deposition.
- 4c. Light and dark bands through film cross section.
