No. 754

AN INVESTIGATION OF THE PREVENTION OF ICE ON
THE AIRPLANE WINDSHIELD

By Lewis A. Rodert
Langley Memorial Aeronautical Laboratory

Washington
March 1940

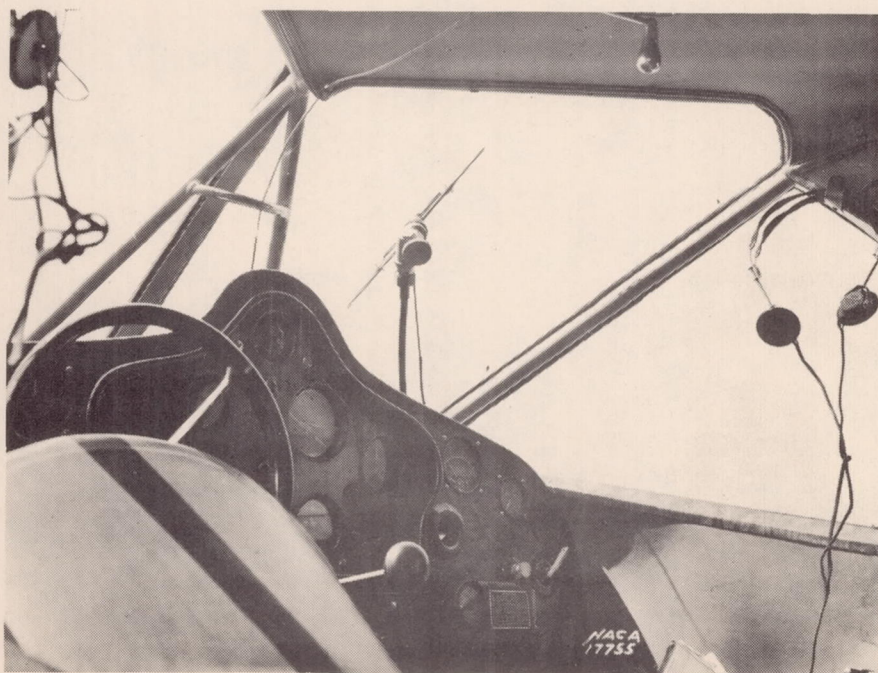
Figure 7.- An engine-driven rotating wiper blade, viewed from the interior of the airplane.

Tests were made of the rotating wiper blades in flight with the models mounted as shown in figures 6, 7, and 8. Three drives for the blades were used during the investigation. For the ice-prevention tests, an electric drive

developed at the N.A.C.A. was used; the wiper blades were driven by a 50-watt electric motor through a flexible shaft at speeds varying from 300 to 750 rpm. In the rain-removal tests, two methods of driving the blade, a drive from the airplane engine through a tachometer shaft and a commercially developed 90-watt motor permitting wiper-blade rotational speeds up to 2,100 rpm, were used.

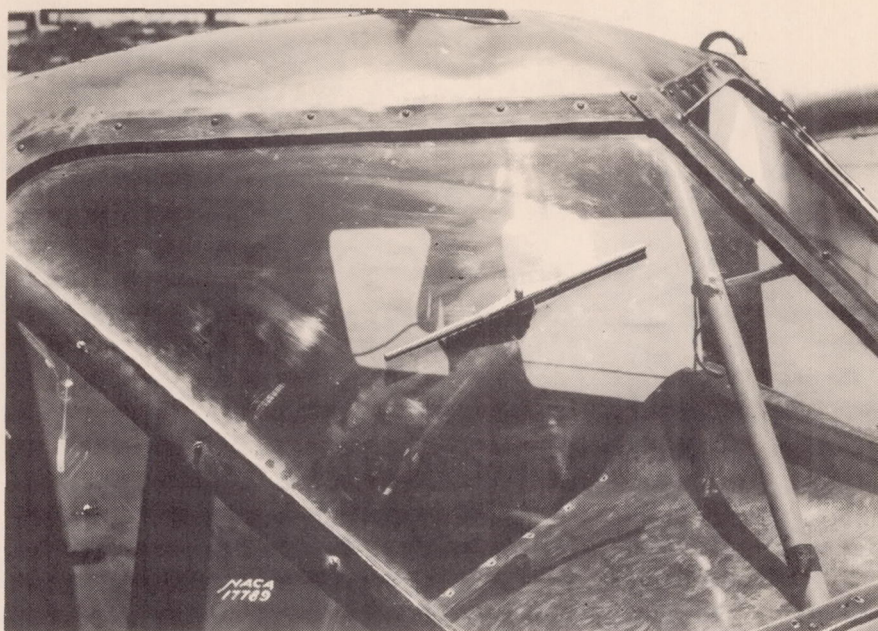
(a) View from the front of the airplane.

(b) View from interior of the airplane showing gear and shaft housing and, for a short distance along the shaft housing, a part of the alcohol tube.

Figure 8.- A commercial model of the electric motor-driven rotating wiper blade.
