# NATIONAL ADVISORY COMMITTEE FOR AERONAUTICS

No. 1178

A FLIGHT INVESTIGATION OF THE THERMAL  
PERFORMANCE OF AN AIR-HEATED PROPELLER

By John F. Darsow and James Selna

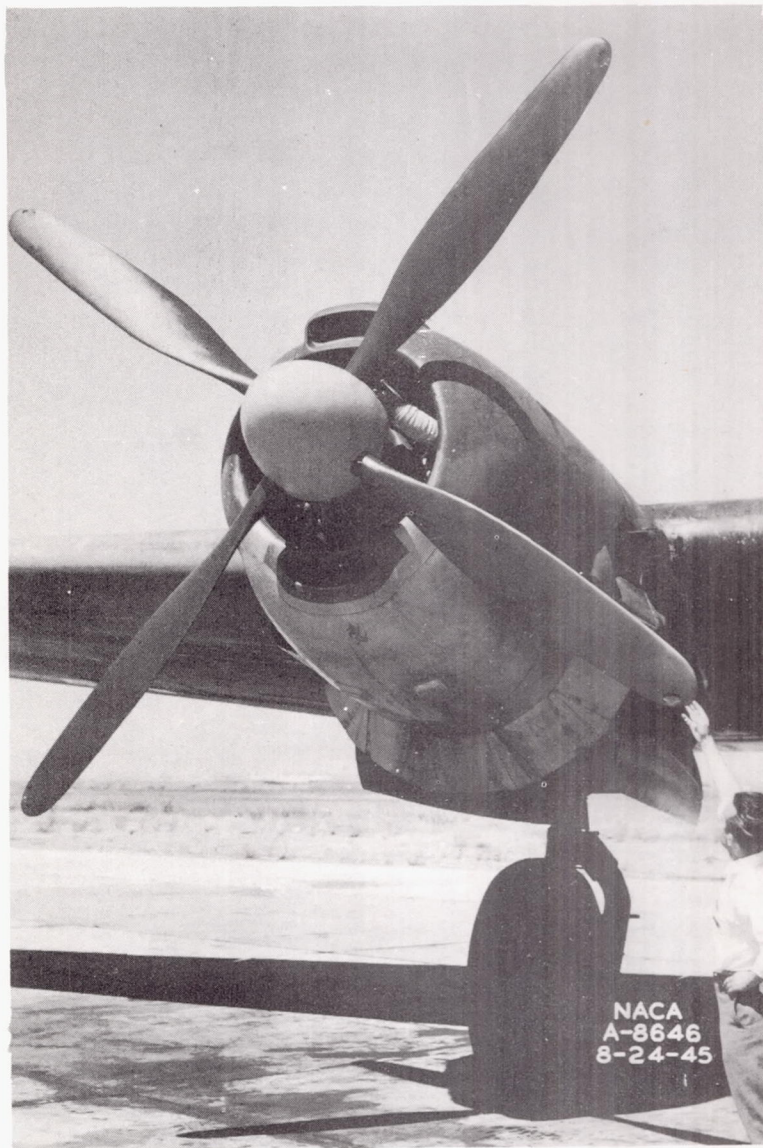
Figure 1.- Air-heated propeller installed on the right engine of the test airplane.

The test propeller, a four-blade, 14-foot-diameter, air-heated propeller was installed on the left engine of a test airplane. A similar installation, which was provided on the right engine for subsequent tests, is shown in figure 1. The operation of the propeller heating system is shown in figures 2 and 3. Ram air, heated by an exhaust-gas-air heat-exchanger installation (described in reference 2) was ducted to the stationary part of the propeller air manifold. The heated air was then transmitted to the rotating part of the propeller air manifold, admitted to the blade cavity through holes in the blade shanks, and discharged through nozzles located at the blade tips. The air particles in the blade are subject to radial accelerations, due to the rotation of the propeller, which results in a pumping action. This pumping action together with the ram pressure at the heat exchanger induced the air flow through the system. In order to reduce the air leakage between the

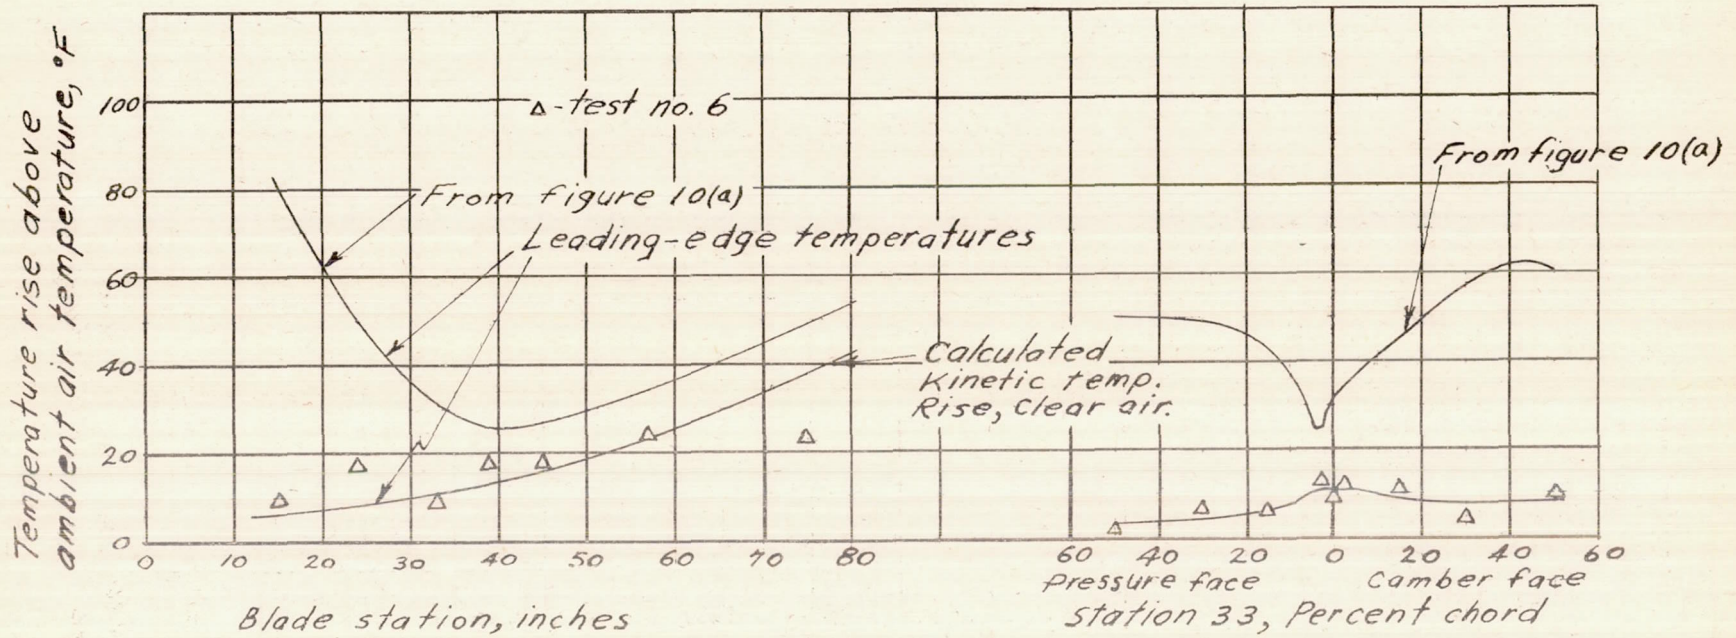
(b) Comparison of (a) with clear air, unheated air flow to propeller

where  $\Delta T$  is the theoretical temperature rise due to external kinetic heating. The temperature difference between these two curves may be attributed to the heat dissipated through the propeller-blade surfaces. It is indicated by figure 10(b) that the temperature rise of the blade leading edges due to the heated-air flow varies approximately from 60° F at station 15 to 10° F at and beyond station 40. The chordwise temperature rise at station 36 due to heated-air flow is shown in this figure to vary from 15° F at the leading edge to about 50° F at 50 percent chord.
