## TECHNICAL NOTE

No. 1224

FLIGHT TESTS OF A DOUBLE-HINGED HORIZONTAL TAIL SURFACE WITH REFERENCE  
TO LONGITUDINAL-STABILITY AND -CONTROL CHARACTERISTICS

By Carl M. Hanson and Seth B. Anderson

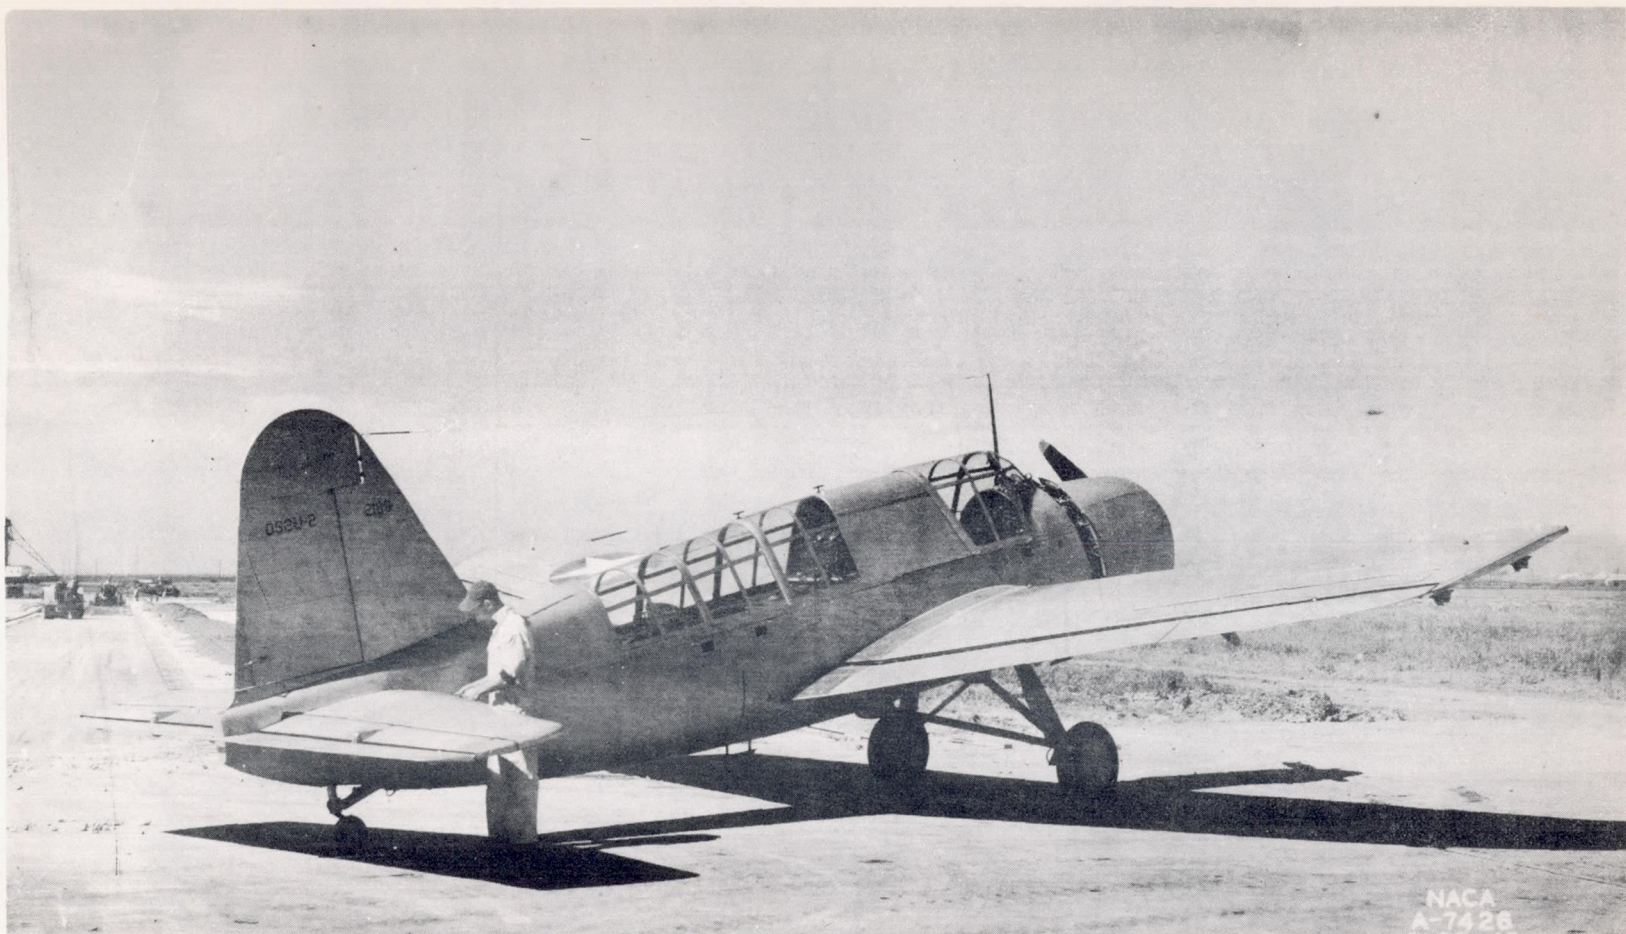
Figure 2.- The double-hinged horizontal-tail surface installed on the test airplane.

A three-view drawing of the airplane is shown in figure 1. A photograph of the airplane instrumented for flight tests is given in figure 2, and figure 3 is a photograph showing various positions of the horizontal control surface. To eliminate any tendency of the separate halves of the elevator to assume different angles (because of play inherent in the actuating mechanism), the two portions of the elevator were connected rigidly together by a strip at the elevator trailing edge. The mechanics of the elevator system were such that the range of elevator deflection (relative to the trimmer) was independent of the trimmer setting. Friction in the elevator control system was less than one-half pound, as measured when the control was moved slowly through the neutral position with no load on the surfaces. The variation of elevator angle with stick position as measured on the ground with no load applied to the surfaces is shown in figure 4. The trimmer drive mechanism was hand-operated from the cockpit through a cable-chain system. The mechanical advantage was such that 1.0 turn of the control handle (on a 5-inch arm) was required to change the trimmer angle 1°. Plan and section views of the horizontal tail are shown in figures 5 and 6, respectively.

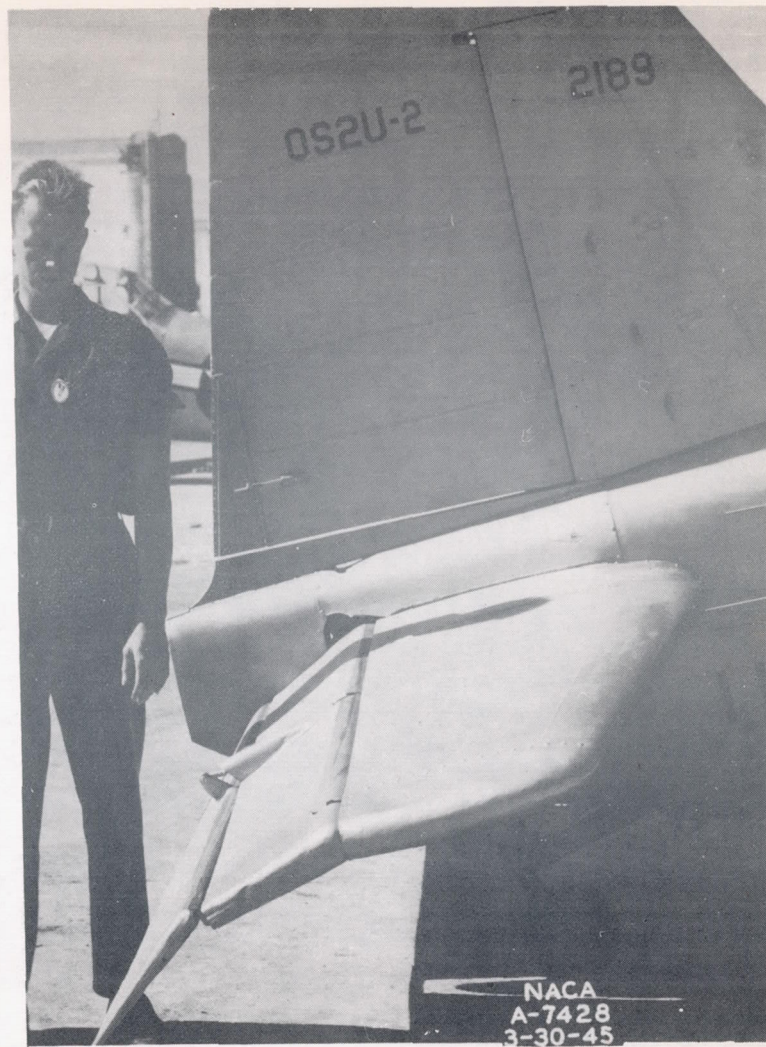
(a) Trimmer full down, elevator full up. (b) Trimmer full down, elevator full down.  
Figure 3.- Side view of the double-hinged horizontal-tail surface, trimmer and elevator deflected.

(c) Trimmer full up, elevator full down. (d) Trimmer full up, elevator full up.  
Figure 3.- Concluded.
