INLET ICING AND EFFECTIVENESS OF HOT-GAS BLEEDBACK FOR

ICE PROTECTION OF TURBOJET ENGINE

By William A. Fleming and Martin J. Saari

RESEARCH MEMORANDUM

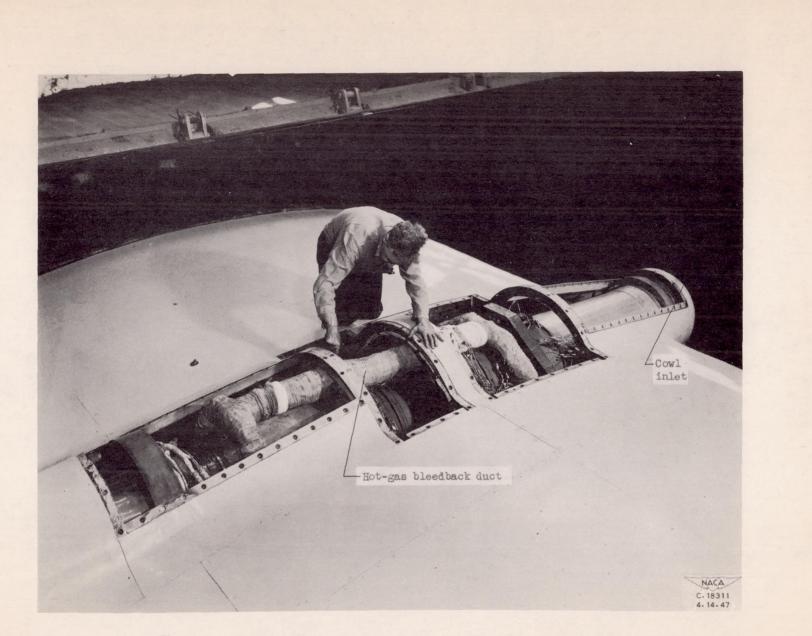
Figure 1. - Engine installation with hot-gas bleedback system installed.

The engine installation with the hot-gas bleedback system installed is shown in figure 1. A plan drawing of the engine and the hot-gas bleedback system is presented in figure 2. Hot gas was bled from two diametrically opposite points at the turbine inlet. The gas was carried to the top of the engine through two 3-inch-diameter ducts and forward in a single 4-inch-diameter duct. At the front of the engine, the hot gas was directed into two 3-inchdiameter ducts on either side of the inlet duct and was discharged into a manifold formed by the cowl-inlet lip. Holes were located around the inner circumference of the cowl-inlet lip, through which

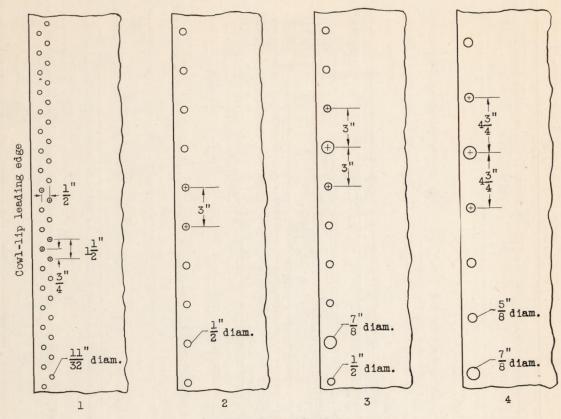
(a) Developed view of inside surface of cowl-inlet lip showing hole arrangements in hot-gas manifold.

Figure 3. - Details of hot-gas bleedback configurations.

Configu- ration	Number of holes	Hole diameter (in.)	Total hole area (sq in.)	Maximum bleedback (percent)
1	76	11/32	7.05	4.8
2	19	1/2	3.74	3.5
3	15 4	1/2 7/8	5.35	4.0
4	9 3	5/8 7/8	4.57	4.7

The following four configurations of hole arrangements in the hot-gas manifold at the cowl inlet were investigated (fig. 3(a)):

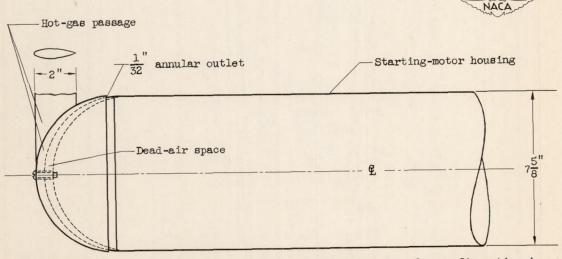
(b) Installation of heated cap on starting-motor-housing dome for configuration 4.

In configuration 4, provision was made to prevent ice formation on the starting-motor housing by internal heating of the housing dome. A hemispherical cap was installed over the dome, as shown in figure 3(b). Hot gas was bled into the cap through a streamlined strut, passed between the cap and the dome, and discharged into the air stream.

For configuration 4, the dome of the starting-motor housing was internally heated with hot gas (fig. 3(b)) and 12 holes were drilled 30° apart in the hot-gas manifold; three of these holes, 120° apart, were $\frac{7}{8}$ inch in diameter and the other nine holes were $\frac{5}{8}$ inch in diameter. Temperature profiles across the diameter of

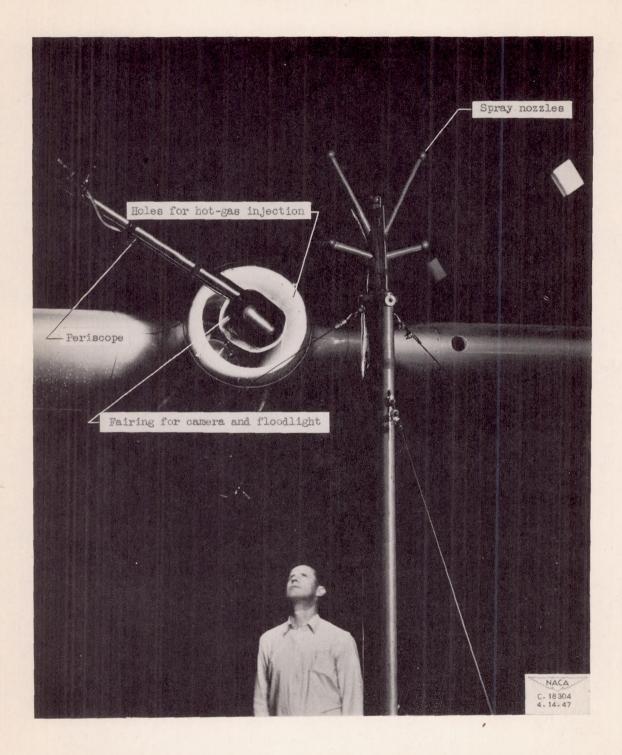
Figure 4. - Front view of engine installation showing water-spray nozzles and periscope.

A strut on which five air-atomizing spray nozzles were mounted (fig. 4) was installed 7 feet ahead of the cowl inlet and 12 feet ahead of the compressor inlet in the tunnel test section. In order to permit better control of inlet icing conditions, a movable spraynozzle assembly was used for configuration 4, with which the spray nozzles could be located at distances from 1 to 7 feet ahead of the cowl inlet. A periscope that extended from the wall of the tunnel test section could be raised above or lowered in front of the engine inlet from outside of the test section (fig. 4). A floodlight and a 16-millimeter motion-picture camera were installed inside the fairing at the lower end of the periscope in order to photograph the inlet of the engine under icing conditions.

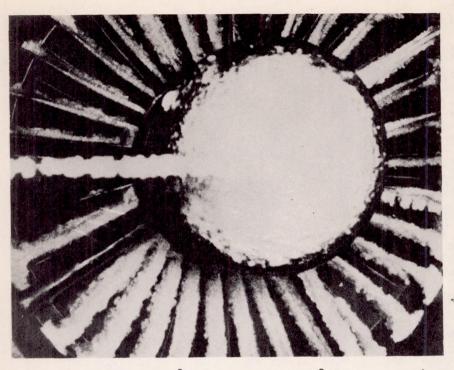
NACA C- 18758 4- 16- 47

(a) Turbine-outlet temperature, 1150° F (approximately 100° F above normal); engine speed, 10,000 rpm.

Figure 5. - Compressor inlet iced with hot-gas bleedback system inoperative. Altitude, 20,000 feet; airspeed, 140 miles per hour; ambient-air temperature, 30° F.

The first indication of inlet icing was a rise in turbineoutlet temperature, which usually occurred approximately 2 to 4 minutes after the water spray was turned on. When the water spray was left on and no effort was made to prevent ice formation on the compressor-inlet guide vanes, excessively high turbineoutlet temperatures occurred at all engine speeds and rendered the engine inoperative within 1 to 2 minutes after the initial indication of icing. A photograph of the compressor inlet partly iced is shown in figure 5(a) for an engine speed of 10,000 rpm and a turbine-outlet temperature of 1150° F, which is approximately 100° F above the normal operating temperature. The photograph shows ice formation on the compressor-inlet guide vanes and a heavy ice formation on the dome of the starting-motor housing. An ice formation at the compressor inlet that rendered the engine inoperative is evident in figure 5(b), which shows that the air passage near the roots of the compressor-inlet guide vanes was almost completely blocked, a large percentage of the air passage near the tips of the guide vanes was blocked, and a very heavy coat of ice had formed on the dome of the starting-motor housing.

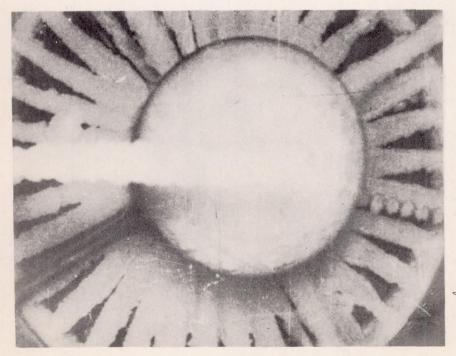
NACA C- 18768 4- 14- 47

(b) Engine inoperative at any engine speed owing to excessive turbine-outlet temperature.

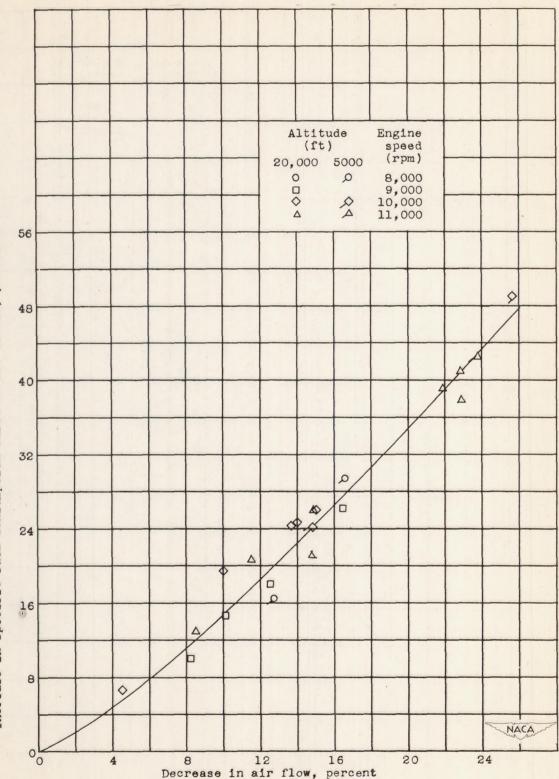
Figure 7. - Effect of inlet icing on specific fuel consumption based on net thrust without hot-gas bleedback for various engine speeds at altitudes of 5000 and 20,000 feet. Airspeed, 140 miles per hour; ambient-air temperature, 30° F.

As the inlet became iced, the specific fuel consumption based on net thrust increased very rapidly, as shown in figure 7. When the air flow was decreased 26 percent, the specific fuel consumption increased 48.0 percent. The increase in specific fuel consumption was large because as the inlet became iced the net thrust was reduced, while the engine fuel flow was increased in order to maintain constant engine speed.

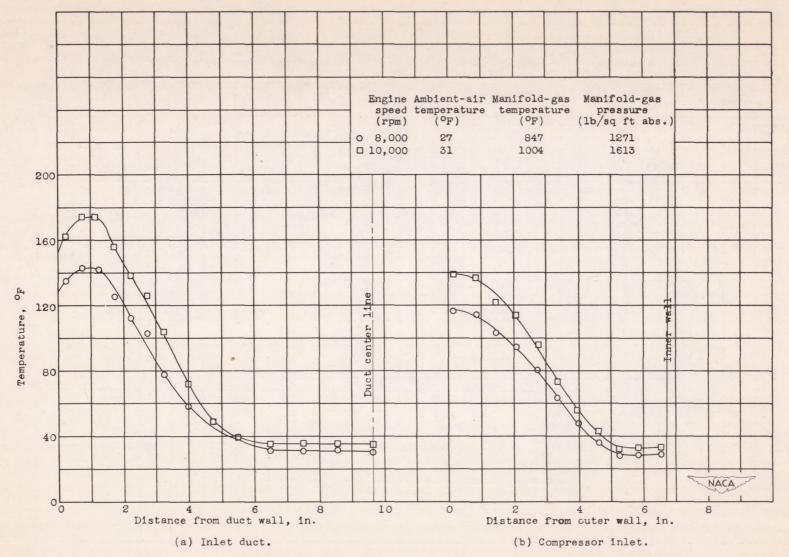
Figure 8. - Temperature profiles across inlet duct and compressor inlet with configuration 1. Altitude, 20,000 feet; airspeed, 140 miles per hour.

The temperature profiles across the inlet duct and the compressor inlet for configuration 1 are shown in figure 8 for engine speeds of 8000 and 10,000 rpm. The hot gas penetrated 6 inches into the air stream (fig. 8(a)). The temperature was excessively high near the outer wall of the inlet duct and the temperature at the center portion of the duct was approximately the same as ambientair temperature. The engine could not be operated at an engine speed of 12,000 rpm with the bleedback valve wide open without exceeding the turbine-outlet temperature limits.

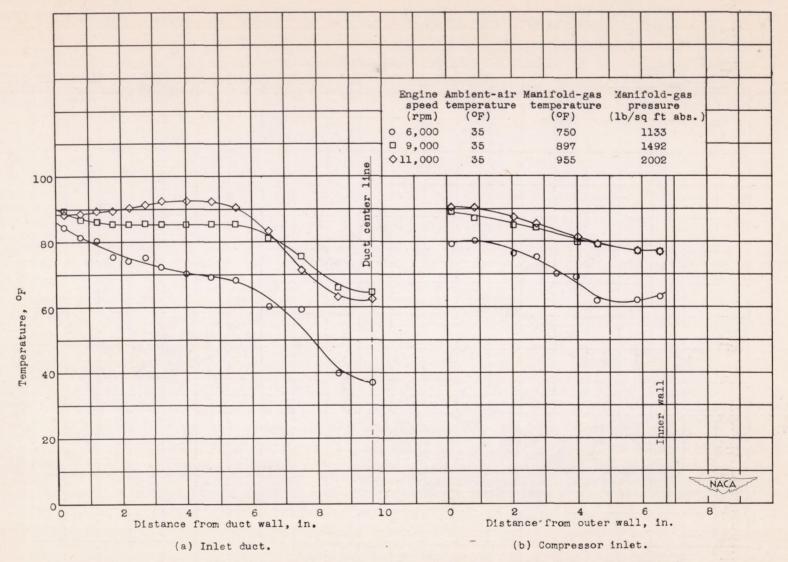
Figure 11. - Temperature profiles across inlet duct and compressor inlet with configuration 3. Altitude, 20,000 feet; airspeed, 140 miles per hour.

In order to improve the penetration, four of the 19 holes in the hot-gas manifold were enlarged from $\frac{1}{2}$ to $\frac{7}{8}$ -inch diameter for configuration 3, with a corresponding increase in area from 3.74 to 5.35 square inches. Temperature profiles obtained with configuration 3 for engine speeds of 6000, 9000, and 11,000 rpm are presented in figure 11. The temperature in the inlet duct, measured directly downstream of one of the large holes (fig. 11(a)), was

approximately constant for a distance of $5\frac{1}{2}$ inches from the outer wall and gradually decreased to approximately 28° F above ambientair temperature at the duct center line for engine speeds of 9000 and 11,000 rpm. At the compressor-inlet annulus, the temperature was only about 15° F lower at the inner wall than at the outer wall (fig. ll(b)).

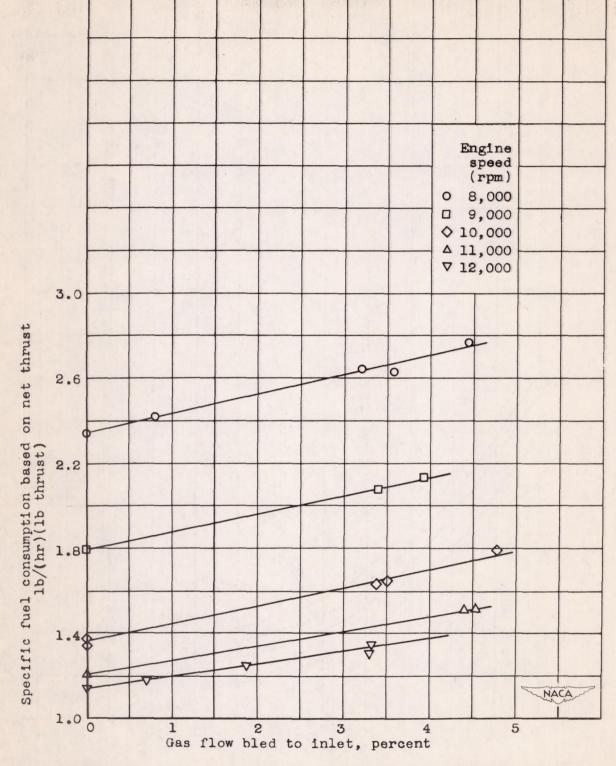
Figure 18. - Variation of specific fuel consumption based on net thrust with percentage gas flow bled to compressor inlet. Altitude, 20,000 feet; airspeed, 140 miles per hour; ambientair temperature, 30° F.

Variations in specific fuel consumption based on net thrust with percentage of gas flow bled to the inlet are shown in figure 18. The specific fuel consumption increased at all engine speeds as hot gas was bled to the inlet. A cross plot of the data shown in figure 18 is presented in figure 19 to show the relation between specific fuel consumption and engine speed for various amounts of bleedback. At an engine speed of 12,000 rpm, the specific fuel consumption was increased from 1.14 to 1.38 when 4.0 percent of the total gas flow was bled to the inlet. The relation between the percentage increase in specific fuel consumption based on net thrust and the percentage of gas flow bled to the inlet is shown in figure 20. The percentage increase in specific fuel consumption varied linearly with the percentage of bleedback. With 4.0 percent of the gas flow bled to the inlet, the specific fuel consumption increased 15.8 percent at 8000 rpm, 24.2 percent at 10,000 rpm, and 21.3 percent at 12,000 rpm.

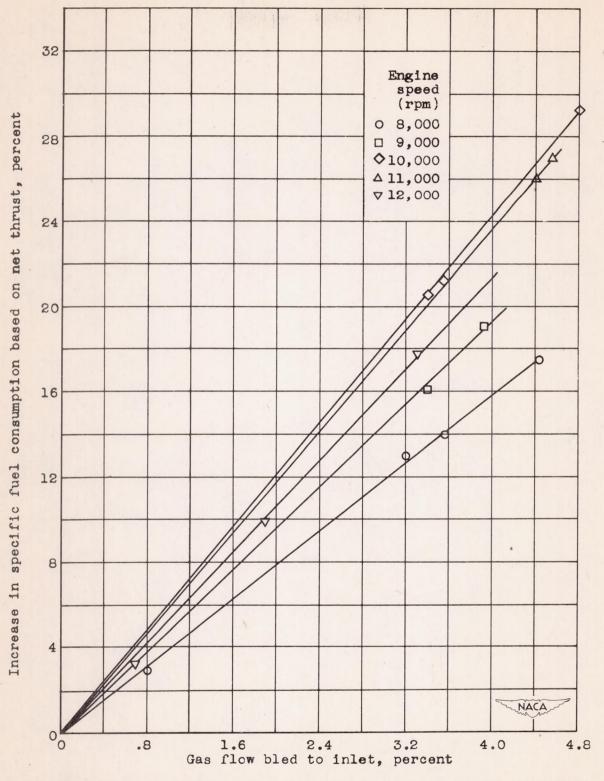
Figure 20. - Variation of percentage increase in specific fuel consumption based on net thrust with percentage gas flow bled to compressor inlet. Altitude, 20,000 feet; airspeed, 140 miles per hour; ambient-air temperature, 30° F.
