NACA RM A53G22

CORRELATION OF FLIGHT AND WIND-TUNNEL MEASUREMENTS OF  
ROLL-OFF IN LOW-SPEED STALLS ON A 35°  
SWEPT-WING AIRCRAFT

By Seth B. Anderson

Ames Aeronautical Laboratory  
Moffett Field, Calif.

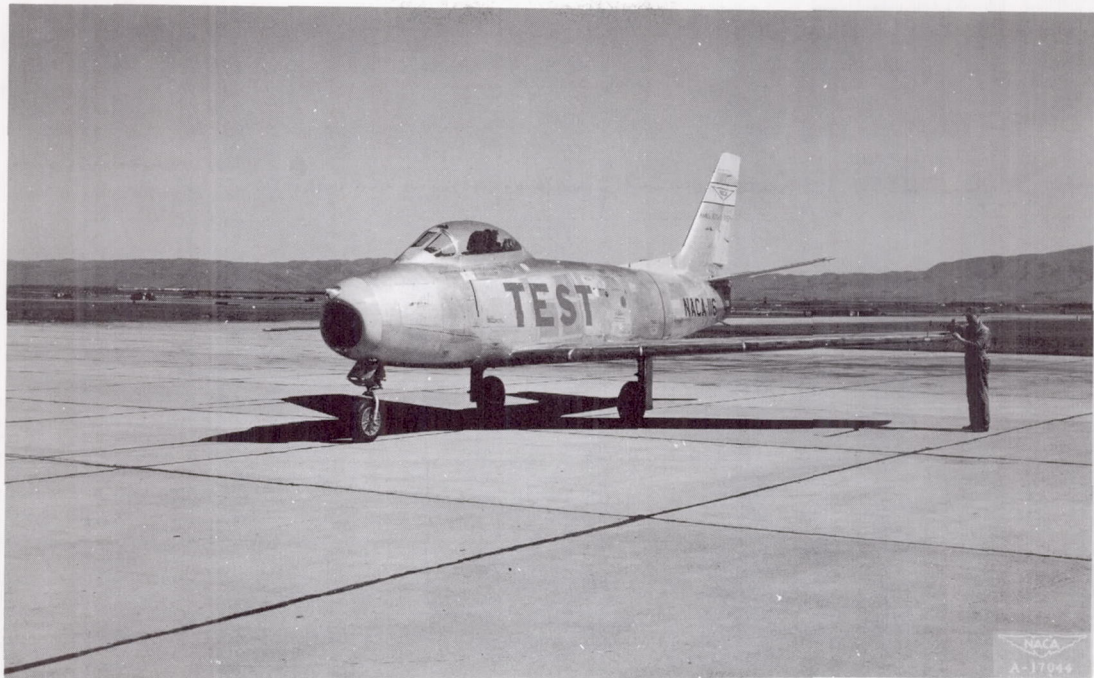
Figure 1.- Photographs of test airplane.

(a) Airplane tested in flight.

(b) Airplane tested in the 40- by 80-foot wind tunnel.

The tests were conducted on a jet-powered fighter aircraft having sweptback wing and tail surfaces. Photographs of similar test airplanes as prepared for flight and wind-tunnel tests are presented in figures 1(a) and 1(b), respectively. Figure 2 is a two-view drawing of the airplane. A description of the geometric details of the airplane is given in table I.

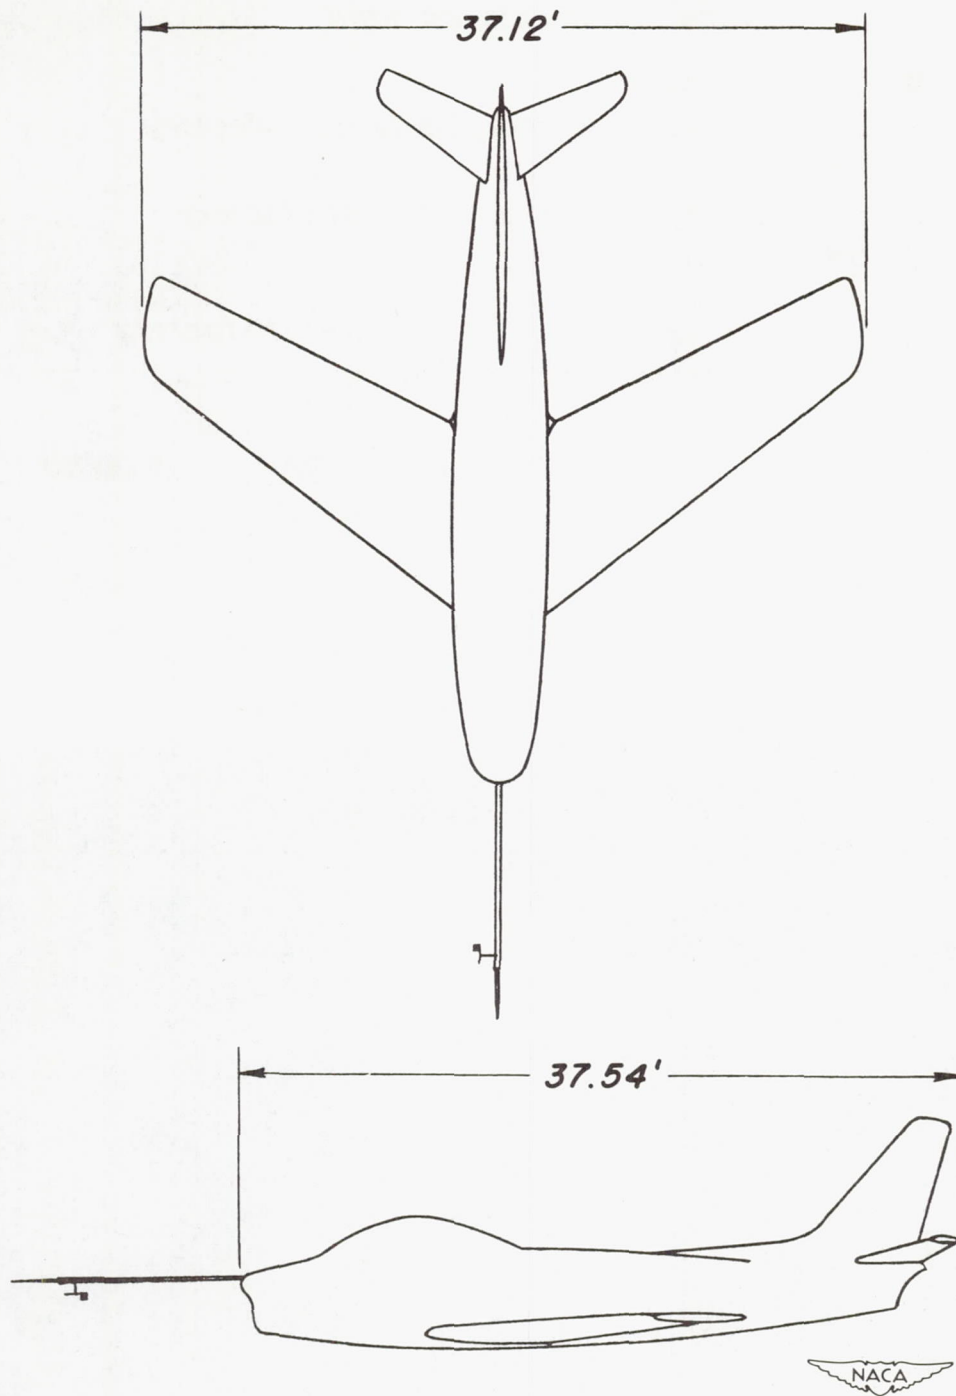
Figure 2.- Two-view drawing of the test airplane.

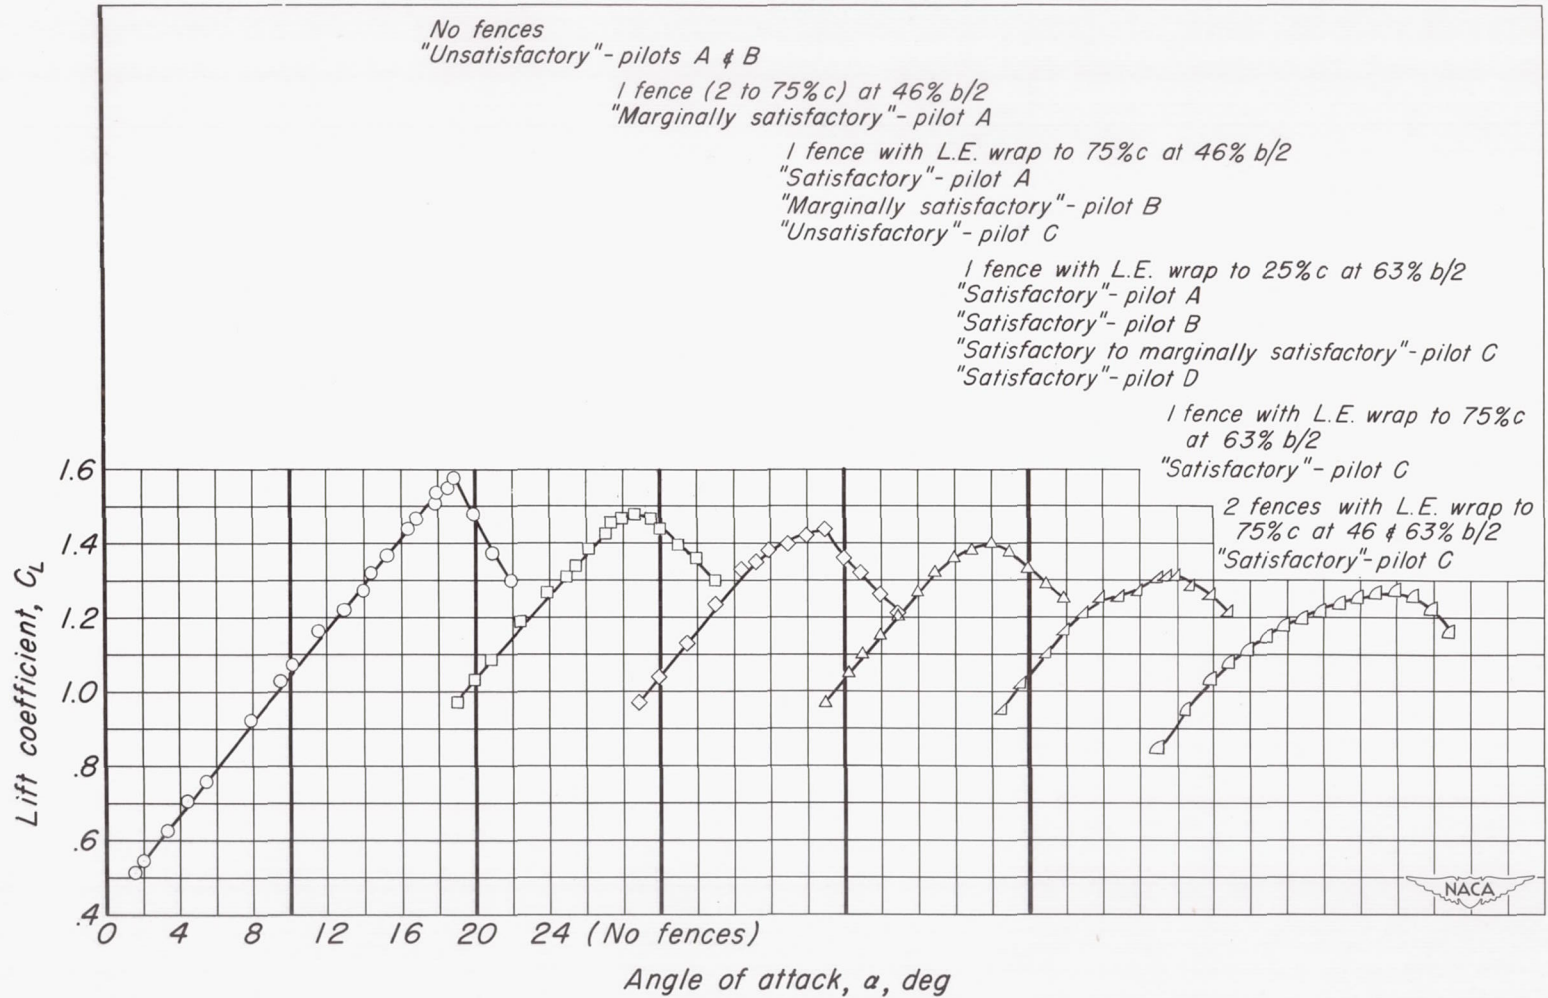
Figure 7.- Lift curves for various configurations measured in flight with cambered leading edge. Flaps down.

The lift curves of the airplane with the cambered leading edge and a series of fence modifications designed to improve the stalling characteristics are presented in figure 7 for the flaps-down case and the results are tabulated in table III. These fence modifications were tested in flight only. It will be noted that the lift-curve peak for the cambered leading edge was sharp and, as noted previously, the stall was reported as unsatisfactory by the pilot because of a severe roll-off. Tuft studies indicated that separation was a combined leading-edge and trailing-edge type, initiating outboard near the wing tip and spreading inboard rapidly. The addition of a fence at 46-percent semispan

(2- to 75-percent chord extent) improved the lateral characteristics at the stall slightly to a rating of "marginally satisfactory" by pilot A. As shown in figure 7, this configuration resulted in rounding the lift-curve peak somewhat and reducing maximum lift about 5.5 percent. The addition of a leading-edge "wrap" to this fence further improved the stalling characteristics to a rating of "satisfactory" by pilot A; however, the other pilots graded the stall from marginally satisfactory to unsatisfactory. Observation of tufts indicated that although this fence installation produced areas of separation inboard and to the rear of the fence, separation still occurred abruptly over a large area outboard of the fence. By moving the fence outboard to 63-percent semi-span it was possible to reduce the chordwise extent of the fence to 25 percent and still retain lateral characteristics at the stall which were acceptable to all four pilots with a decrement in maximum lift of about 11 percent. Extending this fence to 75-percent chord or using large chord fences (to 75-percent chord) at both 46- and 63-percent semispan resulted in further improvements in stalling characteristics beyond that felt necessary, with pronounced rounding of the lift-curve peaks and large reductions in maximum lift (19.5 percent). It will be noted that the pilots tended toward agreement on a satisfactory stall as the lift-curve peak was rounded more and more.
