# RESEARCH MEMORANDUM

INVESTIGATION OF A SUPERSONIC -INLET - TURBOJET -ENGINE  
COMBINATION AT MACH 2.0 AND ANGLES OF ATTACK  
UP TO 6°

By Donald P. Hearth and Norman T. Musial

Lewis Flight Propulsion Laboratory  
Cleveland, Ohio

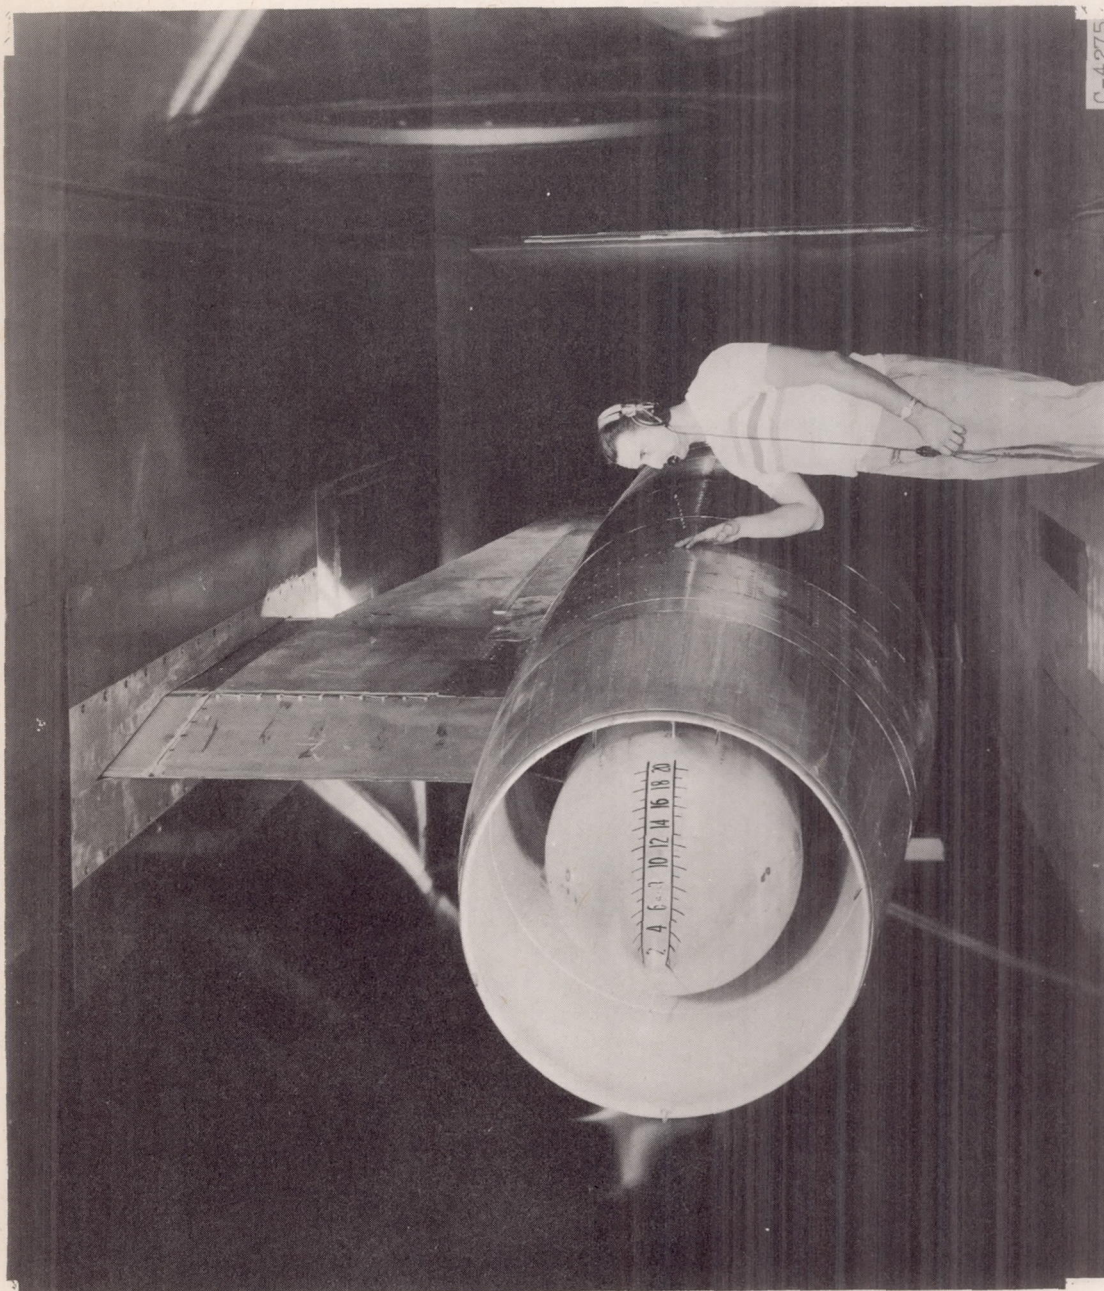
Figure 2. - Nacelle in tunnel.

The engine was installed in a production nacelle for a current supersonic airplane. Figures 2 and 3 show that the nacelle had a bulge on the bottom to provide space for engine accessories. The maximum diameter of the nacelle was about 51 inches. The engine was started by allowing it to windmill until the tunnel was at the test condition and then lighting it; generally, little difficulty was encountered in engine lightoff.
