WARTIME REPORT

MEASUREMENTS OF THE FLYING QUALITIES OF A
SUPERMARINE SPITFIRE VA AIRPLANE

By William H. Phillips and Joseph R. Vensel

Langley Memorial Aeronautical Laboratory
Langley Field, Va.

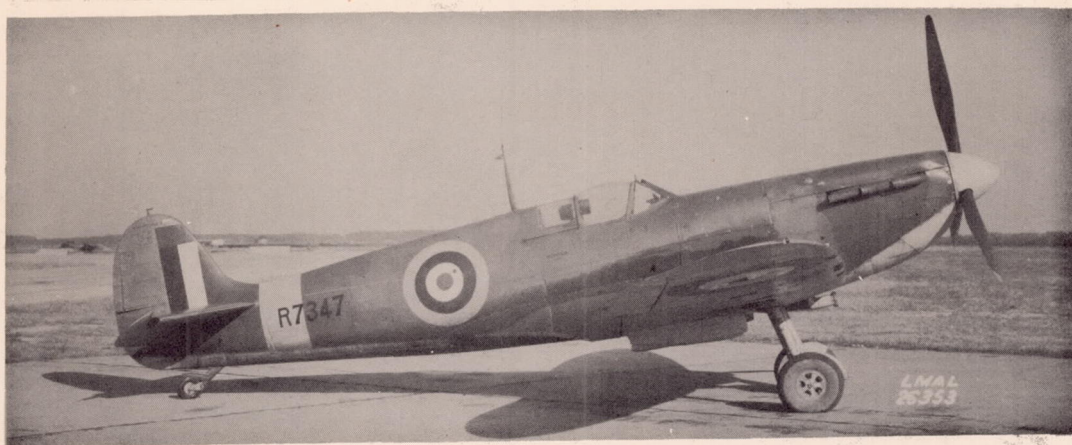
Figure 1.- Side view of the Supermarine Spitfire airplane.

The Supermarine Spitfire is a single-place, single-engine, low-wing, cantilever monoplane with retractable landing gear and partial-span split flaps (figs. 1, 2, 3, and 4). The general specifications of the airplane are as follows:

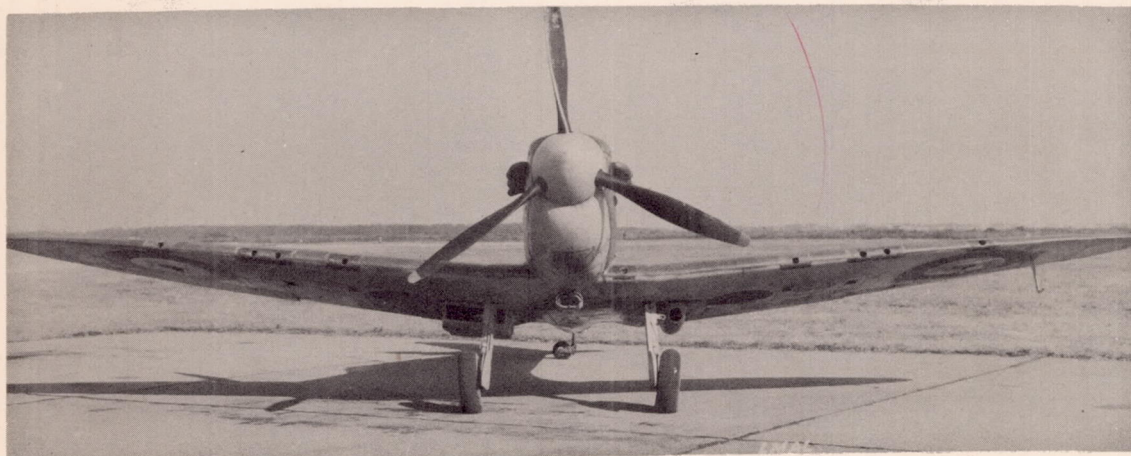
Figure 2.- Front view of the Supermarine Spitfire airplane.

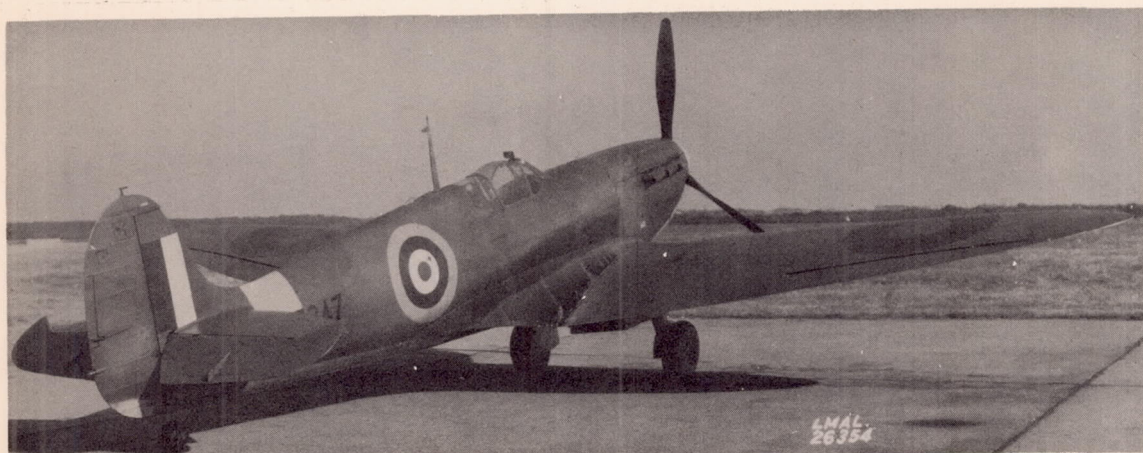
Figure 3.- Three-quarter rear view of the Supermarine airplane.

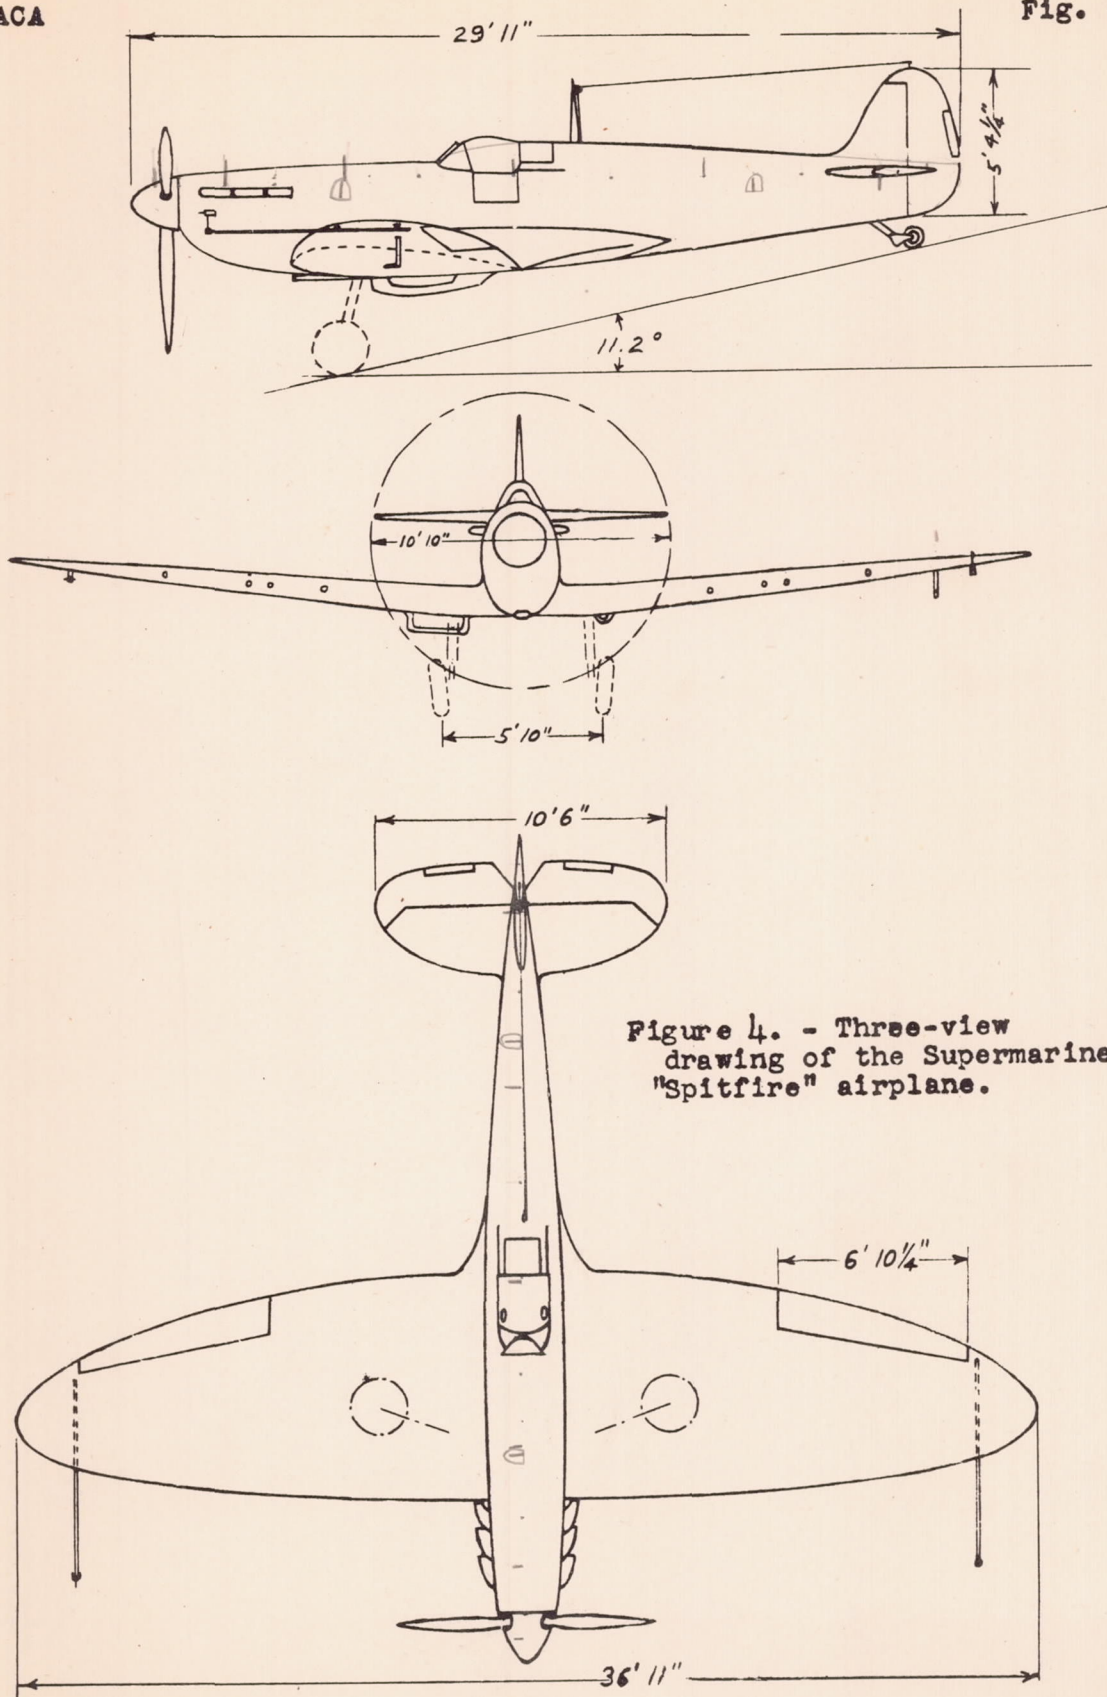
Fig. 4

Figure 4. - Three-view drawing of the Supermarine "Spitfire" airplane.

ahead of the right wing tip. The yaw vane was located at the end of a similar boom on the left wing tip, as shown on figure 4. It was believed that angularity of the flow at this point might cause some error in the recorded sideslip angles. For this reason, another recorder was mounted on the right wing tip and the angles of the two yaw vanes were recorded simultaneously in flight throughout the speed range under various flap and power conditions. Because of symmetry of the airplane, one-half the difference between the readings of the two yaw vanes was taken to represent the correction to apply to each yaw vane. This correction has been applied to all of the recorded values of sideslip angle. These values are therefore believed to represent the actual angles of sideslip of the thrust axis. The difference between the readings of the two yaw vanes was about 3° with level flight power and 2° with power off. The vanes showed the flow to be converging toward the fuselage.

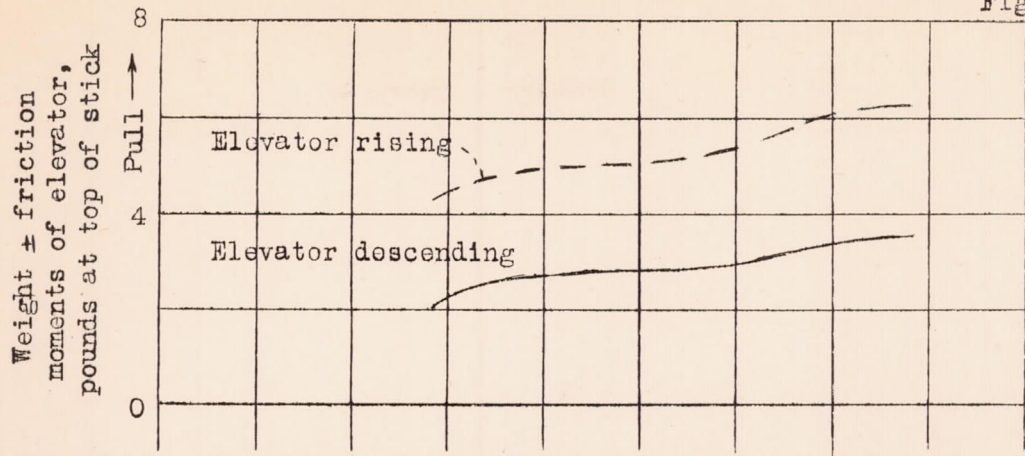
Figure 5.- Variation with control-stick angle of elevator angle and stick force caused by elevator friction and unbalance. Supermarine Spitfire airplane.

3. The friction in the elevator system was such that a force of 2 pounds was required to reverse the motion of the stick, as shown in figure 5. This friction was small enough that, in the flight conditions where a stable stick-force gradient existed, the control would return to its trim position.

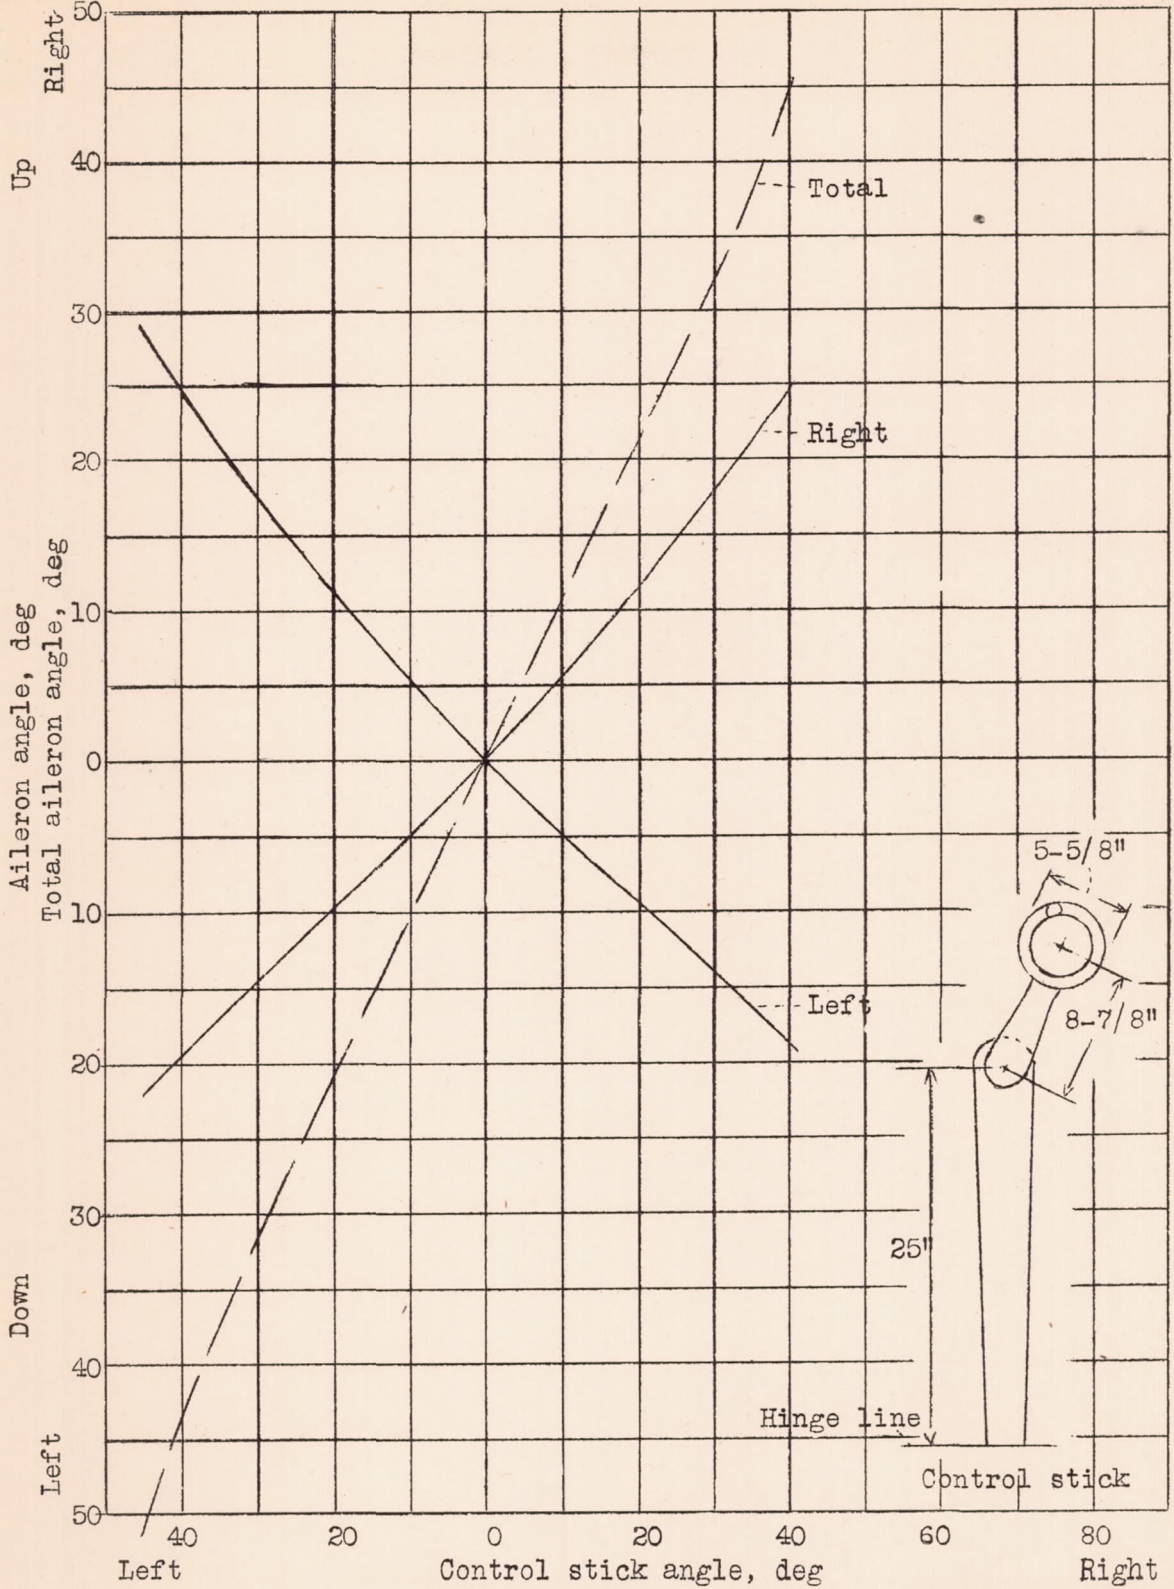
Figure 6.- Variation of left, right, and total-aileron angles with control stick angle. Supermarine Spitfire airplane.

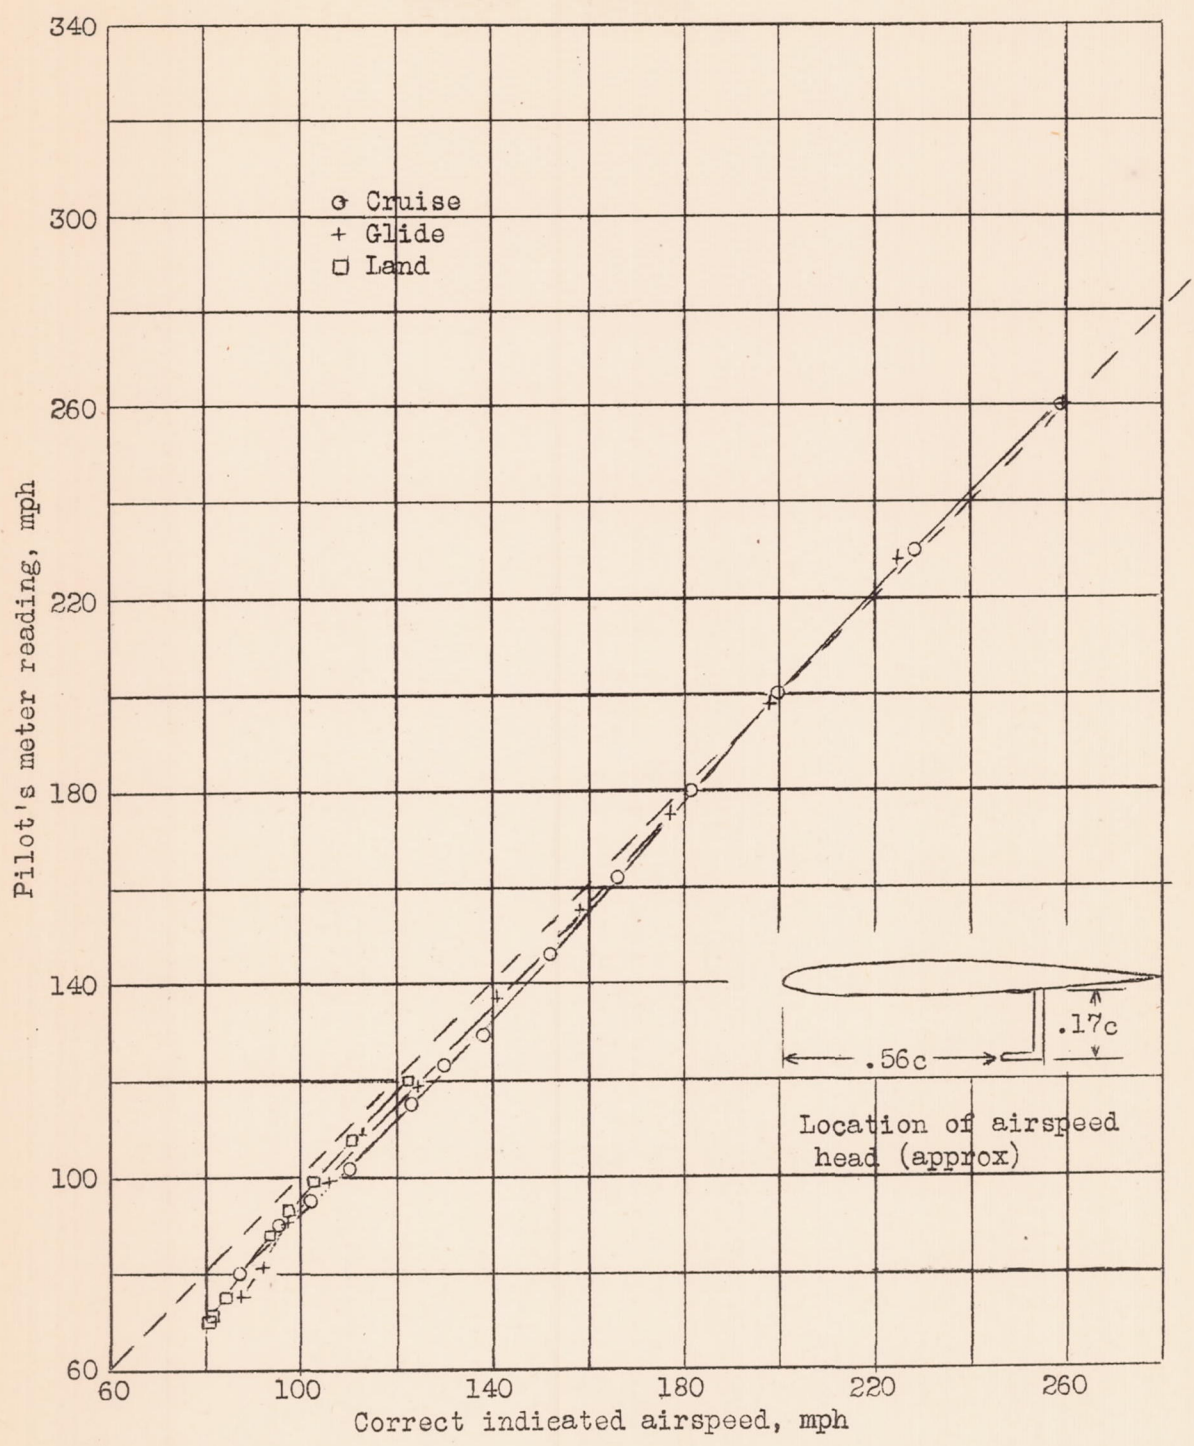
Figure 7.- Calibration of the pilot's airspeed indicator in the Supermarine Spitfire airplane.

The readings of the pilot's meter as compared to the correct indicated airspeed in the cruising, gliding, and landing conditions of flight are plotted on figure 7. The correct speed was determined by flying in formation with another airplane. The calibration of the airspeed recorder in the latter airplane was made by the use of a trailing airspeed head. The installation of the airspeed indicator in the Spitfire consisted of a pitot-static head

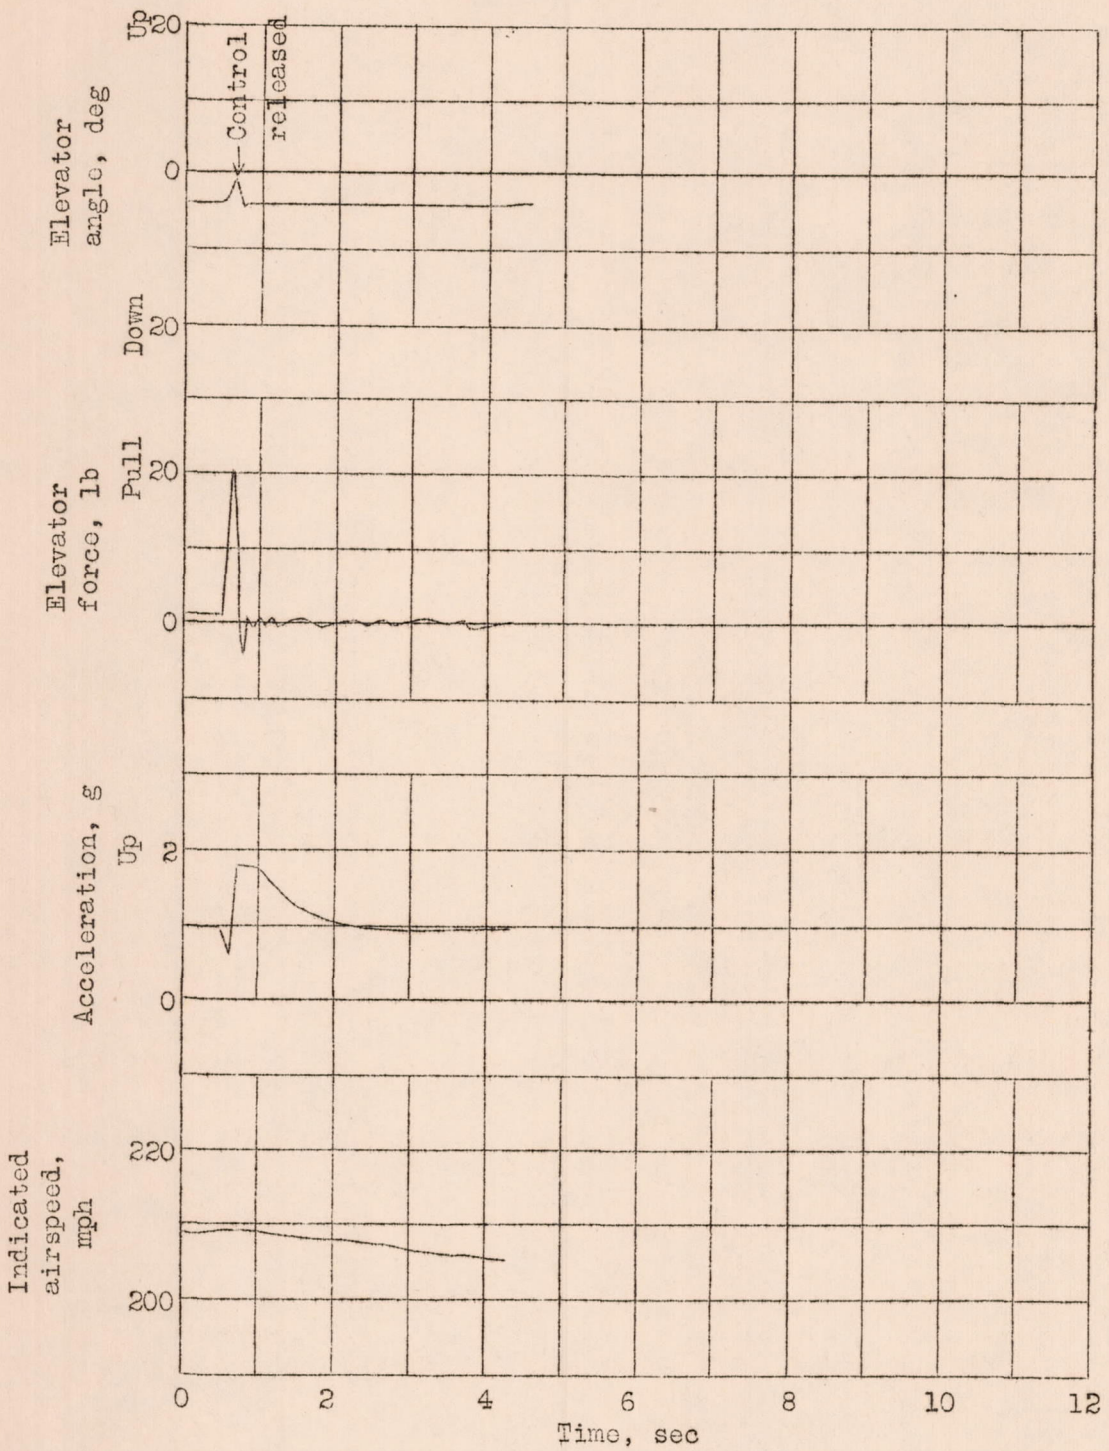
Figure 8.- Time history of a short-period oscillation started by suddenly pulling back the control stick and releasing it in level flight; flaps and gear up. Supermarine Spitfire airplane.

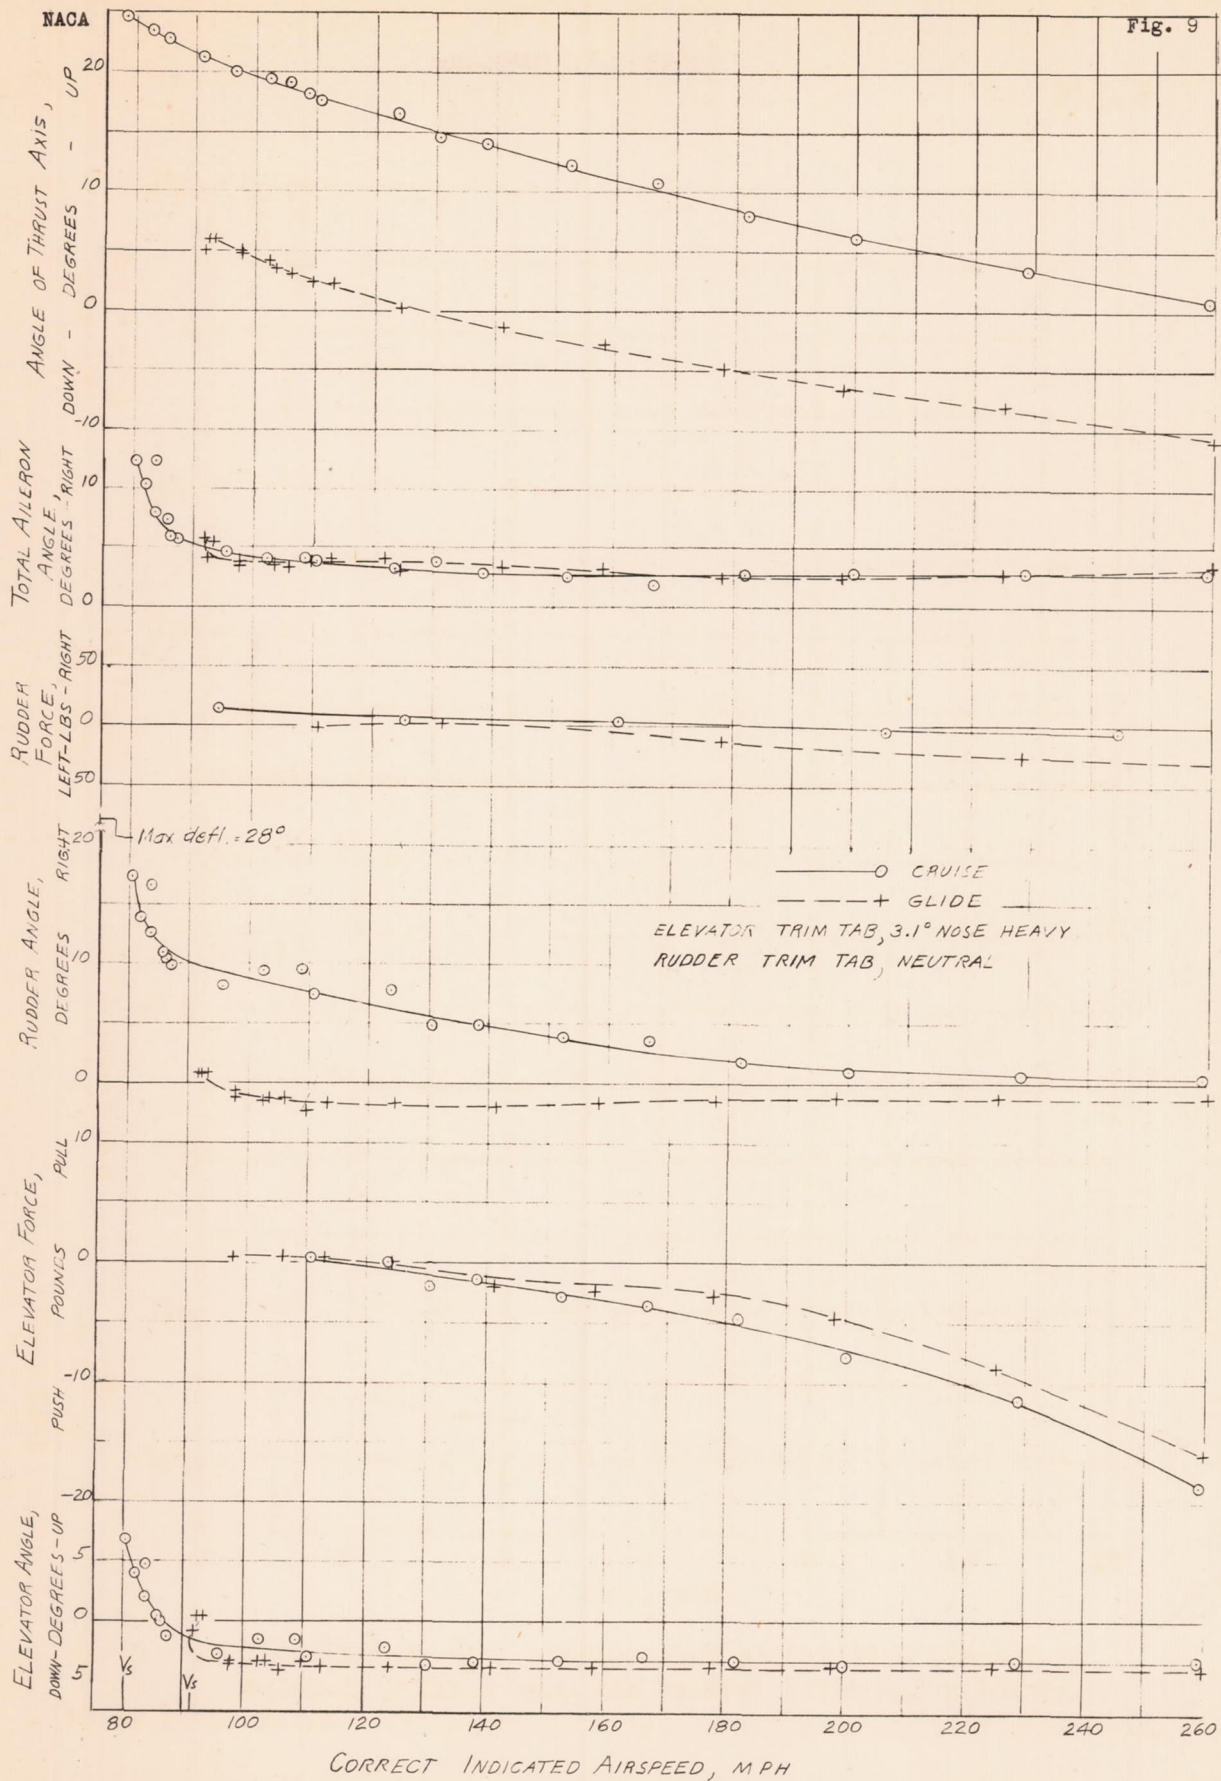
Figure 9. - Static longitudinal-stability characteristics of the Supermarine Spitfire airplane in the cruising and gliding conditions.

2. In spite of the neutral stick-fixed static stability with flaps up, the airplane had a slightly stable stick-force variation with airspeed throughout the speed range (fig. 9). This stable stick-force gradient is attributed to the unbalanced elevator. If a completely mass-balanced elevator had been employed, the stick-force variation would have been slightly unstable, a condition consistent with neutral stick-fixed stability. In the flap-down condition with power on, the stick-force variation for the trim-tab setting used was unstable and, with power off, the stick-free stability was neutral. If the airplane had been trimmed for zero stick force at low speed, the variation might have been slightly stable with

4. The limits of elevator motion were not reached in steady flight from the minimum speed to the highest speeds tested. Figures 9, 10, and 11 show that in all conditions only a few degrees of elevator motion were required to trim throughout the speed range.

Characteristics of longitudinal trimming device.- Because the trim changes required for the different flight conditions were so small, the elevator trim tabs had ample power to trim the airplane at any speed in any flight condition for the center-of-gravity location used in these tests. In order to determine the power of the elevator trim tabs, measurements of the elevator forces required for trim with different trim-tab settings were made at various speeds. The change in stick force per degree trim-tab change is plotted as a function of speed for three flight conditions in figure 24. The variation of stick force with speed for any trim-tab setting may be obtained by adding to the forces plotted on figures 9, 10, and 11 the force caused by the change in trim-tab angle.

Considerable deflection of the rudder to the right was required in the power-on conditions in steady flight near minimum speed as shown on figures 9, 10, and 11. The limits of rudder travel were never exceeded, however. The rudder deflection is needed partly to offset the yawing moment caused by angularity of the flow due to the slipstream, and partly to balance the left yawing moment of the propeller itself that results from the high angle of attack of the propeller axis. The side force on the rudder necessary to maintain equilibrium of yawing moments

The rudder forces required for trim throughout the speed range with the rudder trim tab neutral are plotted for the gliding and cruising conditions on figure 9. These rudder forces were unusually light.

Power of rudder and aileron trimming devices.— The trim tab provided on the rudder was sufficiently powerful to reduce the rudder force to zero in any flight condition. The rudder forces required for trim with the trim tab neutral are plotted on figure 9. No trim tab was provided on the ailerons, but the aileron forces for trim were light. The aileron angles required for trim throughout the speed range in the various flight conditions are plotted in figures 9, 10, and 11.

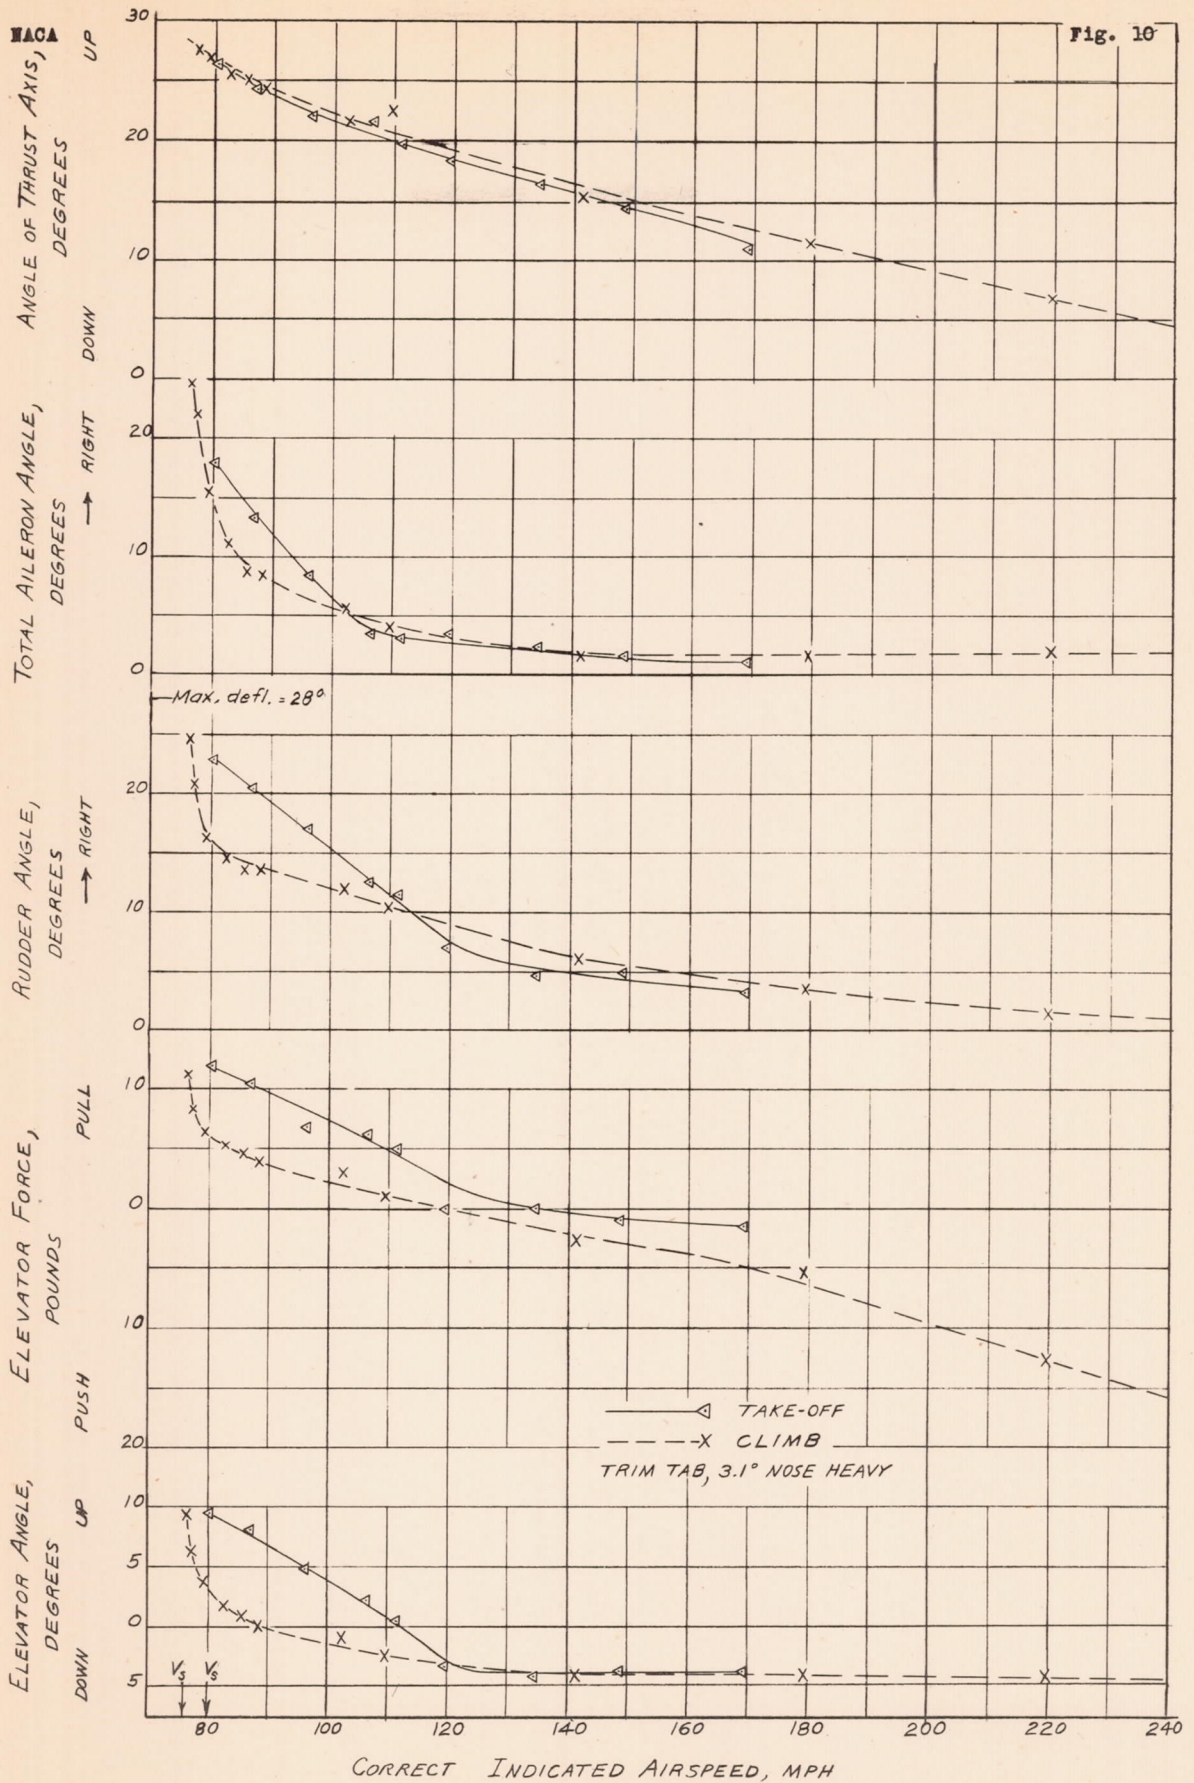
Figure 10. - Static longitudinal-stability characteristics of the Supermarine Spitfire airplane^{HWG} in the climbing and take-off conditions.

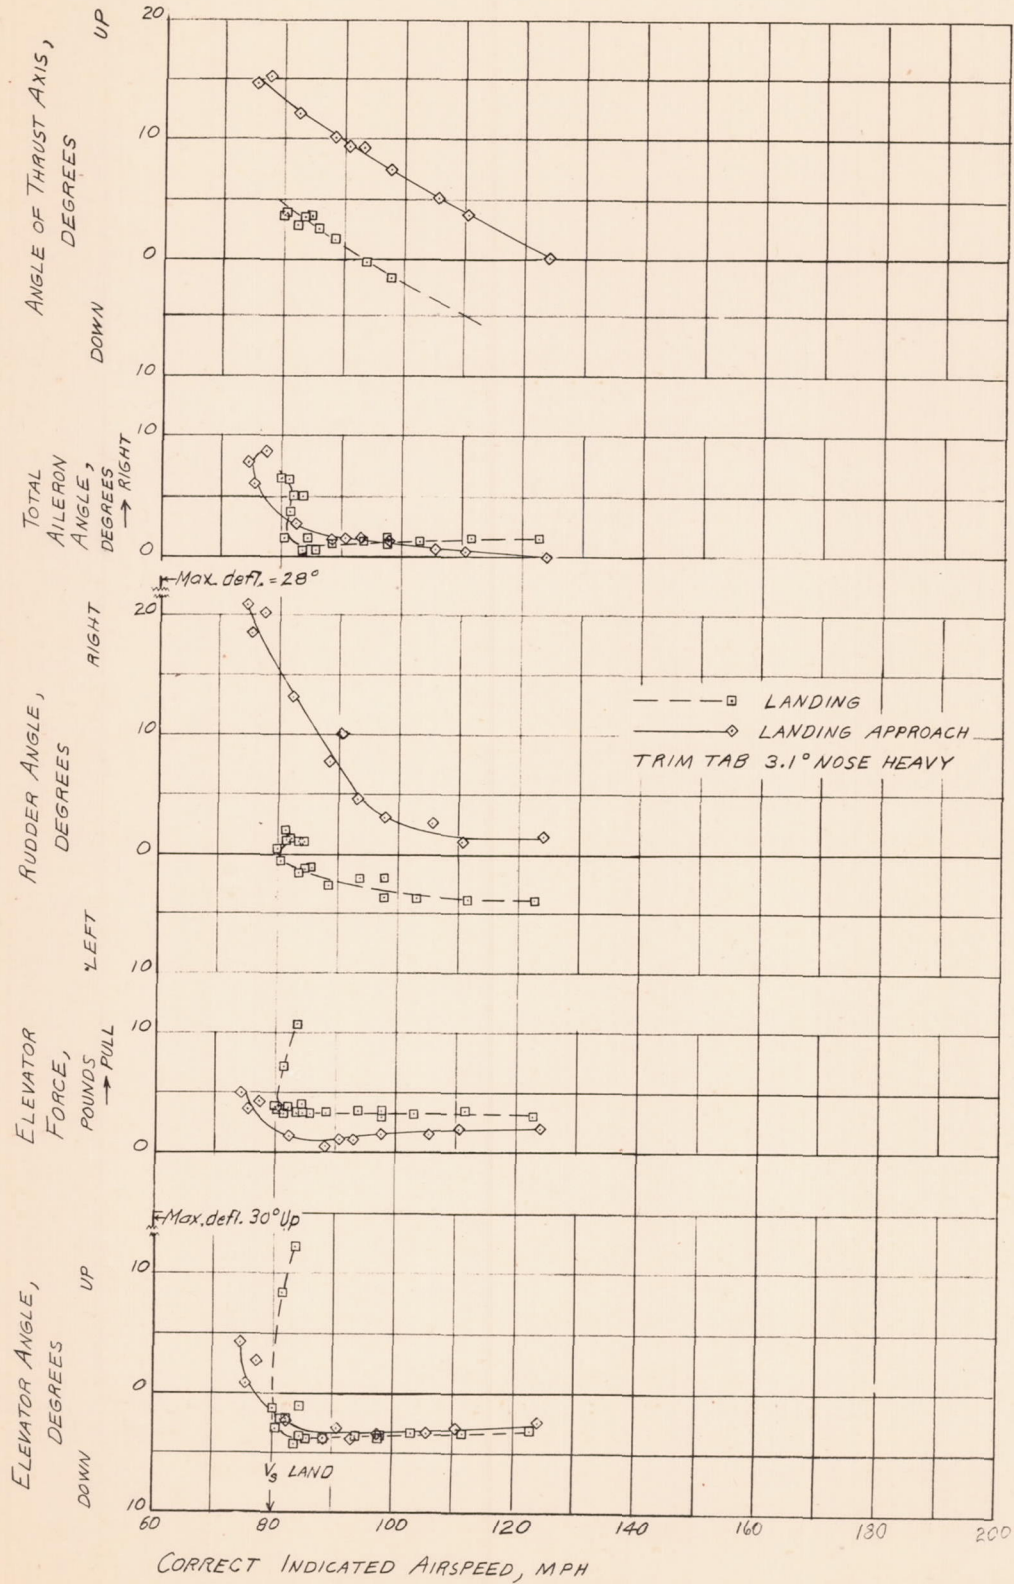
Figure 11. - Static longitudinal-stability characteristics of the Supermarine Spitfire airplane in the landing and landing-approach conditions.

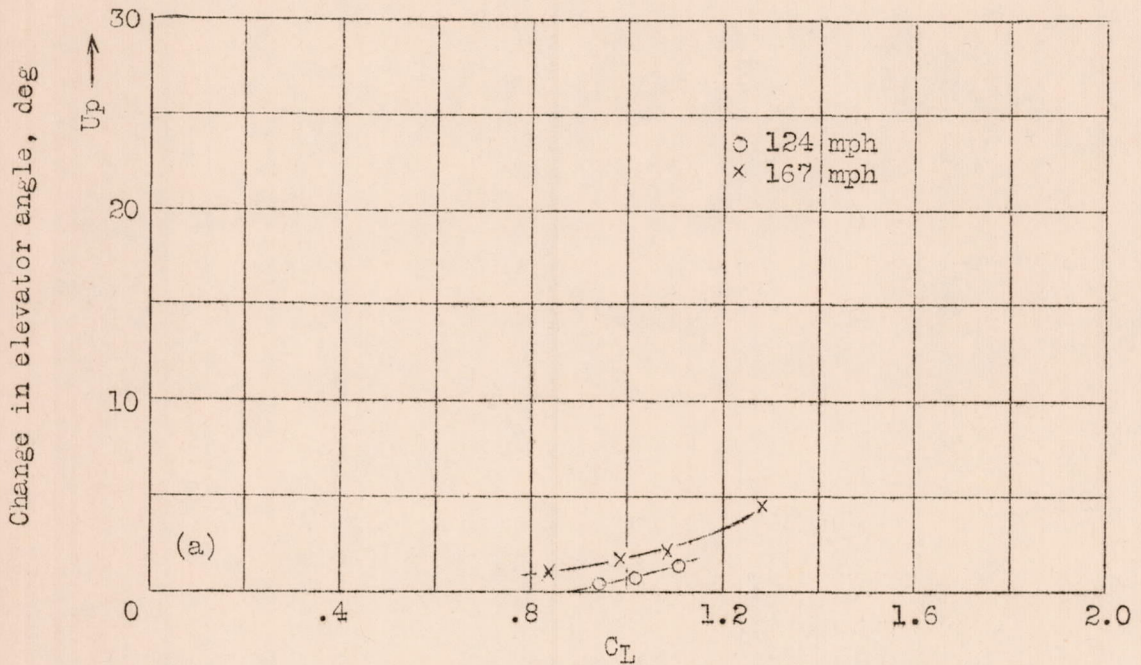
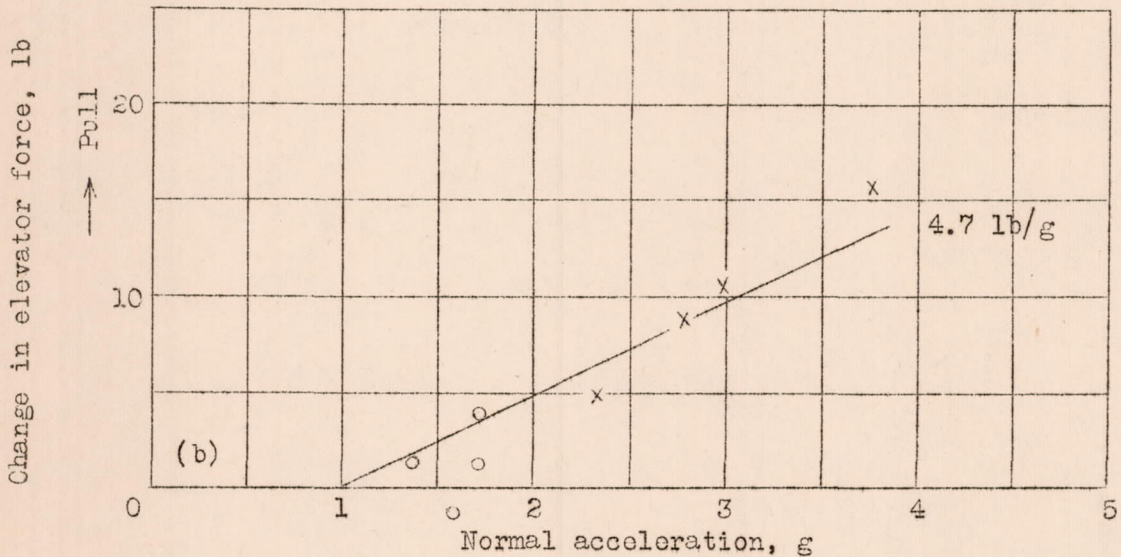
(a) Variation of change in elevator angle with lift coefficient in pull-ups.

(b) Variation of elevator force with normal acceleration in pull-ups.

Figure 12.- Elevator characteristics in pull-ups. Supermarine Spitfire airplane.

The elevator control was found to be powerful enough to develop either the maximum lift coefficient or the allowable load factor at any speed. As shown in figure 12(a), less than 5° movement of the elevator was used in reaching maximum lift coefficient in pull-ups from level flight. In these maneuvers, the elevator was abruptly deflected a small amount and then held fixed with the aid of a graduated tape in the cockpit. In pull-ups made at high speed, the elevator was always eased forward before maximum acceleration had been developed, in order to avoid overloading the structure.

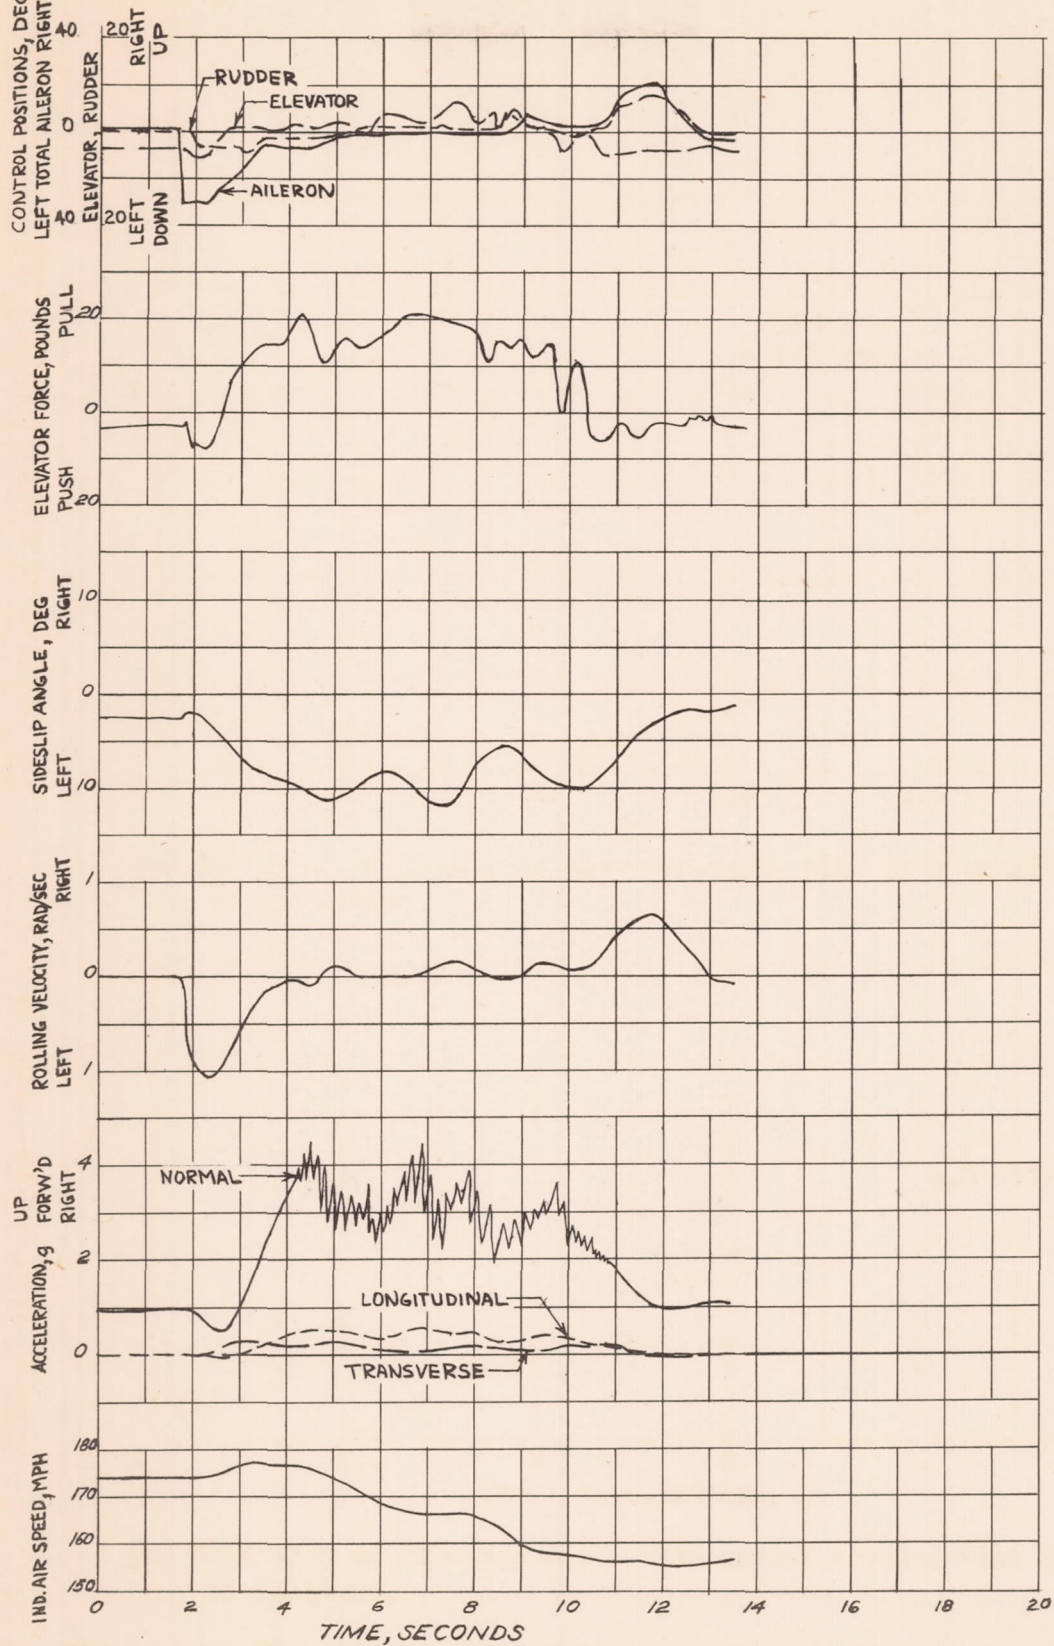
Fig. 13

Figure 13. - Time history of a rapid 180° turn to the left started at 174 miles per hour, in which the stall was reached. Supermarine Spitfire airplane; gun ports covered.

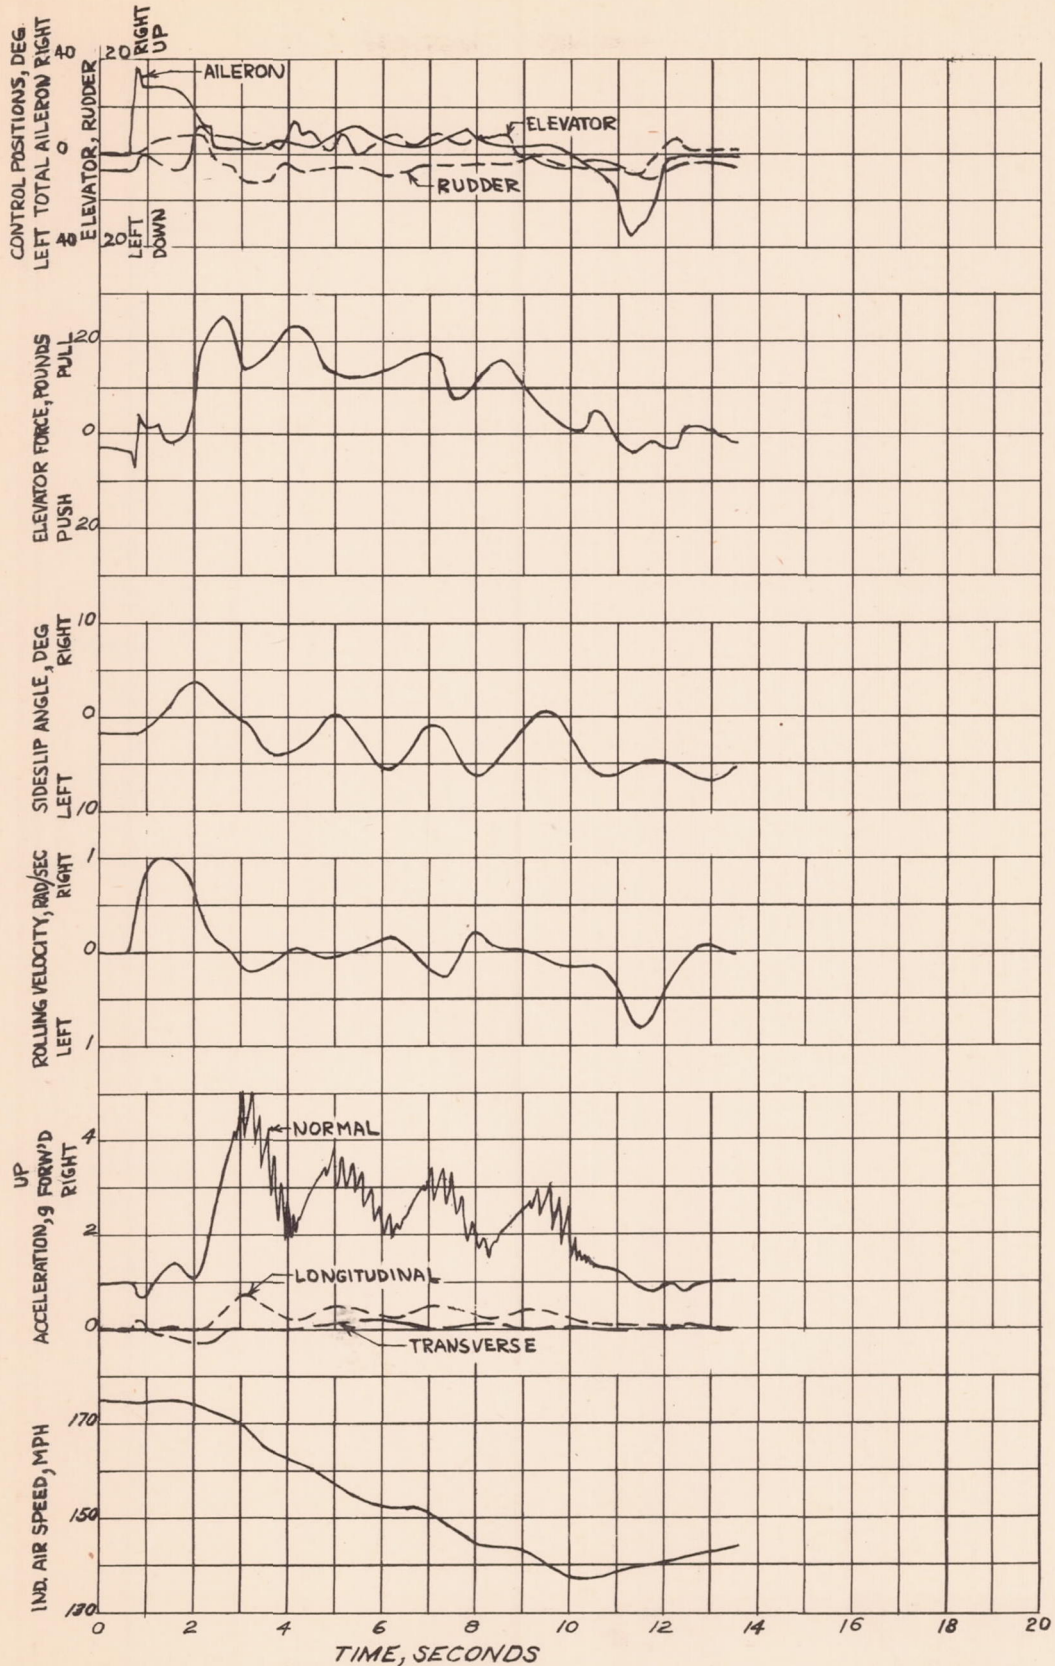
Figure 14. - Time history of a rapid 180° turn to the right started at 175 miles per hour, in which four stalls occurred. Supermarine Spitfire airplane with gun parts covered.
