WARTIME REPORT

MEASUREMENTS OF THE FLYING QUALITIES OF A
SUPERMARINE SPITFIRE VA AIRPLANE

By William H. Phillips and Joseph R. Vensel

Langley Memorial Aeronautical Laboratory
Langley Field, Va.

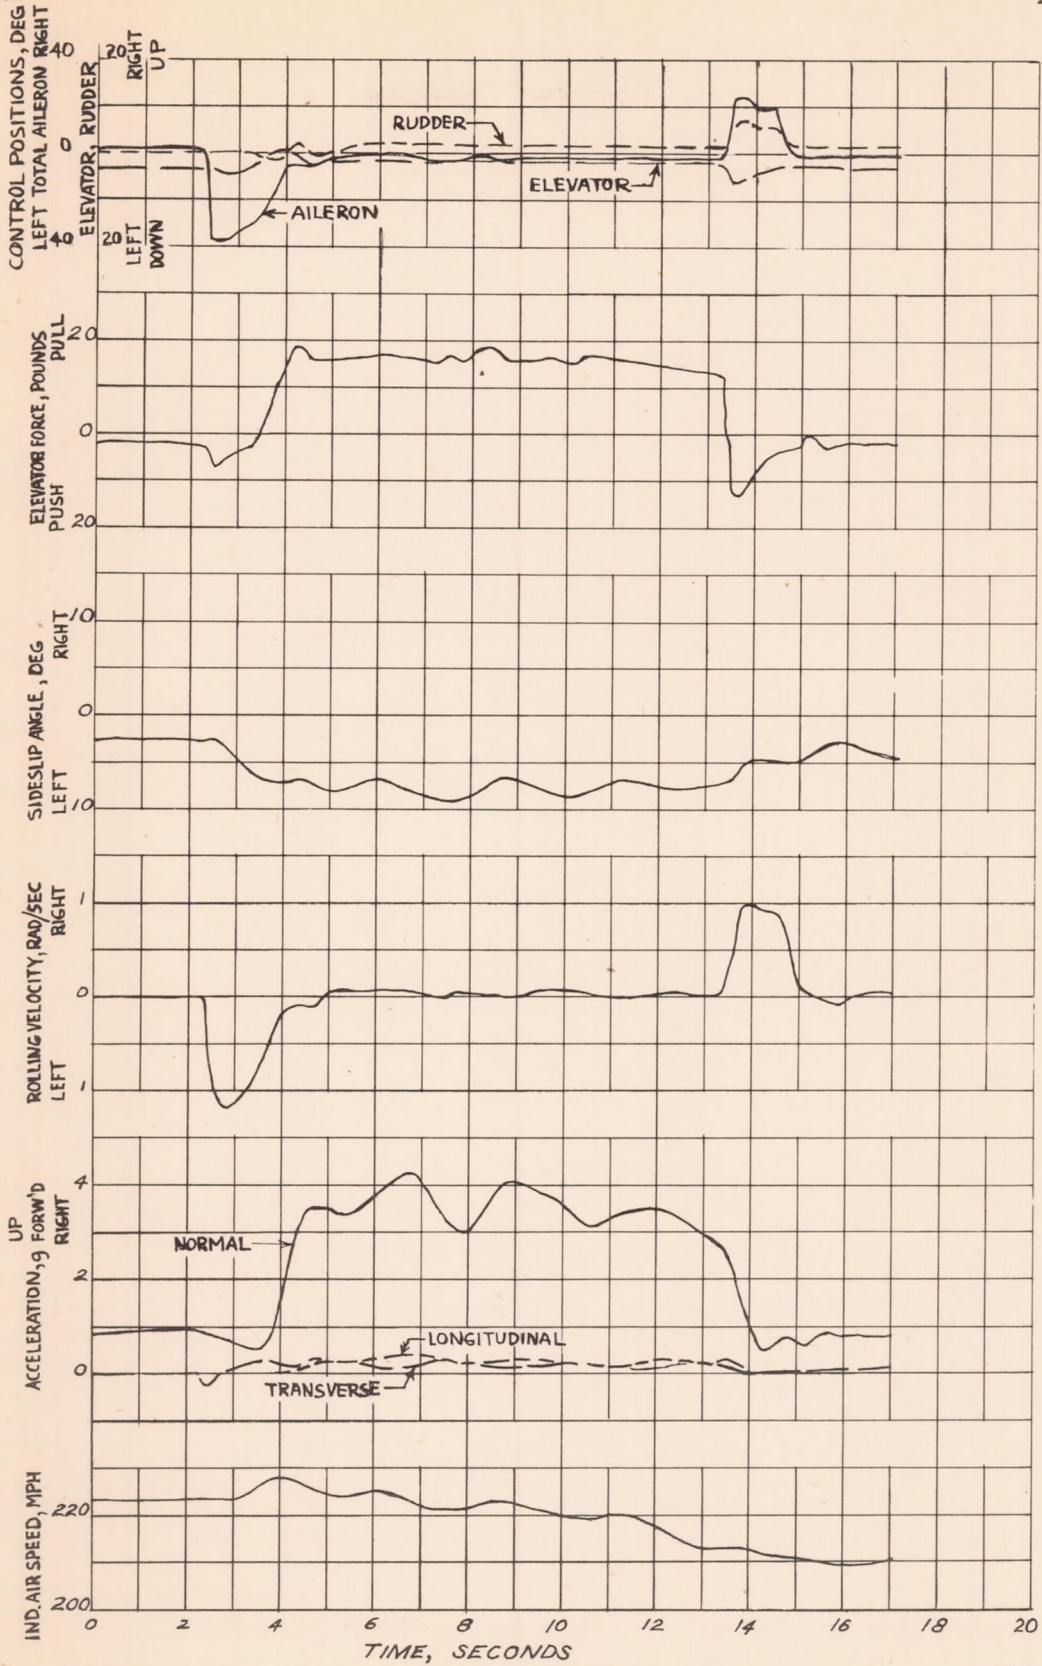
Figure 15. - Time history of a rapid 180° turn to the left started at 223 miles per hour. Supermarine Spitfire airplane with gun ports covered.

the static stability of an airplane is sufficiently large. By careful flying, the pilot was able to make smooth turns at high speed, as shown by figures 17 and 18. Ordinarily, however, small movements of the stick caused appreciable variations in the normal acceleration, as shown in figures 15 and 20.

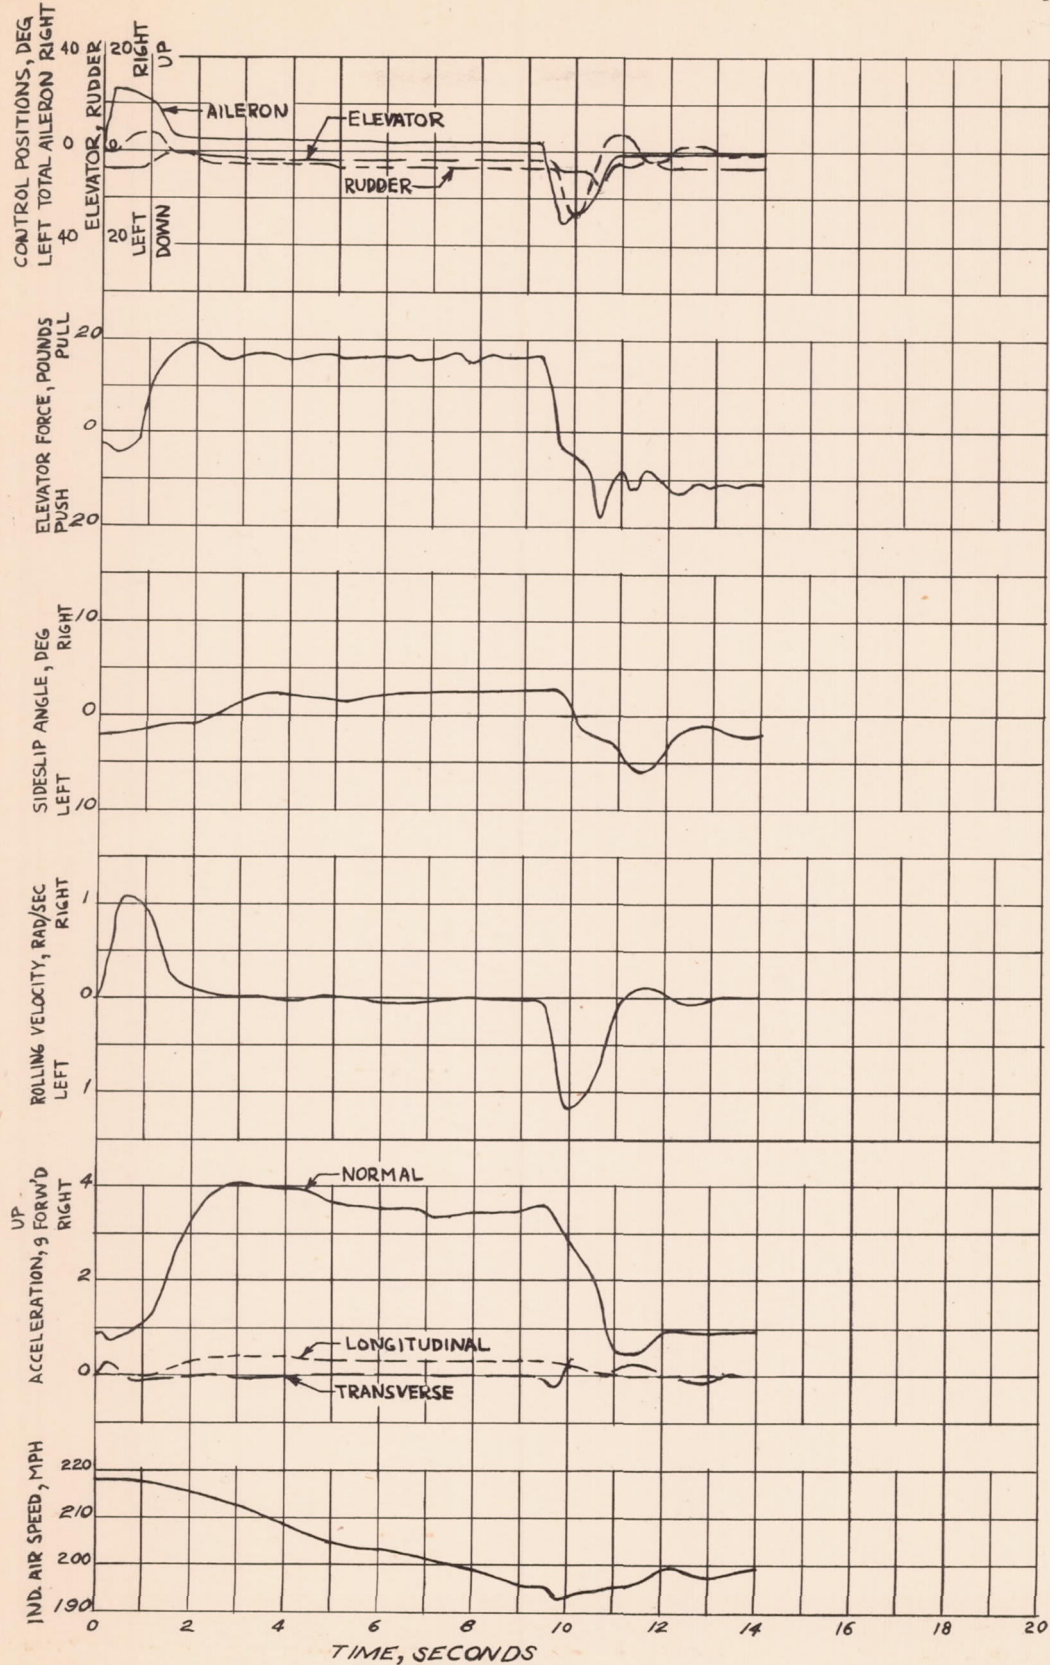
Figure 16. - Time history of a rapid 180° turn to the right started at 218 miles per hour. Supermarine Spitfire airplane with gun ports covered.

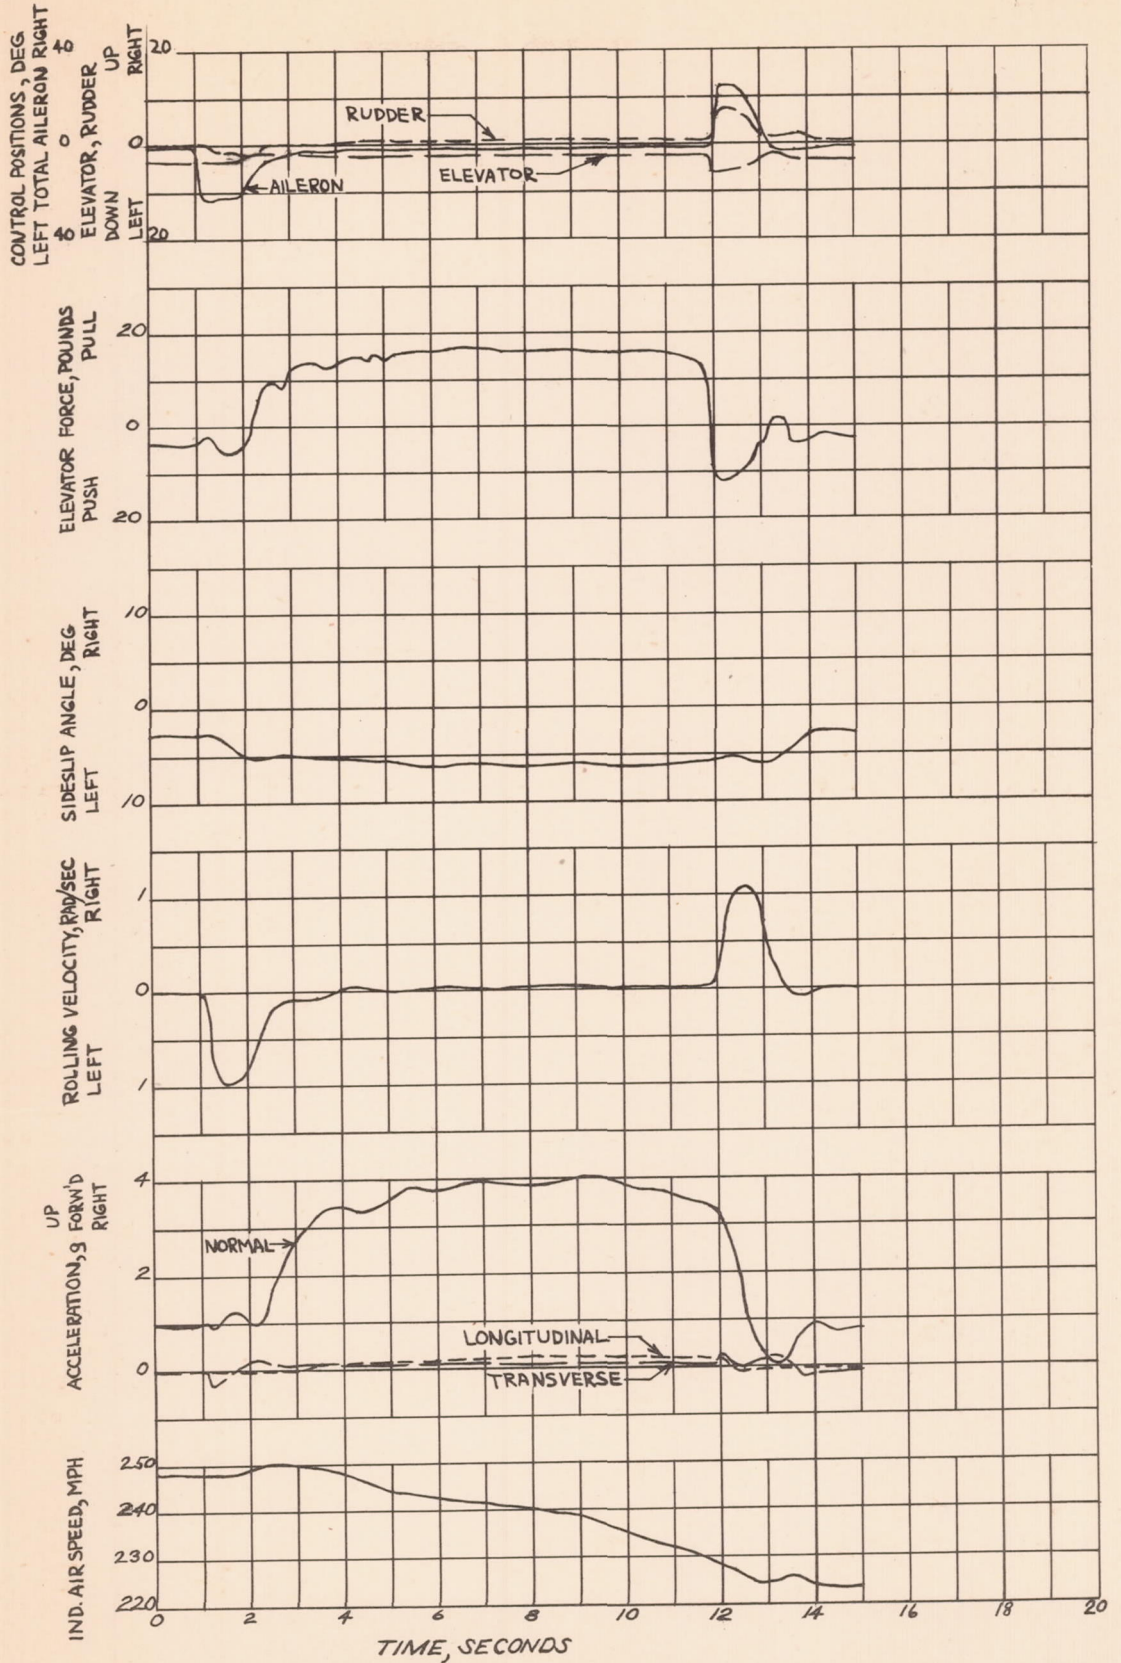
Figure 17. - Time history of a rapid 180° turn to the left started at 248 miles per hour. Supermarine Spitfire airplane with gun ports covered.

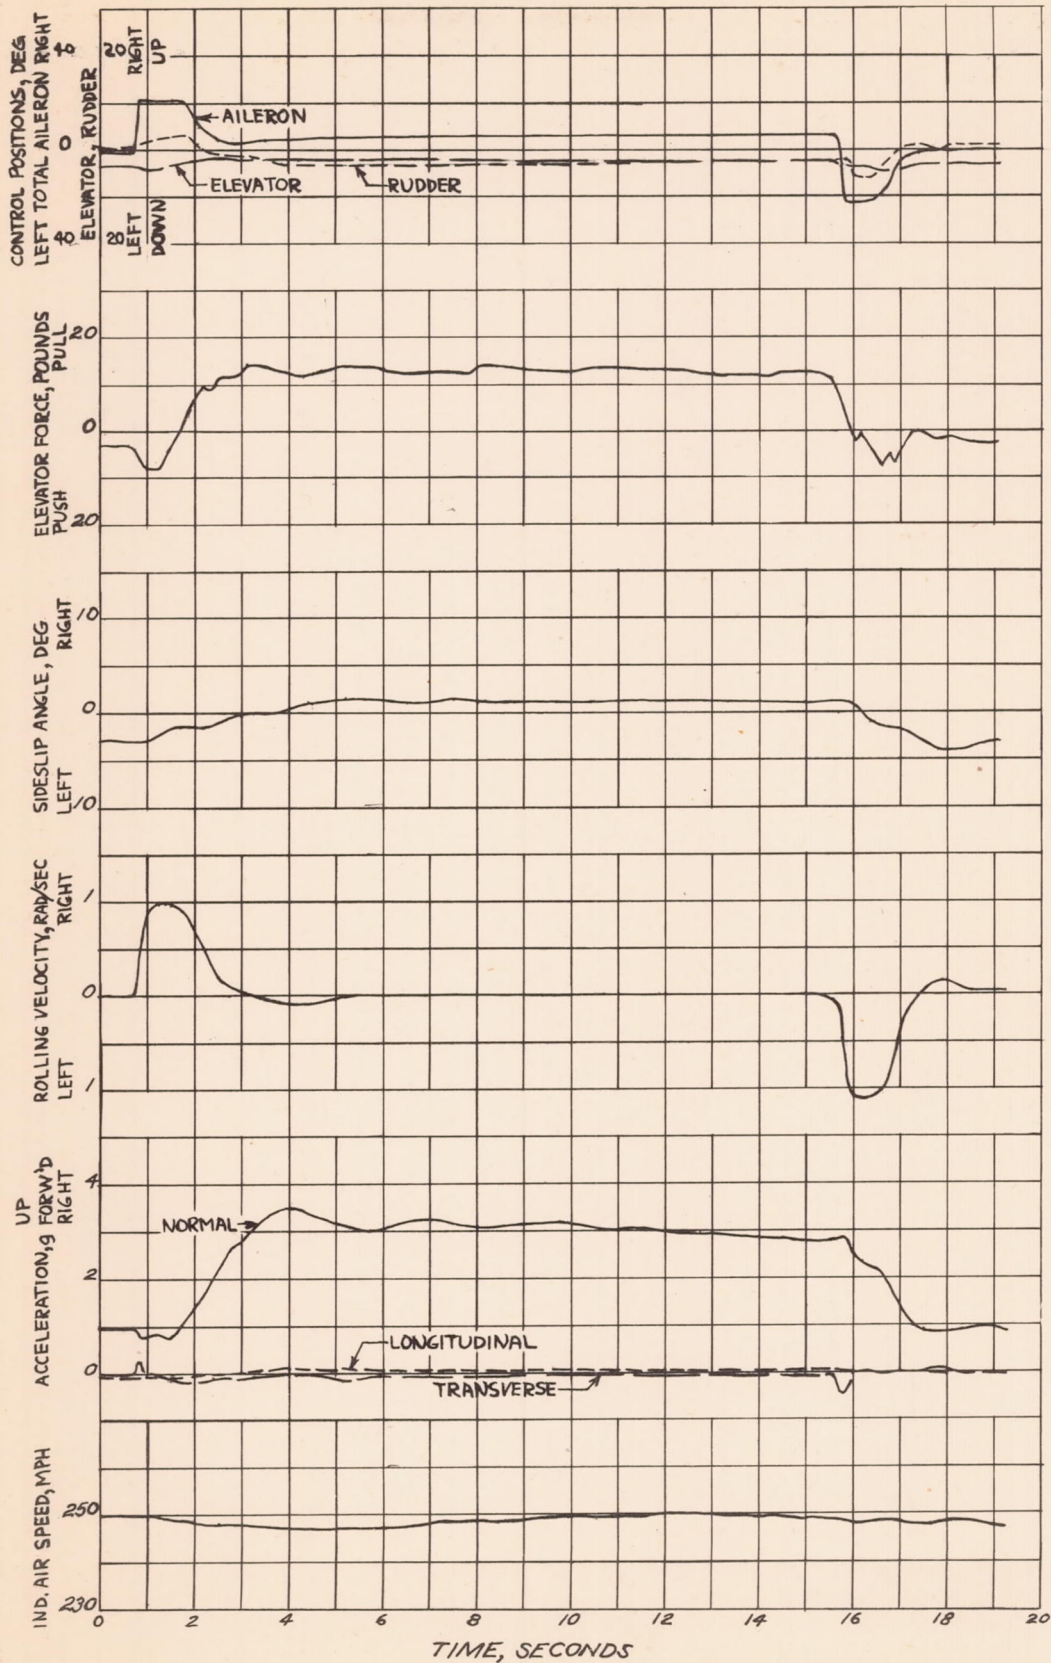
Figure 18. - Time history of a rapid 180° turn to the right started at 250 miles per hour. Supermarine Spitfire airplane with gun parts covered.

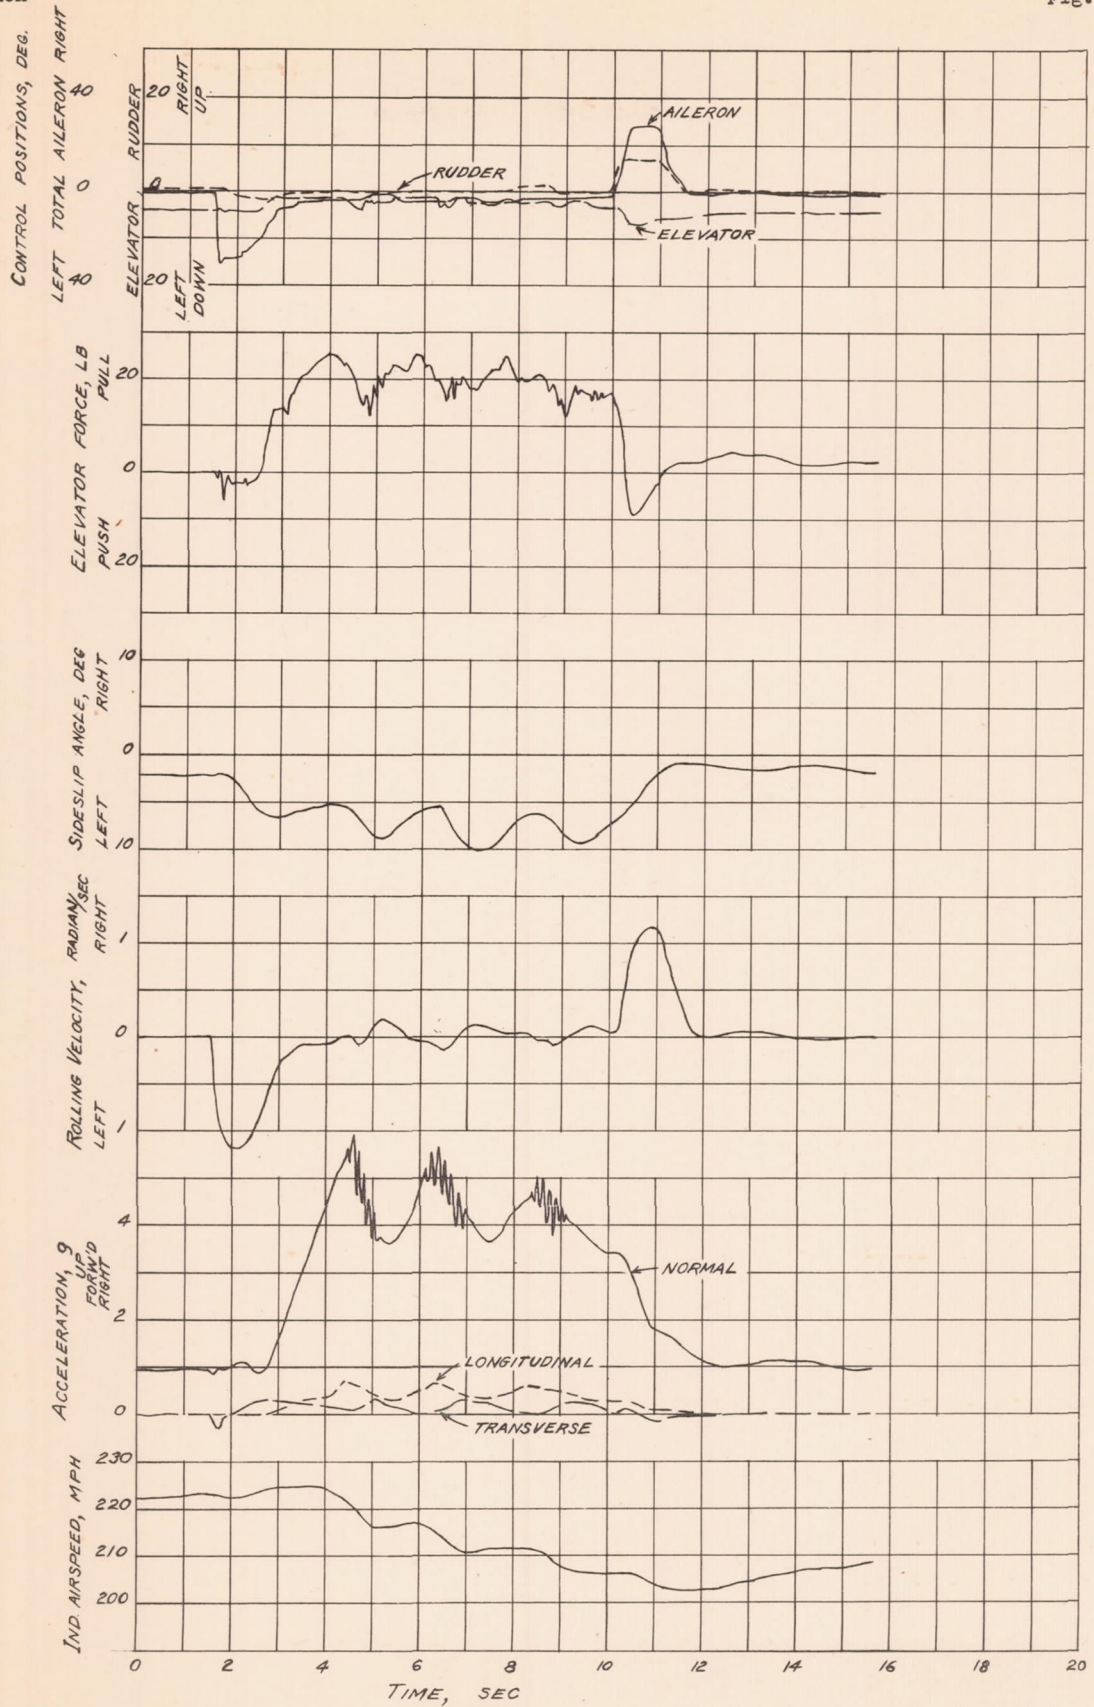
Figure 19. - Time history of a highly accelerated left turn in which the stall was reached three times. Supermarine Spitfire airplane with gun ports covered.

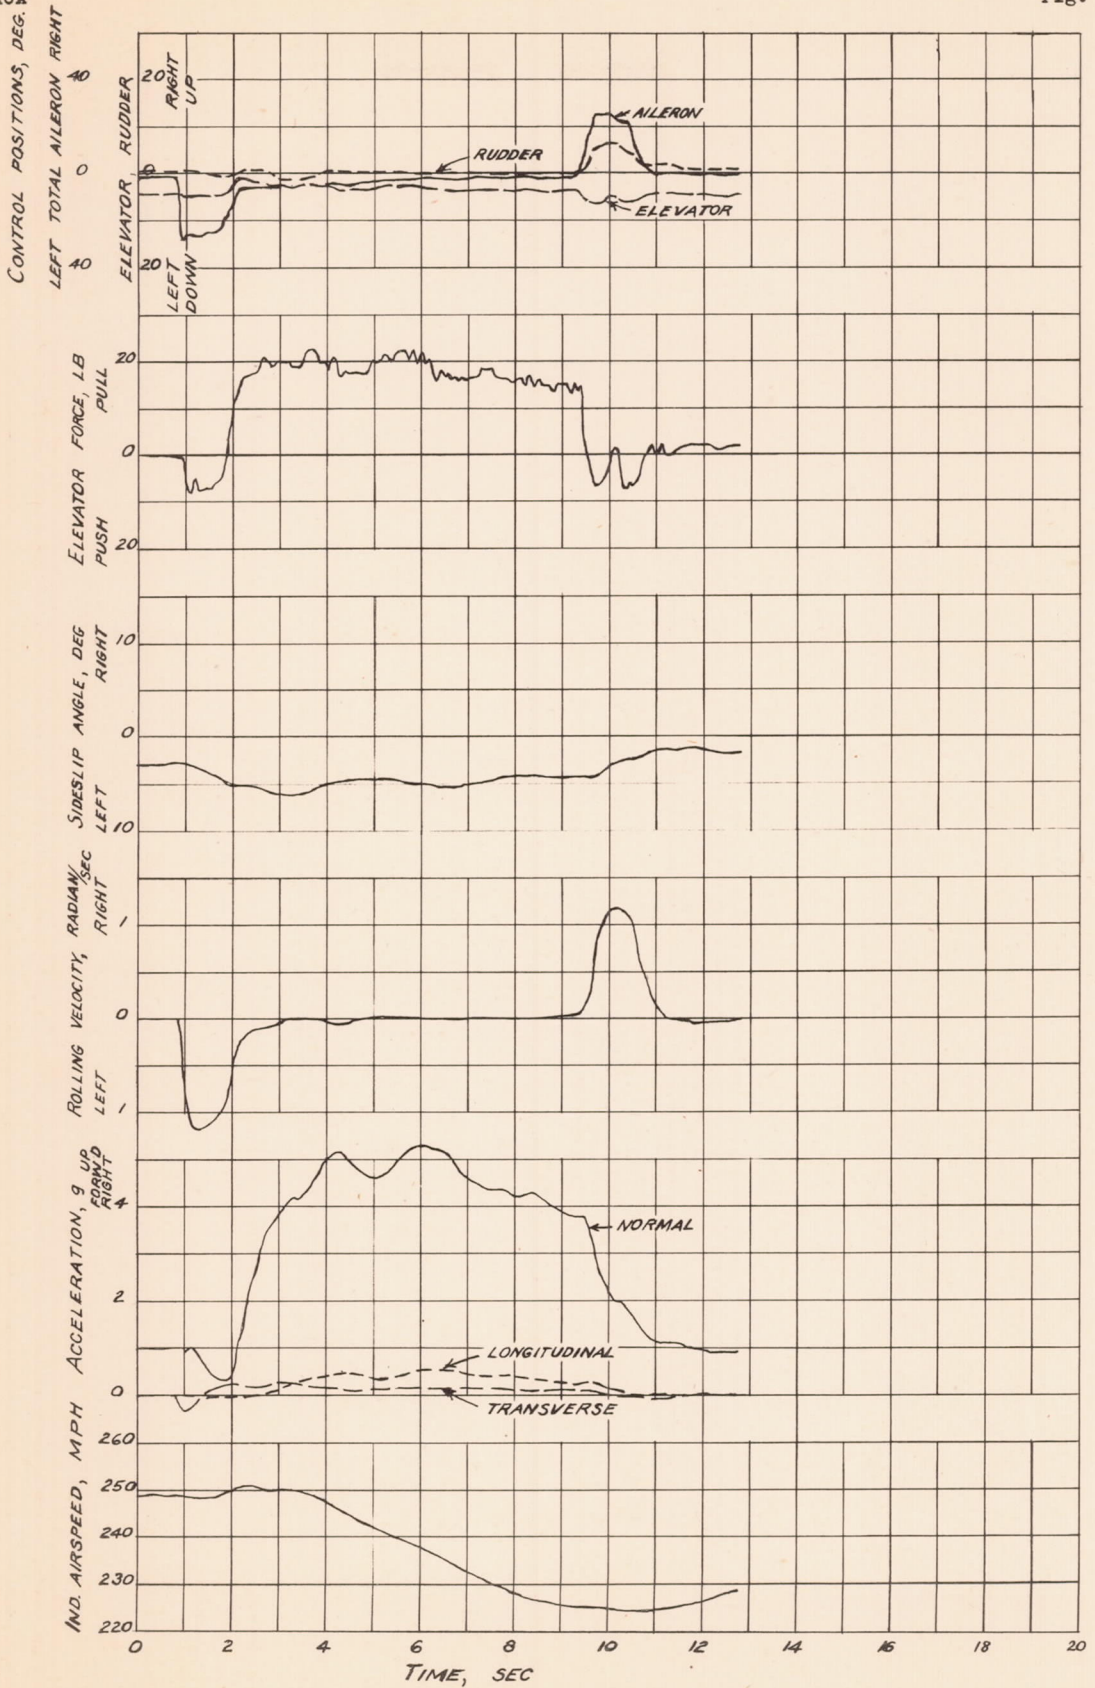
Figure 20. - Time history of a highly accelerated left turn started at 249 miles per hour. Supermarine Spitfire airplane with gun ports covered.

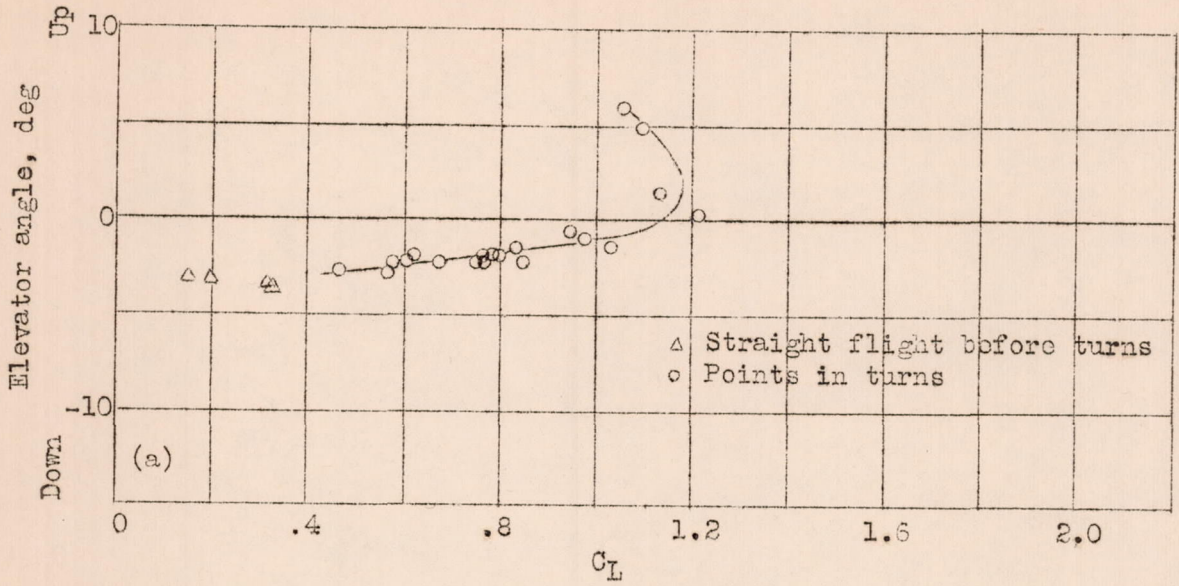
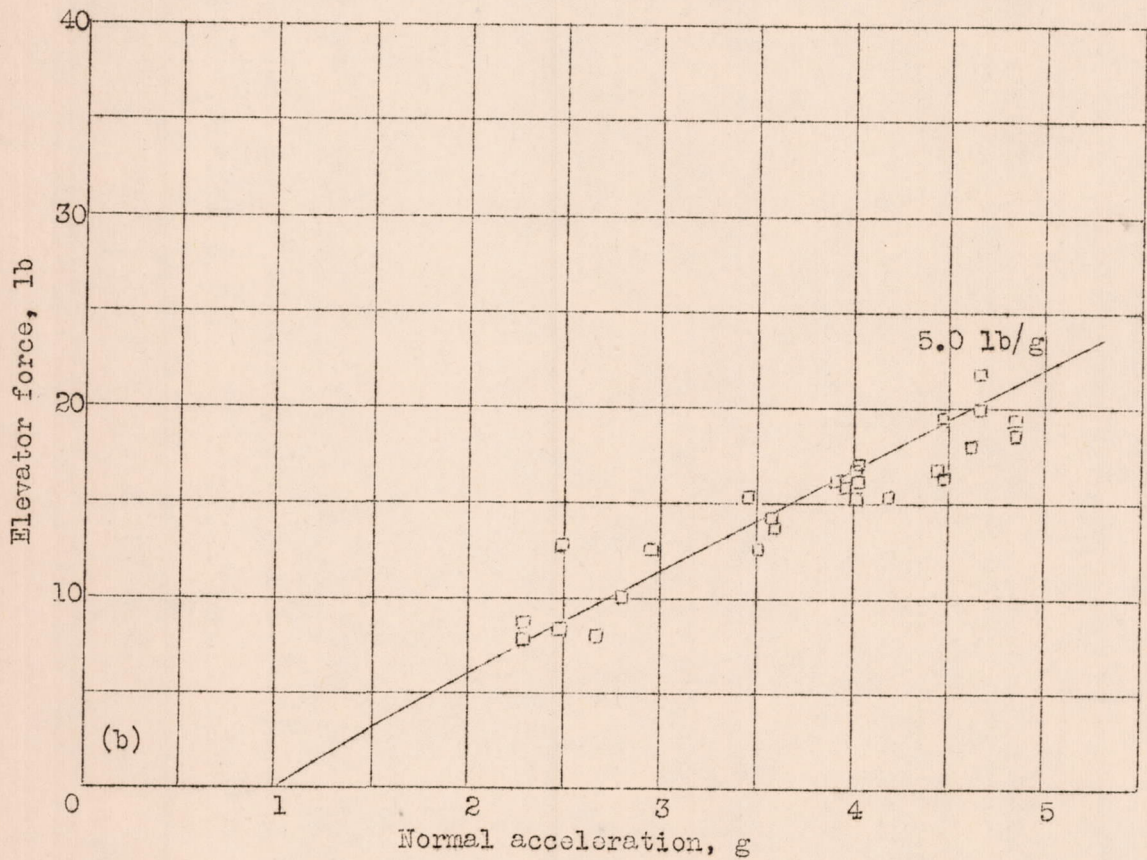
(a) Variation of elevator angle with lift coefficient in turns

(b) Variation of stick force with normal acceleration in turns.

Figure 21.- Elevator characteristics in turns. Supermarine Spitfire airplane.

The variation of stick force with normal acceleration in turns is plotted in figure 21(b). The stick-force gradient of 5.0 pounds per g was considered a little too light by most of the pilots. It is lower than the value of 6 pounds per g recommended as an upper limit in reference 1. Inasmuch as the elevator mass unbalance under static conditions gave a force of 4.0 pounds on the stick, it is apparent that the stick force required in accelerated flight came almost entirely from the statically unbalanced elevator. Practically no stick force would be required in turns if the elevator were mass balanced. This suggests that the airplane would appear definitely unstable in turns if the elevator were mass balanced, as is required for flutter prevention on American pursuit airplanes.

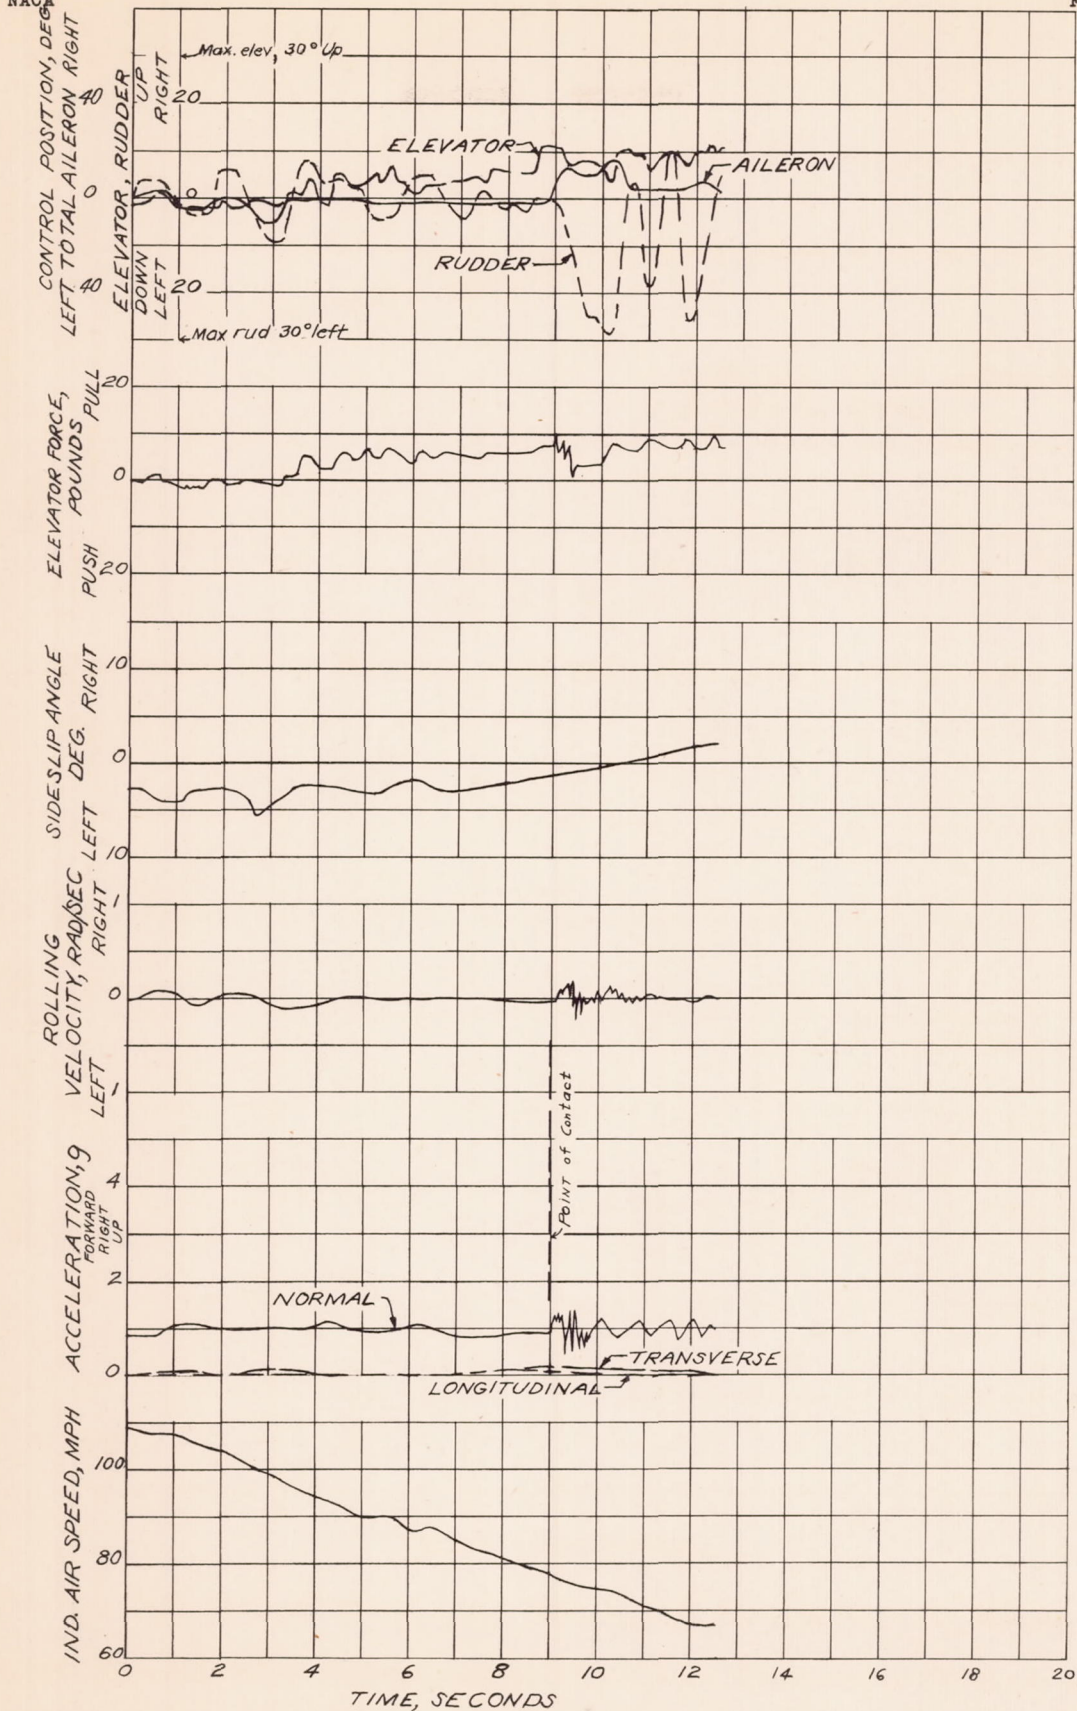
Figure 22. - Time history of a three-point landing (trim tab, 2.3° nose heavy). Note unsteadiness of airplane and controls caused by tail buffeting and instability in the approach. Supermarine Spitfire airplane.

L-334
wash at the tail caused by separation of the flow at the wing root was probably combined with that due to ground effect in the three-point landings. A time history of a three-point landing, shown in figure 22, illustrates the unsteadiness of the airplane and controls as the landing attitude was approached.

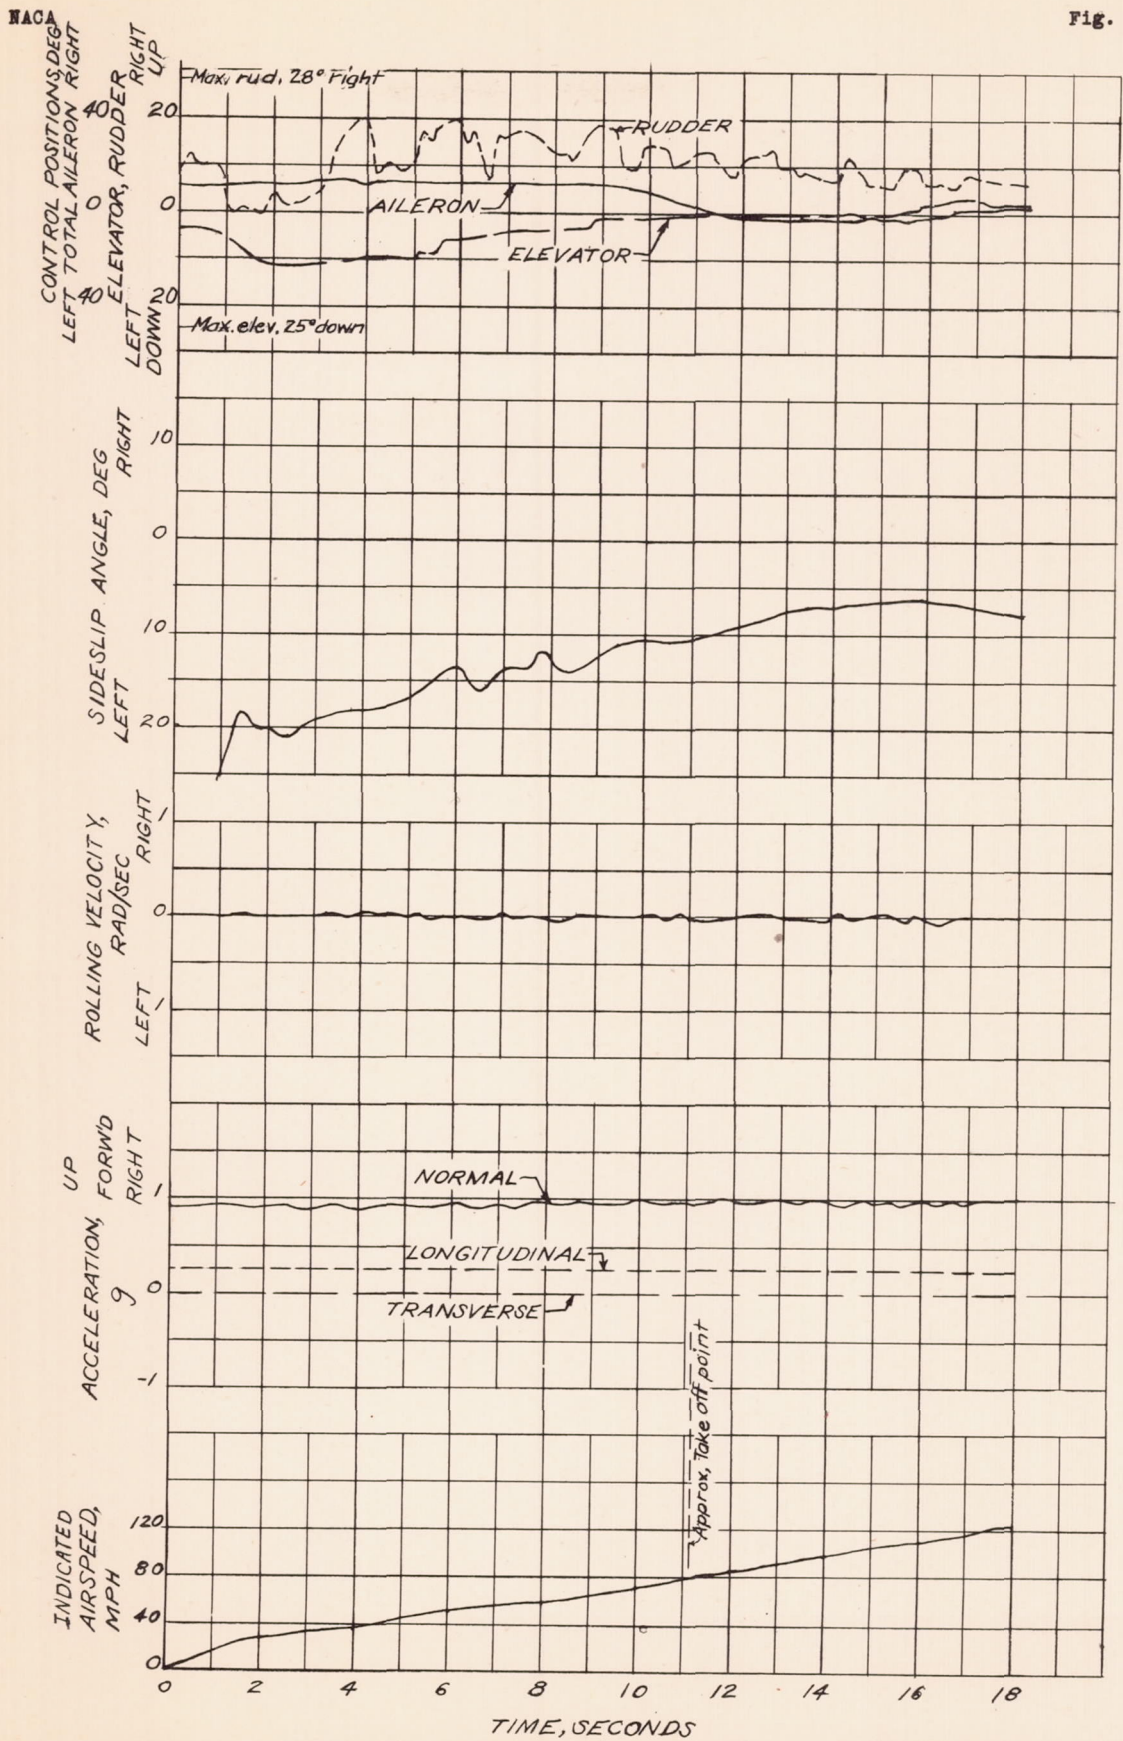
Figure 23. - Time history of a tail-high take-off made with 48 in. Hg manifold pressure. Supermarine Spitfire airplane.

The rudder control, in conjunction with the brakes, was sufficiently powerful to maintain directional control in take-off and landing. A time history of a take-off (fig. 23) shows that some rudder deflection was required to overcome a tendency to turn to the left. The rudder force required for this purpose, however, was observed to be relatively light.

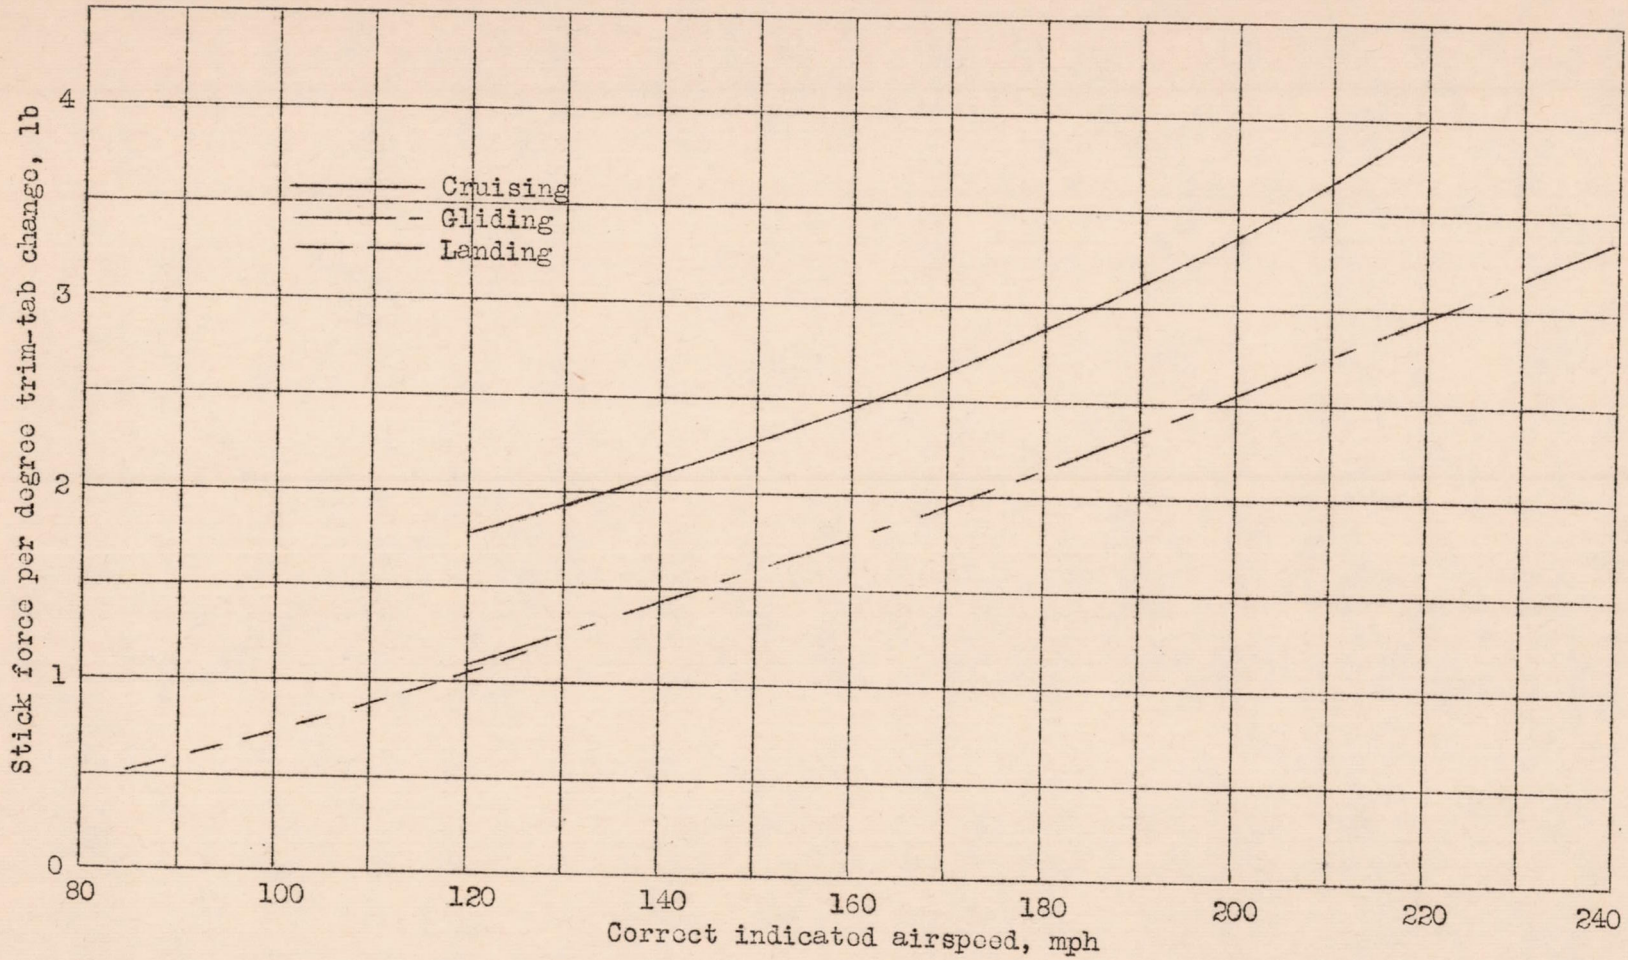
Figure 24.- Variation of power of the elevator trim tabs with indicated airspeed in the cruising, gliding, and landing conditions. Supermarine Spitfire airplane.

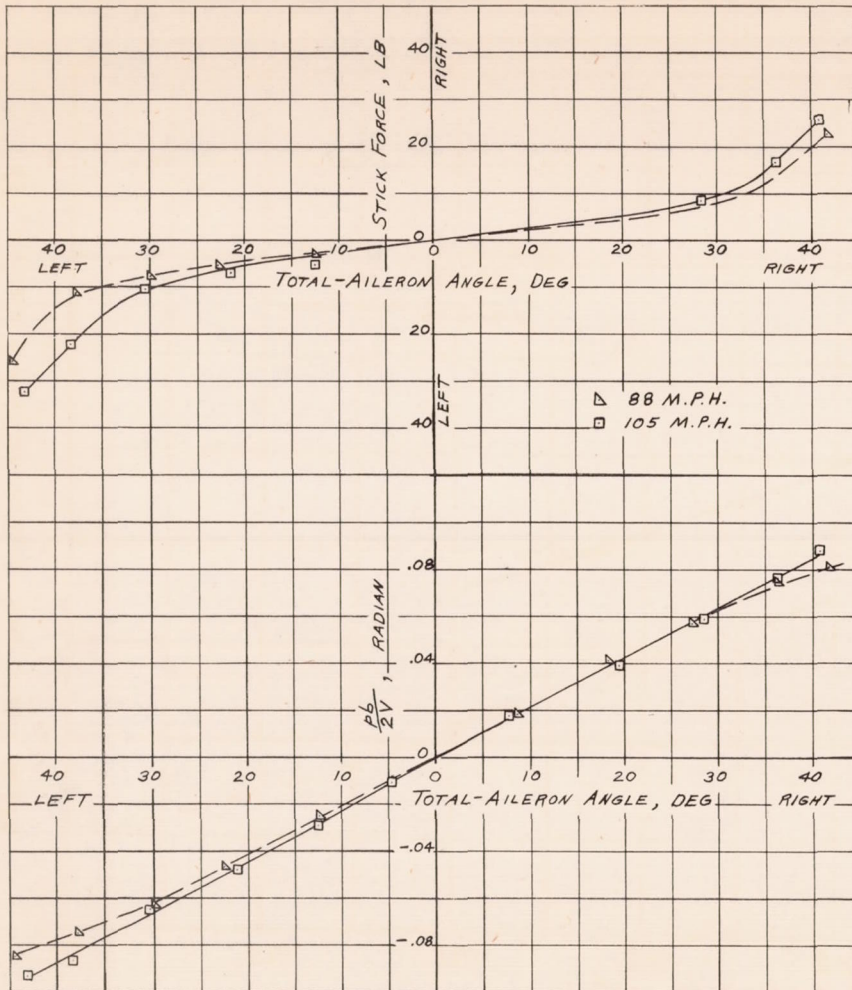
Figure 25. - Variation of aileron force and $\frac{pb}{2V}$ with total aileron deflection in the landing condition (flaps down, gear down, power off). Supermarine Spitfire airplane.

The results of these tests are presented in figures 25 to 28. Figure 25 shows the variation of $pb/2V$ and aileron force with total aileron deflection in the landing condition, and figure 26 gives these curves for level flight with flaps and gear up at three speeds. Total aileron deflection is defined as the sum of the deflections of the right and left ailerons. The quantity $pb/2V$ is the helix angle in radians described by the wing tip in a roll, where p is the rolling velocity in radians per second, b the wing span in feet, and V the true velocity in feet per second. A complete discussion of this criterion for aileron effectiveness is given in reference 3.

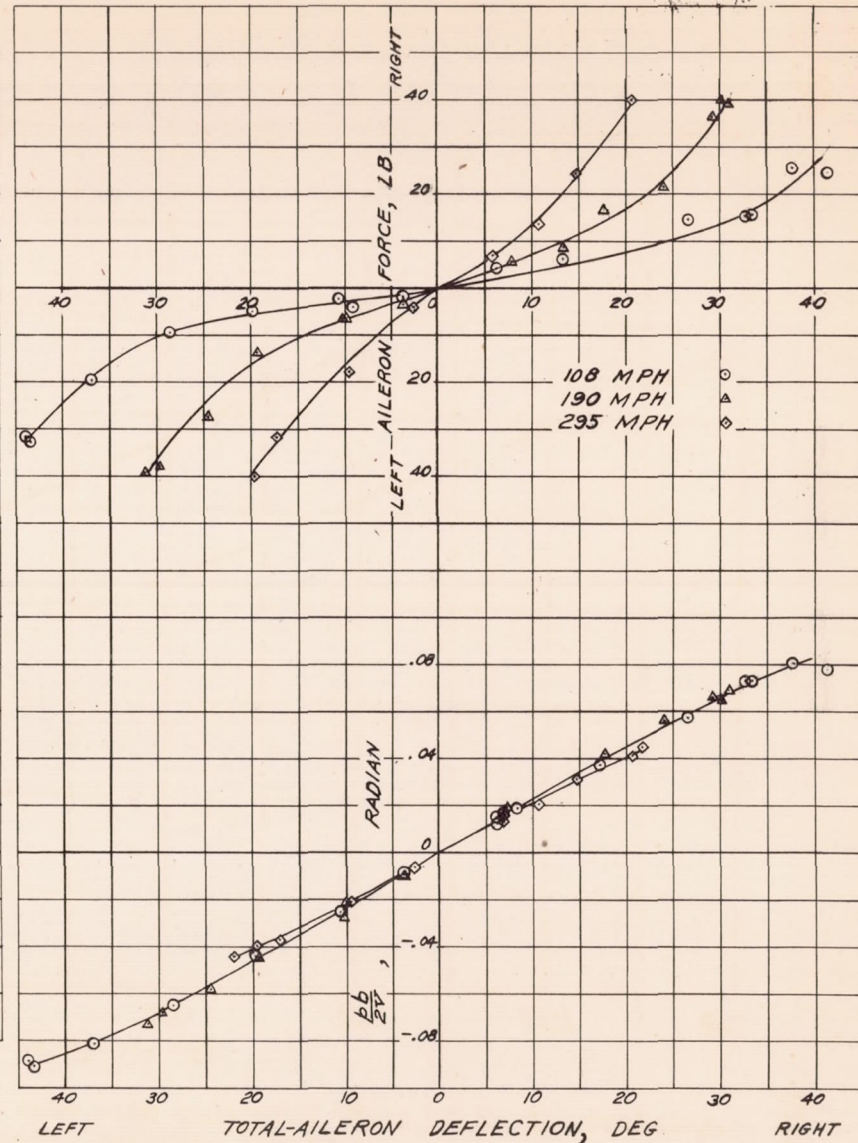
Figure 26. - Variation of aileron force and $\frac{pb}{2V}$ with total aileron deflection in level flight (flaps up, gear up). Supermarine Spitfire airplane.

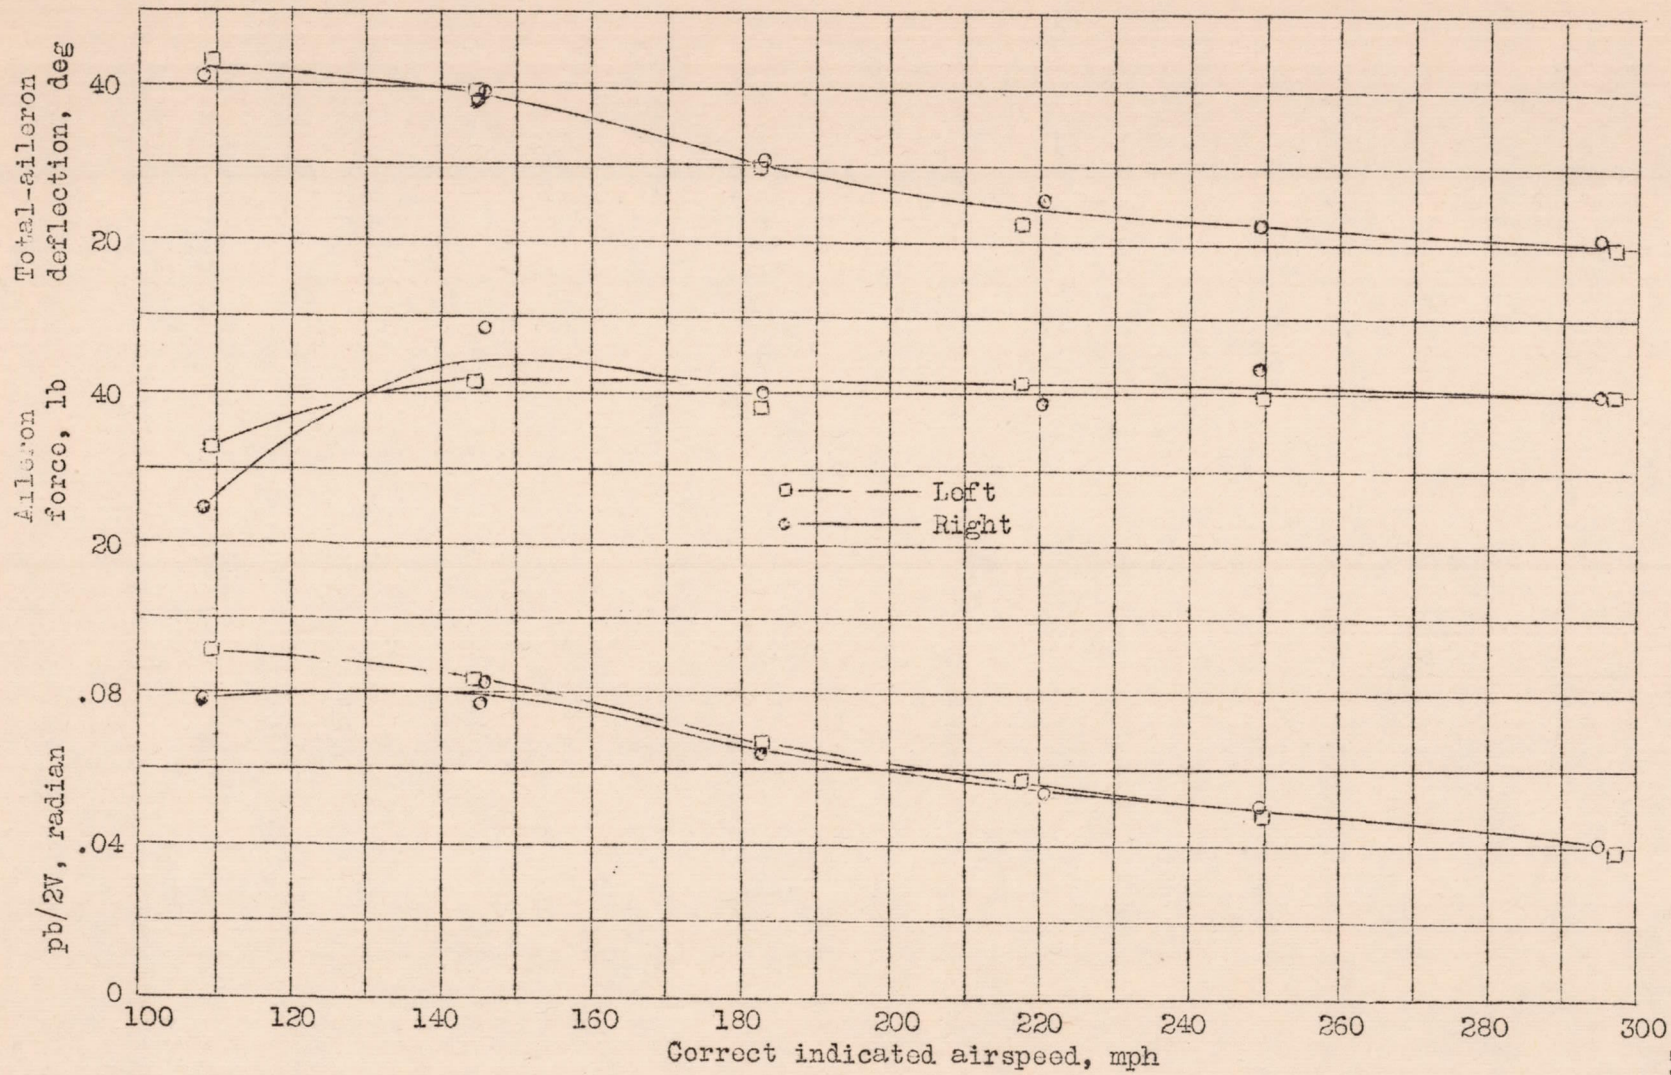
Figure 27.-- Variation of maximum obtainable aileron deflection, aileron force, and $pb/2V$ with indicated airspeed in level flight (flaps up, gear up). Supermarine Spitfire airplane.
