WARTIME REPORT

MEASUREMENTS OF THE FLYING QUALITIES OF A
SUPERMARINE SPITFIRE VA AIRPLANE

By William H. Phillips and Joseph R. Vensel

Langley Memorial Aeronautical Laboratory
Langley Field, Va.

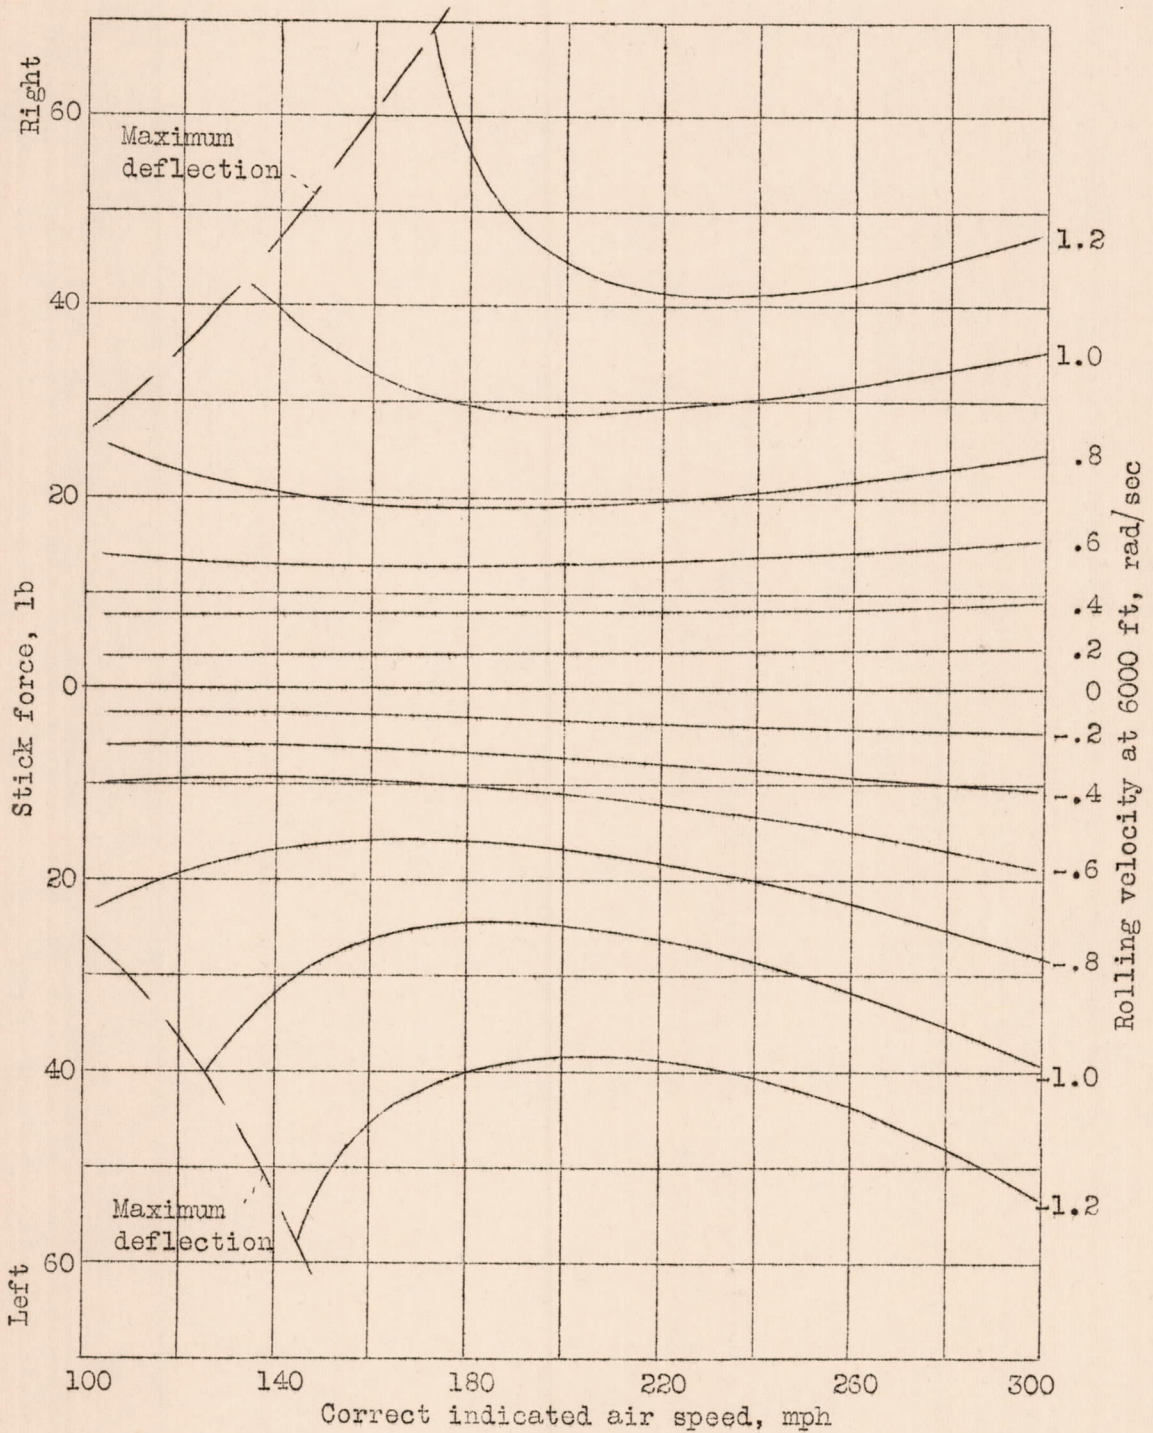
Figure 28.- Variation of aileron stick force with speed for different rolling velocities in level flight (flaps up, gear up). Supermarine Spitfire airplane.

The results of these tests are presented in figures 25 to 28. Figure 25 shows the variation of $pb/2V$ and aileron force with total aileron deflection in the landing condition, and figure 26 gives these curves for level flight with flaps and gear up at three speeds. Total aileron deflection is defined as the sum of the deflections of the right and left ailerons. The quantity $pb/2V$ is the helix angle in radians described by the wing tip in a roll, where p is the rolling velocity in radians per second, b the wing span in feet, and V the true velocity in feet per second. A complete discussion of this criterion for aileron effectiveness is given in reference 3.

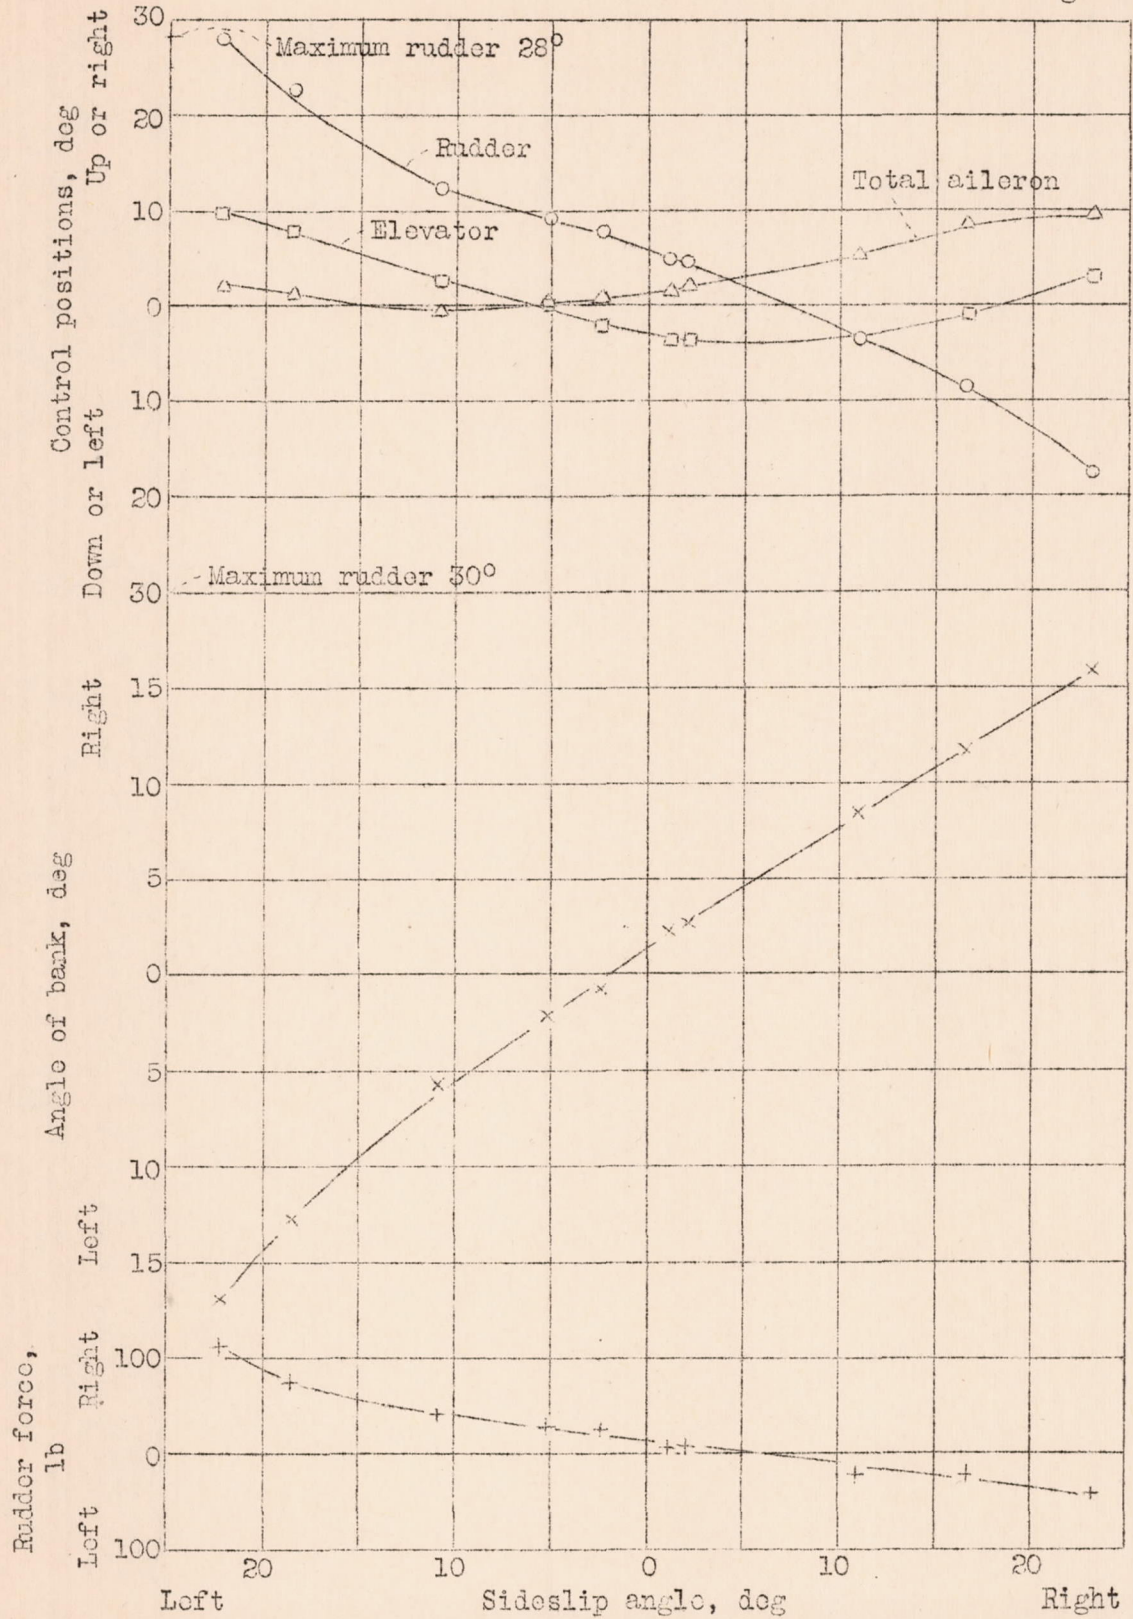
Figure 29.- Steady sideslip characteristics in the cruising condition (flaps up, gear up, power on) at 120 miles per hour. Supermarine Spitfire airplane.

Rolling moment due to sideslip.— The rolling moment due to sideslip of the Spitfire airplane was determined by recording the aileron angles required in steady sideslips. The results of these measurements are presented in figures 29 to 34, where the rudder, elevator and aileron angles, angle of bank, and rudder force are plotted as functions of the sideslip angle. The dihedral effect was stable in all conditions, with the exception that in left sideslips in the cruising condition the dihedral effect was practically neutral. The requirement of reference 1 was therefore met in all conditions except in left sideslips with power on.

angles of bank required to hold steady sideslips in the various flight conditions (figs. 29 to 34). The angles of bank were small at low speeds, but they increased rapidly with speed because the side force for a given sideslip angle varies approximately as the square of the speed. The Spitfire showed a slightly smaller side-force gradient than any other pursuit-type airplane tested previously. A larger side-force gradient would seem to be desirable because the pilot would find it easier to maintain unyawed flight if a large angle of bank were required to sideslip.

Pitching moment due to sideslip.- The pitching moment due to sideslip is shown by the variation of elevator angle with angle of sideslip in the steady sideslip measurements (figs. 29 to 33) and by the variation of normal acceleration with rudder angle in the rudder kicks (figs. 35 and 36). The Spitfire showed a tendency to pitch down both in left and right sideslips. In power-on flight, this airplane failed to meet the requirement (reference 1) that less than 1° change in elevator angle should accompany 5° deflection of rudder. As shown on figure 29, left sideslip occurred in the trim condition with wings level, and at this sideslip angle the elevator angle increased approximately linearly with the left sideslip angle. The static longitudinal-stability measurements indicated that the sideslip increased as the speed was reduced until it reached about 10° at the stall. The elevator angle required for this sideslip completely overshadowed any elevator motion required to change speed in unyawed flight. The increased up-elevator angles encountered at low speeds in the cruising condition therefore do not represent static longitudinal stability. It is doubtful that this type of variation of elevator angle with speed is helpful to the pilot in maintaining a fixed trim speed. Furthermore, the static longitudinal-stability characteristics recorded by two pilots might disagree considerably, because slight errors in holding the wings level would result in appreciable differences in sideslip angle.

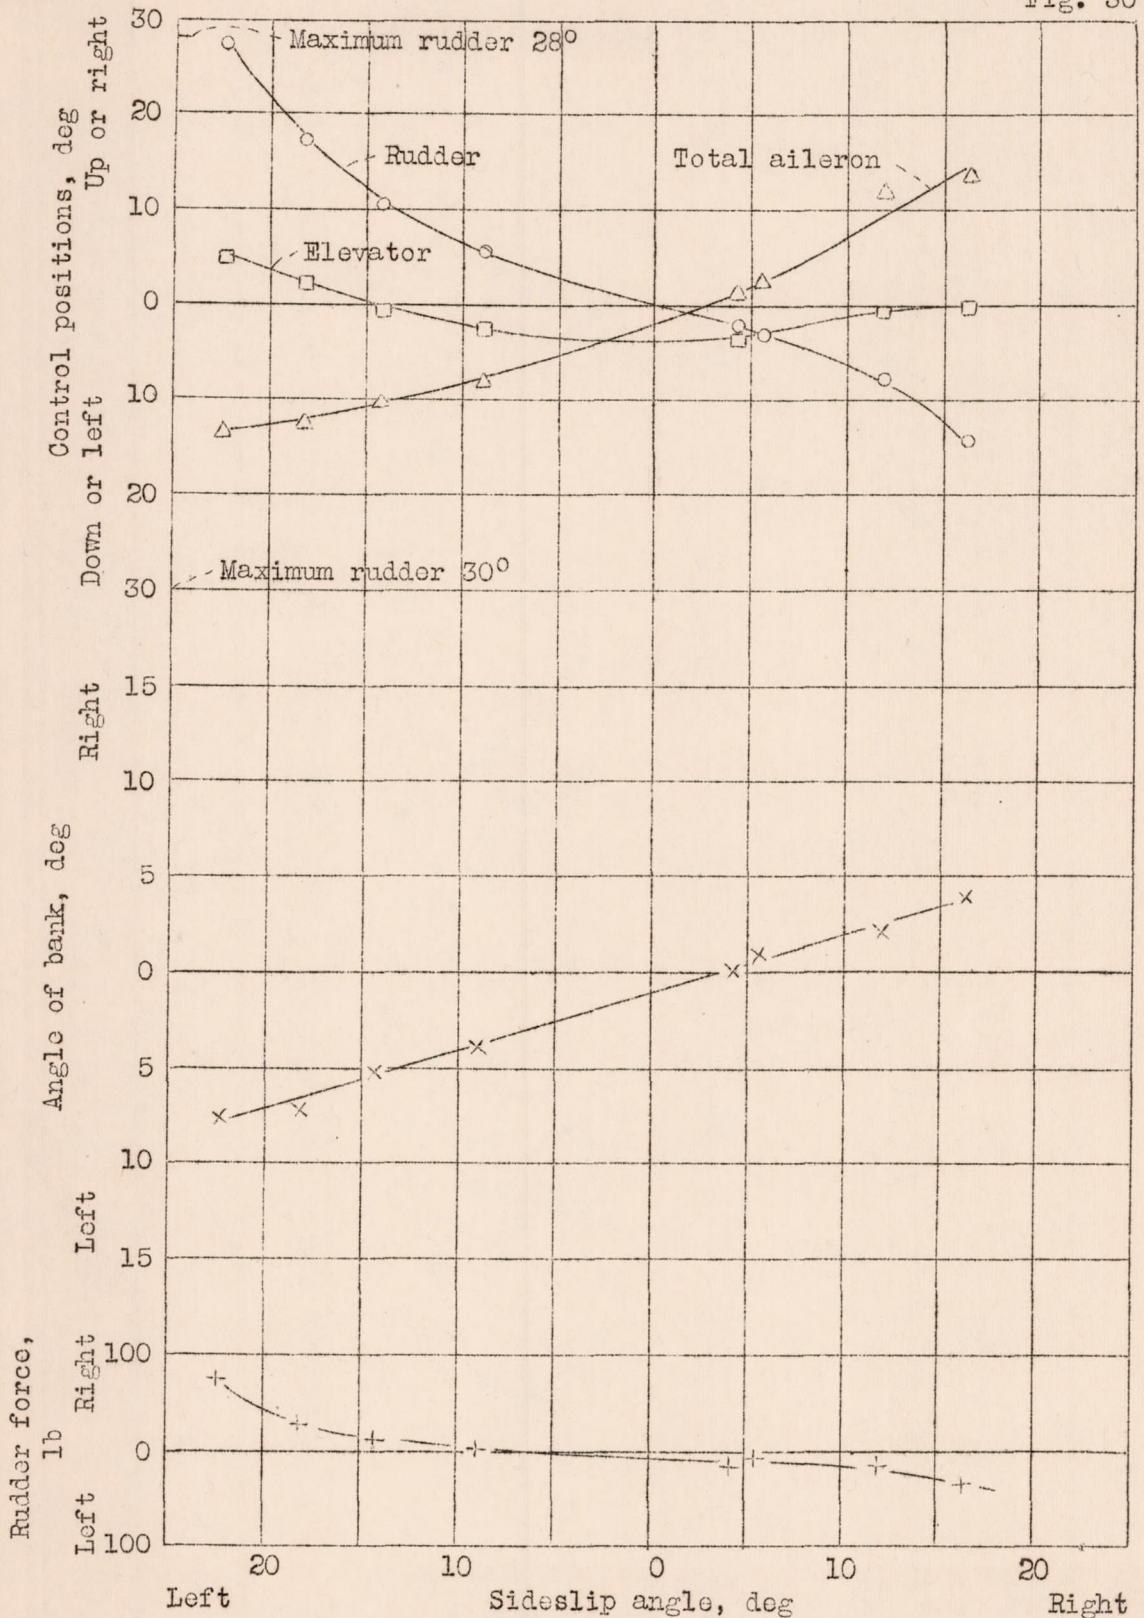
Figure 30.- Steady sideslip characteristics in the gliding condition (flaps up, gear up, power off) at 107 miles per hour. Supermarine Spitfire airplane.

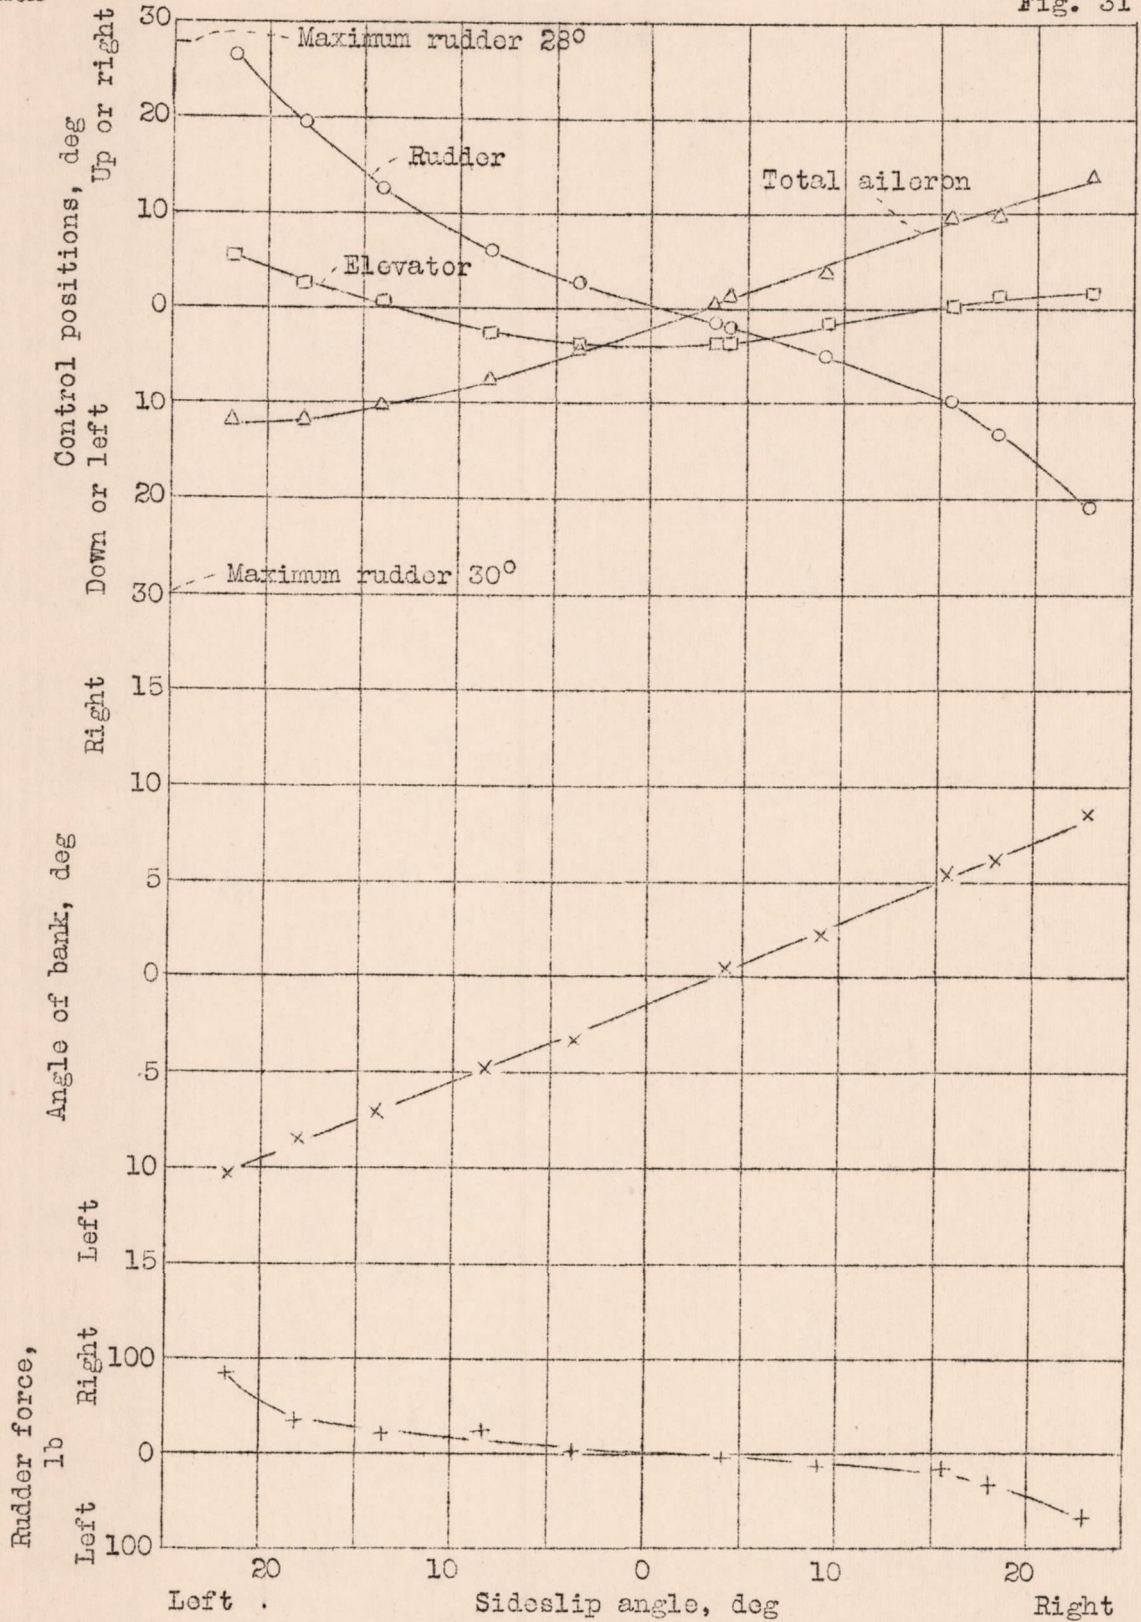
Figure 31.- Steady sideslip characteristics in the gliding condition (flaps up, gear up, power off) at 122 miles per hour. Supermarine Spitfire airplane.

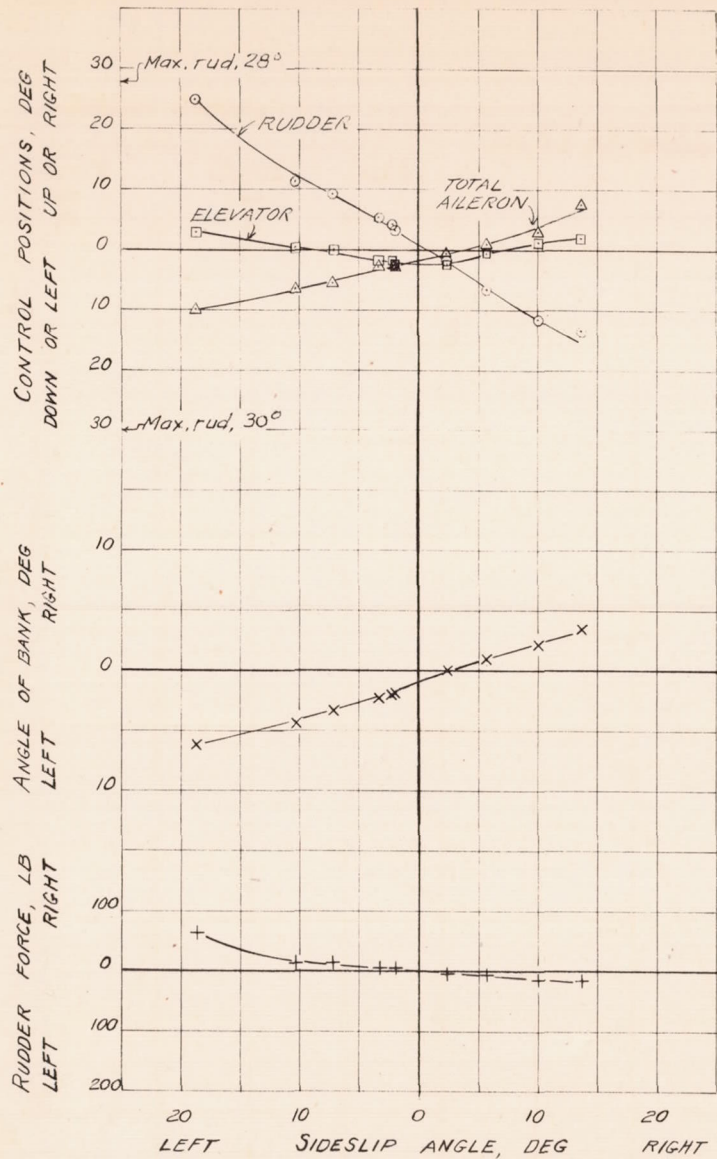
Figure 32. - Steady sideslip characteristics in the landing condition (flaps down, gear down, power off) at 95 miles per hour. Supermarine Spitfire airplane.

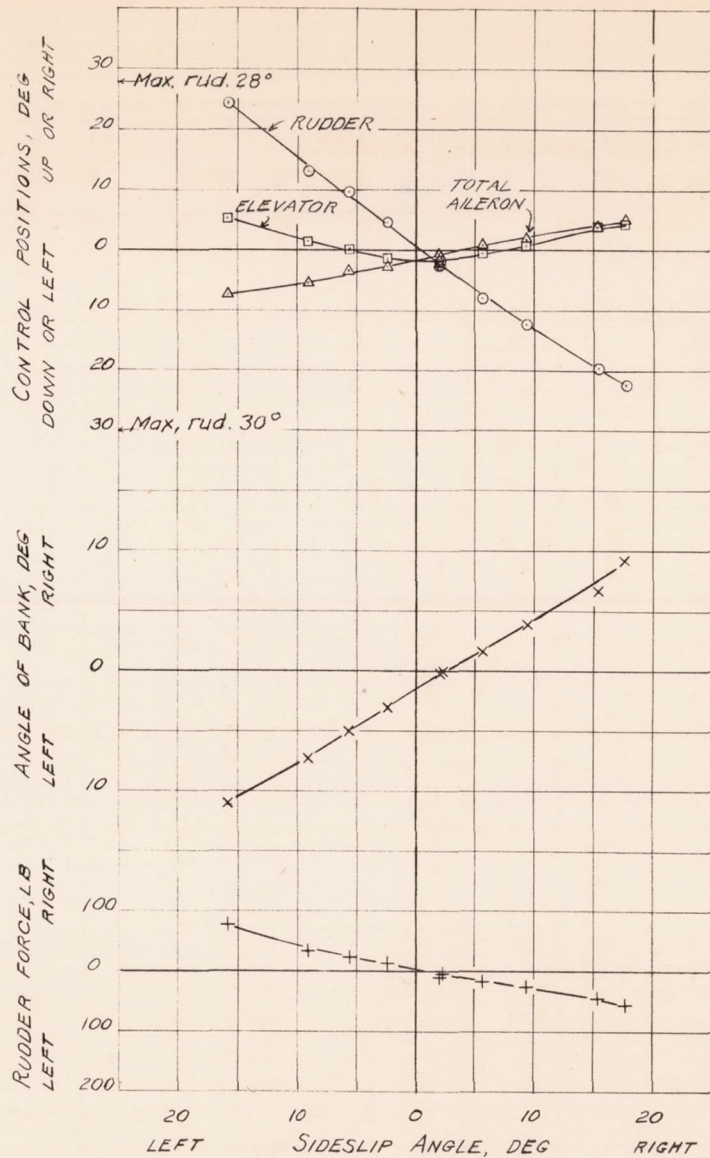
Figure 33. - Steady sideslip characteristics in the landing condition (flaps down, gear down, power off) at 124 miles per hour. Supermarine Spitfire airplane.

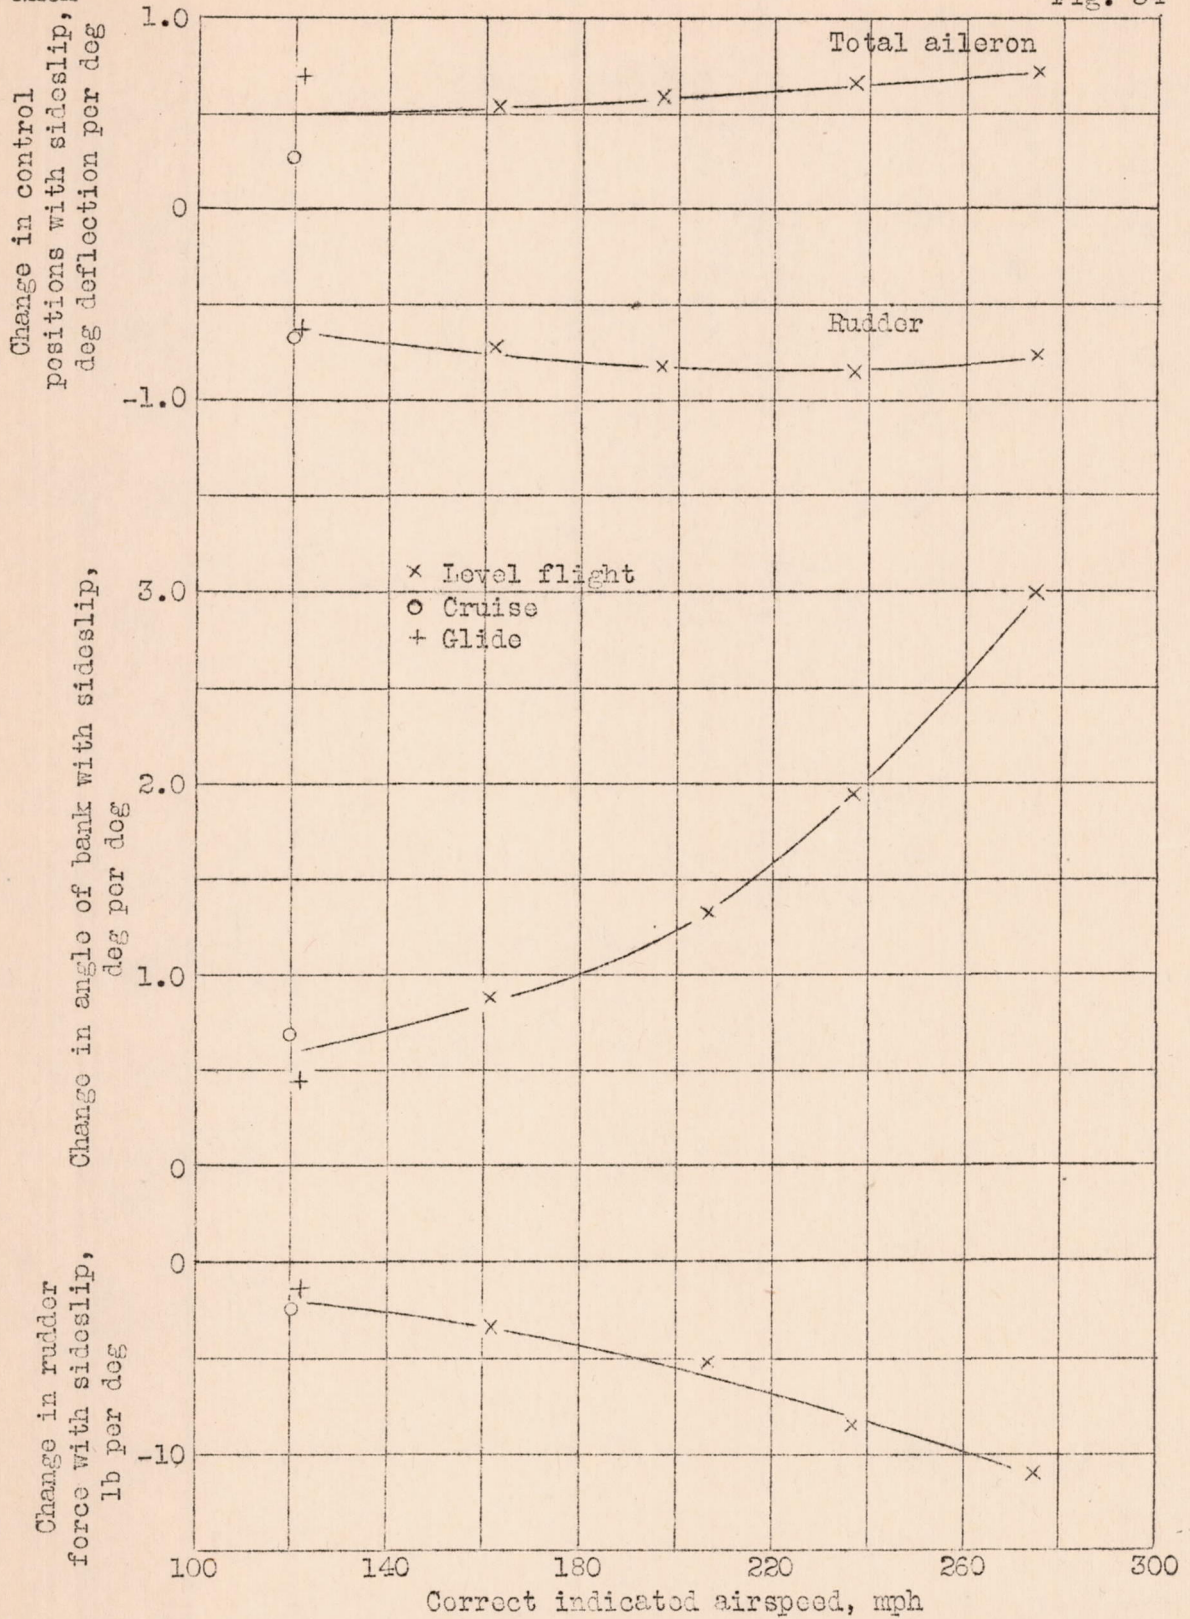
Figure 34.- Steady sideslip characteristics for small rudder deflections at various speeds in level flight with flaps and gear up, hood closed. Supermarine Spitfire airplane.

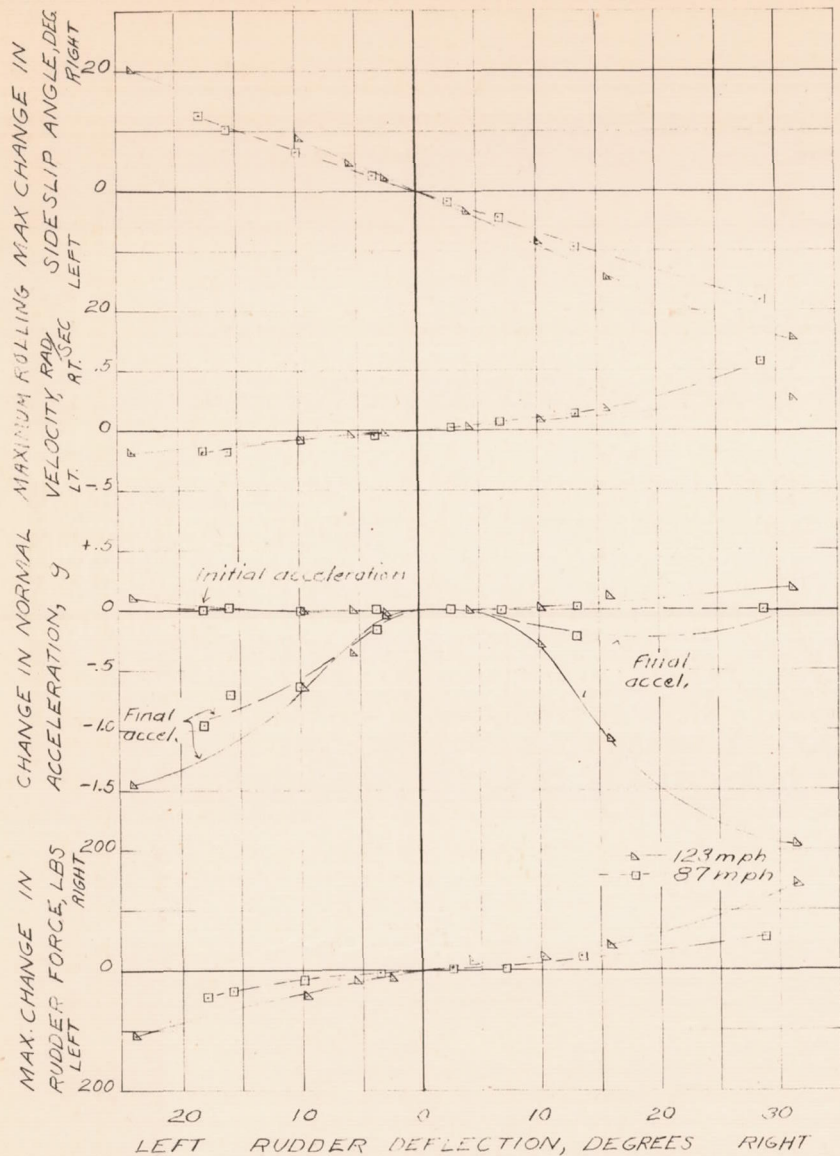
Figure 35. - Variation of maximum change in sideslip angle, rolling velocity, change in normal acceleration, and change in rudder force, with rudder deflection in abrupt rudder kicks in the landing condition. Supermarine Spitfire airplane.

A further indication of the rolling moment due to sideslip is given by the rolling velocities caused by abrupt deflections of the rudder (figs. 35 and 36). The airplane always rolled in the correct direction. The rolling moment due to yawing velocity is combined with that due to sideslip in these tests.

The initial values of rudder force in rudder kicks, plotted in figures 35 and 36, show that the rudder was desirably light. The floating tendency of the rudder caused the pedal force to drop to about one-third of its initial value after the sideslip had built up. No reversal of rudder force ever occurred, however. The requirement of reference 1, which states that left rudder force should always be required for left rudder deflections and right rudder force for right rudder deflections, was therefore satisfied.

The violence of the pitching motions of the airplane in rudder kicks is shown by the variation of normal acceleration with rudder angle (figs. 35 and 36). Because the large accelerations made it difficult for the pilot to hold the elevator angle constant, the normal acceleration plotted on these figures may be partly the result of elevator motion. Nevertheless, the plotted values give a qualitative idea of the pitching motions caused by rudder

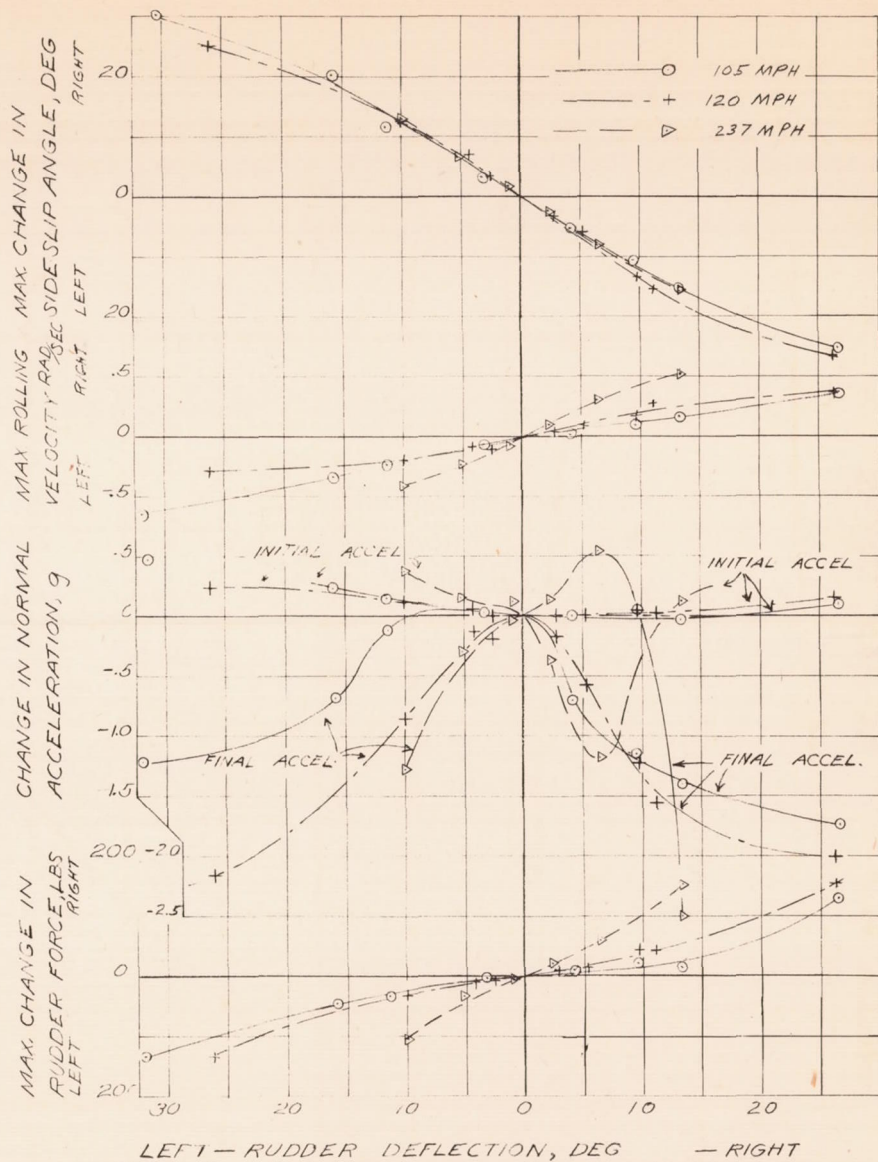
Figure 36. - Variation of maximum change in sideslip angle, rolling velocity, change in normal acceleration, and change in rudder force, with rudder deflection in abrupt rudder kicks in level flight. Supermarine Spitfire airplane.
