WARTIME REPORT

March 1946 as
Advance Confidential Report L6B21

FLIGHT INVESTIGATION AT HIGH SPEEDS OF PROFILE DRAG
OF WING OF A P-47D AIRPLANE HAVING PRODUCTION
SURFACES COVERED WITH CAMOUFLAGE PAINT

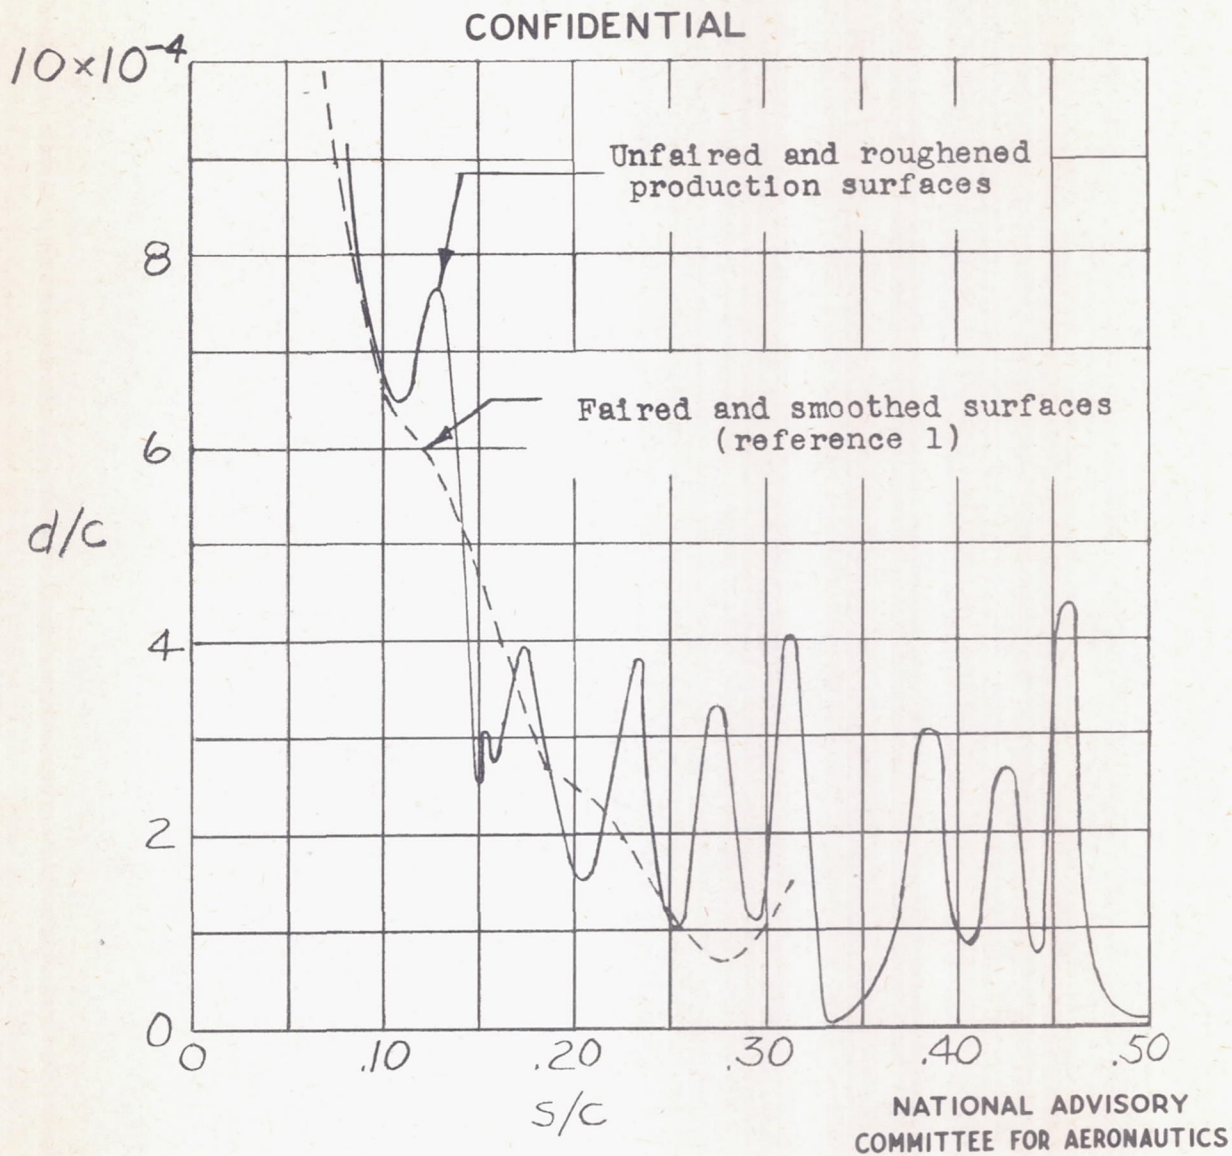
Figure 4.- Surface-waviness index of unfaired and roughened production surfaces and of faired and smoothed surfaces.

An indication of surface waviness was obtained by means of a curvature gage (fig. 2) with legs spaced 4 percent of the test section chord. The waviness condition of the unfaired and roughened production surfaces and also of the faired and smoothed surfaces of reference 1 is indicated in figure 4 by the plot of the waviness index d/c against s/c , where d is the deflection of the curvature gage, s is the distance along the surface from the leading edge, and c is the test section chord.

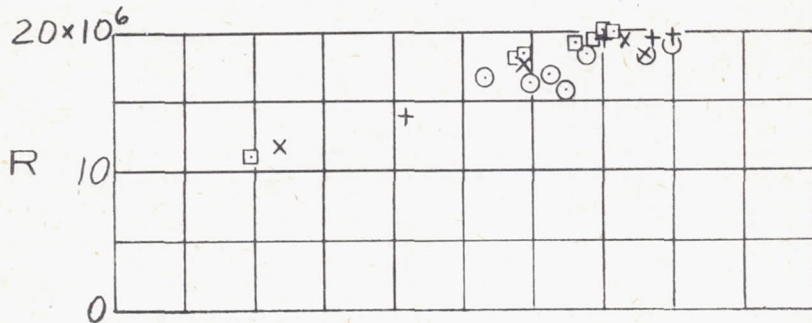
- C_L 0.16
- +— .25
- x— .33
- .40

Figure 5.- Profile-drag coefficient of P-47D wing section having production surfaces covered with camouflage paint. Reynolds number is plotted above drag curves.

Profile-drag coefficients selected for several lift coefficients for which the data were most complete are plotted against Mach number in figure 5. The corresponding Reynolds numbers are plotted above the profile-drag curves.

Figure 5 shows that the profile-drag coefficient decreased with lift coefficient and attained a minimum value of 0.0097 over a range of lift coefficients from at least 0.16 to 0.25 at Mach numbers below 0.67. The minimum value of the profile-drag coefficient of the faired and smoothed surfaces reported in reference 1 was 0.0062. At Mach numbers below that at which compressibility shock was evident, as indicated by the rapid increase in profile-drag coefficient, variation in Mach number of as much as 0.2 appeared to have no effect on the profile-drag coefficient. This variation in Mach number, however, was accompanied by an appreciable variation in Reynolds number, which may have had some effect on the results obtained. In the tests of references 1 and 2 variations in Mach number of as much as 0.16, with negligible variation in Reynolds number, had no effect on the profile-drag coefficient for the wing section with smooth surfaces and for the wing section with smooth and rough surfaces with transition fixed far forward.

In figure 6 the demarcation of flight conditions with respect to the presence or absence of shock losses in the wake is well defined. At lift coefficients of 0.10 and 0.50, shock was first indicated at Mach numbers 0.69 and 0.62, respectively. The first indications of shock in the wake as shown by figure 6 correspond to the beginning of the rapid increase in profile-drag coefficients in figure 5.

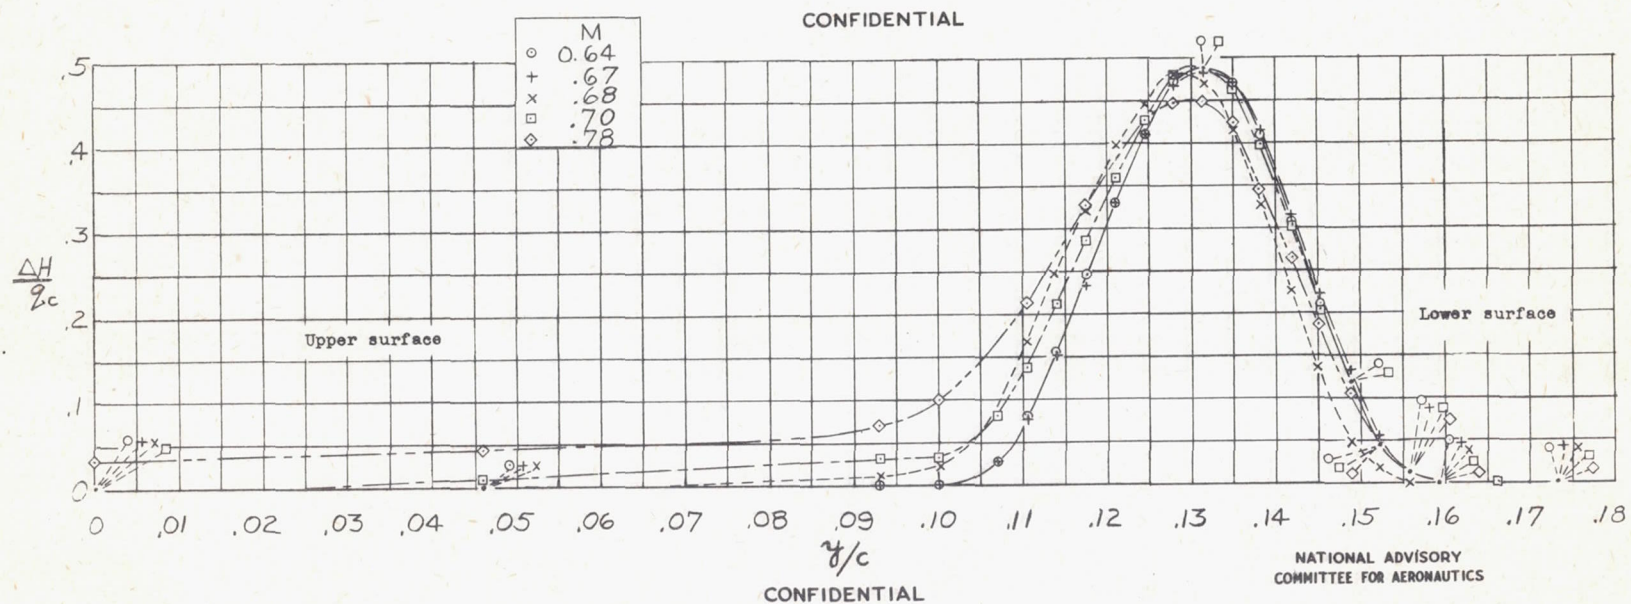
Figure 7.- Wake profiles at an airplane lift coefficient of 0.16 for several Mach numbers. (Position $\frac{x}{c} = 0$ corresponds to top tube in wake-survey rake.)

The flight Mach number and airplane lift coefficient at which compressibility shock losses became evident in the wake are shown by figure 6. The rapidly increasing width of wake with Mach number is shown in figure 7 as an indication of the presence of compressibility shock losses in the wake. In this figure the total-pressure loss across the wake is presented for several Mach numbers at a lift coefficient of about 0.16 as a plot of $\Delta H/q_c$ against y/c , where ΔH is the loss in total pressure at position y in the wake, q_c is the free-stream impact pressure, and c is the chord of the wing section. (Position $y/c = 0$ corresponds to the top tube of the rake.) Wake profiles for Mach numbers 0.64 and 0.67 showed no evidence of shock, but profiles for Mach numbers 0.68, 0.70, and 0.78 indicated shock of increasing intensity on the upper surface.
