EFFECTS OF THERMAL AND MOISTURE CYCLING ON THE
INTERNAL STRUCTURE OF STITCHED RTM LAMINATES *

Jeff Walker
Douglas Aircraft Company
Long Beach, CA

Lance Roundy
McDonnell Aircraft Company
St. Louis, MO

Jon Goering
McDonnell Aircraft Company
St. Louis, MO

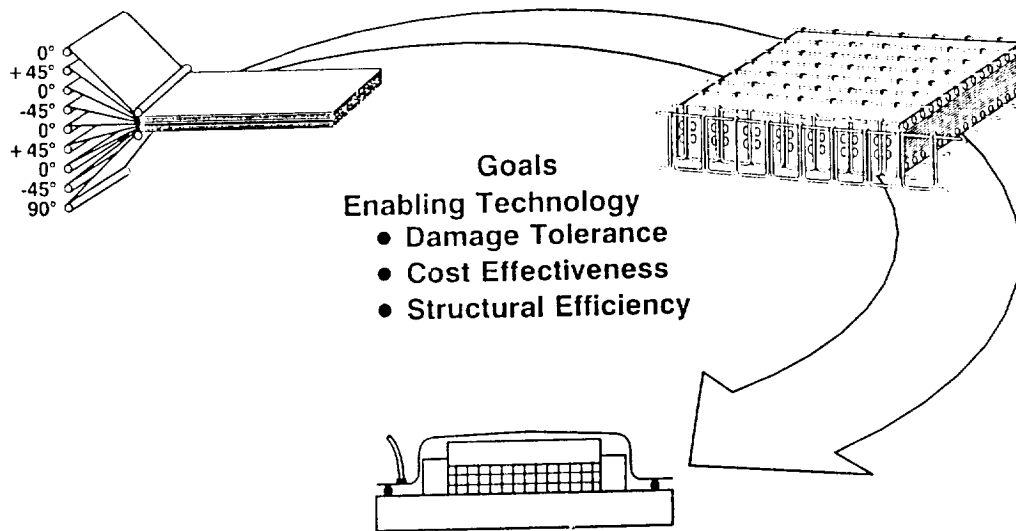
Figure 1. Process Overview

Stitching of dry fiber preforms followed by RTM processing holds attractive potential for transport wing structure

The NASA Innovative Composite Advanced Primary Structure (ICAPS) program has utilized Z-axis stitching to increase damage tolerance and stabilize and compact dry fiber preforms. These preforms are then impregnated with resin using the resin transfer molding (RTM) technique or autoclave resin film infusion (RFI) (Figure 1).

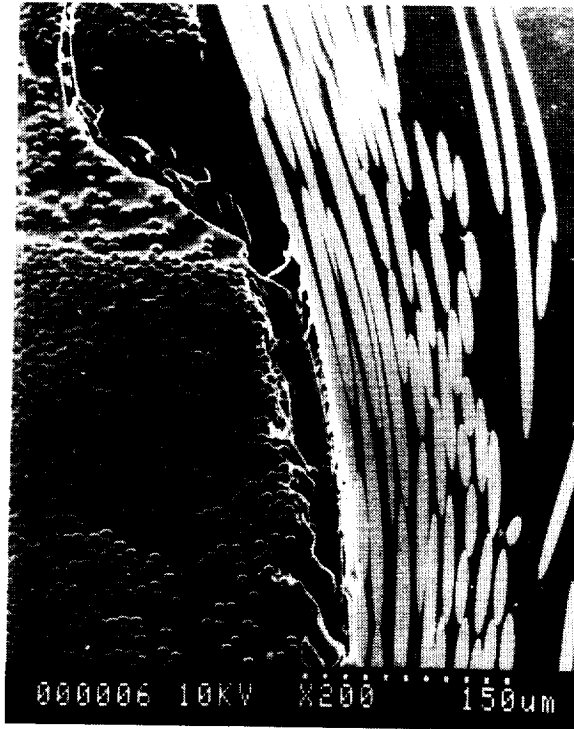
Figure 3. Resin Cavities at Thread

- Resin separation cavities -- These areas appear to form before the epoxy matrix has completely set-up as seen by the smooth fracture surfaces (Figure 3). These voids may be formed due to the resin shrinking away from the surface of the thread during cure.
- Matrix cracks -- These cracks appear to be traditional fracture surfaces created after the resin has hardened. They are most often found at the ends of the separation cavities and propagate into a resin-rich area either inter- or intraply.

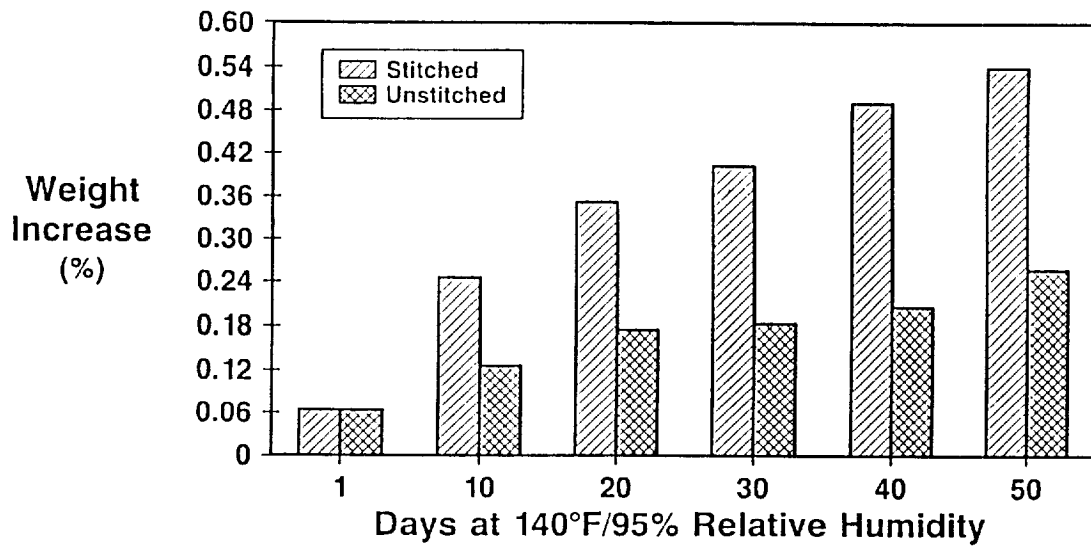
Figure 4. Weight Gain Study

A possible variable in predicting resin cracking is the effect of moisture. If voids and cracks exist around the stitching thread, water could permeate into the laminate and be absorbed into the resin matrix, which could cause fracture propagation during freeze/thaw cycles. A weight gain study (Figure 4) was carried out using 0.325 inch thick wing skin stiffened panels. The control specimens were nonstitched panels with stiffeners secondarily bonded. The stitched specimens were sections from wing element panels fabricated using the resin film infusion method. In each case, the resin system used was Hercules 3501-6 with AS4 fiber.

The specimens were weighed and then placed in a 140°F oven at 95-percent relative humidity. The data show that the stitched panels pick up moisture at twice the rate of the unstitched panels. It is important to note that the 0.54-percent increase in weight is not considered excessive, but the test was only run for 50 days because of an equipment malfunction. This was not enough time for the samples to reach complete saturation, but it is clear that a surface seal coat may be required to protect Z-axis stitched parts in service environments. An unstitched laminate usually reaches moisture equilibrium with a weight increase of approximately 1-percent. This experiment will continue until a saturation level is reached in the stitched specimens.

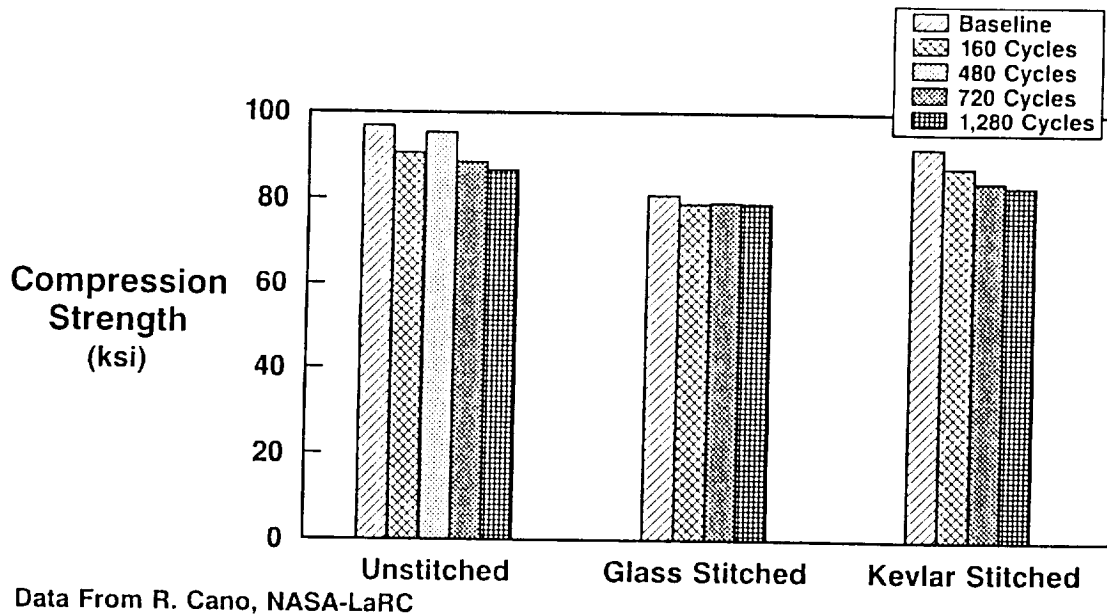
Figure 6. NASA Compression Data

Work done under NASA contract by Roberto Cano at LaRC (Ref. 1) showed that compression strength was not substantially affected by cycling between hot/wet and cold environments (Figure 6). The data supports the conclusion that strength knockdowns occur initially during cycling but do not continue to decrease substantially over time.

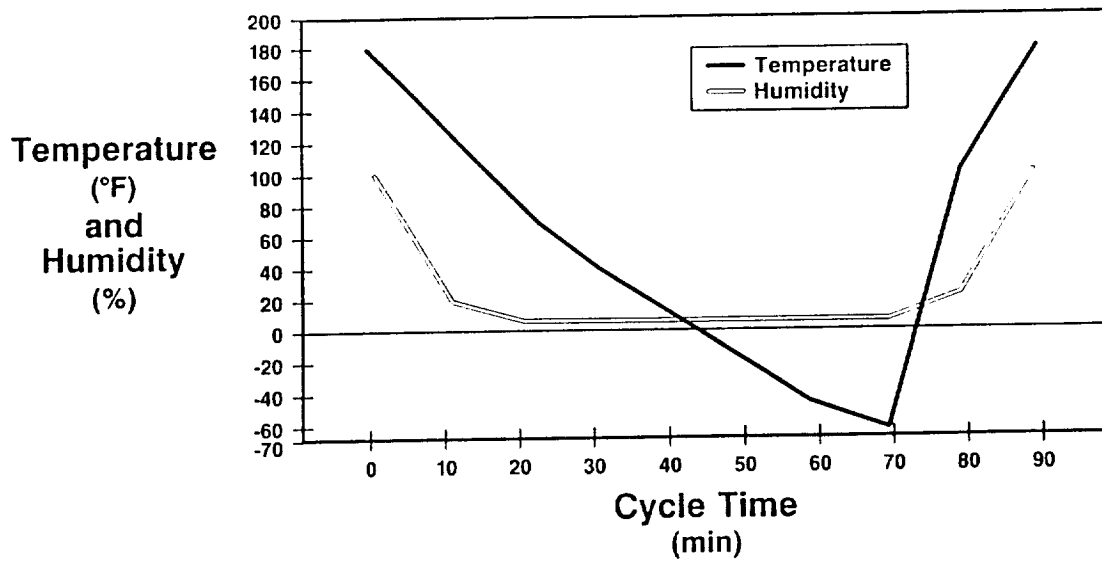
Figure 7. Enviromental Cycle

The cycle (Figure 7) requires 90 minutes to complete and simulates a worst-case environment for the aircraft. Specimens will be examined after 10, 100, and 1,000 cycles, and surface crack density will be compared to service parts to establish cycle-to-flight ratios.

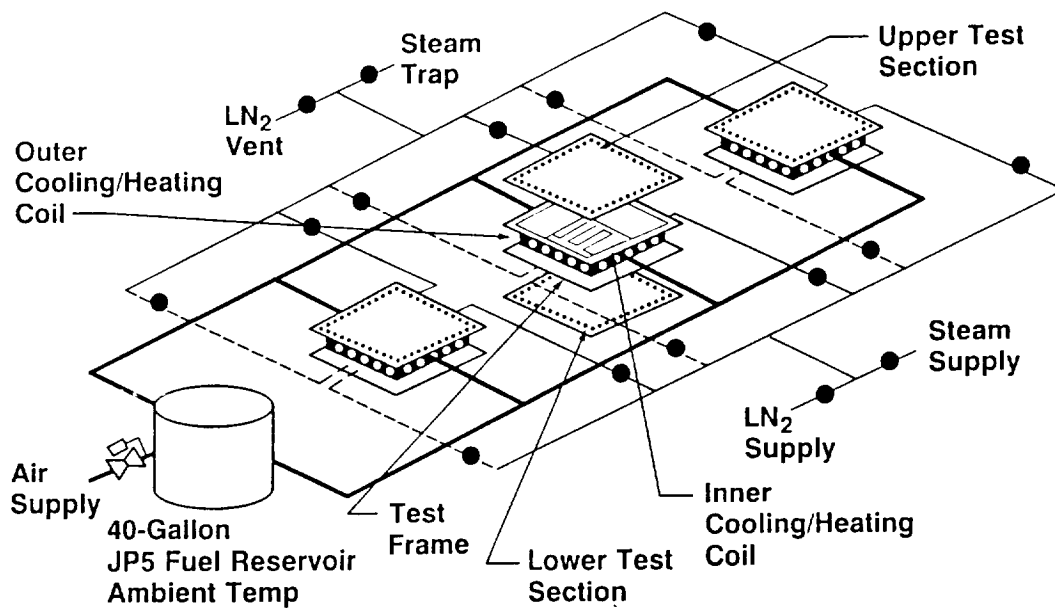
Figure 9. Fuel Leak Test Set-Up

A MCAIR chamber designed to environmentally cycle test coupons while exposing them to JP5 fuel under pressure will be used to evaluate post impact leakage (Figure 9). The specimens will be coated on the surface opposite the impact with Chemglaze® or polysulfide sealer per production process standards. The coupons will then be impacted to the threshold level of visible damage (~ 35 foot-pounds), C-scanned, and subjected to the pressurized fuel. Fluorescent dye added to the fuel will help detect the degree of penetration into the damaged laminate.

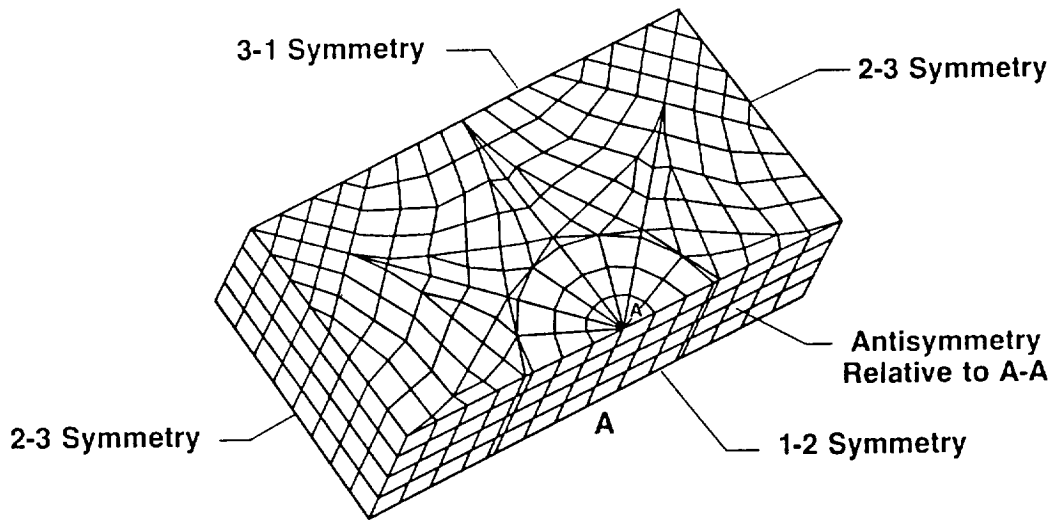
Figure 13. MCAIR 3D Model

The MCAIR model utilizes three dimensional solid brick elements to explicitly model each ply of the laminate. The mesh for this model is based on the intersections of the matrix pockets in 0, 90, and ± 45 degree plies. A generic mesh for a single ply, regardless of orientation, has been developed. This mesh includes all possible matrix pockets, and can be used for any ply by specifying that matrix properties be used for elements in the appropriate pocket, and that lamina properties be used for elements in all other areas. Since the same mesh is used for all plies, a laminate model is built by stacking the required number of ply models (Figure 13). Symmetry conditions are used at the mid-plane of the laminate, and anti-symmetry conditions are used along a plane through the centerline of the stitch to reduce the size of the model to one-fourth of the actual RVE.

MCAIR modeling encompasses through-the-thickness effects,
utilized to ensure the accuracy of the previous models
