Bidirectional Brush Seals

Prepared for the
Turbo Expo '97
sponsored by the American Society of Mechanical Engineers
Orlando, Florida, June 2-5, 1997

BIDIRECTIONAL BRUSH SEALS

1. AGENCY USE ONLY (Leave blank)		2. REPORT DATE January 1997		3. REPORT TYPE AND DATES COVERED Technical Memorandum
4. TITLE AND SUBTITLE Bidirectional Brush Seals			5. FUNDING NUMBERS WU-233-1B-1B

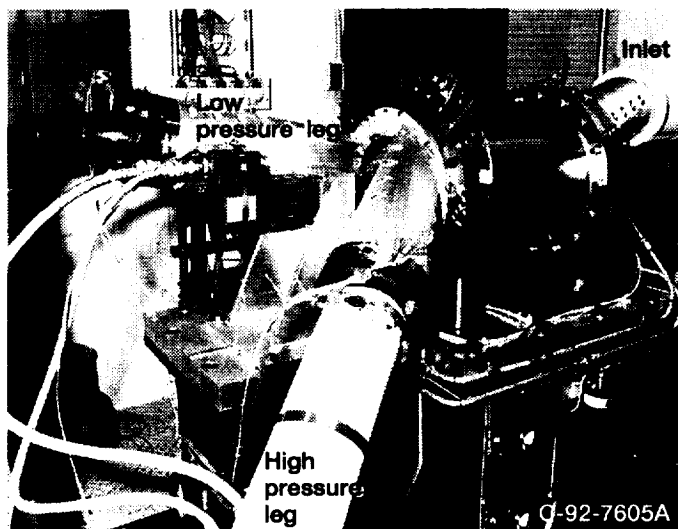
Figure 1.—Wave rotor test rig.

A photograph of the wave rotor test rig illustrates the nature of a three-port flow divider (figure 1). There is a single inlet flow, which is separated into two outlet flows, one at higher stagnation pressure than the inlet, and the other at lower stagnation pressure. The gas flow inlet is at the upper right of the photograph and the low pressure fluid exhausts

out the duct in the middle left part of the photograph. The high pressure air exhausts from the duct in the center. The rotor itself is a cylinder with axially aligned passages on its circumference. As a passage rotates, the pressure at the ends of the passage fluctuates between the high and low pressures. The cavity surrounding the rotor will be at a pressure close to the inlet pressure. Leakage will take place from the passage to the cavity when the passage is at high pressure and from the cavity to the passage when the latter is at low pressure. Thus the seals must be capable of withstanding pressure reversals with the corresponding flow reversals.

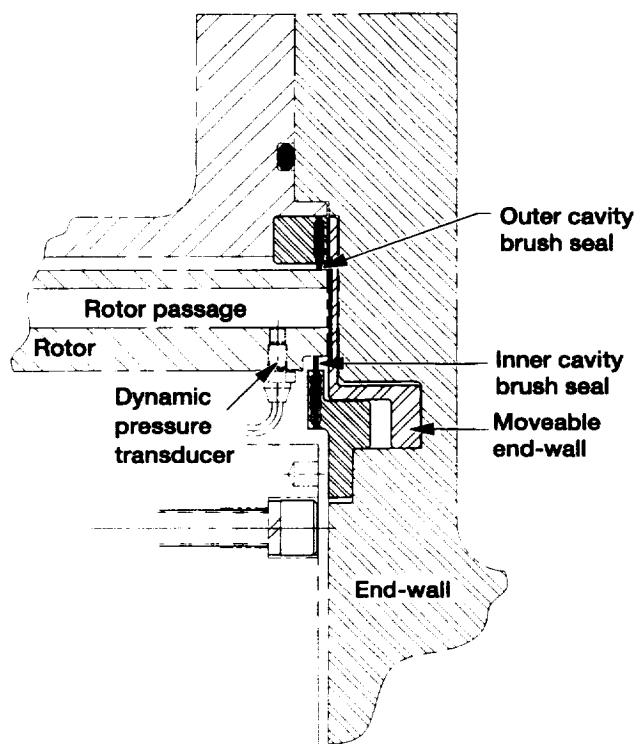
Figure 2.—Rotor cross section.

A cross-sectional view of the rotor (Fig. 2) illustrates the cavities and placement of the brush seals. The rotor passage represents that portion of the rotating cylinder containing the working fluid while the inner and outer cavities constitute potential paths for leakage. The movable end wall establishes a gap between the rotor/stator interface and to some extent controls the cavity volumes at the seal-rotor-stator interface.

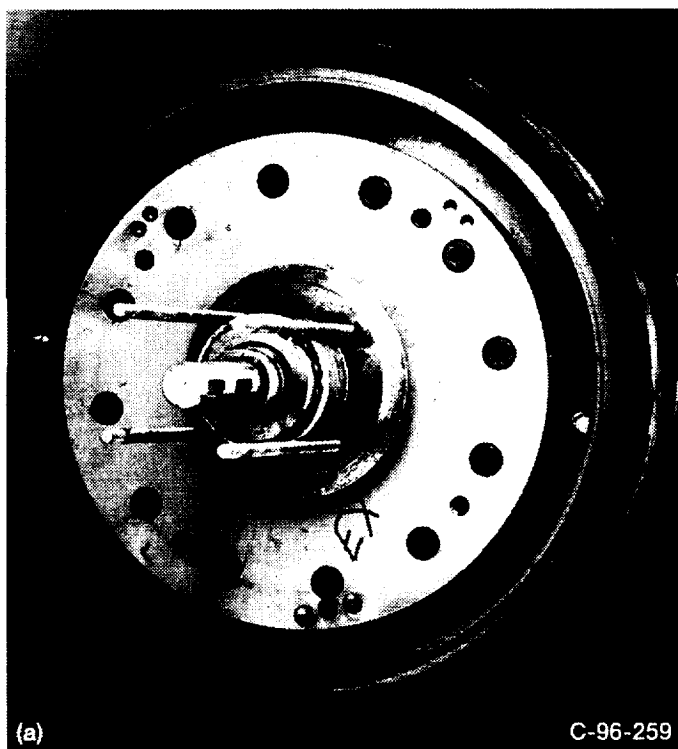
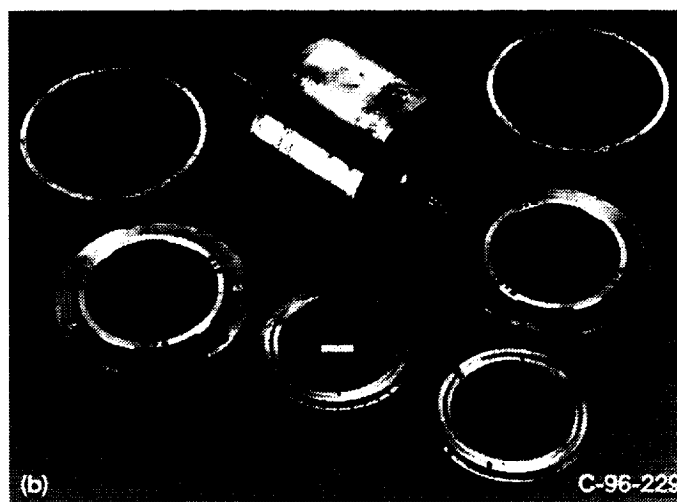
Figure 3.—(a) View of 60-passage rotor configuration. (b) Rotor, end flanges, and bush seals.

There are sixty (60) 0.54-in. wide passages spaced about the circumference of the rotor, Fig. 3(a). As the rotor turns the pressure at each end of the passage varies with the highest pressure being about 3 to 4 times that of the lowest. The cavity pressure is nearly the average of the two. The rotor, seals and end plates are illustrated in Fig. 3(b). The function of the seals is to prevent leakage from the cavities into the rotor passage and vice versa (Fig. 2). The leakage may be thought of as composed of radial and circumferential components. Circumferential leakage is from passage to passage where the pressure differences are not large, so this leakage is believed to be less important than radial leakage. While this circumferential leakage could have been moderated somewhat by swirl brakes, only the brush seals were considered, which had little effect on the circumferential leakage. Radial leakage is from a high pressure passage into the cavity, and then from the cavity back into a low pressure passage. By blocking the path from the passages into the cavity brush seals can reduce the radial leakage.

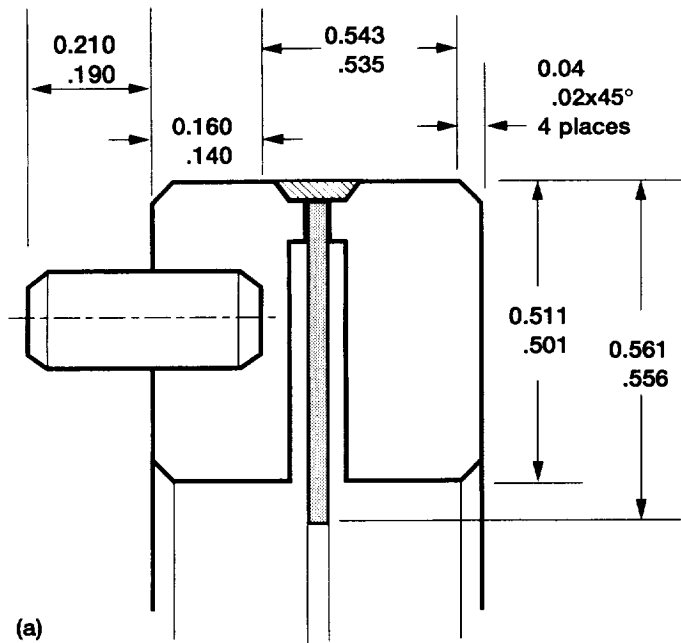
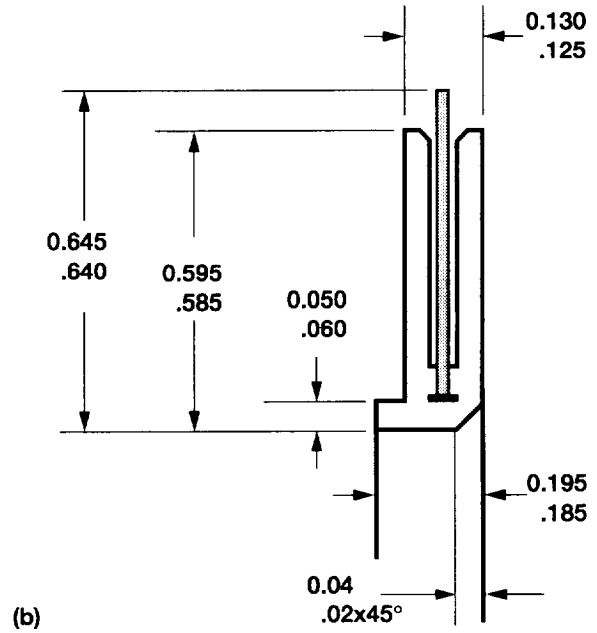
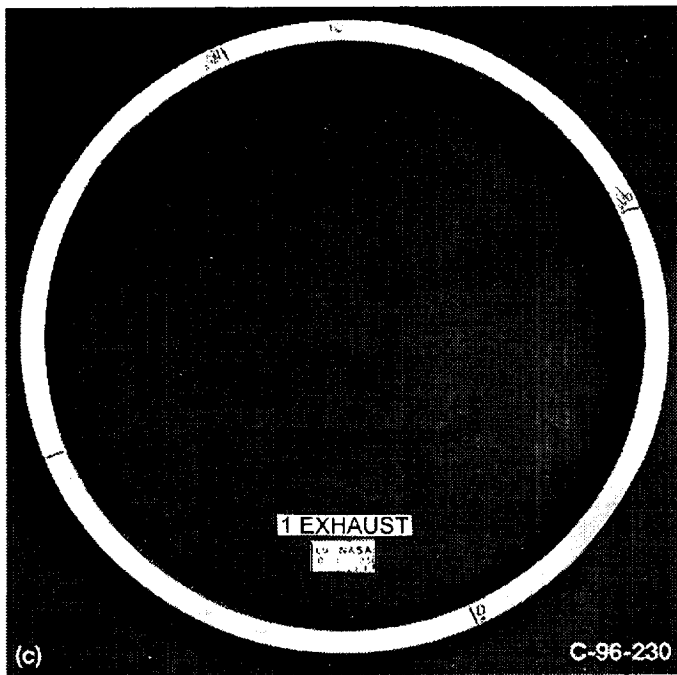
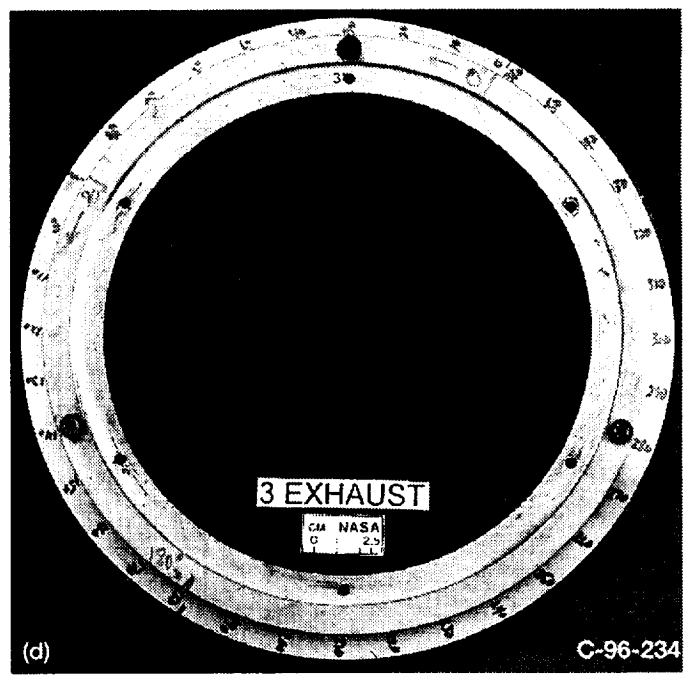
Figure 4.—Details of the seal cross section and photographs of brush seals taken after testing. (a) Outer brush seal cross section. (b) inner brush seal cross section. (c) OD seal. (d) ID seal.

Figure 4(a) OD seal and Fig. 4(b) ID seal, illustrates the cross section views. The brush was otherwise of standard Cross Mfg. Co. construction. The bristles were 0.0028-in. diameter Haynes 25 AMS 5796 28, at angles 40 to 50° to the interface and inclined in the direction of rotation with suitable antirotation pins (Fig. 4). The rotor inner seal

radius was nominally 5.518-in. (5.5167 left and 5.5192 right) after testing and the rotor outer seal radius was nominally 6.380-in. (6.3747 left and 6.3803 right) after testing. In each case 0.010 inch radial interference was built into the as manufactured seal.

Photographs of the OD seal and ID seal are Figs. 4(c) and (d) respectively. The photographs shown herein were taken after the wave rotor testing was completed. Figures 4(e) and (f) represent a closer look at the bristle interfaces. Figures 4(g) and (h) illustrate a sharp view of the 0.028-inch bristles protruding from the seal fence (the fence is the same on both sides, see Figs. 4(a) and (b), and Figs. 4(i) and (j) represent the direct view of the brush bristle interface for the OD and ID seals respectively. As can be seen, the brushes are in good condition, with the exception of a tuft pullout in one location of the ID brush that can be seen in Fig. 4(h).

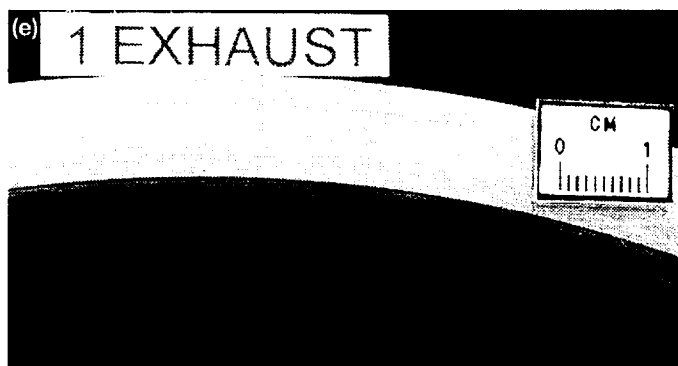
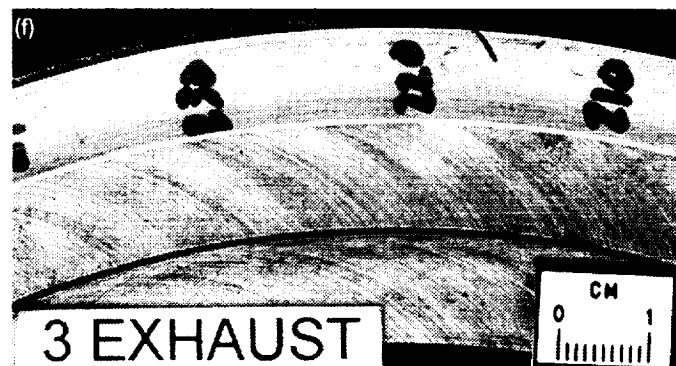
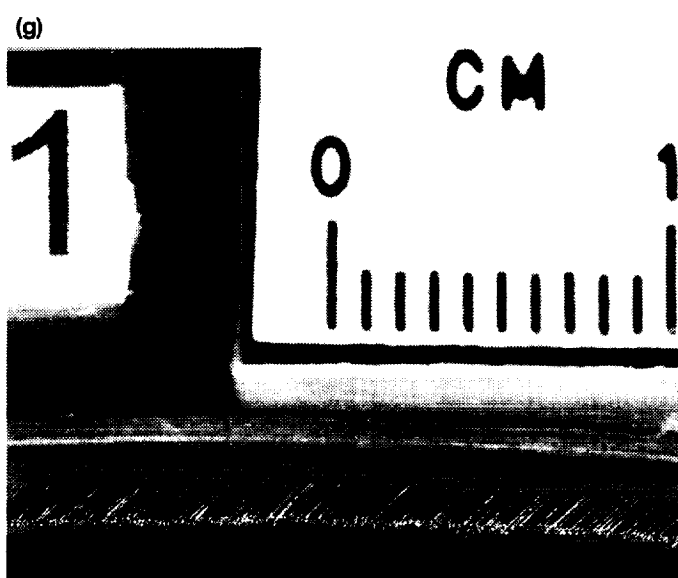
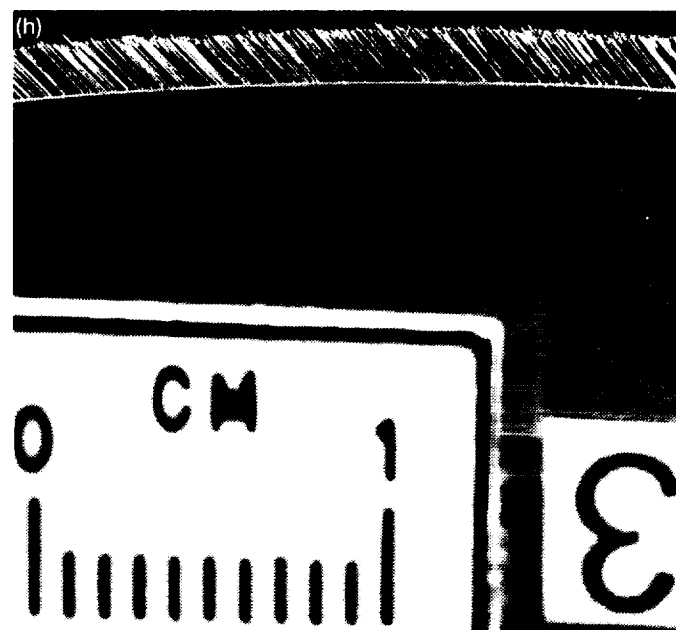
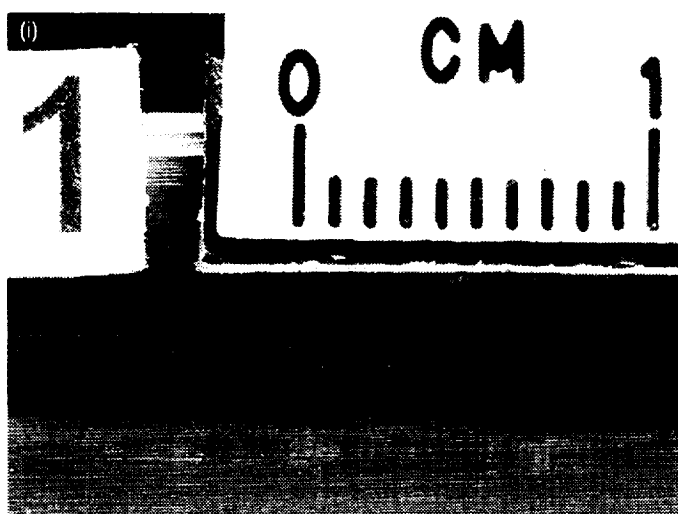
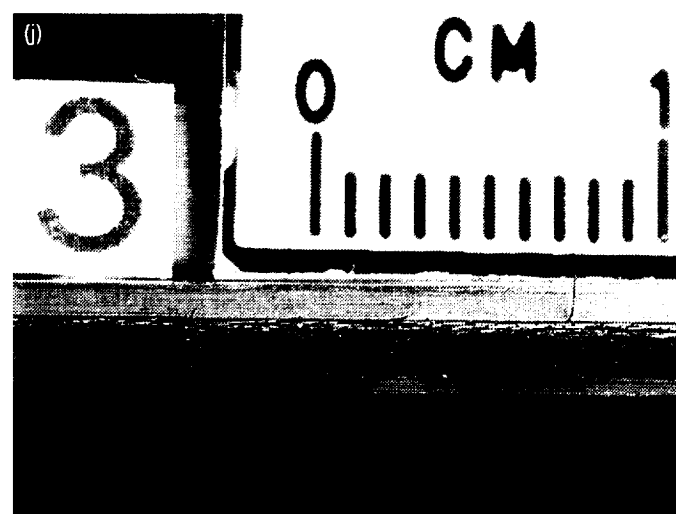
Figure 4.—Concluded. (e) OD seal close up. (f) ID seal close up. (g) OD seal bristles and side plate fence. (h) ID seal bristles and side plate fence. (i) OD seal, view of bristle tips. (j) ID seal, view of bristle tips.

The brush seals were installed by rotating them into position (i.e., in a direction opposite to the rotor rotating direction) and suitable static "O"-rings provided the necessary static seals. The rotor was torqued by hand to set the bristles, followed by a set of break in runs where the speed was incremented 1000 to 7500 rpm at nominal 1 hr intervals (10 hr) no heat and a similar schedule at 120 °F inlet temperature (7.5 hr) with 5 hr additional for 22.5 hr wear-in of the bristles. Once the bristles were set and rubbed into place a borescope examination of the bristles revealed the characteristic powder debris in flow stagnation regions with the remainder being swept away with the flow. Some bristles strayed beyond the pack with those of the inner seal being most susceptible. The photographs, Figs. 4(c) to (j), show little evidence of unusual bristle dispersion with the exception of Fig. 4(h).

While the bristles wore significantly, and some tufts were disheveled to the point of permitting rivering, Figs. 4(i) and (j), both sets of brushes did not appear to deteriorate further with time, albeit, the testing time was 19 hr 54 min and not thousands of hours operating at nominal interferences of 6 and 9 mils (radial) for the OD and ID brush seals respectively.

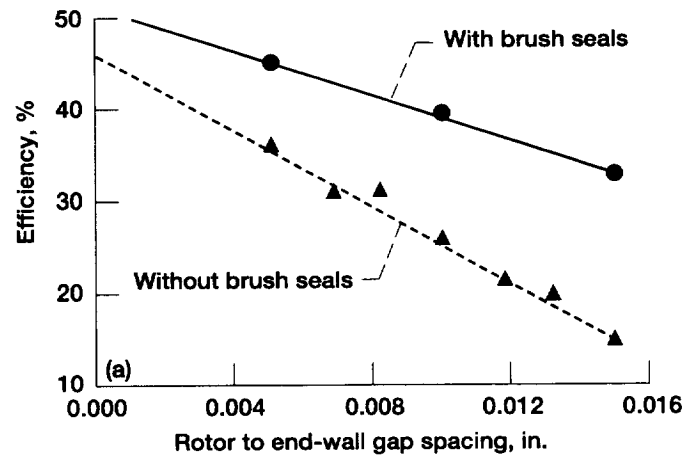
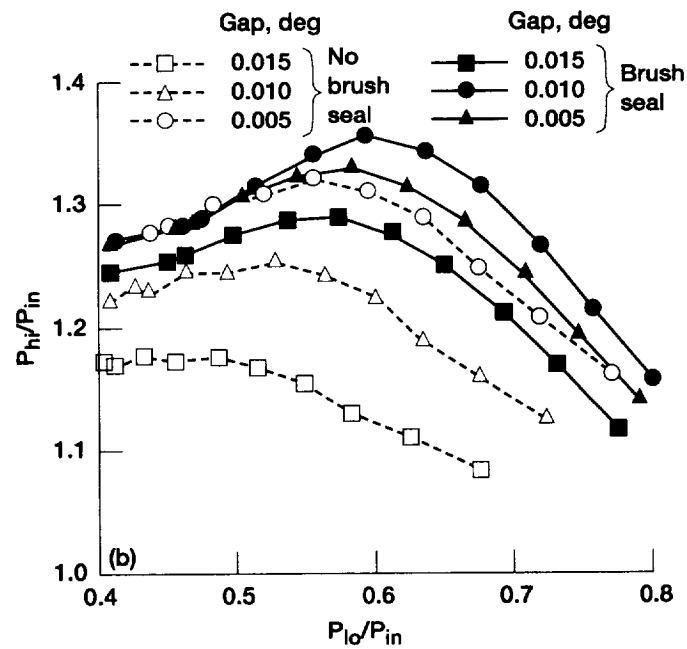
Figure 5.—(a) Efficiency vs gap for the wave rotor with and without brush seals. (b) High pressure/inlet pressure ratio vs low pressure/inlet pressure ratio with rotor to end wall gap as a parameter.

The wave rotor efficiency as a function of the size of the gap between the end wall and the rotor, for $\beta = 0.37$, and $P_{lo}/P_{in} = 0.6$, is illustrated in Fig. 5(a). It can be seen that the brush seals were effective in increasing efficiency. The mass leakage is approximately proportional to gap size, and in the experiment, the gap size was altered and the associated wave rotor efficiencies measured. To enable a direct comparison, tests were run with and without the brush seals.

The performance of a three port wave rotor is typically described by plotting P_{hi}/P_{in} versus P_{lo}/P_{in} . Such a plot is shown in Fig. 5(b), again for $\beta = 0.37$. The maximum efficiency occurs at roughly $P_{lo}/P_{in} = 0.6$. Again, this figure shows that use of the seals did result in higher pressures, with a corresponding increase in efficiency. On the average, the brushes diminished the leakage by a factor of 2. At a large gap spacing, the brush seals have a very pronounced effect. However, at small spacings, there is less of an effect on efficiency and pressure.

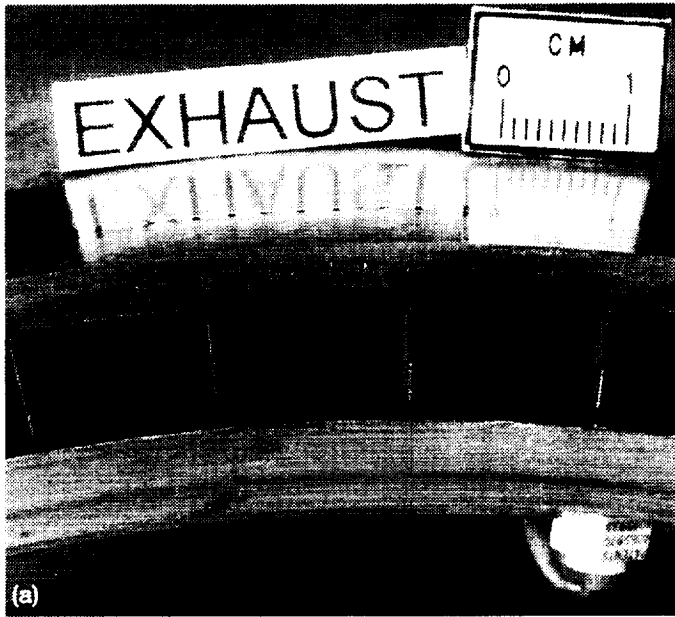
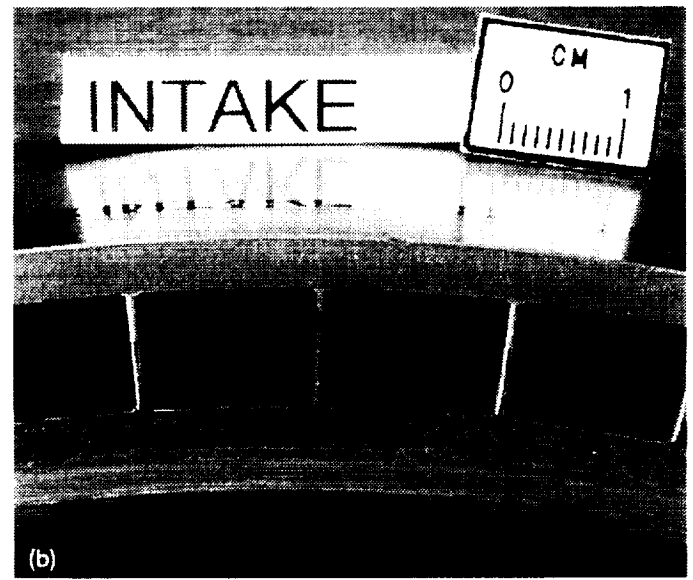
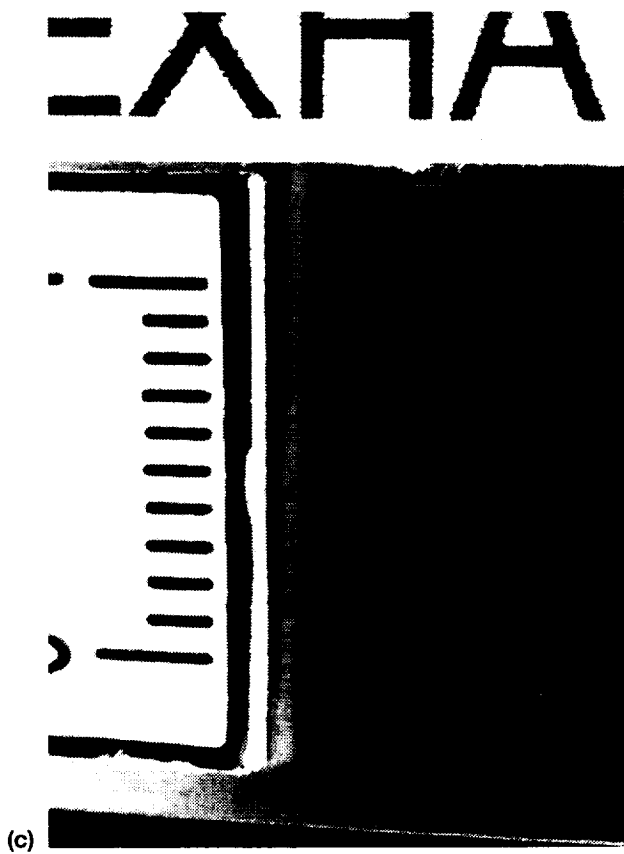
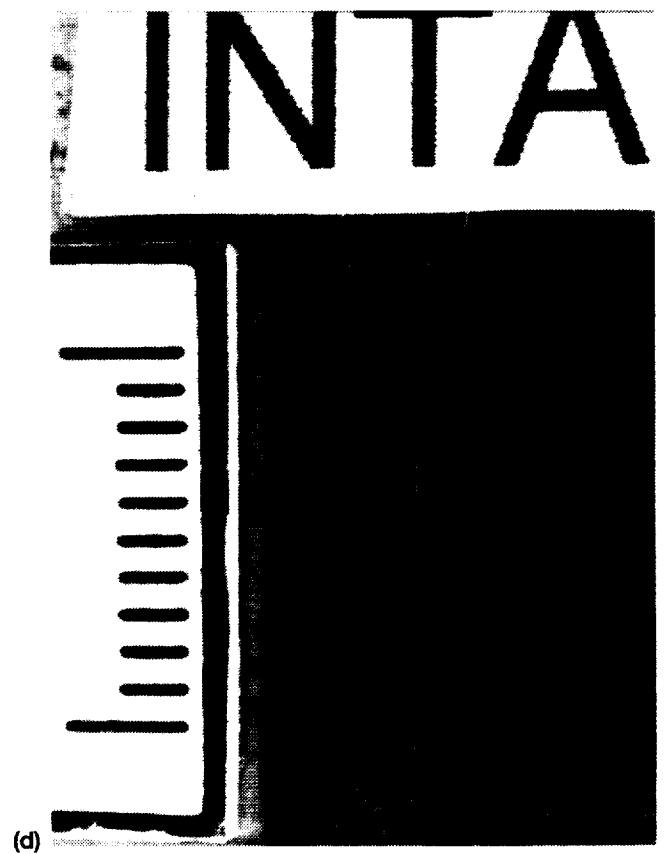
Figure 6.—(a) OD seal wear track seen as polished surface, exhaust side. (b) OD seal wear track seen as polished surface, inlet side. (c) Wear track closeup, exhaust side. (d) Wear track closeup, inlet side.

Attempts to quantify the surface wear were unsuccessful. From surface measurements we know, however, that the CrC interface coating wore less than 0.001-in., on all four interfaces. Optically however, polishing/ burnishing of the interfaces could be readily observed, Fig. 6(a) shows the polished track on the OD of the exhaust side and Fig. 6(b) shows the track on the inlet side. A closer examination of these tracks reveals "skipping" or changes in hardness which may represent tool marks of the parent machining operation or changes in the CrC coating. In Figs. 6(c) and (d), these types of marks are seen as bands extending beyond the brush wear path implying a precondition of the surface by machining. Figure 6(d) shows "spottiness" of the surface that may be related to bristle wearing. Figures 7(a) to (c) show similar patterns. No definitive tests were undertaken during the break-in stage or during the

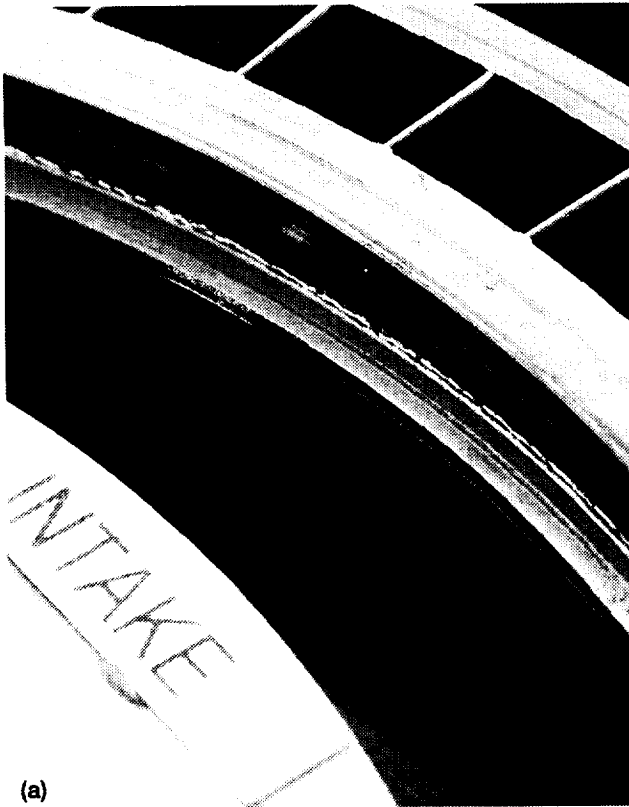
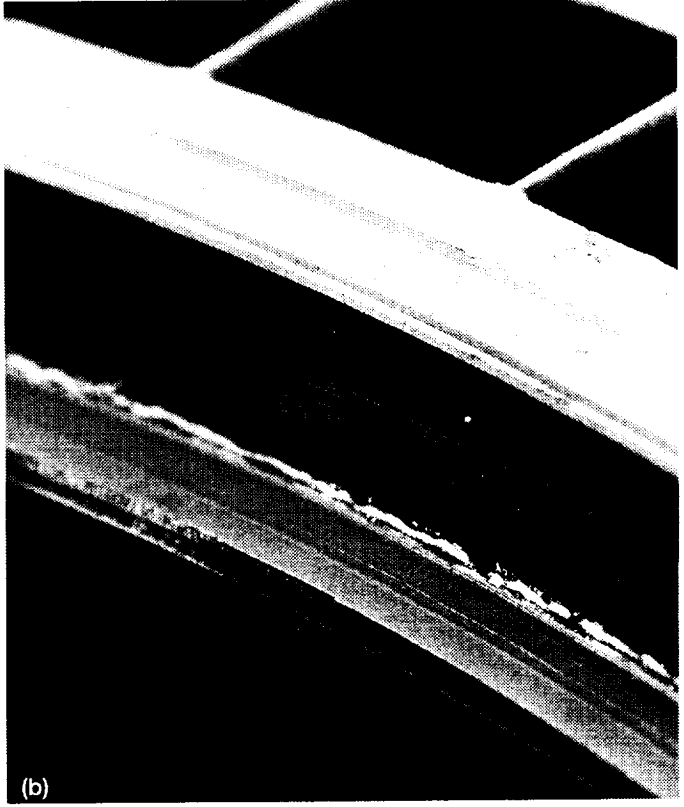
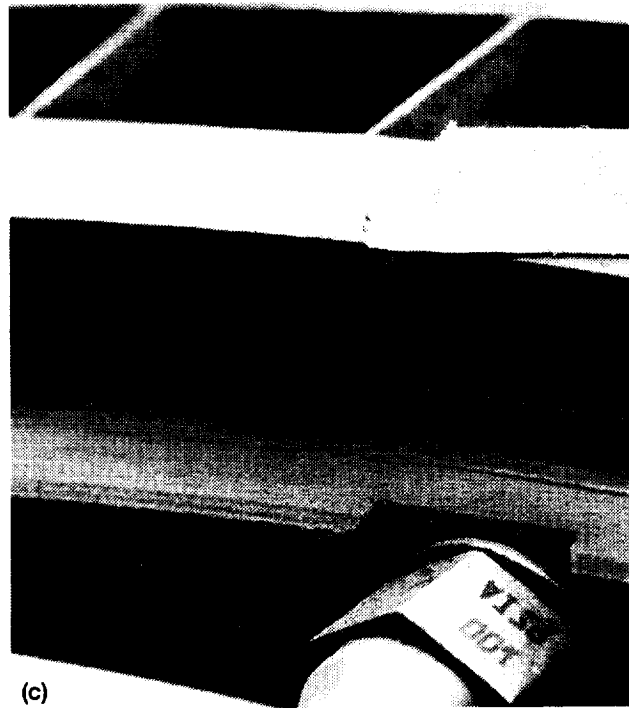
Figure 7.—(a) ID seal wear surface. (b) ID seal wear surface band marks. (c) ID seal "spotty" surface.

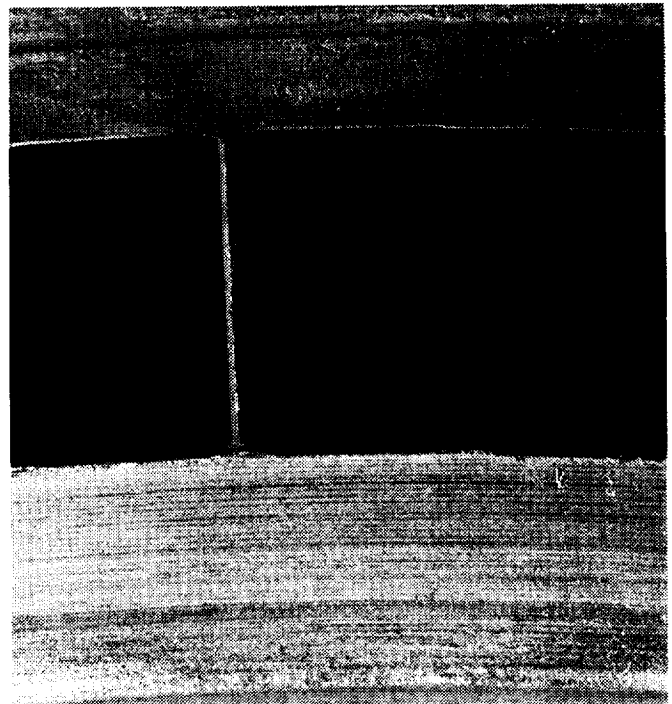
Figure 8.—Exhaust port powder bristle debris.

testing; thus one can only conclude that the bristles wore significantly, and the rotor coating showed little evidence of tracking other than being highly polished. Some powder debris is shown in Fig. 8.
