Performance of an Electro-Hydrostatic Actuator on the F-18 Systems Research Aircraft

*Robert Navarro
Dryden Flight Research Center
Edwards, California*

October 1997

NASA/TM-97-206224

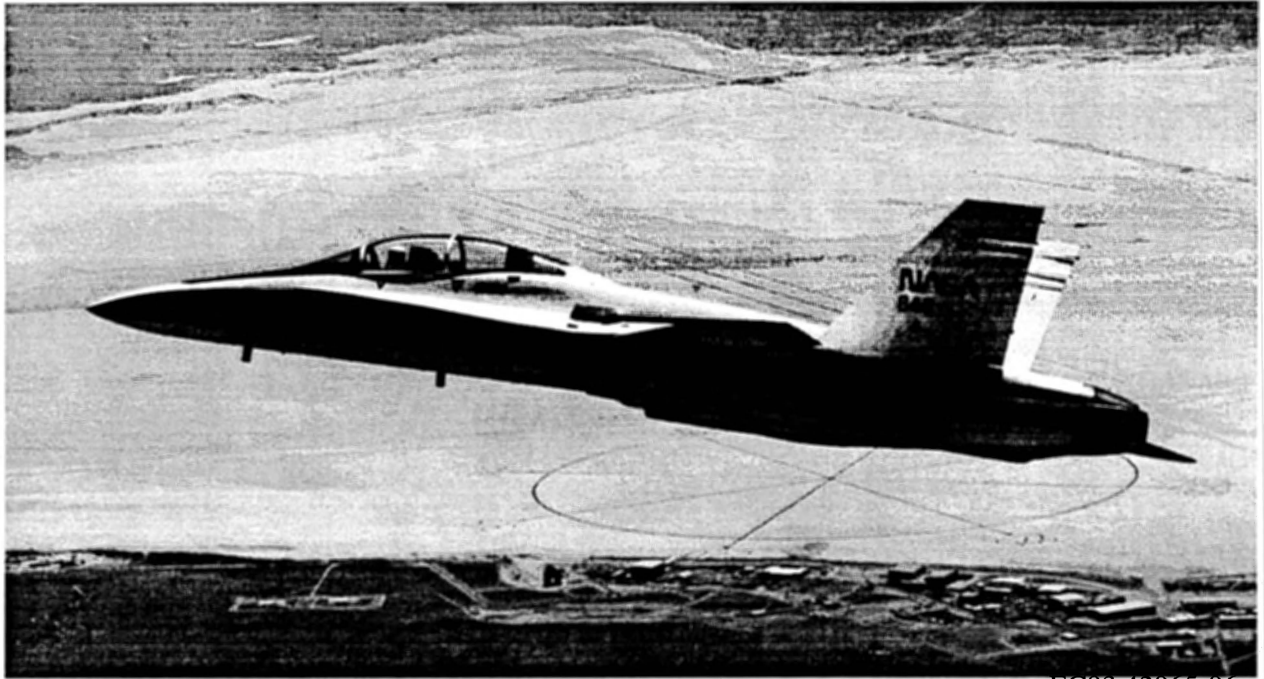
EC93 42065-06

Figure 1. Systems Research Aircraft (SRA).

The F-18 Systems Research Aircraft (SRA) [1], (fig. 1), at the National Aeronautics and Space Administration (NASA) Dryden Flight Research Center (DFRC) is a dual-purpose test bed benefiting both commercial and military developments. A primary goal is to identify and flight test new technologies on the SRA that will be beneficial to subsonic, supersonic, hypersonic, or space applications. One of these technologies is the electro-hydrostatic actuator (EHA) system, provided by Wright-Patterson Air Force Base (WPAFB), Dayton, Ohio. Using the EHA eliminates the central hydraulic system and reduces complexity, maintenance and support personnel. The two interface boxes (Ibox) and the power conversion unit (PCU) used for these tests were provided by Dynamic Controls, Incorporated (DCI), Dayton, Ohio. Lockheed-Martin Control Systems (LMCS), Johnson City, New York, integrated the actuator, motor, pump, and electronics. Dowty Aerospace, Duarte, California; Vickers, Jackson, Mississippi; and Electromech, Wichita, Kansas, provided the actuator, pump, and electric motor.

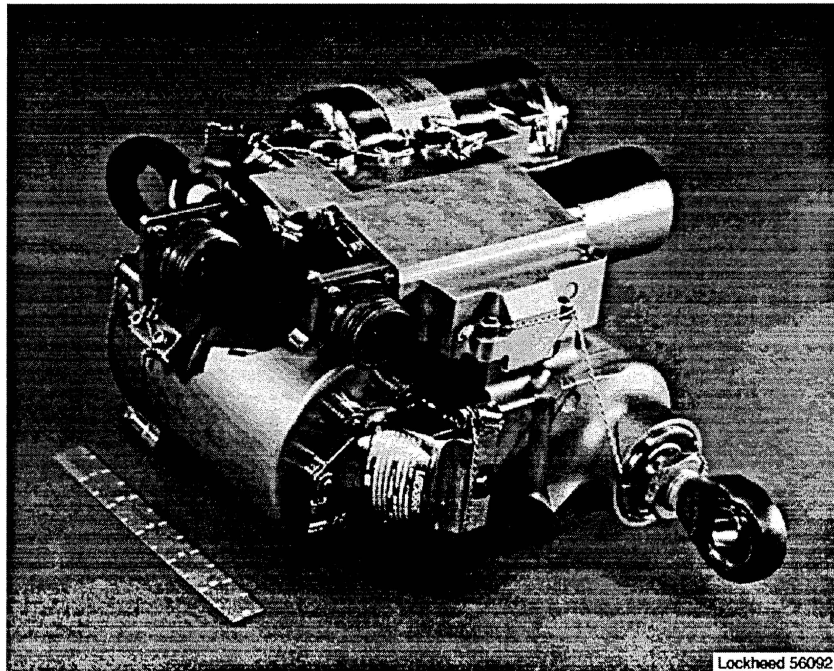
Figure 2. Electro-hydrostatic actuator (EHA).

Testing the EHA system demonstrated in flight power-by-wire (PBW) technology on a primary flight control surface. For this test the EHA (fig. 2) replaced the standard F-18 left aileron actuator on the SRA. The flight test program consisted of several maneuvers throughout the SRA flight envelope. This report presents EHA test results during the maneuvers and compares them to the standard aileron actuator. Lessons learned during ground testing are also presented.

The EHA utilizes a single positive displacement bidirectional bent-axis pump driven by a single three-phase, permanent magnet motor. The motor direction determines ram extension or retraction. The 41.5 lb actuator is designed to require no active cooling. The EHA contains a hydraulic fluid accumulator which is packaged together with fluid components, and a bypass shutoff valve (SOV). The hydraulic integrated manifold contains two back-to-back check valves, two cross-port pressure relief valves and the solenoid operated shutoff valve with an internal damping orifice. The two back-to-back check valves allow the reservoir to replenish fluid in the balanced actuator cylinder. Cross-port pressure relief valves are used to protect the actuator, mounting structure, and aileron surface from overpressure and overstress. The SOV disengages the actuator ram from the motor and pump assembly, reverts cycling the fluid through an orifice from one side to the other of the balanced actuator ram, to provide the trail-damped mode. The EHA also uses a linear variable differential transformer (LVDT) and a resolver for position feedback. It has a temperature transducer and a pressure transducer for status and health information used by the PCME. The LVDT measures ram position, the temperature transducer measures motor winding temperature, the pressure transducer measures reservoir pressure, and the resolver measures motor rotor position and velocity.

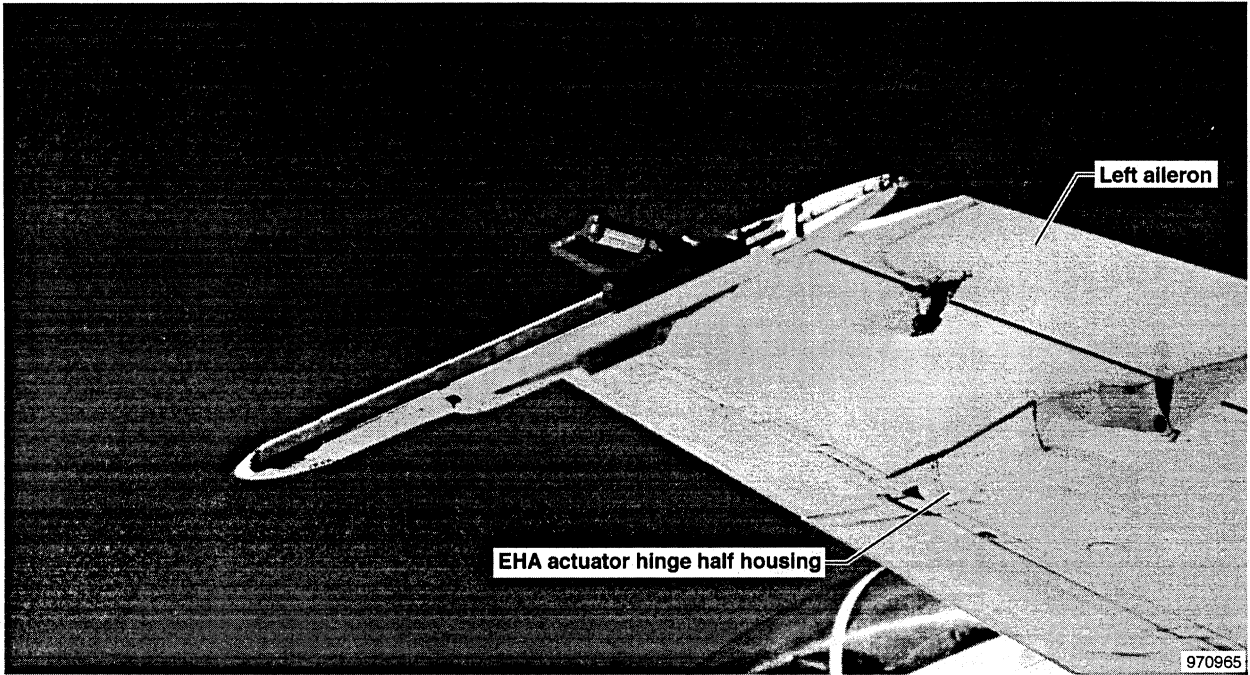
Figure 3. Hinge half housing.

The SRA was retrofitted with a larger left wing hinge half to accommodate the larger size of the EHA (fig. 3). Figure 4 shows the EHA integrated into the left wing of the SRA.

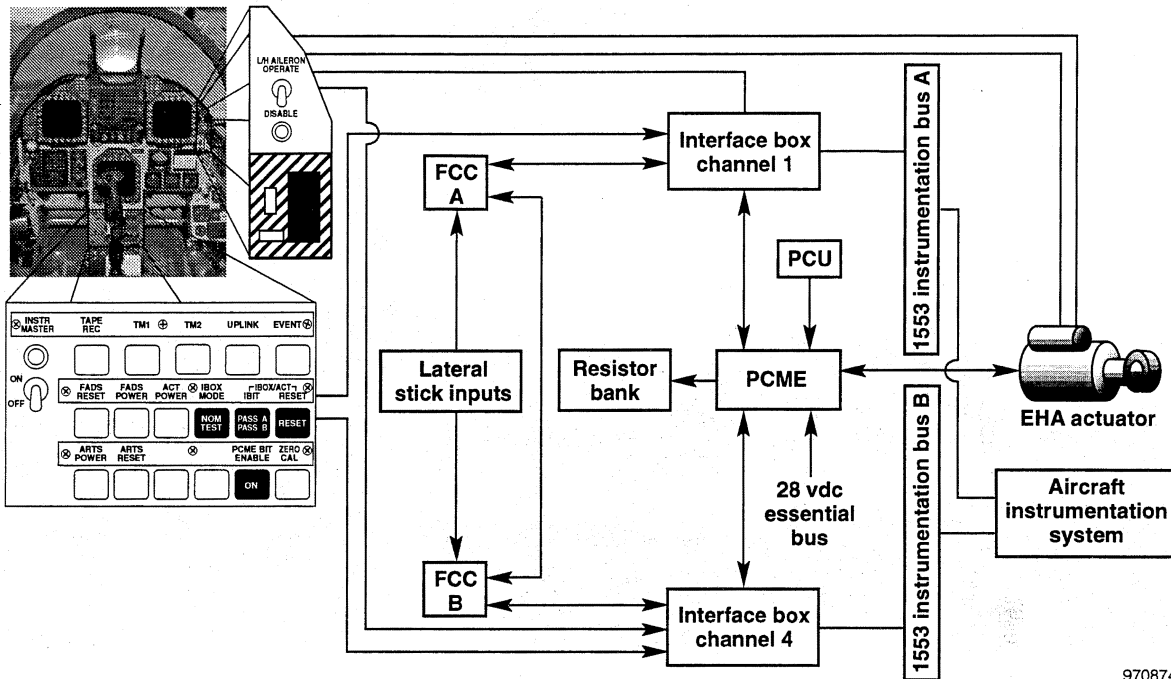
Figure 5. Systems Research Aircraft system architecture.

Figure 5 shows the interface of the EHA components and the two flight control computers (FCC's). The FCC's (FCC ch 1 and FCC ch 4) generate servo-current position commands which are fed to the Iboxes, one Ibox for each FCC channel. The Iboxes receive the servocurrent position commands from the FCC's, generate commands to the PCME and generate a simulated feedback response to the FCC's. The simulated feedback is used for loop closure and to fool the FCC's into thinking that there is a standard actuator on board. The PCME receives the command signals generated by the Iboxes, then compares these signals to verify that they are within a set limit and averages them into a single command signal for the EHA. The EHA feeds status and health information back to the PCME to be used for fault detection. The PCU provides the high power necessary to the EHA through the PCME. Figure 6 shows the location of the EHA system components in the SRA.

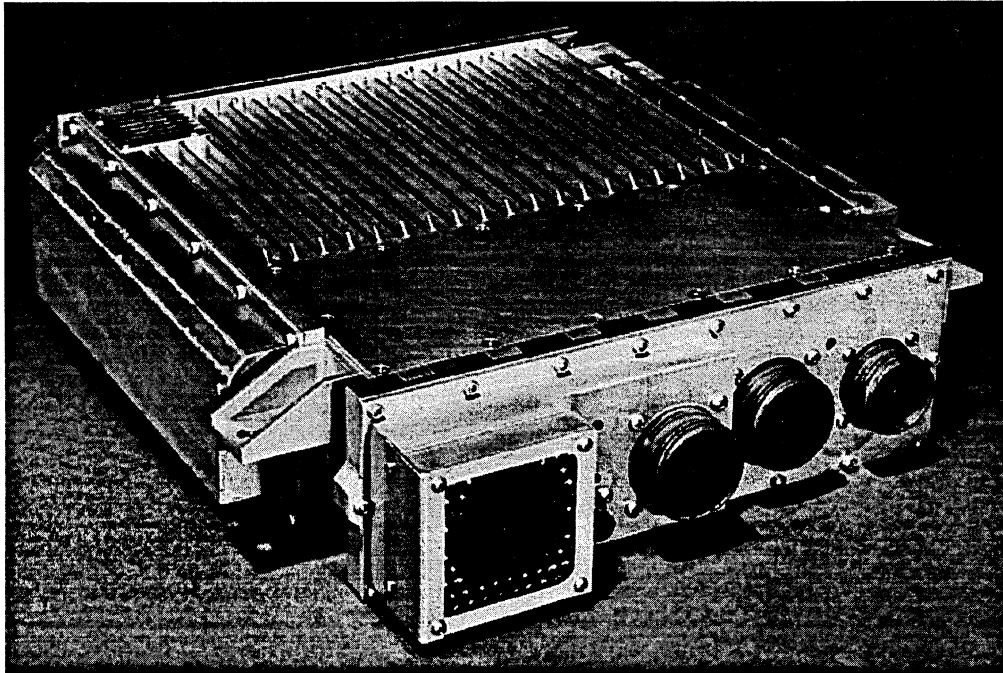
Figure 7. Power control and monitoring electronics (PCME).

The electronics required for controlling the power and position commands to the EHA and the monitoring of the actuator responses are located in the PCME unit (fig. 7). The PCME is equipped with an 115 V ac cooling fan and weighs approximately 20 lb. The electronics monitoring provides continuous fault monitoring and transfers the actuator to the trail-damped mode when any failure is detected. The PCME communicates with the SRA FCC's through the two Iboxes. The inputs to the PCME provide commands for actuator mode and position. These actuator command signals are translated by the PCME hardware and software into motor current commands through appropriate control laws which enable the actuator to be driven to its desired position. The PCME is responsible for actuator position, motor velocity, and current (acceleration) loop closures. In

addition, the PCME software provides BIT capabilities to test the PCME computer hardware, sensors, servoelectronics and actuator mechanics.

The PCME receives the high power ± 135 V dc from the PCU and translates it to current commands for the EHA through the Mos Controlled Thyristors (MCT). Regenerative energy from the EHA is stored in capacitors. Any excess regenerative energy is dissipated through an external resistor bank.

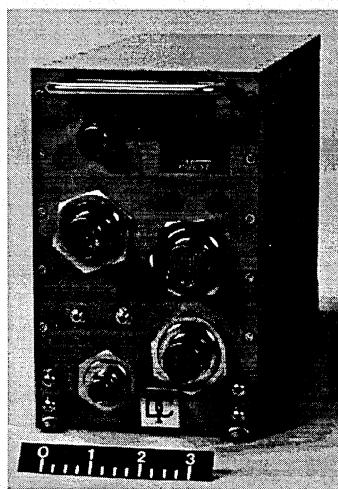
Figure 8. Interface box (Ibox).

The Iboxes (fig. 8) provide the interface between the F-18 FCCs and the EHA system. The Iboxes provide the two FCC channels (FCC ch1 and FCC ch4) with all the required loop closures. Two Iboxes are used, one for each FCC channel. The Iboxes receive the servocurrent position commands from the FCC's, generate the commands to be sent to the PCME, and generate the simulated feedback responses to the FCC's. The Iboxes also provide monitoring of the research actuator through the system and allow research and performance data to be monitored through a MIL-STD-1553 Response Multiplex Data Bus (1553 data bus) [2].

The PCME reports health status of the EHA system to the Iboxes. Once the Iboxes receive a failure, the simulated position feedback to the FCC's recognize open position feedback as a failure. Once the FCC's recognize the failure, it de-energizes the SOV output signal which causes the Iboxes to command the EHA system into a trail-damped mode. The PCME also de-energizes the SOV.

The Iboxes are designed to self-monitor internal functions. Because there is no cross-channel communications between the Iboxes, discrepancies between the two channel position commands received by the FCC's cannot be detected by the Iboxes. Therefore, each Ibox splits the servocurrent position commands into two redundant paths to generate position command signals for the PCME. The two command signals are compared and their differences calculated. If the difference is not within a set limit a failure is declared and the position feedbacks are opened to the FCC's, transferring the EHA system to the trail-damped mode. The Ibox self-monitoring system includes failures of power supply, software and central processing unit (CPU).

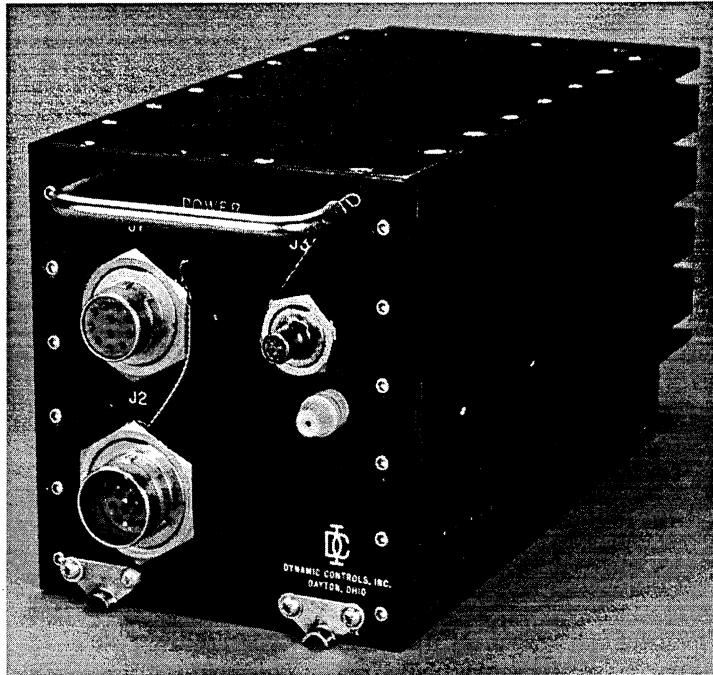
Figure 9. Power conversion unit (PCU).

The PCU (fig. 9) provides the ± 135 V dc, which powers the EHA system. The PCU takes the 115 V ac, 400 Hz, three-phase F-18 aircraft power and converts it to ± 135 V dc, which is delivered to the PCME. The PCME then sends the high power through the MCT's to the motor windings. The PCU is fused with two 35-amp fuses to protect the aircraft electrical systems and EHA system.

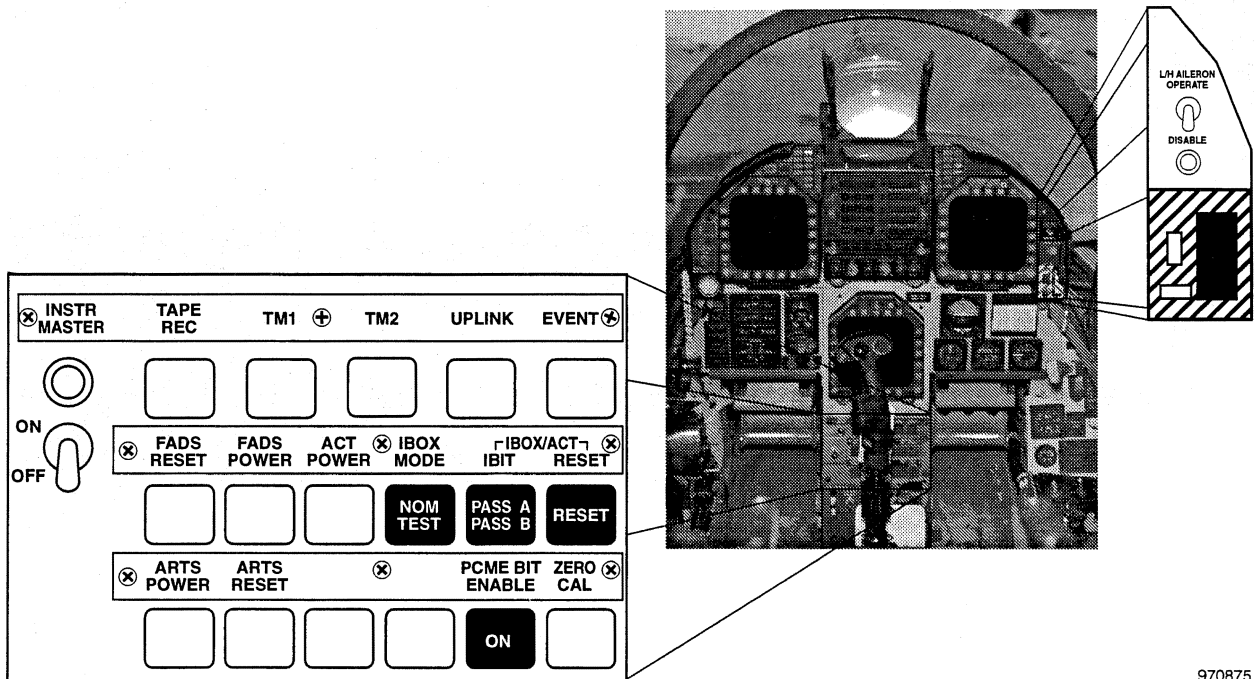
Figure 10. Electro-hydraulic actuator disable switch and control panel in cockpit.

The pilot control panel contains control switches for various experiments integrated into the SRA. Four control push-button switches and a toggle switch are allocated for the EHA system as follows (fig. 10).

- *The Ibox mode* switch commands the EHA system to be in Normal or Test mode, Normal mode puts the system in normal operation mode and Test mode is selected when performing an aircraft flight control system (FCS) BIT.

- *The IBIT button* commands the EHA system initiated BIT. IBIT is used by the PCME to verify the failure logic used to monitor correct operation of the EHA prior to aircraft takeoff (weight-on-wheels is needed to invoke IBIT). After a successful completion of IBIT the button is lit to indicate a passed condition for the test.

- *The reset button* is used to reset the EHA system after IBIT or a failure. The system only resets with weight-on-wheels (aircraft on ground).
- *The PCME BIT enable switch*, in the off position, prevents one Ibox from sending an IBIT command to the PCME which prevents initiating an IBIT on the ground. It is used as a precaution to prevent an IBIT in flight.

- *The left aileron disable switch* allows the pilot to actively de-energize the SOV valve and transfer the EHA into a trail-damped mode.

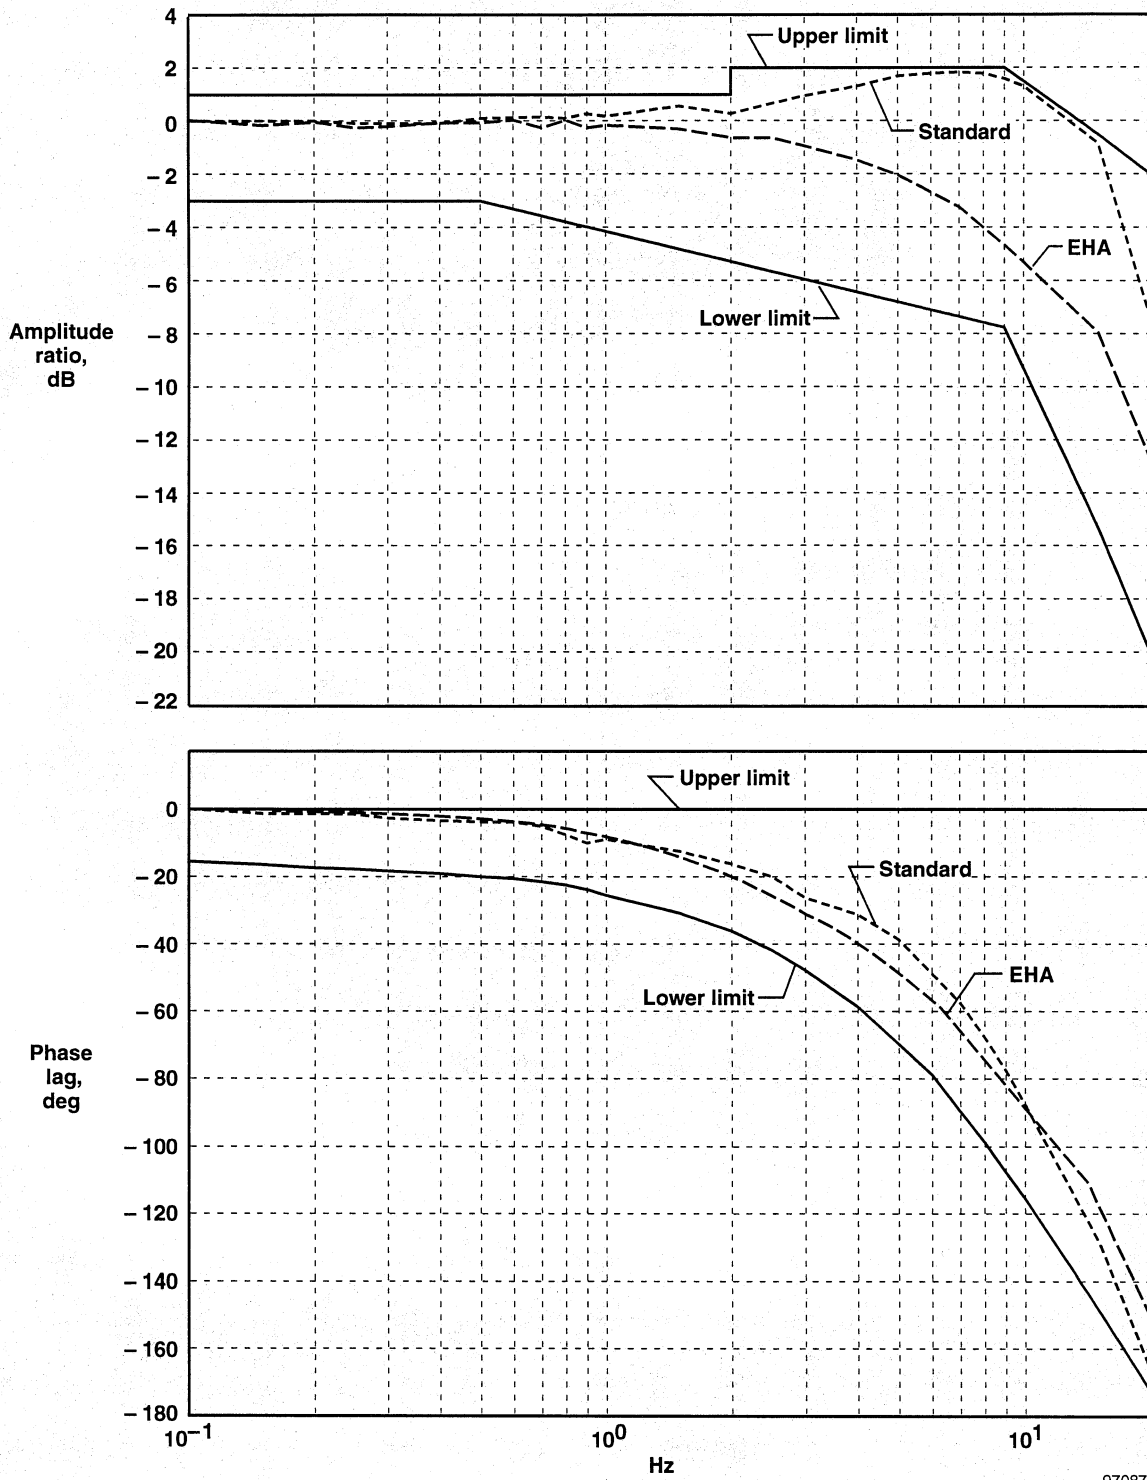
Figure 11. Electro-hydrostatic actuator and standard actuator open-loop small amplitude frequency response.

The EHA successfully passed the ATP, FWT, and validation tests (functional, continuous and frequency). Table 1 through 4 illustrate requirements and test results. Figure 11 shows that the EHA and standard open-loop frequency are within MDA aileron small amplitude specification limits. Figure 12 shows that the EHA tracks closely to the standard actuator in the open-loop frequency response.

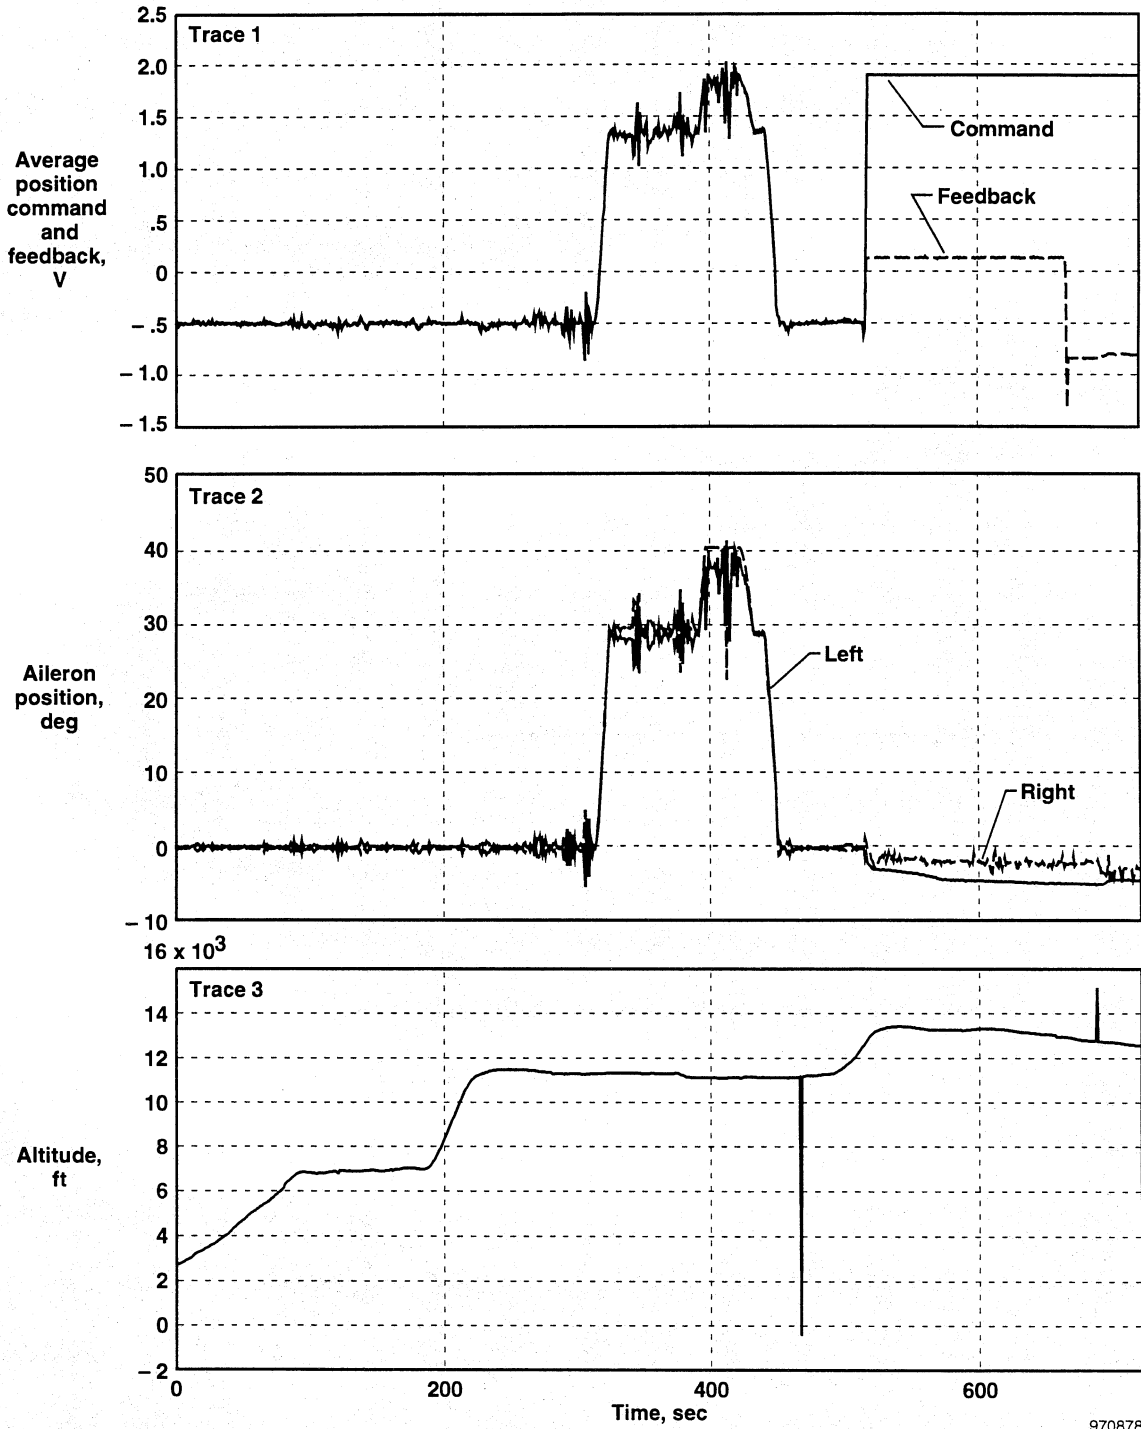
Figure 13. In-flight failure, January 16, 1996, flight 564.

Figure 13 and 14 show the in-flight failures of flight 564 and 585, respectively. Trace 1 shows how the EHA position feedback departs from the average position command at the time of failure. The average position command is designed to move to a positive 1.9 volts, hardover down, once the EHA system has failed. This hardover down command during a failure was incorporated to minimize the differential between the ailerons in case the EHA system inadvertently came back online, particularly when the aircraft is close to the ground. The EHA is in a trail-damped mode once a failure has been detected. Trace 2, with the standard actuator aileron position inverted and trim removed, is plotted against the EHA aileron position. As illustrated, the EHA position departs from standard actuator position at the time of failure as it fails to a trail-damped mode. Trace 3 illustrates SRA altitude at the time of failure.

While set 2 was being repaired, set 1 (qualified by similarity) was installed in the aircraft. The cause of the flight 564 failure was suspected to be the loss of 28 V dc power in the power supply internal to the PCME. All components of the power supply were tested and no anomalies were found. A vibration problem was speculated to be the cause, so set 1 was vibrated to the worst-case axis. This vibration test did not reproduce the failure. Set 1 was reflown on January 10, 1997, on flight 585 and shortly after takeoff the EHA system went into a trail-damped mode. The failures of set 1 for the two flights, 564 and 585, were correlated to altitude. Both in-flight failures occurred at an altitude of slightly above 11,000 ft. The failure was reproduced in an altitude chamber and the cause of the shutdown was determined to be arcing. The leads in the power supply would arc to a circuit board located above the power supply at higher altitudes. The arcing was

stopped by adding a layer of capton tape between the leads and the circuit board.

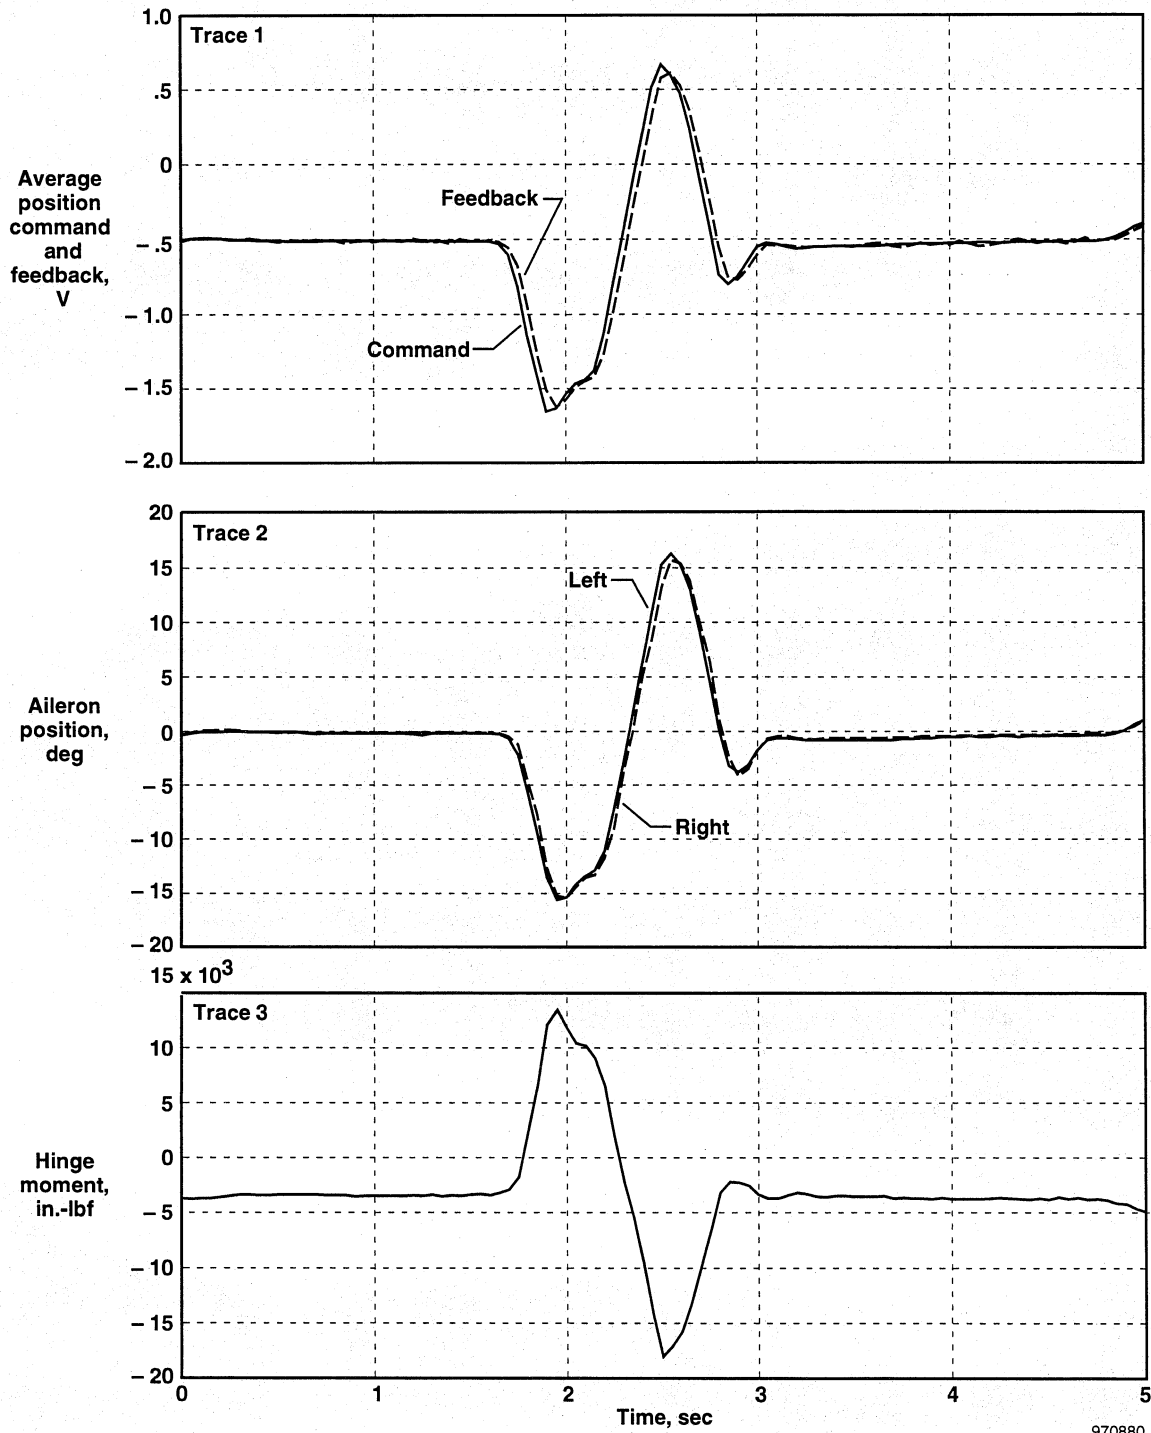
970880

Figure 15. Abrupt roll doublet—full stick (left).
 $M=0.72$, altitude=25,000 ft, $q\text{-bar}=284 \text{ lbf/ft}^2$.

Figure 15 through 18 show typical test maneuvers. Trace 1 illustrates tracking of the EHA position feedback with the average position command. The timelag between command and feedback is approximately 30 ms and is associated with data sampling. In trace 2 the standard actuator aileron position is inverted and trim is removed, and then plotted against the EHA aileron position. Here the EHA performs as well as the standard actuator. Trace 3 shows the EHA hinge moment, a negative hinge moment puts the actuator in tension and a positive hinge moment puts the actuator in compression. Figures 19 and 20 illustrate the test points where the EHA actuator stalled. Figure 21 shows a test point where the standard actuator stalled and the EHA did not.

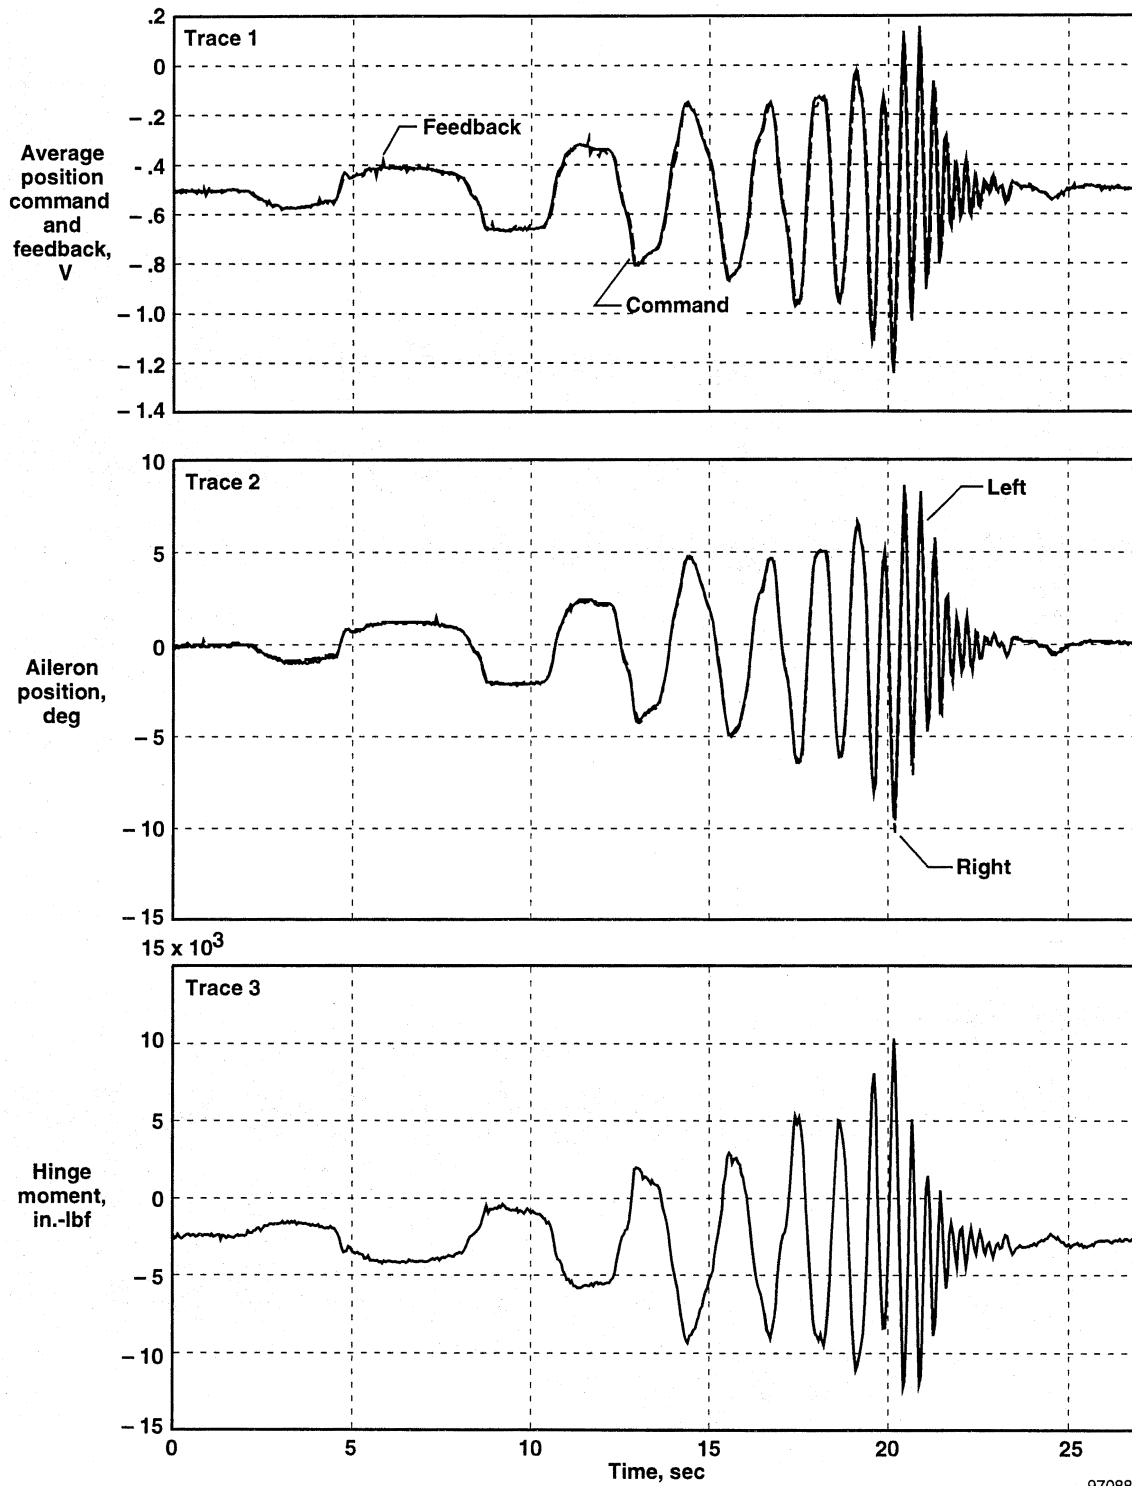
970881

Figure 16. Slow—fast lateral frequency sweep.
 $M=0.83$, altitude=25,000 ft, $q\text{-bar}=376 \text{ lbf/ft}^2$.

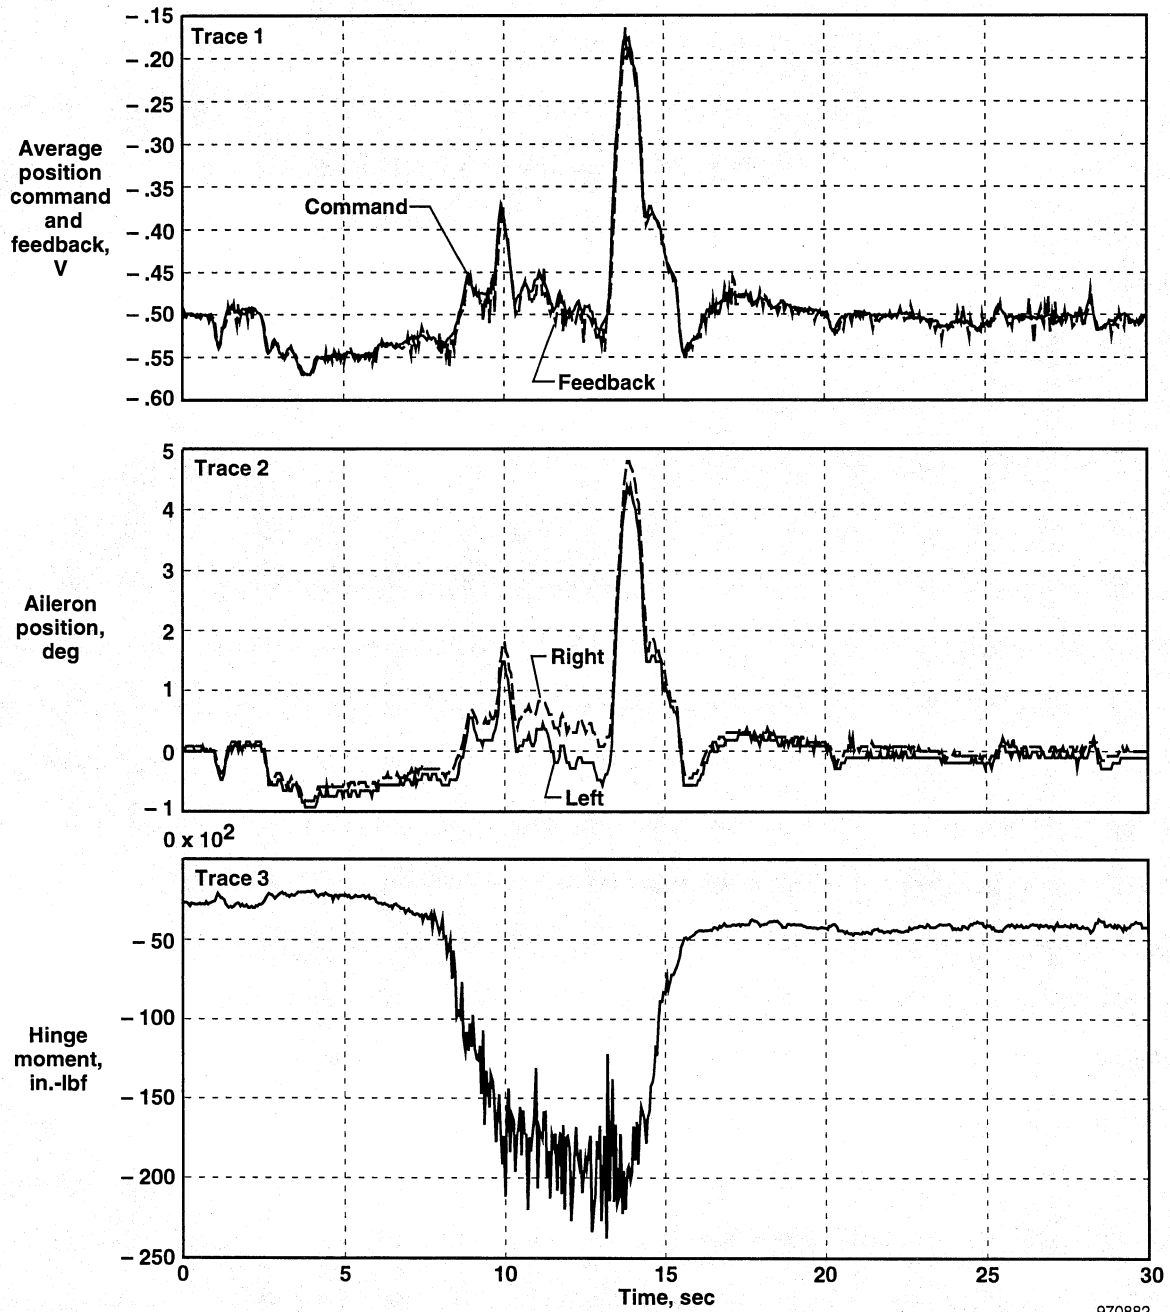
970882

Figure 17. Windup turn to $20^\circ \alpha$.
 $M=0.83$, altitude=25,000 ft, $q\text{-bar}=376 \text{ lbf/ft}^2$.

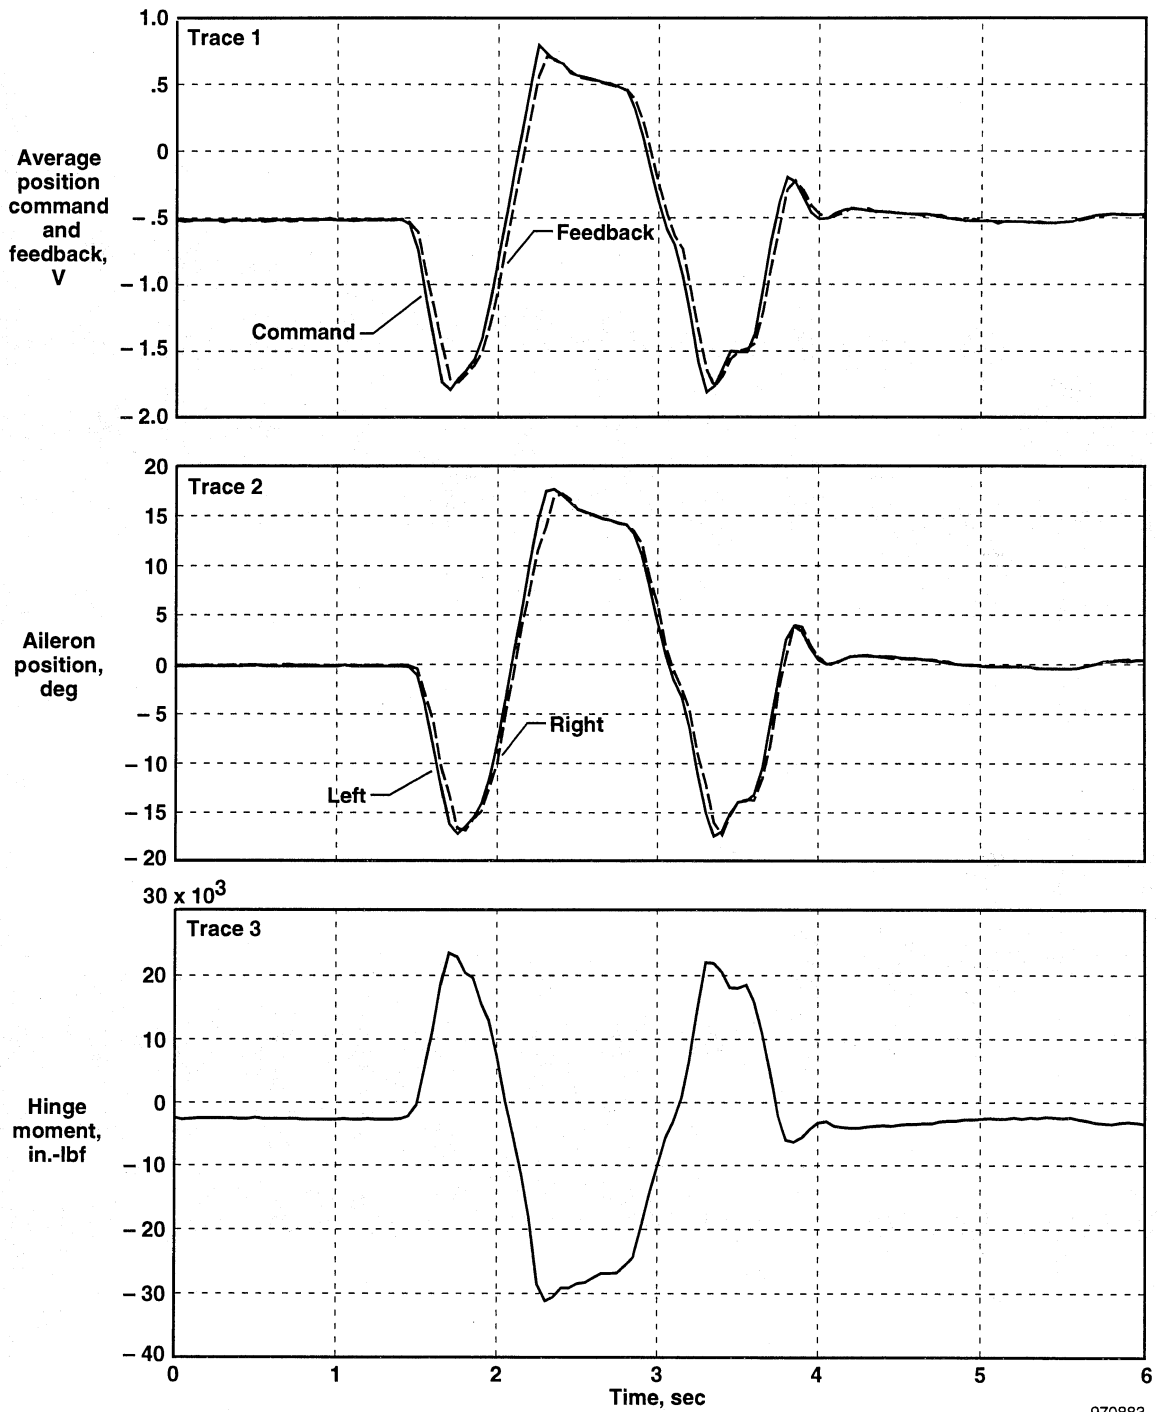
970883

Figure 18. Abrupt aileron reversal—full stick (left).

$M=0.84$, altitude=25,000 ft, $q\text{-bar}=382 \text{ lbf/ft}^2$.

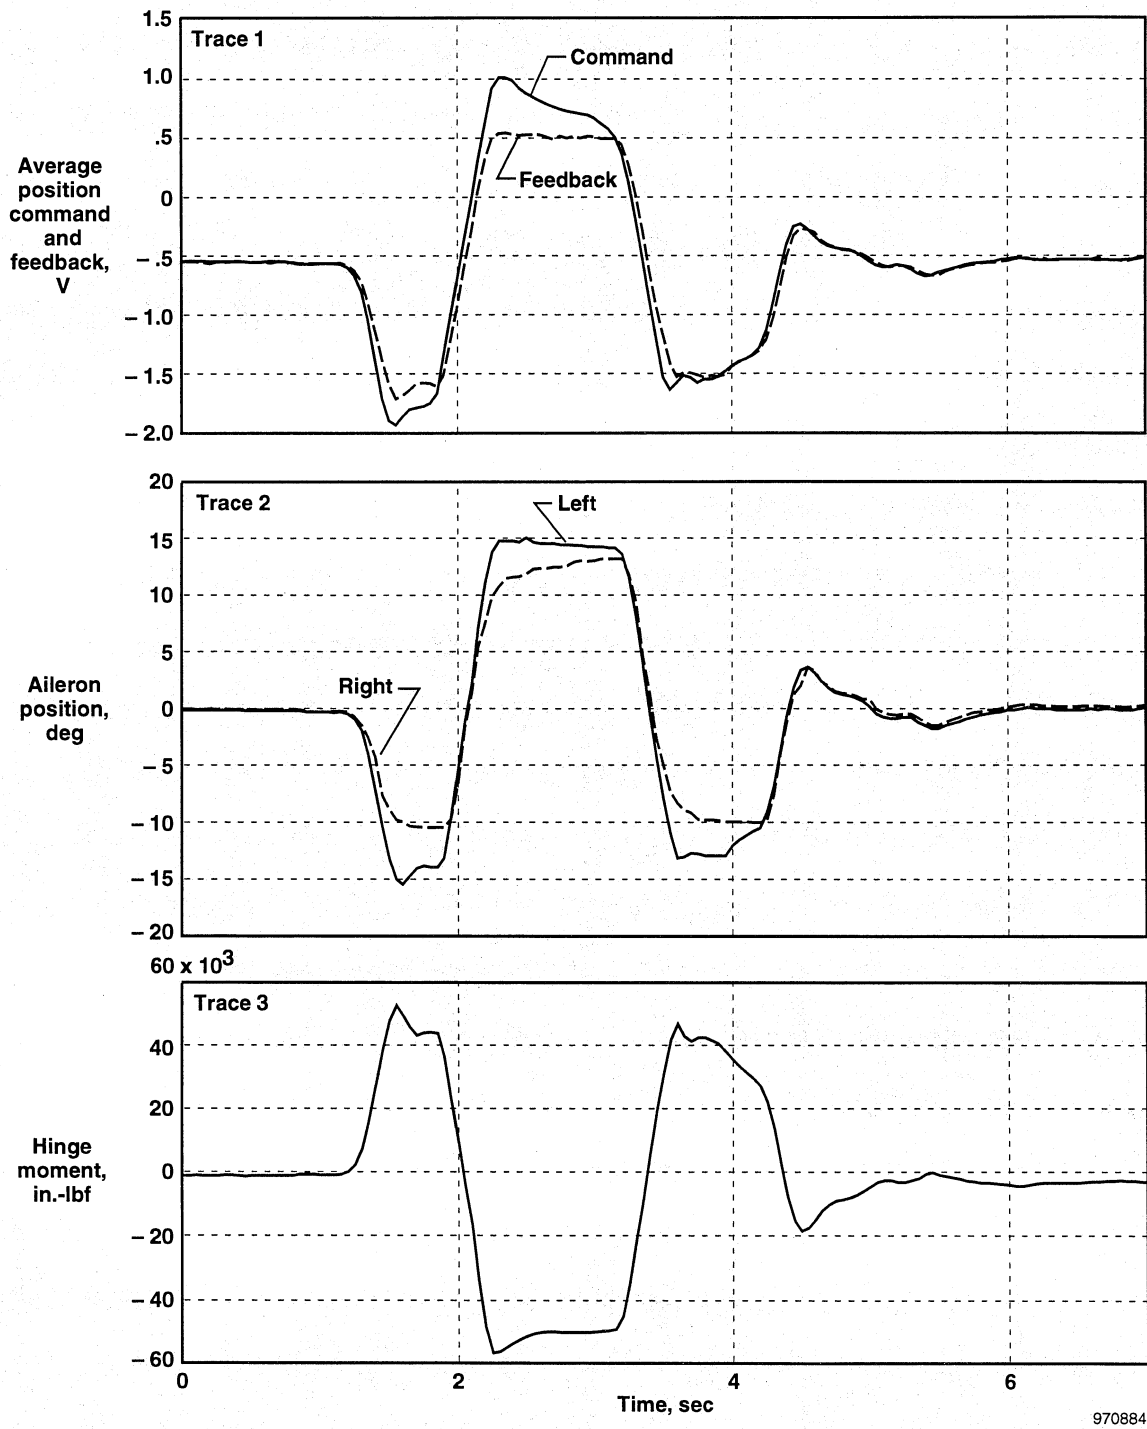
970884

Figure 19. Aileron reversal—half stick (left).
 $M=1.58$, altitude=34,000 ft, $q\text{-bar}=890$ lbf/ft².

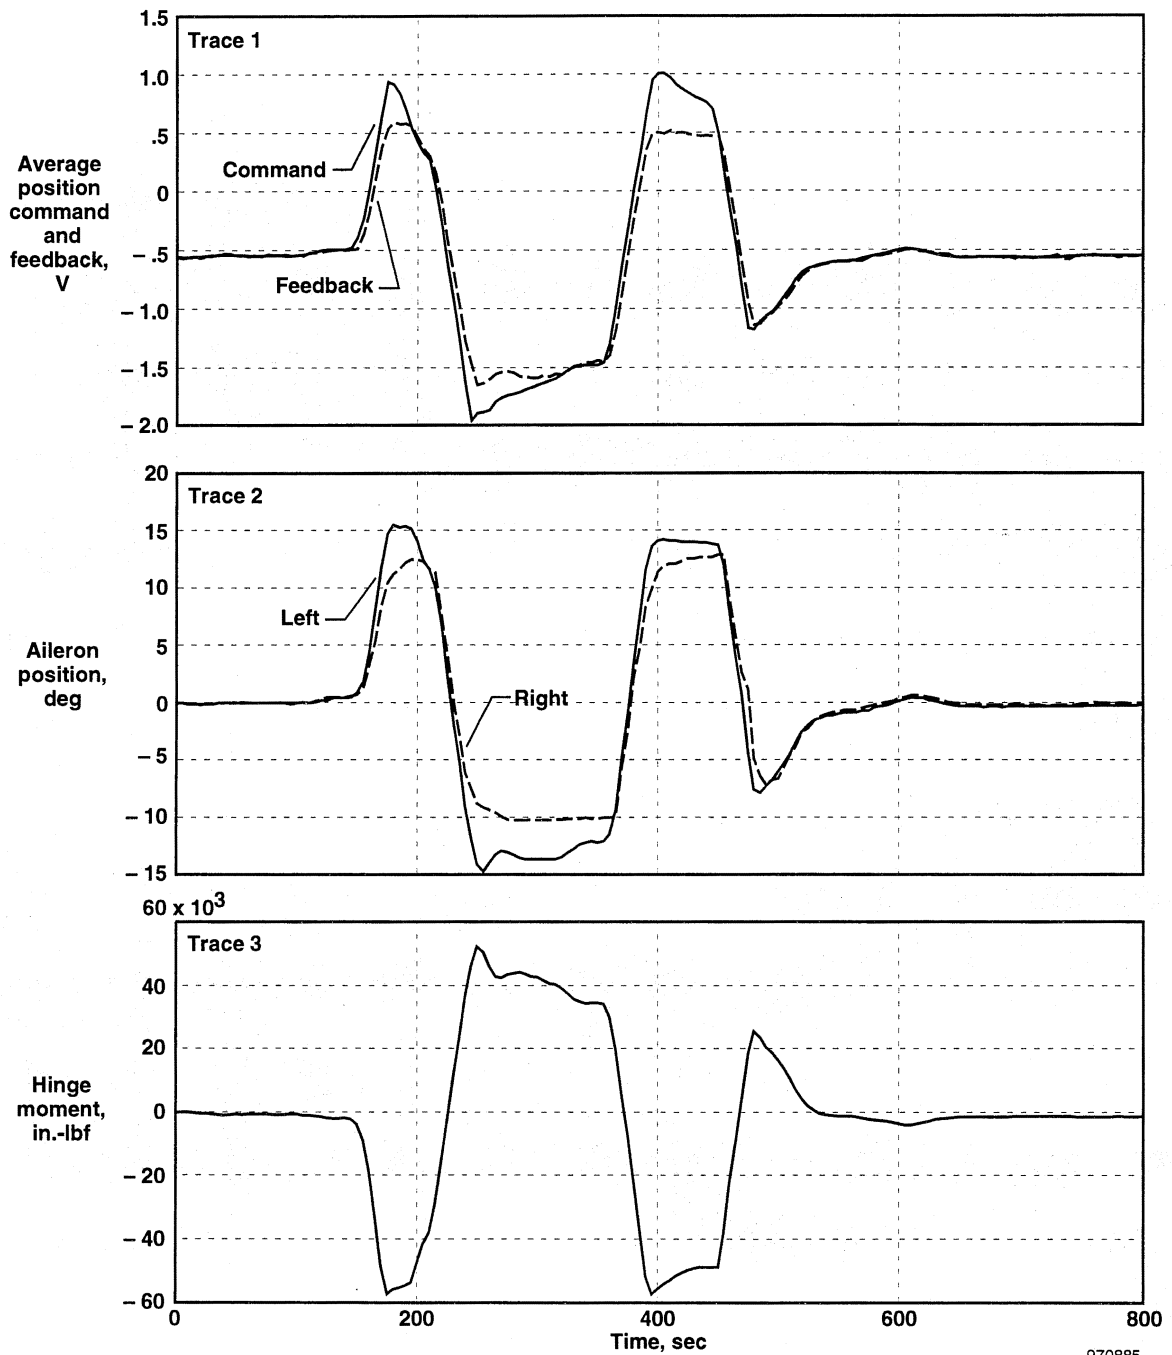
970885

Figure 20. Abrupt aileron reversal—full stick (right).

$M=1.6$, altitude=34,000 ft, $q\text{-bar}=925$ lbf/ft².
