Performance of an Electro-Hydrostatic Actuator on the F-18 Systems Research Aircraft

*Robert Navarro
Dryden Flight Research Center
Edwards, California*

October 1997

NASA/TM-97-206224

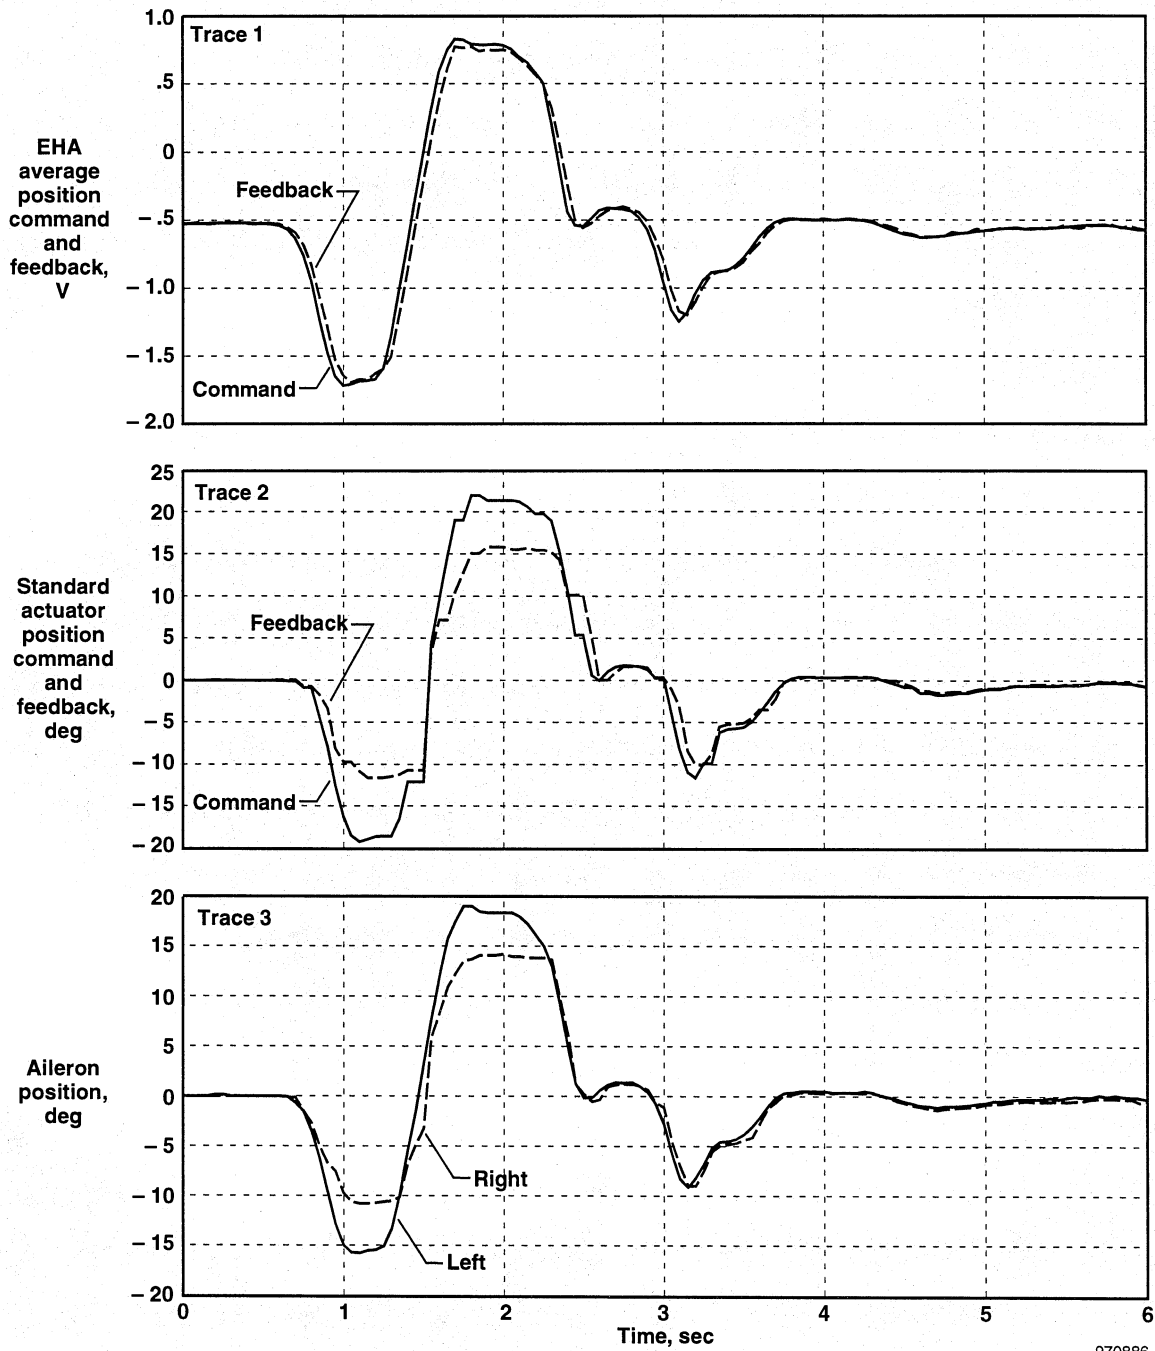
970886

Figure 21. Abrupt aileron reversal—full stick (left).

Figure 15 through 18 show typical test maneuvers. Trace 1 illustrates tracking of the EHA position feedback with the average position command. The timelag between command and feedback is approximately 30 ms and is associated with data sampling. In trace 2 the standard actuator aileron position is inverted and trim is removed, and then plotted against the EHA aileron position. Here the EHA performs as well as the standard actuator. Trace 3 shows the EHA hinge moment, a negative hinge moment puts the actuator in tension and a positive hinge moment puts the actuator in compression. Figures 19 and 20 illustrate the test points where the EHA actuator stalled. Figure 21 shows a test point where the standard actuator stalled and the EHA did not.
