# Bidirectional Brush Seals—Post-test Analysis

Prepared for the  
Seventh International Symposium on Transport Phenomena  
and Dynamics of Rotating Machinery  
cosponsored by the Pacific Center of Thermal Fluids Engineering and the  
U.S. Turbo and Power Machinery Research Center  
Honolulu, Hawaii, February 22–26, 1998

# BIDIRECTIONAL BRUSH SEALS—POST-TEST ANALYSIS

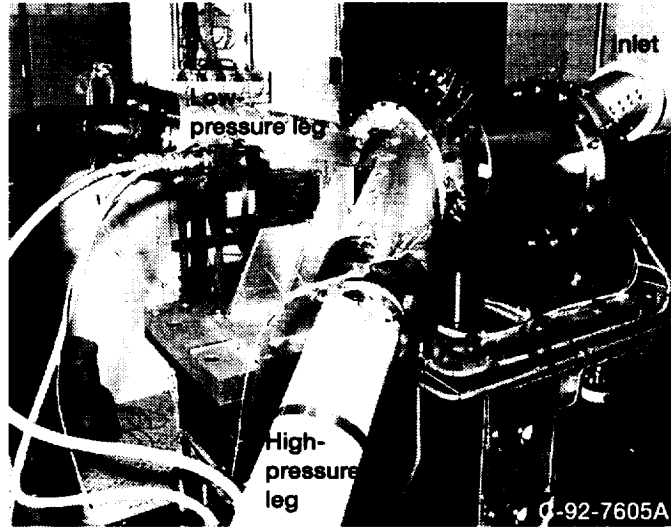
A photograph of the wave rotor test rig (Fig. 1) illustrates the nature of a three-port flow divider. A single inlet flow is separated into two outlet flows, one at higher stagnation pressure than the inlet and the other at lower stagnation pressure. The rotor itself is a cylinder with axially aligned passages on its circumference. As a passage rotates, the pressures at the ends of the passage fluctuate between the high and low pressures. The cavity surrounding the rotor will be at a pressure close to the inlet pressure. Leakage will take place from a passage to the cavity when the passage is at high pressure and from the cavity to a passage when the latter is at low pressure. Thus, the seals must be capable of withstanding pressure reversals and the corresponding flow reversals.

Figure 1.—Wave rotor test rig.

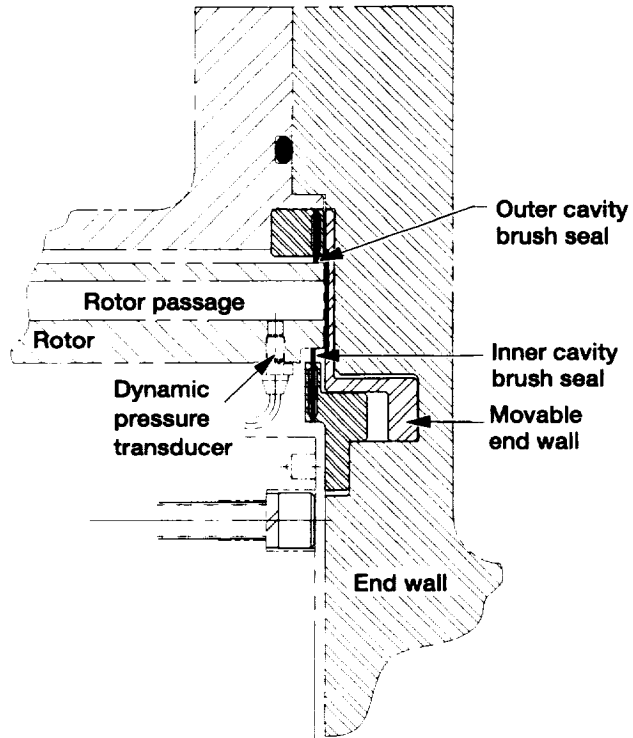
A cross-sectional view of the rotor (Fig. 2) illustrates the cavities and the placement of the brush seals. The rotor passage represents that portion of the rotating cylinder containing the working fluid; the inner and outer cavities constitute potential leakage paths. The movable end wall establishes a gap between the unsealed rotor/stator interface and to some extent controls the cavity volumes at the sealed rotor/stator interface.

Figure 2.—Rotor cross section.

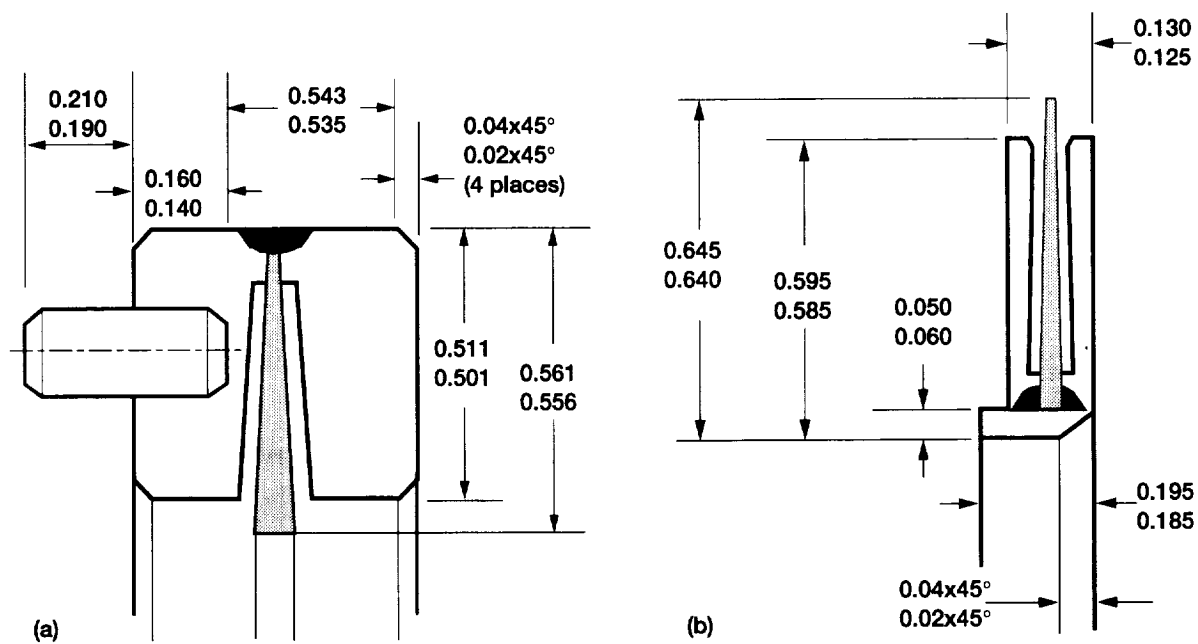
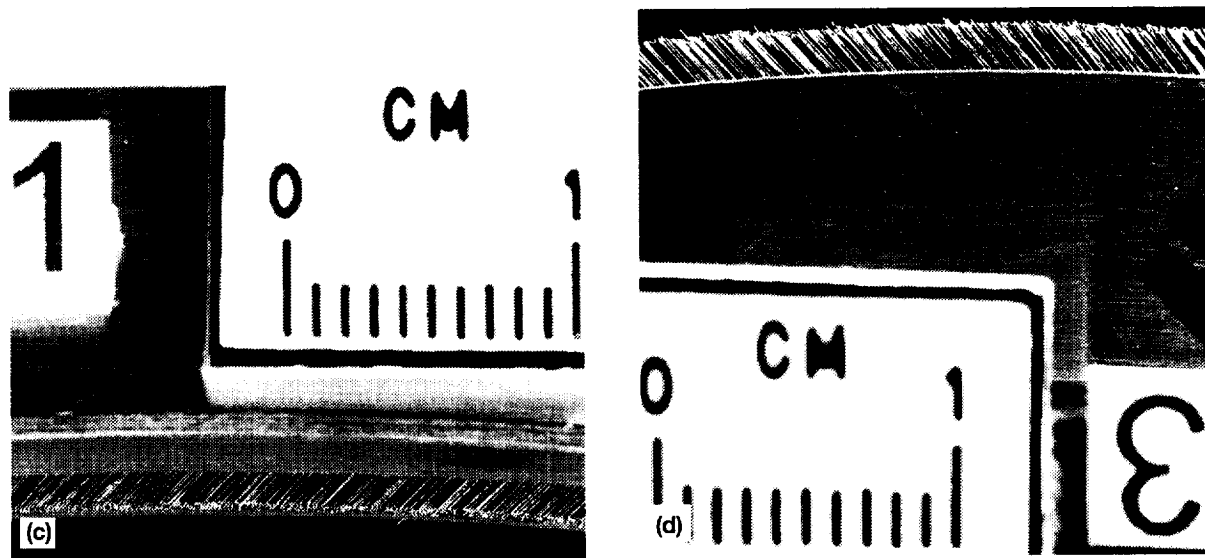
The shielded design (Hendricks et al., 1992) can be modified to provide sealing in both directions, provided that a gap is introduced between the side plates and the bristles. Figure 3 shows cross-sectional views of the OD and ID seals. The brush was otherwise of standard Cross Mfg. Co. construction. The bristles were 0.071-mm-diameter (0.0028-in.-diameter) Haynes 25 (AMS 5796 28) at 40° to 50° angles to the interface and inclined in the direction of rotation with suitable antirotation pins to prevent seal rotation. The rotor seal radii after testing were nominally 140.2 mm (5.518 in.) (inner) and 162.1 mm (6.380 in.) (outer). In each case 0.25-mm (10-mil) radial interference was built into the as-manufactured seal.

Figure 3.—Details of seal cross sections and photographs of brush seals taken after testing. (a) Outer brush seal cross section. (b) Inner brush seal cross section. (c) OD seal bristles and side plate fence. (d) ID seal bristle and side plate fence.

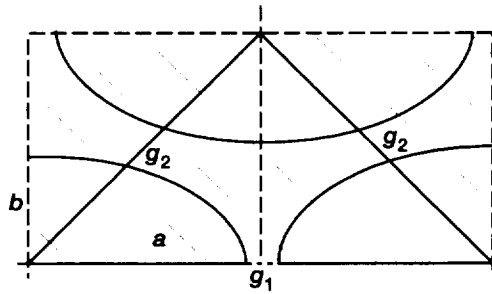
where  $g$  denotes gap;  $2a$  indicates the major axis; and  $2b$ , the minor axis (Fig. 4). The bristle-rotor interface, for most brush seals, represents a plane of small curvature. At this interface leakage occurs and is compounded by flows along the bristles.

Figure 4.—Ideal packing of cylinders (brush-bristle geometry).

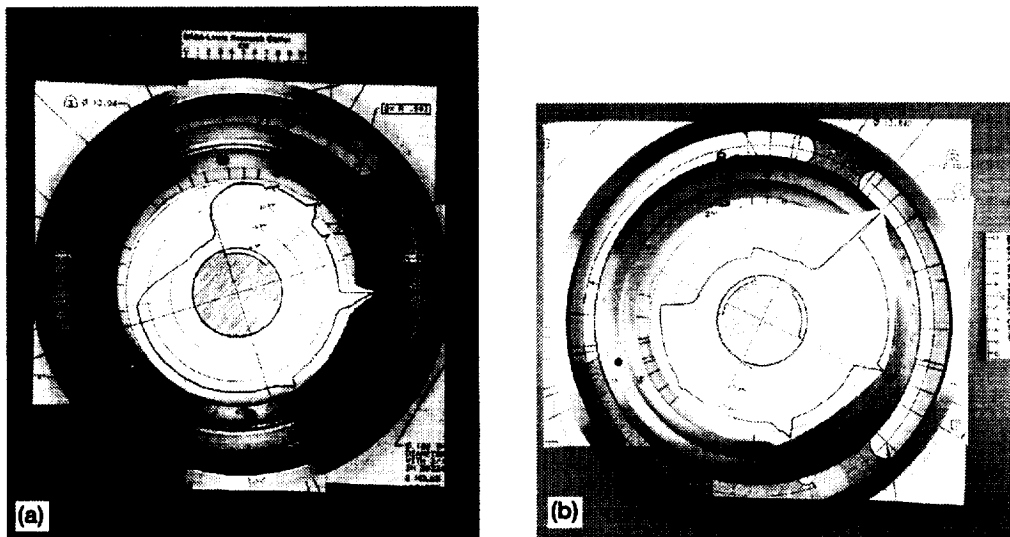
Figure 5 represents the inlet and outlet seal configurations for the wave rotor machine. The ID and OD brush seals are overlaid on a drawing of the wave rotor configuration with the associated pressure profiles to simulate the brush pressure loading. Although the 60 rotor passages rotating at 7500 rpm provided rapidly changing pressure in the passages, the pressure profiles were steady in the laboratory reference frame. The pressure peaks and reversals with respect to the mean were substantial, forcing the bristles to “flip-flop” axially as the passage rotated through a cycle (Fig. 6). Consequently, one would expect to witness some changes in the brush bristle patterns in the regions of rapid pressure changes. However, bristle wear and packing abnormalities appeared to be dispersed over the entire circumference of the brush and showed no evidence of the local pressure changes on bristle packing or wear. Nevertheless, the rotor surface was affected as discussed in the section Surface Tribology.

Figure 5.—Simulation overlay of wave rotor end wall with no-seal pressure distribution. (a) Inlet. (b) Outlet.

These results infer that the wear surface reflects the axial pressure distribution applied to the bristles (see Figs. 5 and 6). If the bristles do follow the pressure loading, they are flip-flopped at about the rotor-passage passing frequency (i.e., they perform a major flip toward the fence plate at the opening of the high-pressure port and a major flop toward the gap plate at the opening of the low-pressure port during a single rotor-passage rotation. However, at 120° from the opening of the high-pressure port they again flip toward the fence plate. During the lightly loaded portion of the cycle the bristles are perturbed (e.g., 60°, 185°, etc.) and could be flip-flopping in a fashion similar to flutter. These comments are nearly consistent with the potentially two to three prominent spacings in one passage width in the wear scars (Fig. 14). No sacrificial metallurgical examinations have been performed on either the brushes or the rotor. Thus, one can only conclude that the bristles wore significantly and that the rotor coating showed car-tracking but little distress other than local burnish tracks and a high polish.

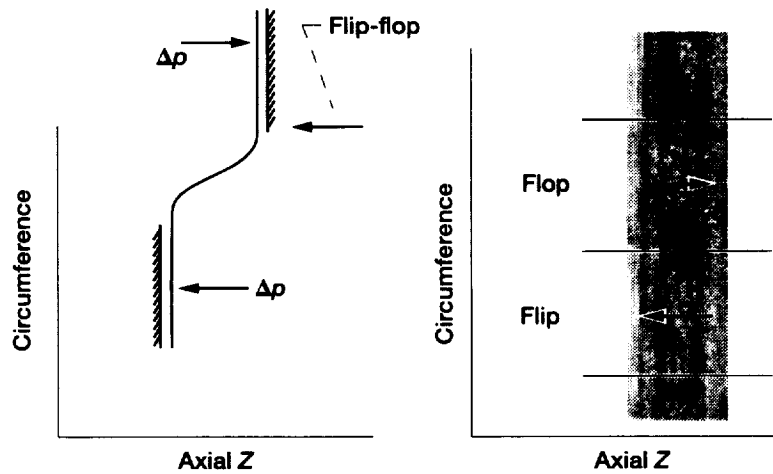
Figure 6.—Bristle "flip-flop" with passage rotation.

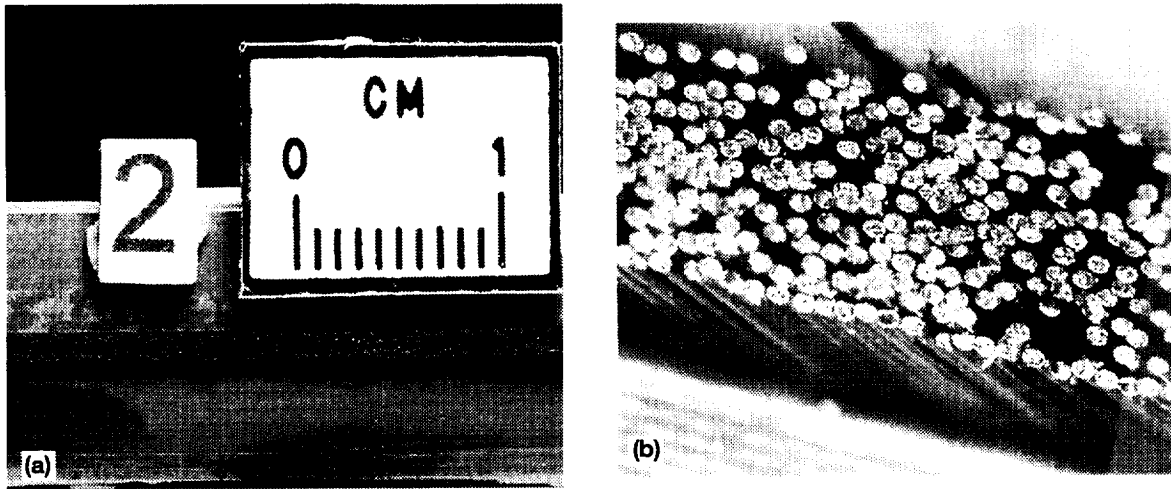
Figure 7 is a typical representation of the OD brush seal's bristle tip configuration. The unpacked bidirectional brush seal differs from a unidirectional brush seal in that the bristles are more disheveled. Although these photographs are typical, some regions show a higher degree of bristle void. For example, in counting the bristle tips in Fig. 7(a) over a circumferential distance of about 4.67 mm (1.84 in.) and an unpacked-brush thickness ( $t$ ) of about 1.19 mm (0.468 in.), three separate counts gave  $N_t$  of 240, 300, 370, depending on where and how the count was taken. The manufacturer estimates  $N_t = 459$ . The number of bristle rows was estimated at  $N_x = 11$ . The average bristle diameter was 0.071 mm (0.0028 in.), and the average interface angle ( $\theta + \phi$ ) was  $46^\circ$ . The porosity adapted from Eq. (2), where  $V_s$  denotes bristle volume and  $V_t$  denotes total volume,

The unpacked porosities were also estimated from post-test photographs (e.g., Fig. 7(b) at 50X), although the packed porosities were estimated by measuring the axial thickness reduction ratio of the packed to unpacked brush  $2\langle t \rangle_{\text{unpacked}}/3 < \langle t \rangle_{\text{packed}} < 3\langle t \rangle_{\text{unpacked}}/4$ . Assuming the ideal equilateral bristle packing configuration, this ratio would be applied to all sides of the ideal packing triangle (i.e., axial and circumferential packing versus axial packing alone) and can lead to unrealistic results because of the small differences in void.

Counting the bristles in each row  $N_x$  in Fig. 7(b) gave  $N_t = 140$ . Counting the bristles over a fixed area gave  $N_t = 156$ . For a area of 70 mm by 40 mm and a scale factor of 3 mm =  $d$ , with other parameters essentially the same and  $N_t = 148$ , the unpacked porosity became

Figure 7.—Unpacked OD brush seal. (a) Overview. (b) 50X.

Noting the circumferential orderly nature of the bristles near the fence (Figs. 7 and 10) and then overlaying Fig. 7(a) onto Fig. 14(c) and recalling the pressure profiles (Fig. 5), the width of the dark bands (or "car tracks") within the wear scar appear to be the packed thickness of the bidirectional brush seal. The distinctness of the upper darkened wear scar band in Fig. 14(c) then could result from bristle stiffening near the fence plate during one portion of the rotor cycle. The lower darkened wear scar band could result from bristle stiffening against the gap plate during other portions of the rotor cycle. The lack of distinctness of the lower band may be due to enhanced bristle flexure at the gap plate during operation. The spotted nature of the wear track between the bands may have been caused by bristle flutter due to load perturbations during the lightly loaded portion of the cycle. The whipped appearance of the surface may then be caused by transverse bristle motion due to sharp pressure changes over the rotor cycle. The broadening of the lower band can also be attributed to bristle spreading at the rotor interface during seal installation and subsequent wear-in. The ID brush seal surface showed similar patterns, which are difficult to capture photographically.

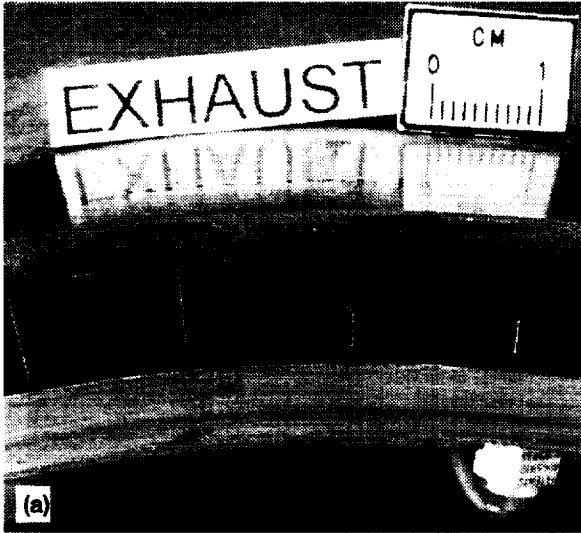
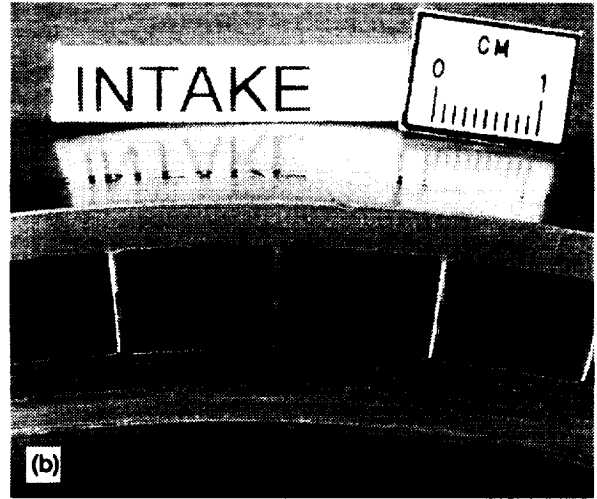
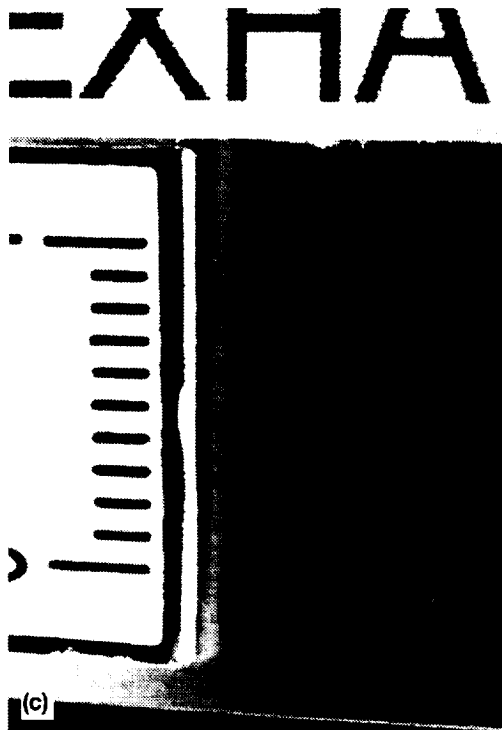
Attempts to quantify the surface wear were unsuccessful. Surface measurements, however, showed that the chromium carbide (CrC) interface coating wore less than 0.025 mm (0.001 in.) on all four interfaces. Optically, interface polishing or burnishing could be readily observed (Figs. 14(a) and (b)). A closer examination of the tracks revealed dark bands and "skipping," or changes in hardness, which may represent either tool marks of the parent machining operation or changes in the CrC coating. Banded wear scars and marks (Figs. 14(c) and (d)) extended beyond the brush wear path, implying a preconditioning of the rotor surface by machining. Figures 14(c) and (d) also show surface "spottiness," which may be related to bristle wear. Perhaps the spots were caused by bristle bunching combined with a fluttering motion during the lightly loaded portion of the cycle, a hard rub, or both.

Figure 14.—OD seal wear tracks. (a) Outlet side. (b) Inlet side. (c) Closeup, outlet side. (d) Closeup, inlet side.
