FLIGHT DEMONSTRATION OF X-33 VEHICLE HEALTH MANAGEMENT SYSTEM COMPONENTS ON THE F/A-18 SYSTEMS RESEARCH AIRCRAFT

*Keith A. Schweikhard, W. Lance Richards, NASA Dryden Flight Research Center,
Edwards, California*

Abstract

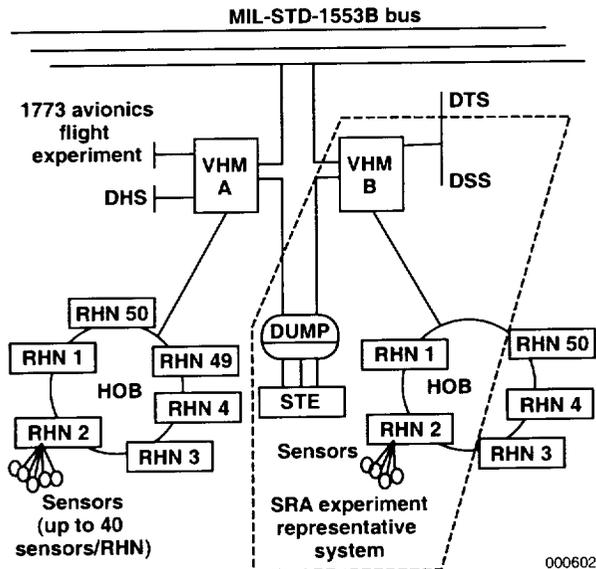
Figure 1. X-33/SRA configuration.

The X-33 VHM architecture (fig. 1) acquires data from a wide variety of sensors and systems. The system monitors and records all data on the vehicle, including all the flight bus data, all vehicle health data (structural, mechanical and system built-in test (BIT) status), and all the flight test instrumentation sensor data. This system interfaces to a NASA Jet Propulsion Laboratory avionics flight experiment that communicates over a MIL-STD-1773 fiber optic interface [2].

The VHM system uses a distributed sensing architecture to collect data from conventional sensors. The data are concentrated using 50 RHNs to gather structural, mechanical and environmental sensor data. Each RHN communicates with the VHM computer over a fiber optic health optical bus (HOB). The VHM computers (1) acquire data from the HOB, (2) monitor and record all MIL-STD-1553B data [3], and (3) gather fiber optic distributed temperature, hydrogen, and strain sensor data from digital signal processors which reside in the VHM computer. Optical sensors are mounted directly on the X-33 propellant tanks, while the driving optics and processing are housed in the VHM computers.

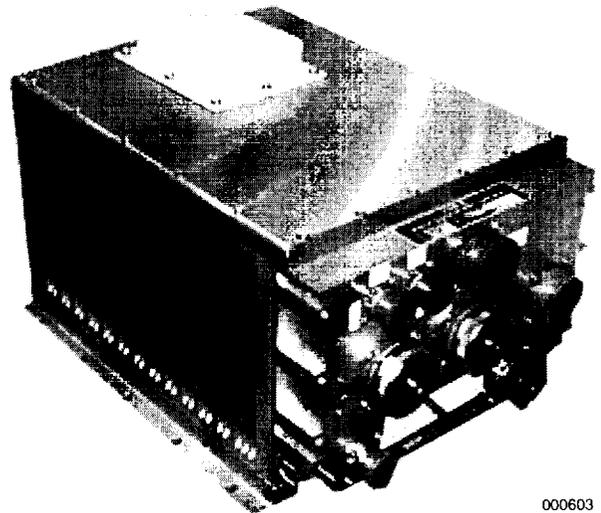
Figure 2. VHM-A/B.

The X-33 vehicle health manager-A (VHM-A) shown in figure 2 is one of two nearly identical versa-module-eurocard (VME)-based computers housed in a modified full air transportation rack chassis used to monitor and record data. VHM-A contains a commercial off-the-shelf or military off-the-shelf standard processor interfaced to a 4.5 gigabyte PC-based hard disk drive storage module and various input/output modules. VHM-A connects to 25 RHNs by means of the fiber optic HOB implementing an FDDI. The distributed fiber optic temperature sensors and MIL-STD-1553B bus monitors interface directly to the VHM-A computer. The VHM-A computer acts as a remote terminal by using a MIL-STD-1553B interface for VHM command and control information. VHM-B is nearly identical to VHM-A; the differences are that the VHM-B line replaceable unit contains the distributed fiber optic strain and hydrogen sensors. The VHM computer also handles telemetry downlink, recorder download, and system diagnostic functions.

The modified chassis design for the VHM computer (fig. 2) resulted in a box that would not fit in a standard avionics rack. As a result the computer was installed vertically on an instrumentation rack located in the gun bay on the SRA. This installation subjected the VHM computer to “off axis” loading for a significant portion of the test program.

VHM computer modifications included incorporation of GEN II fiber optic connectors and a multi-channel single-mode fiber optic connector for the DSS. Software modifications were made to integrate the system onto the SRA. These modifications changed the computer operating commands and time synchronization from a MIL-STD-1553B interface to an analog switch to command the recorder and an RS-422 interface to provide time synchronization. Additional changes included; changing to a single FDDI module for both the RHN network and the recorder download, and the use of solid-state memory replacing the hard disk drive.

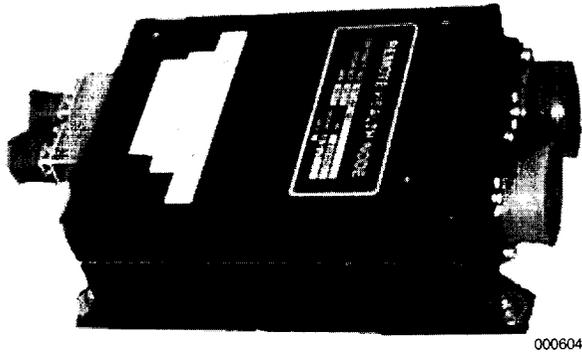
Figure 3. Figure 3 RHN.

The RHN shown in figure 3 acts as a data concentrator for analog sensor information. Each RHN communicates with its respective VHM computer over two independent HOBs using FDDI as the network protocol. The FDDI uses a full duplex, dual counter-rotating token ring topology to provide reliable communications in the event of a failure.

Each individual RHN can collect data from up to 40 sensors located in close proximity of the RHN mounting location. This configuration reduces sensor wire weight and the chance of lost data that could result from electromagnetic interference and other outside phenomena. The RHN interfaces with several types of sensors including accelerometers, strain gages, thermocouples, resistive temperature devices, and sensors that measure pressure, rate, angular position, voltage, current, angular rate, and linear position. The RHN also provides the excitation to the sensor, if any is required. The sensor data are collected, conditioned, digitized, and time-tagged in the RHN. The data are sent to the associated VHM computer by means of the HOB to be recorded on a mass storage device in the VHM computer. After the vehicle lands, the data are downloaded by an optical connection from the VHM-A and VHM-B computers to the ground-based processing and storage facilities.

The main obstacle to integrating the RHN was connector placement on both ends of the RHN, as seen in figure 3. Fiber optic and power connectors were located on one end of each RHN. The sensor inputs on two connectors were located on the opposite end of the RHN. This design made it difficult to install and remove RHNs from the aircraft because it either required access to both ends of the RHN, or that RHN connectors be mated prior to mounting the RHN to the aircraft structure.

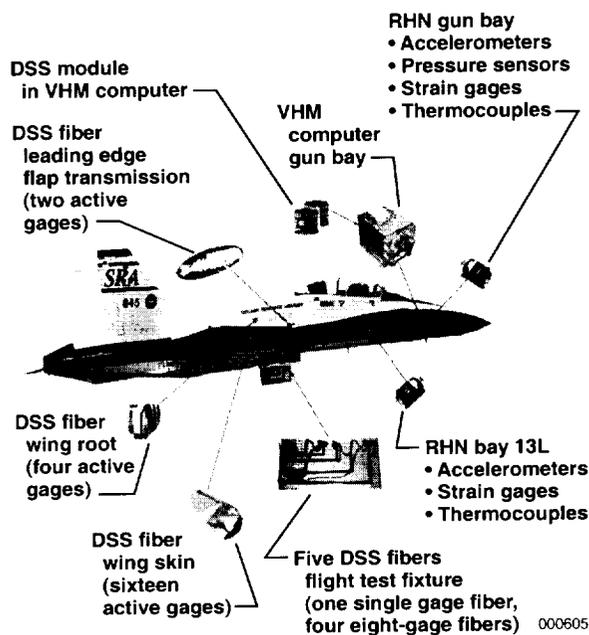
Figure 4. VHM experiment configuration.

High-risk components of the X-33 VHM system were identified for the SRA flight demonstration. These components comprised a representative subset of the overall X-33 VHM system architecture (fig. 1). Slight modifications were made to the X-33 VHM components to either validate technologies that would eventually be fielded in a VHM system or that were necessary to interface into the F/A-18 SRA. A diagram of the SRA experiment configuration is shown in figure 4.

Modifications to the SRA VHM experiment included: a single VHM computer with solid-state memory replacing the disk drive, a single FDDI module, a DSS module, and GEN II optical interconnects. Two RHNs were configured in a half-FDDI ring configuration.

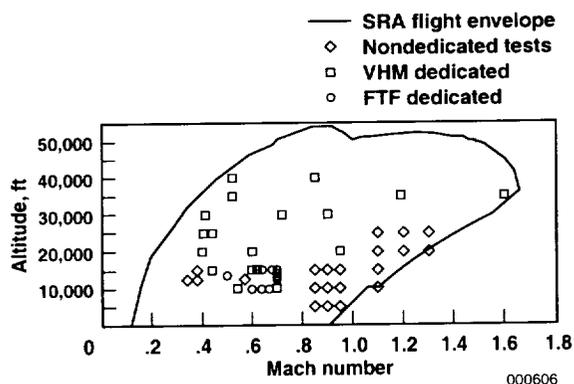
Figure 5. Flight envelope.

The VHM experiment began flying on the SRA at the end of September 1999. Flight tests concluded in early April 2000. The experiment was installed on the aircraft for 53 flights and flew for over 46 hours. These missions covered a large portion of the SRA flight envelope. Figure 5 shows the flight conditions accomplished during the test program. Thirteen of the 53 flights were dedicated to testing the VHM system. Eleven of the thirteen dedicated VHM flights were used to characterize the DSS using the FTF. The remaining two dedicated flights were used to gather RHN data in regions of the aircraft flight envelope not covered during the nondedicated flights. The remaining 40 flights were dedicated to testing other experiments being flown on the aircraft. Data were collected during these 40 missions, but there were no test maneuvers specifically dedicated to the VHM experiment.

Two of the fifteen dedicated flights were used to gather RHN data in regions of the flight envelope that were not reached during nondedicated flight test, nor during FTF flights. Constant speed climbs and descents, and dynamic maneuvers were performed at eighteen flight conditions highlighted in figure 5. The aircraft was dynamically loaded to 6 g and subjected to high pitch- and roll-rate maneuvers during these flights. The aircraft reached altitudes of over 40,000 ft and speeds of Mach 1.6 during these test maneuvers.

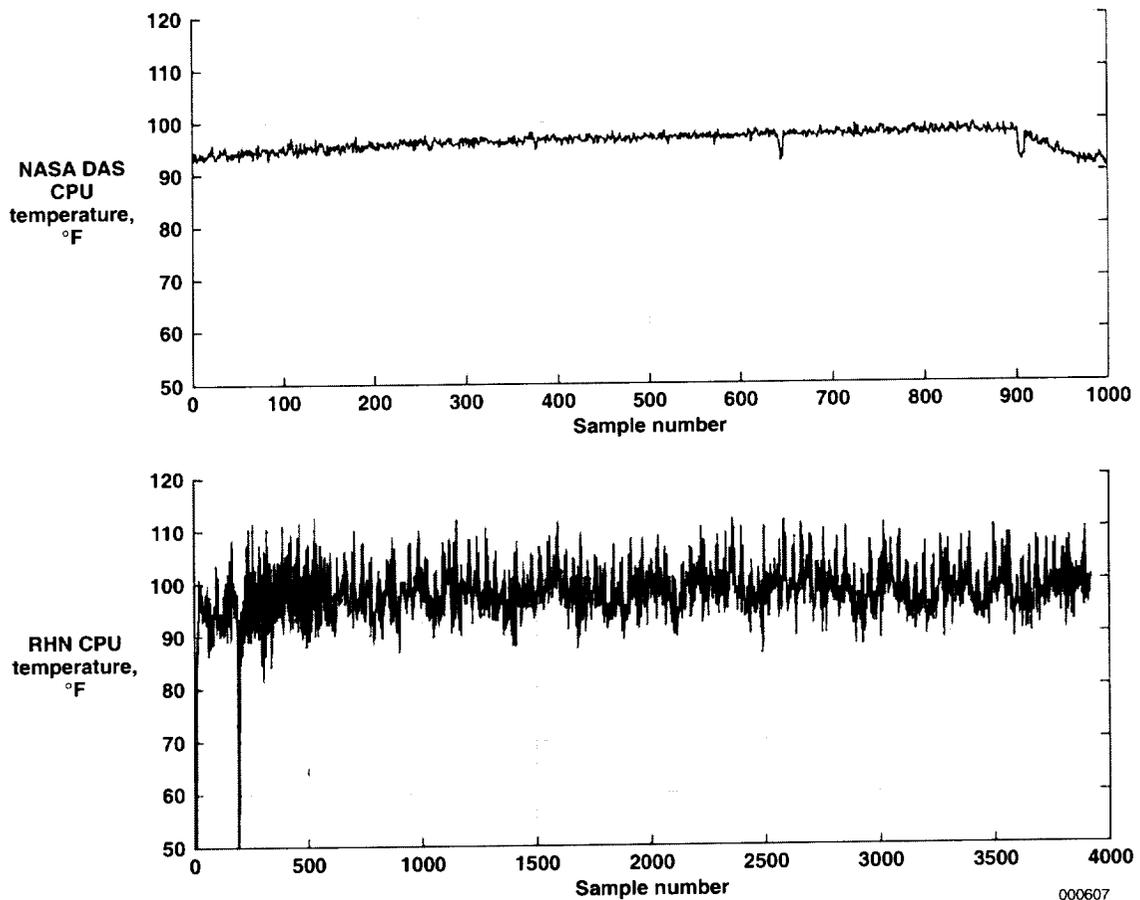
Figure 6. Flight data.

The RHNs performed without failure during the entire flight program. The data correlated well with the NASA DAS but exhibited higher levels of noise on the individual channels. Figure 6 shows elevated noise levels for collocated thermocouples recorded using the VHM System and the NASA DAS. RHN-B data were lost for the first 21 flights
