AIAA 2001-3631

**Compton Gamma Ray Observatory:  
Lessons Learned in Propulsion**

**37<sup>th</sup> AIAA/ASME/SAE/ASEE Joint Propulsion  
Conference and Exhibit**

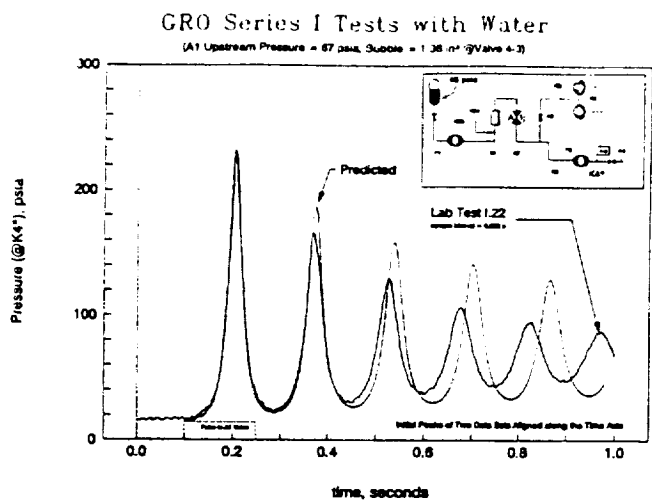
Figure 5. Water/1.36 in<sup>3</sup> Bubble/67 psia Tank

Comparisons between tests and analysis with water yielded peak pressure and frequency results of the decaying pulses typically within 15 percent of each other. This was true for initial  $\Delta P$ s of 50 psid and 100 psid. The actual decay rates of the pressure pulses were quite a bit faster than calculated, which is due to a smaller amount of damping in the model as compared to the tests.

Examples of these results are shown in Figures 5 and 6. It should also be noted that the pressure ratio of peak pressure after opening the valve to the pressure differential before opening the valve is approximately 5 at
