AIAA-2002-3793

**High-Speed, High-Temperature Finger Seal
Test Results**

**38th AIAA/ASME/SAE/ASEE
Joint Propulsion Conference and Exhibit
July 7-10, 2002 / Indianapolis, IN**

HIGH-SPEED, HIGH-TEMPERATURE FINGER SEAL TEST RESULTS

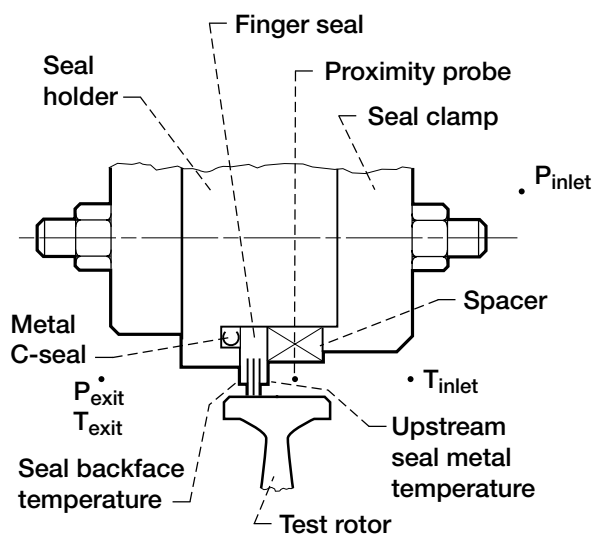
Figure 3.—Test seal configuration and location of research measurements.

Seal inlet and exit temperatures and static pressures, seal upstream metal temperature, and seal backface temperatures were measured at the locations shown in figure 3. For each measurement there were 3 probes equally spaced around the circumference, except for the upstream seal metal temperature for which 2 thermocouples were located at the 90 and 180° positions (0° is top dead center). Type-K thermocouples were used and all were 0.062 in., Inconel sheath, closed ball except the seal exit temperatures, which were 1/8-in. diameter and the seal metal and backface temperatures, which were open-ball.

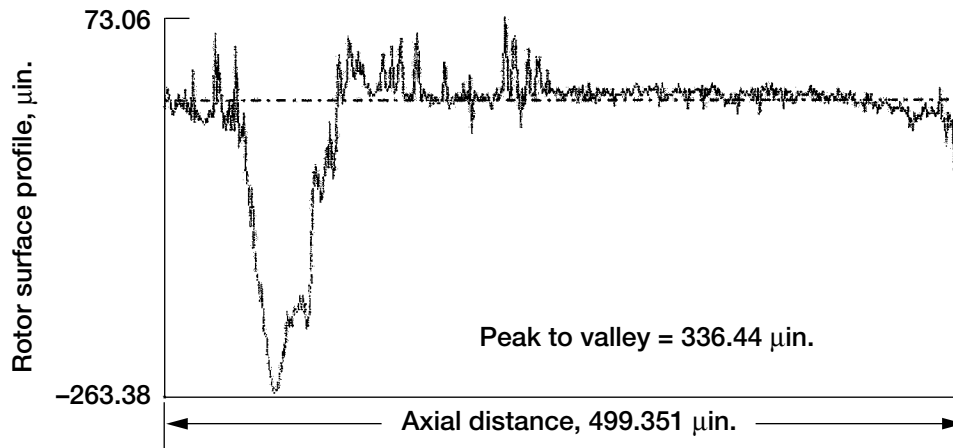
Figure 15.—Typical profile of seal wear track on rotor outer diameter.

Rotor wear was quantified using a profilometer. A typical profile of the wear track is shown in figure 15. Eight measurements were taken around the circumference of the rotor to determine an average track width and depth. These averages are presented in table II for each inspection. Both the track width and track depth measurements indicate that the majority of the seal wear took place during the first performance test. The average track width ranged from 0.080 to 0.100 in. and the average track depth ranged from 150 to 250 μ in. This is a small and acceptable amount of

wear. The scatter in the data is likely due to the uncertainty in taking the measurements at the same circumferential location on the rotor for each inspection. The circumferential locations were visually sighted using the bolt hole locations and etch marks as guides. Given that the performance test effectively covers the entire range of temperatures, pressures, and surface speeds that the seal would be subjected to during the test program, it is likely that the overall seal track width was worn in during this first performance test.
