Thermographic Inspections Save Skins and Prevent Blackouts

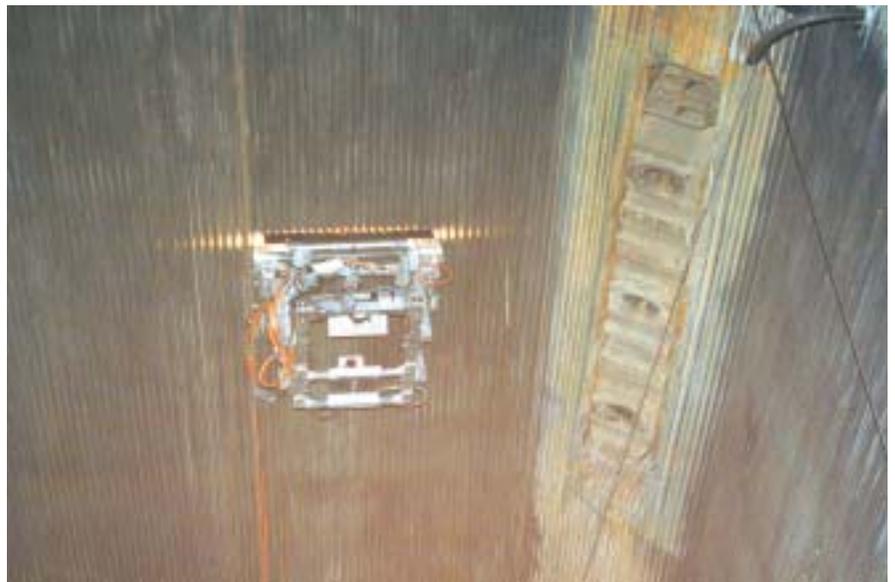
ThermTech Services, Inc.'s robotic crawler scales the inside wall of a boiler at the Schuylkill Generating Station, Philadelphia, Pennsylvania. During the inspection, the initial call outs indicated 54 tubes in the super-heat furnace rear wall should be removed. Upon removal, the 54 tubes were subjected to a boroscope exam, and the defects found by the crawler were confirmed visually.

The ThermTech robotic system using NASA technology has proved to be extremely successful and cost effective in performing detailed inspections of large structures such as boiler waterwalls and aboveground chemical storage tanks. It is capable of inspecting a waterwall, tank-wall, or other large surfaces at a rate of approximately 10 square feet per minute or faster. The inspection results provide a computerized map of the wall thickness with high-resolution data equivalent to that of existing inspection methods. Prior to the development of this technology, existing inspection methods would only allow inspection of a limited area (less than 10 percent) of the entire structure, because they are typically either manually operated or mounted on small-scale robots. Now, with the development of the thermal line scanner, it is possible to inspect nearly 100 percent of the structure in approximately the same time it takes to perform the limited area inspection.
