# Overview of High Speed Close-Up Imaging in an Icing Environment

Dean R. Miller  
Glenn Research Center, Cleveland, Ohio

Prepared for the  
42nd Aerospace Sciences Meeting and Exhibit  
sponsored by the American Institute of Aeronautics and Astronautics  
Reno, Nevada, January 5–8, 2004

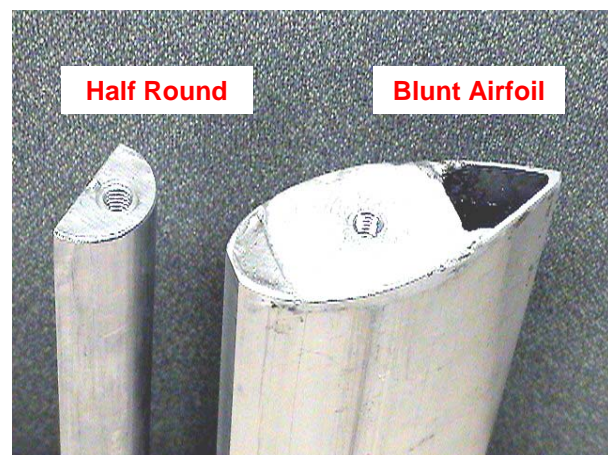
Figure 1. Test articles used for splashing visualization test.

Two test articles were selected for this test: A 2.5 in. (6.35 cm) chord symmetrical airfoil and a half round cylinder which are shown in figure 1.

The small airfoil was selected to image more direct droplet impacts at 75 and 90 degrees with respect to the impact surface, while the half-round was chosen for more shallow impacts of 15 degrees.

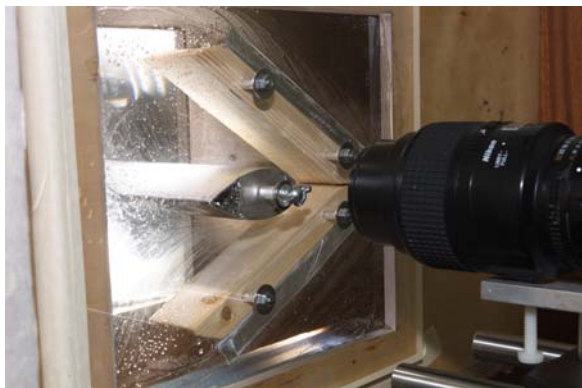
Figure 2. Blunt airfoil test article installed in 7 in. by 12 in. ACT icing tunnel test section.

The majority of test points were obtained with the airfoil model, and so the discussion from this point on will be focused on this model. The airfoil model was horizontally mounted in the test section and used as a target for this droplet impact visualization study. A portion of the model leading edge (10 mm about the highlight) was blunted to facilitate imaging of the droplet impact process. Figure 2 shows a close-up of the test section with the airfoil test article installed.

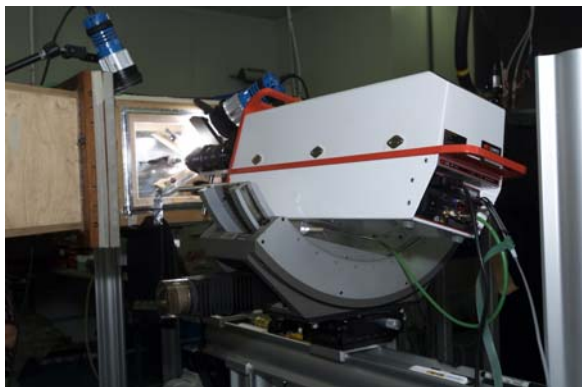
Figure 3. Ultra-8 high speed imaging system.

**Imaging System:** An Ultra-8 high speed imaging system (shown in fig. 3) was used to record the droplet impact process as a sequence of 8 images.

This camera system had previously found application in the area of high speed ballistics research, and its features are listed below:

- Gated high resolution image intensified high speed digital camera
- Captures 8 images at 520×520 pixel resolution
  - pixel size 14×14  $\mu\text{m}$
- Programmable exposure and inter-frame times ranging from 10 nanoseconds to 1 millisecond
- Framing rate of 500 to 100 million frames/sec
- Software functions:
  - calculate distance, velocity, and angle
  - contrast adjustment on stored images
  - create intensity profiles for single images

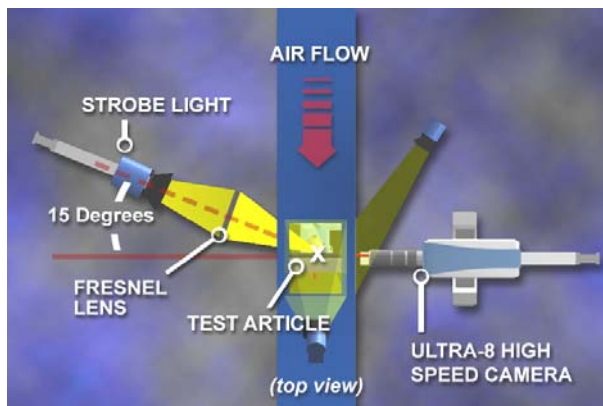
Figure 4. Top view of imaging setup at ACT icing tunnel.

Figures 4 and 5 show the overall setup of the imaging systems with respect to the test article and tunnel airflow direction.

Because imaging was attempted in a spray environment, the cloud itself produced a very high level of reflected light (noise) which was undesirable. To mitigate this, a powerful electronic strobe (6400 watt-sec) and a fresnel lens (254 mm focal length) were used to concentrate the light at the imaging target area on the test article. This approach created a point source of very intense light to illuminate splash events, essentially increasing the optical signal to noise ratio. We also found that orienting the strobe unit at 15 degrees with respect to the impact plane increased the illumination level for viewing the splash event (fig. 4).

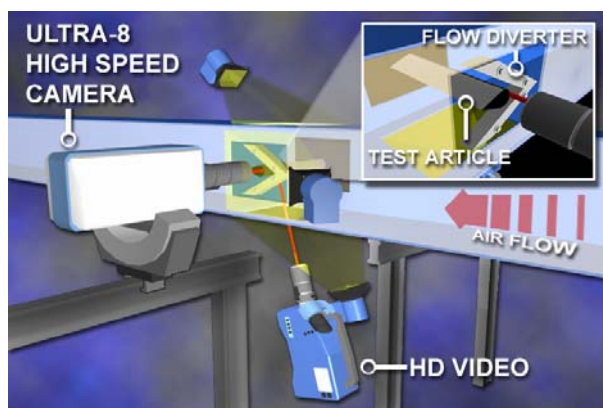
Figure 5. Side view of imaging setup at ACT icing tunnel.

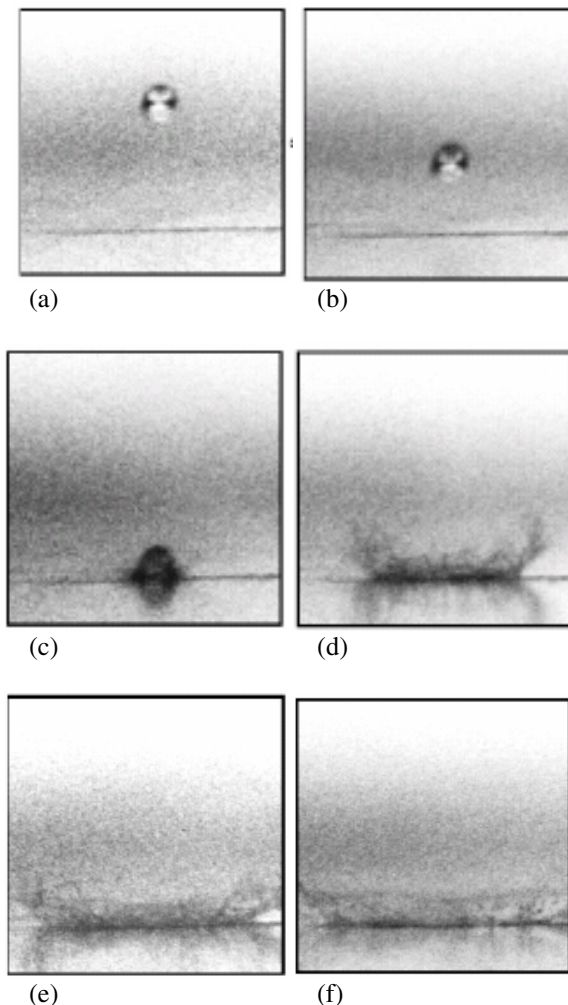
Figure 6. Ultra-high speed image sequence of a 540  $\mu\text{m}$  diameter droplet impact and splash ( $V = 50$  mps,  $T_{\text{tot}} = 17$  °C,  $\text{LWC} = 1.35$  g/m<sup>3</sup>,  $\text{FOV} = 3.7$  mm<sup>2</sup>, Exposure = 35 ns, Frame Rate = 50000 frames/sec, Gain = 3).

**Imaging Results:** Images of large water droplet impact, were captured with the ultra-high speed camera system. A progression of 6 sequential images is shown in figure 6. This sequence shows the approach, and eventual impact with the surface of the blunt airfoil test article. The relatively high level of background noise is evident in this image sequence and was a factor which limited our ability to define the smaller features of the splash event. This background noise was believed to be due to the scattered light from the water droplets and the Ultra-8 image intensifier. For the optical setup employed in this test, the minimum resolvable droplet diameter was determined to be 100  $\mu\text{m}$ .

It was possible to quantify the incoming droplet diameter and velocity, as well as the splash height using calculation functions, which were native to the Ultra-8 camera system. For the sequence shown above, the following measurements were made:

- droplet diameter = 540  $\mu\text{m}$
- velocity = 35.29 m/s
- splash height = 960  $\mu\text{m}$

The difference between the measured drop velocity and the tunnel airspeed suggests that the larger droplets may not have fully accelerated to the tunnel airspeed of 50 mps in the relatively short distance of 1.6 meters between the spray bar location and the test article.

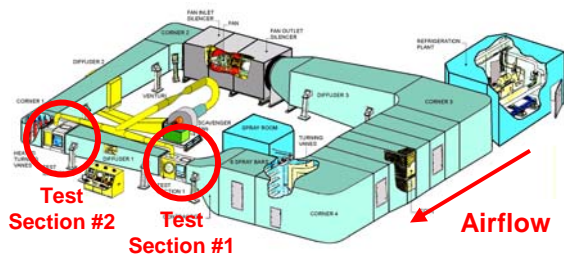
Figure 7. Cox & Company icing wind tunnel.

A test to investigate these questions was conducted in the Cox and Company LeClerc Icing Research Laboratory wind tunnel (fig. 7).<sup>5</sup> This test was sponsored by the FAA, and was a collaborative activity between Cox & Company, NASA Glenn Research Center, and Wichita State University. A test article

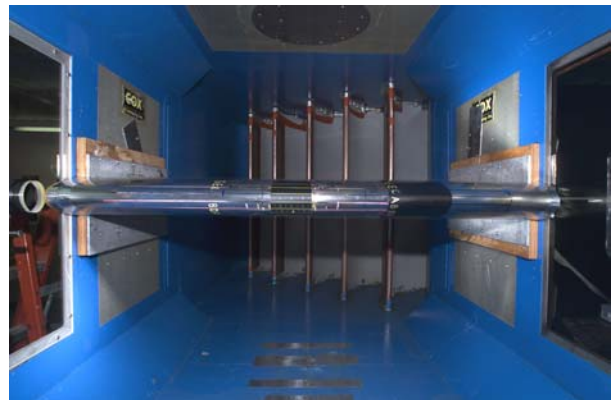
Figure 8. Electro-thermally heated test article mounted in the Cox & Company icing wind tunnel.

consisting of a 2-D wing section with an electro-thermal ice protection system was tested under a variety of mixed phase conditions. NASA Glenn provided high speed close-up imaging systems for this test. The visual information obtained from the imaging systems was intended to complement thermal measurements from the test article. High speed close-up imaging methods were thus used to acquire a better understanding of the impact process, and the degree to which ice particles “stick” or “bounce” for particular mixed phase tunnel and test article surface conditions.

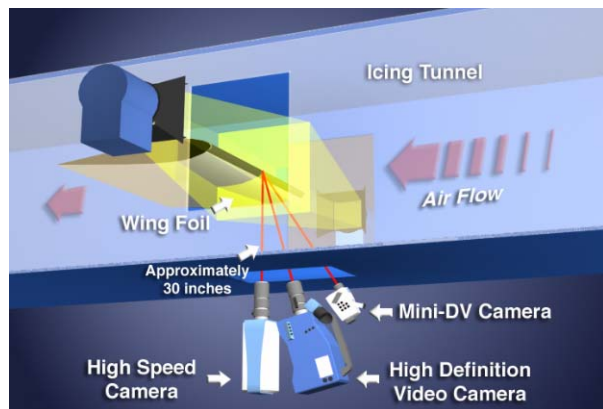
Figure 9. Orientation of three camera systems used to characterize the ice particle impact process.

With the test article horizontally mounted in the tunnel, imaging of the leading edge area was best accomplished by either an overhead view, or from below. Since there was no visual access from above, a window in the floor of the test section was used to image the leading edge area of the airfoil (as shown in fig. 9). The cameras were tilted on a slight angle off vertical, and were approximately 30 in. (0.76m) from the test article. Lighting of the test article was done using HMI lights thru both side windows in test section #2.

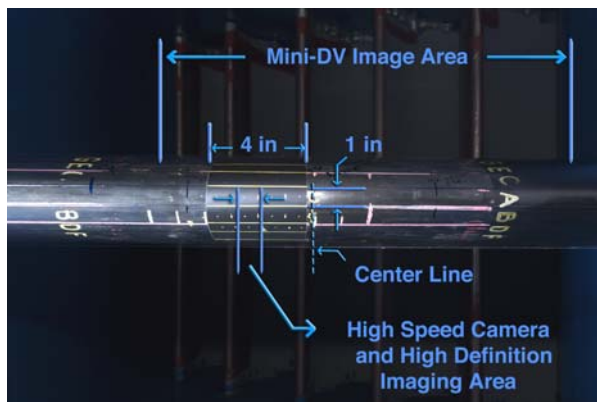
Figure 10. Close-up view of test article leading edge showing the imaging areas for the 3 camera systems.

The primary area of interest was a 1 in. (2.5 cm) square area located along the stagnation line of the airfoil, approximately 2.5 in. to the left of the tunnel centerline. Both the HD and high speed camera systems were focused within this area. The imaging locations were chosen near the horizontal centerline of the tunnel, to ensure that icing conditions would be as uniform as possible. The imaging areas for the 3 camera systems are shown in figure 10.

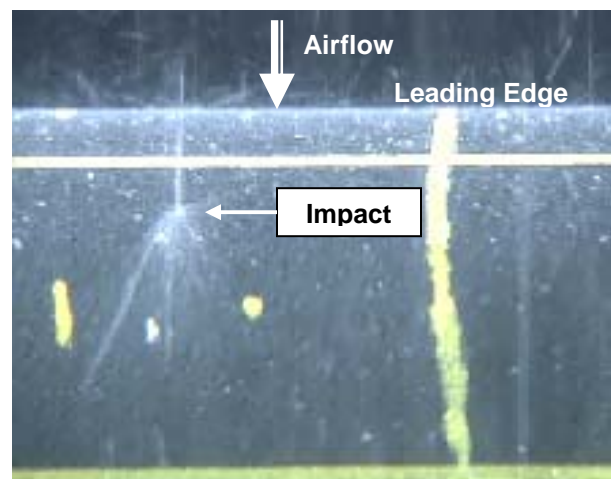
Figure 11. Frame capture image from high-definition video camera showing ice particle impact on an unheated surface. Residual pieces of ice on surface appear as specks of white against black airfoil surface.

Figure 11 shows an ice particle impact and residual ice fragments on an unheated surface. No ice accumulation developed from the residual ice fragments that remained on the unheated surface.

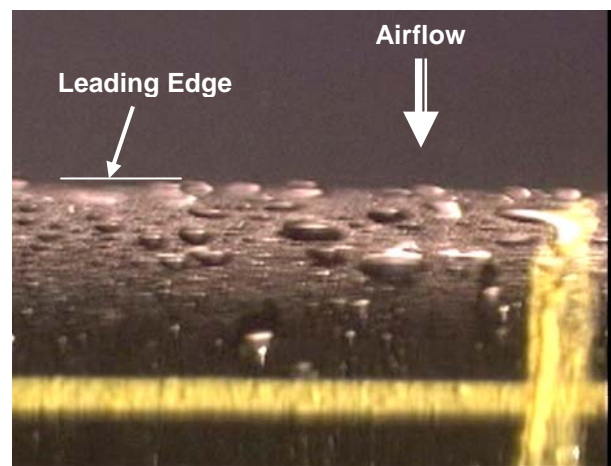
Figure 12. Frame capture image from high-definition video camera, showing water beads on the airfoil leading edge, with a heated surface.

For cases where the surface was heated, water beads were observed to form on the leading edge in the vicinity of the stagnation line. This was noted for all mixed phase spray conditions (100% supercooled liquid, part liquid and ice, or 100% ice). The water beads then began to coalesce into larger beads and eventually ran back toward the trailing edge of the airfoil. Figure 12 is an example of imagery from the high-definition camera, showing water beads on the leading edge of the airfoil.

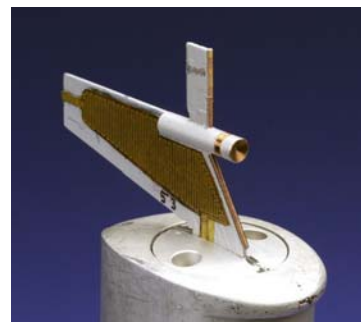
Figure 14. Nevzorov TWC/LWC probe.

The Nevzorov probe (fig. 14) has both a TWC sensor and an LWC sensor integrated into one vane. This feature enables it not only to measure the Total Water Content (Liquid + Ice), but to provide an estimate of Ice Water Content (IWC) in mixed phase conditions. Though water content measurements were recorded from both sensors, the imaging equipment was focused only on the conical TWC sensing element.

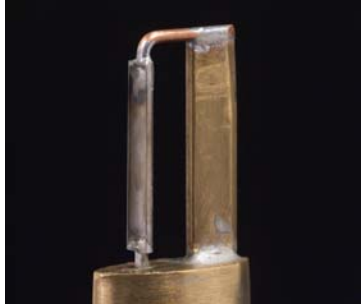
Figure 15. Science Engineering Assoc. TWC probe.

Another TWC probe developed by Science Engineering Associates (SEA) was evaluated, with the outside shroud removed. Normally this probe has an annular shroud surrounding the half-cylindrical shaped sensing element. However, the shroud was removed to facilitate lighting and viewing of the sense element for this test.

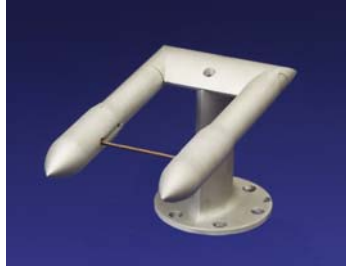
Figure 16. King LWC probe.

A King LWC probe was also evaluated for its response to ice particles. The imaging equipment was focused on the sensing wire, which extended between the two horizontal support arms. The King probe was included in this test because it has been used extensively over the years, resulting in a large database to characterize its performance. Therefore, it was thought that King probe results from this test might be able to be compared with this body of existing data for liquid and mixed phase conditions.

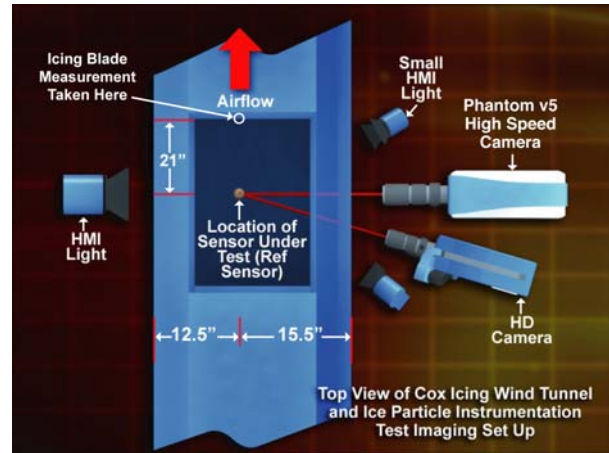
Figure 17. Imaging setup for investigation of ice particle impact on cloud water content instrumentation.

**Imaging System:** The cameras used in this test were the same as those used in the mixed-phase icing test discussed previously. A high-definition video camera, and a Phantom v5 high speed camera were used to visually study the impact of ice particles on the sensing element of the hot-wire cloud water content probes. The high-definition video camera was intended to provide a real-time high resolution record of each test run. The high speed camera was intended to capture ice particle impact at high frame rates, to facilitate later playback at reduced speeds. Imaging and lighting of the instruments under test were accomplished using the side windows of test section #1. The imaging setup for this test is shown in figure 17.

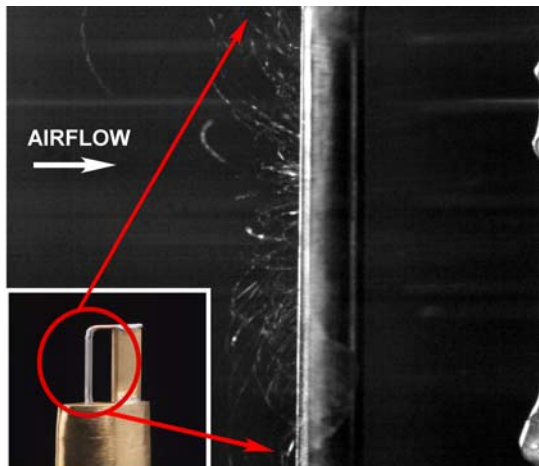
Figure 18. Ice particle impact on Science Engineering Associates TWC hot-wire sensing element (half-cylinder cross section).

Ice particles were observed to impact the hot-wire sensing element of the probes. In some cases the ice particles shattered into multiple smaller fragments, some of which rebounded off the sensor surface into the air-stream and were swept away. Also, a small residual piece of ice tended to remain on the surface of the sensing element after impact, until it apparently sublimated or melted. In other cases, the ice particle impact was observed to splash liquid off the sensing element and into the air-stream where it was swept away. Typical high-frame rate camera imagery of ice particle impacts are shown in figures 18 and 19 for the SEA TWC sensor, and the King probe sense wire, respectively.

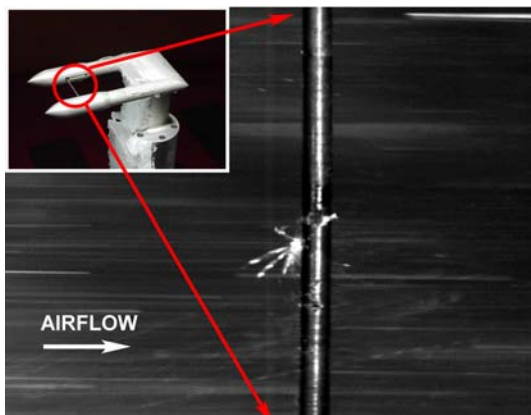
Figure 19. Ice particle impact on King probe hot-wire sensing element (cylindrical cross section).

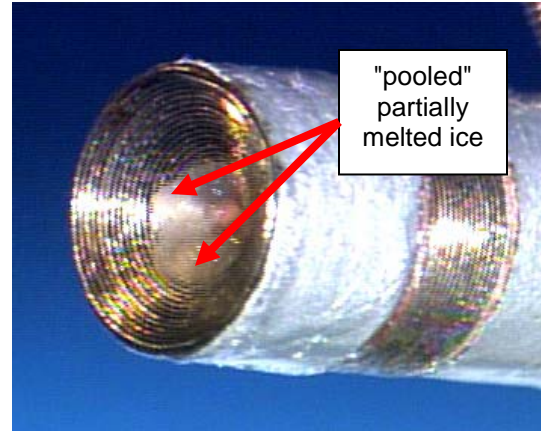
Figure 20. Close-up of Nevzorov TWC hot-wire sensing element showing melted ice particles.

One unexpected result, was a phenomena we called “pooling.” It was first noticed occurring on the Nevzorov TWC sensor, and post-test review of high speed camera imagery suggests it may also be occurring on the SEA TWC sensor (to some degree). This

phenomenon was manifest as a buildup of what appeared to be a slushy “pooled” mass of partially melted ice particles, as shown in figure 20. This mass appeared to grow in size, and at some point was eventually ejected from the sensing cone element, whereupon the cycle would start again. It was not known if this was an artifact of the test condition (i.e., choice of relatively high IWC levels compared to what exists in natural conditions).
