Effects of Heavy Ion Exposure on Nanocrystal Nonvolatile Memory

Timothy R. Oldham,¹ Mohammed Suhail,² Peter Kuhn,² Erwin Prinz,² Hak Kim,³ and
Kenneth A. LaBel,⁴

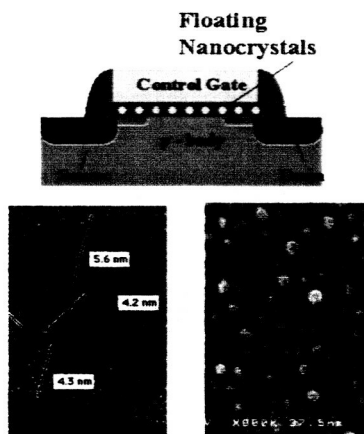
Figure 1 Silicon nanocrystal nonvolatile memory bitcell showing the floating silicon nanocrystals used for isolated charge storage.

The test chips were experimental 4Mb Flash EEPROM memories fabricated using 0.13μm design rules. Nanocrystal technology is a new approach for non-volatile memory that may eventually replace the established floating gate technology. In this technology the storage medium consists of a layer of silicon nanocrystals, sandwiched between a bottom and a top oxide, instead of the continuous polysilicon storage medium of floating gate technology. The use of silicon nanocrystals (Fig. 1) as a storage medium has shown to provide immunity from oxide defects which can arise during program / erase

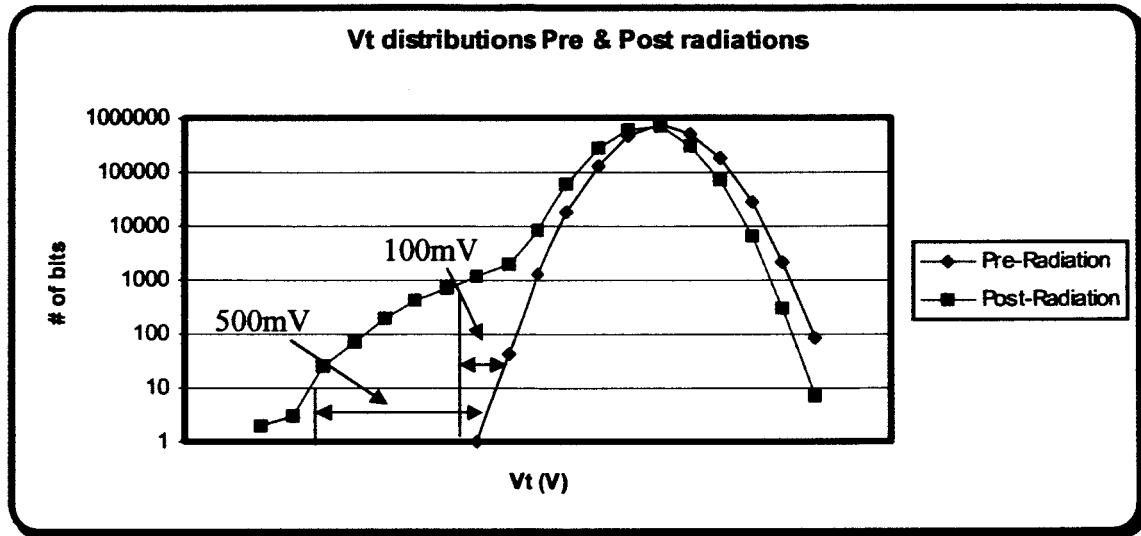
Fig. 2 shows the tail in the threshold voltage distributions post radiation. Similar behavior has been reported on floating gate bit-cells. [6-8]. The test vehicle used for this experiment has special test modes, which can be used to set the fail criteria. To maximize sensitivity without introducing noise into the measurement the fail criteria

during this experiment was set to 100mV from the initial threshold distribution as shown in Fig 2. A product would have a much wider fail margin, typically >500mV. Fig 2 shows that the SEU would decrease by a two orders of magnitude if the fail criteria were set at a realistic target of 500mV.

Fig 2: Program state threshold voltage distributions pre and post radiations.

Fig. 2 shows the tail in the threshold voltage distributions immediately after radiation. The shift is caused by radiation induced charge loss from the silicon nanocrystals. The instantaneous shift in the threshold distributions can cause read errors, but no permanent damage is done to the bit-cell, and the data can be restored by resetting the array. In addition to the read errors, long term data retention performance of the radiated bit-cells after reset is of concern. It has been reported that the long-term data retention of the

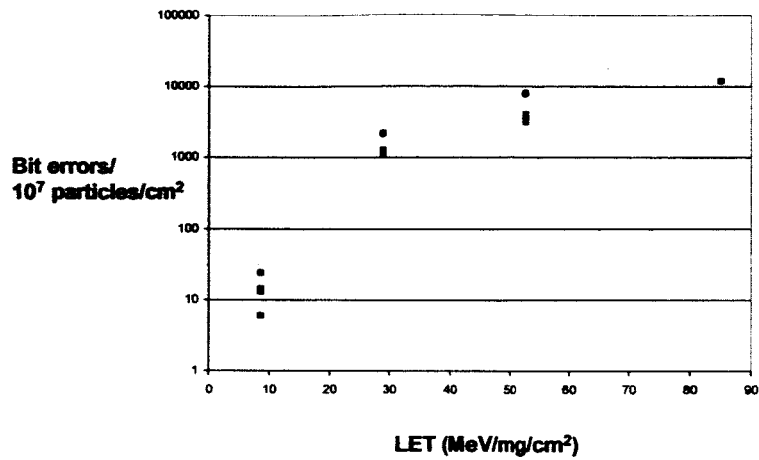
For the nanocrystal technology, the results for stored zeroes are summarized in Figure 3. For the read tests illustrated in Fig. 3, the maximum bit error count was slightly more than 10^4 , for 10^7 particles/cm². However, the area of the memory array is much less than a square cm, approximately 0.02 cm². Therefore, the number of ions hitting the array is on the order of 2×10^5 per exposure. Perhaps 30 percent of the array area is active gate area (estimated from a SEM picture), so the number of ions hitting active gate regions is about 6×10^4 per exposure. In other words, about one ion out of 6 that hits the active gate area changes the state of the cell, even at the highest LET tested so far. Therefore, the observed cross section is about one sixth times the geometric gate cross-section.

Fig. 3 Read errors

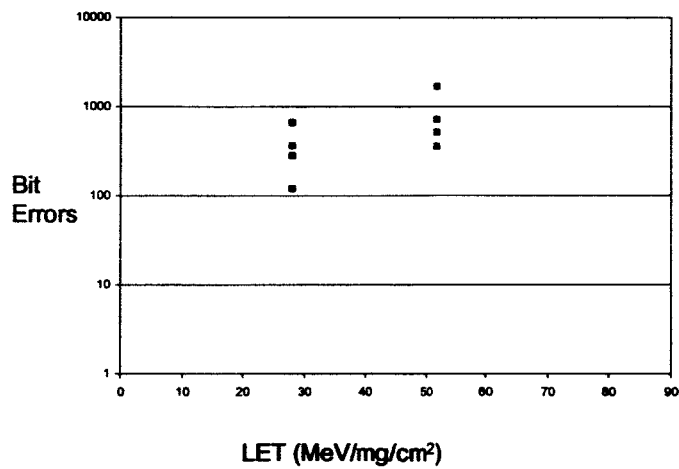
The results of the dynamic write/read testing are summarized in Fig. 4. The errors appear to all be static single bit errors, and the total count is less than in the read only test, because the flipped bits are being rewritten during the test, instead of being allowed to build up. No functional interrupts were observed, nor any other errors that could be attributed to the control circuits.

Fig. 4 Write/Read Errors

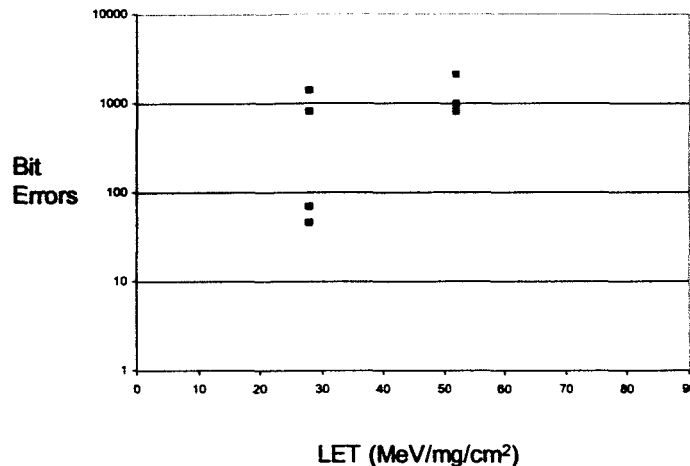
The results of the dynamic erase/write/read test are summarized in Fig. 5. Again, the errors appear to be all static single bit errors, where the total count is less than in the read only test, because the errors are being rewritten during the test. No functional interrupts were observed, nor any other errors that could be attributed to the control circuits.

Fig. 5 Erase/Write/Read Errors
