Teflon FEP Analyzed After Retrieval From the Hubble Space Telescope

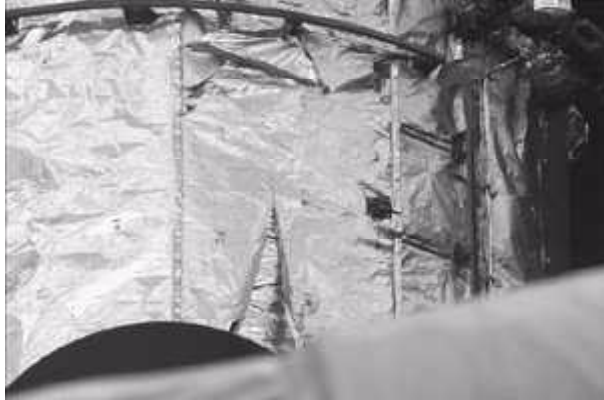
Hubble Space Telescope light shield sample retrieved during the second servicing mission; shown prior to removal.

During the Hubble Space Telescope (HST) Second Servicing Mission, 6.8 years after the telescope was deployed in low Earth orbit, degradation of unsupported Teflon FEP (DuPont; fluorinated ethylene propylene), used as the outer layer of the multilayer insulation (MLI) blankets, was evident as large cracks on the telescope light shield. A sample of the degraded outer layer (see the photograph) was retrieved during the second servicing mission and returned to Earth for ground testing and evaluation. Also retrieved was a Teflon FEP radiator surface from a cryogen vent cover that was exposed to the space environment on the aft bulkhead of the HST. NASA Goddard Space Flight Center directed the efforts of the Hubble Space Telescope MLI Failure Review Board, whose goals included determining the FEP degradation mechanisms. As part of the investigations into the degradation mechanisms, specimens retrieved from the first and second HST servicing missions, 3.6 and 6.8 years after launch, respectively, were characterized through exhaustive mechanical, optical, and chemical testing. Testing led by Goddard included scanning electron microscopy, optical microscopy, tensile testing, solar absorptance measurements, time-of-flight secondary ion mass spectroscopy (TOF-SIMS), Fourier transform infrared microscopy (μ -FTIR), attenuated total reflectance infrared microscopy (ATR/FTIR), and x-ray diffraction (XRD). The NASA Lewis Research Center contributed significantly to the analysis of the retrieved HST materials by leading efforts and providing results of bend testing, surface microhardness measurements, x-ray photoelectron spectroscopy, solid-state nuclear magnetic resonance spectroscopy, and density measurements. Other testing was conducted by Nano Instruments, Inc., and the University of Akron.

surface hardness that decreased with depth. Solar absorptance of the space-exposed FEP was slightly increased. In general, analyses showed that all of the retrieved specimens underwent chain scission. Evidence of increased crystallinity was found only in the light shield specimen from the second servicing mission, which had curled on orbit and thus experienced a significantly higher temperature than is typical for the HST light shield. Heating specimens from the first servicing mission also generated increased crystallinity. The conclusions of the Hubble Space Telescope MLI Failure Review Board were based on the combined evidence of HST damage and data uncovered in ground-based experiments. The review board concluded the following:
