ISS Internal Active Thermal Control System (IATCS) Coolant Remediation Project

Russell H. Morrison
The Boeing Company

Mike Holt
NASA Marshall Space Flight Center

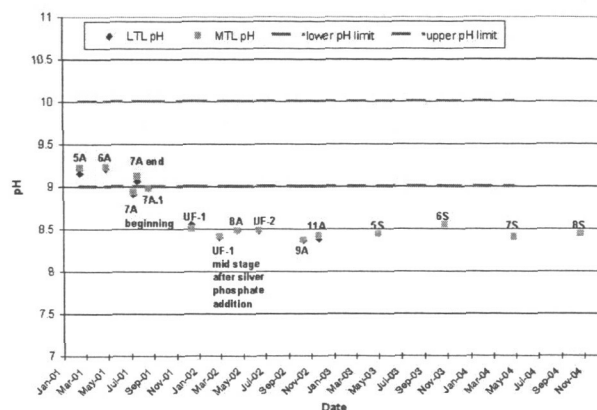
Figure 1. Coolant pH as measured in coolant samples returned from ISS for ground analysis.

The Teflon flexhoses are not only permeable to oxygen, but they are also permeable to CO₂ and this resulted in increases in total inorganic carbon (TIC) to levels on the order of 200 ppm and a reduction in coolant pH, Figure 1, as the borate/phosphate buffer was affected by the increasing concentration of carbon dioxide in the coolant.

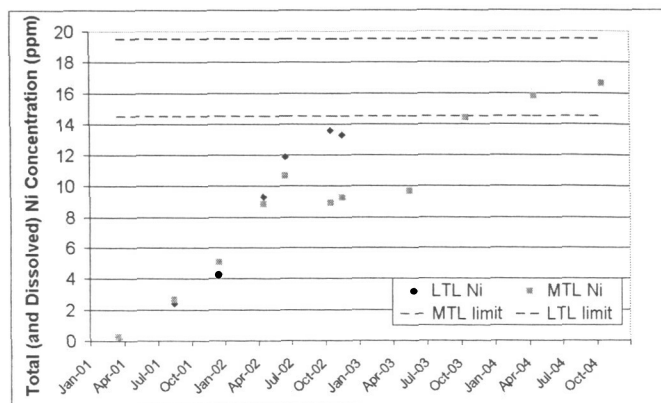
Figure 2. Total (approximately equal to dissolved) nickel concentration as measured in ISS coolant samples returned to ground for analysis

The decrease in pH was accompanied by an increase in dissolved nickel ions within the coolant as illustrated in Figure 2. As the pH decreased and the nickel ion concentration increased, the point was finally reached when the phosphate in the coolant began to combine with the nickel to precipitate as nickel phosphate. The falling phosphate concentration is illustrated in Figure 3.

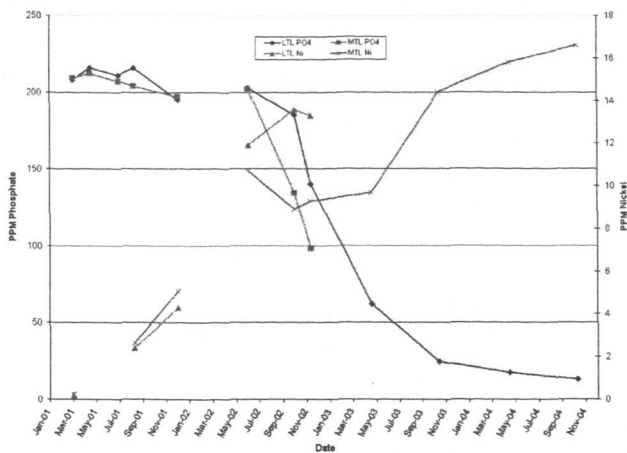
Figure 3. Phosphate and dissolved nickel trends showing nickel concentration leveling off as phosphate concentration drops (forming nickel phosphate)

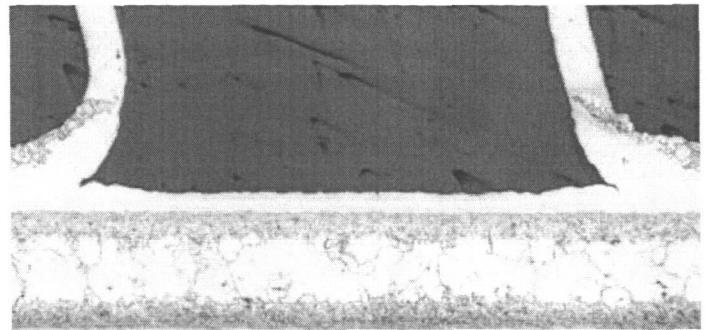
Figure 4 Typical HX cross-section

Nickel 201 fins and CRES 347 parting sheets held together with BNi2 or BNi3 nickel braze as shown in Figure 4. Figure 5 [3] shows a highly magnified cross-section of a typical BNi3 brazed parting sheet. There is a layer of nickel braze that is approximately 0.001 inch thick which is in contact with the coolant. The bulk of this layer is "matrix" phase nickel, which is relatively pure nickel and very corrosion resistant. It is not significantly affected by the lower pH. Within this nickel layer are pockets of non-diffused "intermetallic" nickel. Intermetallic nickel within the braze layer is a blend of primarily nickel and silicon, from the braze itself. Both nickel and silicon concentrations were determined in the flight 7S coolant sample from April 2004 and were found to be 15.7 and 7.5 ppm, respectively, providing further evidence for this non-diffused intermetallic nickel as the source of the increasing nickel concentration. It is found in the fillet regions of all the nickel brazed components and in the flat surfaces of most of the BNi3 brazed components, which include the coldplates and some critical heat exchangers. This material becomes more and more susceptible to corrosion or dissolution in the IATCS coolant as the pH falls below 9.5 and leaves behind voids as shown in Figure 6. A survey of over 100 BNi3 samples has shown that the deepest void can extend down to within 0.0002 inch of the bottom of the braze layer. Life predictions for these components begin with the assumption that there is only 0.0002 inch of corrosion resistant matrix phase material before the

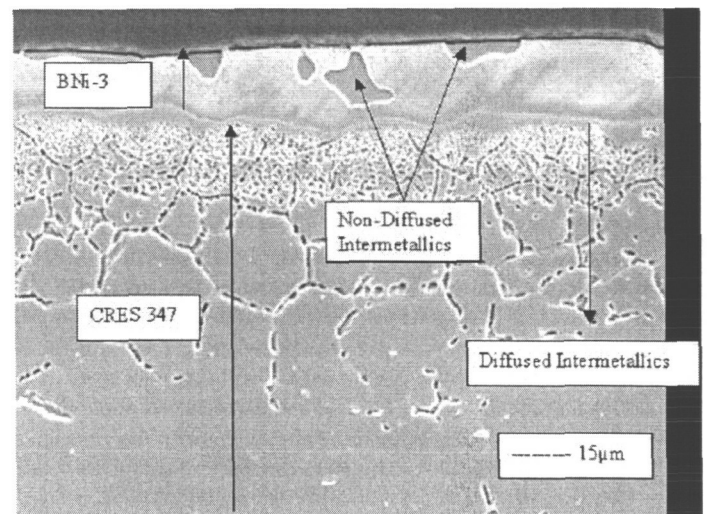
Figure 5. Typical BNi3 Cross-section before exposure to IATCS Coolant

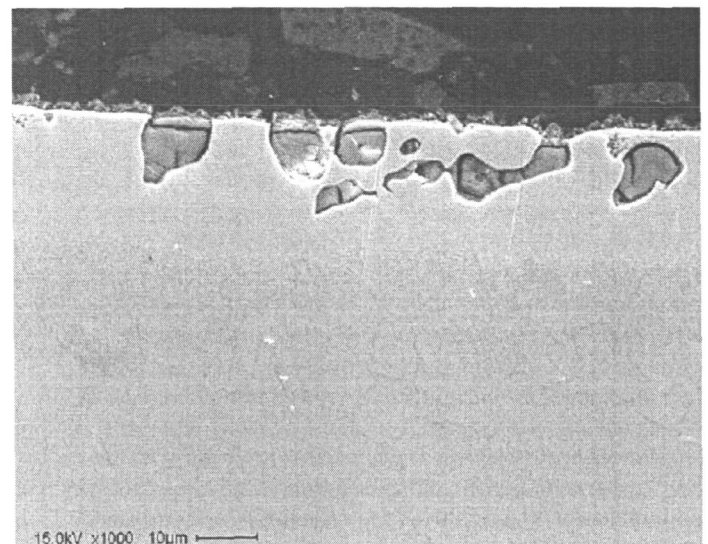
Figure 6. Typical BNI3 after non-diffused intermetallic are corroded away

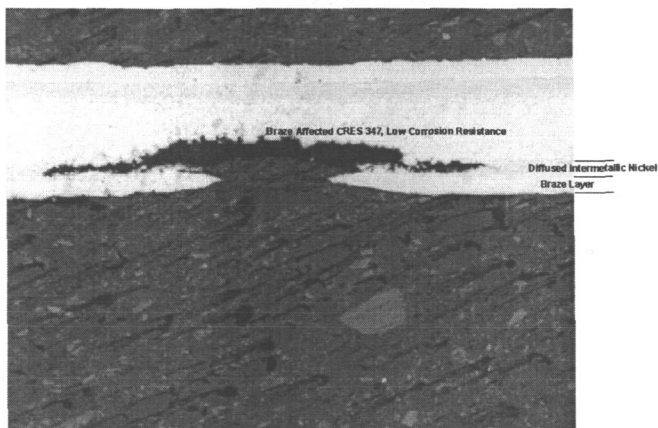
Figure 7. Effects of corrosive attack on diffused intermetallic in BNI3 braze coupon

Beneath the braze layer of nickel is another layer with a thickness, typically 0.001 to 0.002 inch of diffused intermetallic nickel into the CRES 347 parent material. Within this layer, the chromium at the grain boundaries within the CRES 347 alloy is bound up with boron introduced by the braze process. This layer is also highly susceptible to corrosive attack as can be seen in Figure 7 where the nickel braze was penetrated by coolant in this case, during Cyclic Potentiodynamic Polarization testing. In heat exchangers, the CRES 347 parting sheet is 0.006 inch thick and has a braze layer on both sides, so there may be only about 1/3 of the parting sheet with any real corrosion resistance. This corrosion rate is so high that when predicting component life for certain critical components, the coolant chemistry team typically considered penetration of the braze layer as being the life limiting event and would assign no additional life to the hardware for the parting sheet thickness. Once penetrated, iron oxide is produced from the 347 parent material and typically adheres close to point of penetration providing a clear marker for the penetration, as in Figure 8.

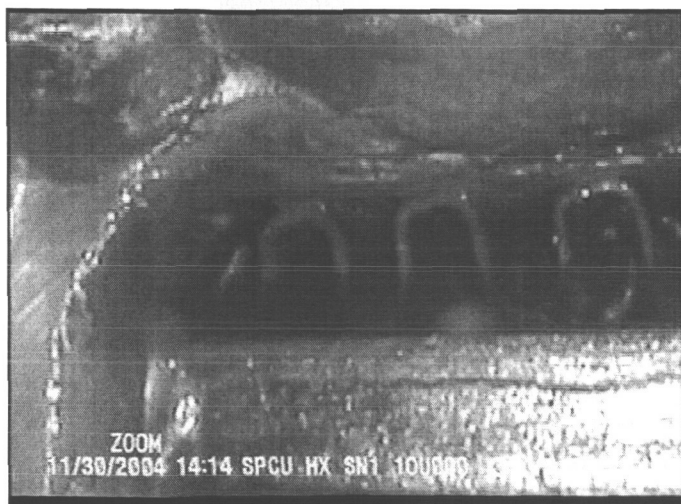
Figure 8. Iron oxide in vicinity of braze layer penetration on SPCU qualification unit

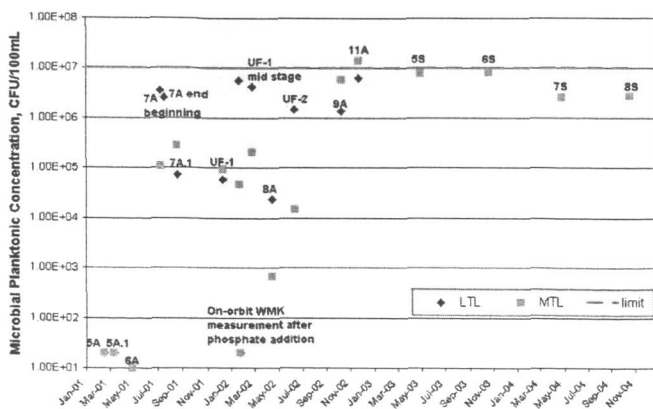
Figure 9. Planktonic microbial heterotrophic plate counts on R2A Agar as measured in ISS coolant samples returned to ground for analysis

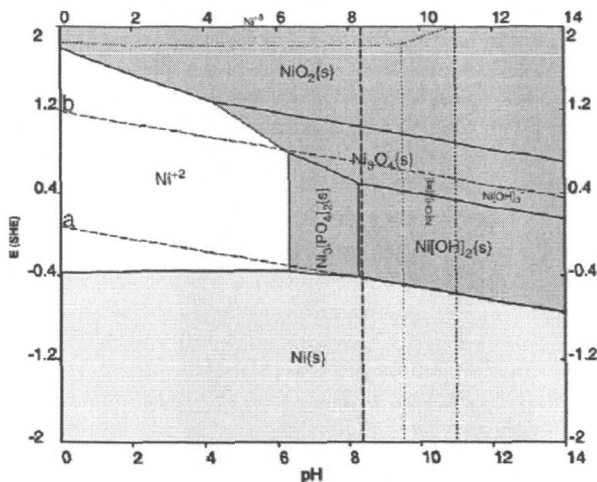
Figure 10. Stability diagram for Nickel in IATCS coolant showing that on-orbit equilibrium pH lies at boundary between nickel hydroxide and nickel phosphate formation.

PRECIPITATE FORMATION - The corrosion and biofilm effects on the IATCS are only based on literature reviews and ground testing. Nickel precipitation, on the other hand, has been a confirmed nuisance on orbit. Nickel phosphate becomes the most stable form for the dissolved nickel from the braze intermetallic layer as the pH of the coolant solution drops to 8.3. This is illustrated in a stability diagram, Figure 10, from an equilibrium model of the coolant chemistry [7]. As chance would have it, the CO₂ concentration on orbit is at exactly the right level to naturally drive the IATCS coolant, with its buffers, to a pH of about 8.4. It is expected that small changes in pH, either up or down, could result in the conversion of nickel precipitate from the phosphate form to the hydroxide form and vice versa. This is a potentially very unstable situation. Figure 3 clearly illustrates how the increasing nickel concentration flattened out at around 10 – 12 ppm beginning around March 2002, just as the coolant pH was dipping below 8.5, Figure 1, and the phosphate concentration plunged from over 200 ppm to about 50 ppm after which the nickel concentration began to rise again. Nickel phosphate is a hard, green, crystalline precipitate. At higher pH, nickel hydroxide is the stable form for the nickel to take and it is a gelatinous precipitate.

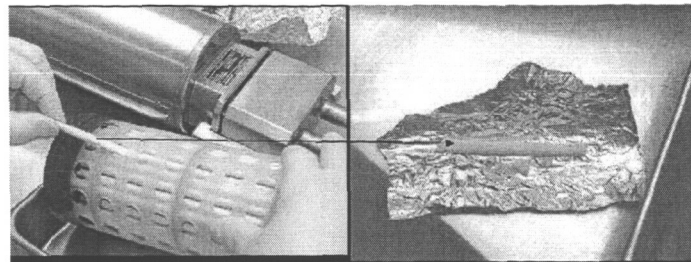
Figure 11. "Green gas trap" – contaminated with nickel precipitates, suspect primarily phosphate

Green Gas Trap, July 2001 - The effects of nickel precipitation were believed to be first observed in the IATCS in July 2001 when the pressure drop across a gas trap installed in the MTL had risen to 6 psid from a nominal 4.4 psid last observed in November 1999 [8]. The pressure drop across this gas trap had been rising even during ground testing of the US Lab. The last pressure drop observed on the ground before launch was 5.3 psid in September 2000. The US Lab was activated on-orbit in February 2001 and by May 2001, the gas trap pressure drop had risen to 5.7 psid. It was returned to the ground in August 2001. The hydrophilic membranes had a green appearance as illustrated in Figure 11, rather than the normal white. Tests revealed no significant microbiological contamination. Flushing with de-ionized water, isopropyl alcohol, and dilute hydrochloric acid cleaned the membrane module. At the time of its removal, the pH of the IATCS coolant was still around 9 and had never been below 9. Phosphate concentration was still in the normal range. Nickel concentration in the coolant was still below 2 ppm and was never high when the first increases in pressure drop were observed on the ground. Analysis of contamination from the membrane did reveal some nickel, phosphorus, silicon, aluminum and oxygen. It is not clear that these compounds were in large enough quantities to be responsible for the pressure drop observed. It is interesting that even in the surge of nickel phosphate precipitation that occurred over an 18 month period beginning in March 2002, it was not until one year into the process that the MTL gas trap pressure drop again reached 6 psid. It is not clear what role nickel precipitation played in the gas trap failure of July 2001, but it did alert the program to potential issues with nickel precipitates in the months to come.

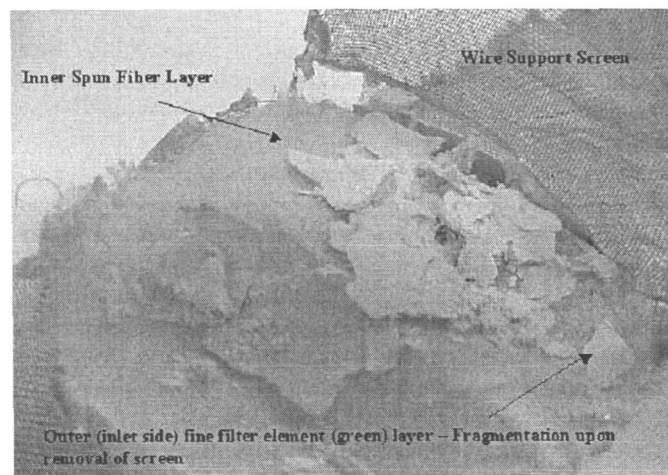
Figure 12. Green filter – contaminated with nickel precipitates, primarily phosphate

Green Filter, October 2002 – This filter was installed on the MTL in January 2002 after having been seeded with silver phosphate in an attempt to achieve some measure of microbiological control. After dissolution of the silver phosphate, pressure drop fell to the normal 1.9 psid. By October 2002, well into the main nickel phosphate precipitation event, the pressure drop in this filter had risen to 4 psid. It was replaced and returned on flight 9A. Green precipitate was quite obvious on this filter as seen in Figure 12. Scanning Electron Microscope/Energy Dispersive X-Ray Fluorescence (SEM/EDXRF) analysis clearly showed strong nickel and phosphate peaks. Fourier Transform Infrared (FTIR) spectrum analysis also closely matched that for nickel phosphate. This filter was clearly consumed due to nickel phosphate precipitation.

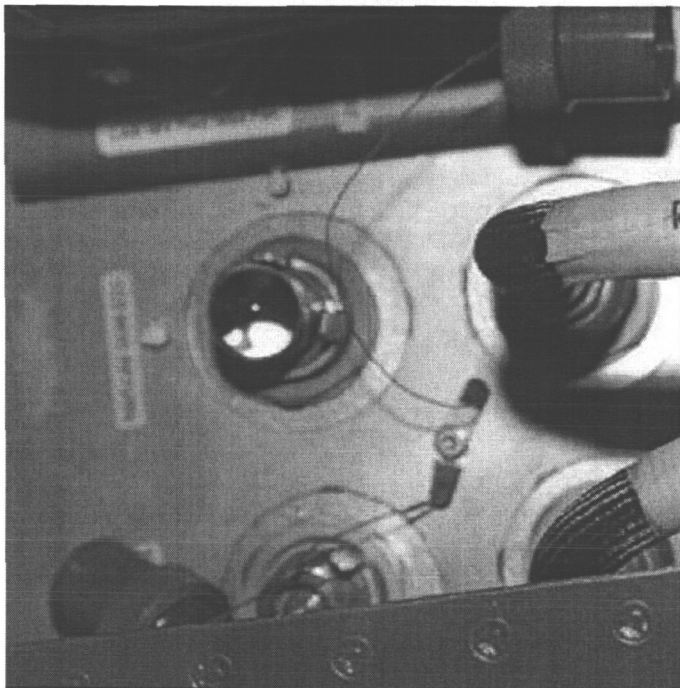
Figure 13. On-orbit quick disconnect leak

Quick Disconnect (QD), February 2004 – A temporary reconfiguration of the coolant loops to support a Soyuz vehicle relocation on ISS left four normally mated male and female QDs in a demated state for a period of approximately 56 hours. Two of the QD halves, one male, one female, had water blobs on their open faces totaling approximately 100 ml just before they were mated. The male QD water blob is visible in Figure 13. These parts remain in service. It is premature to conclude that nickel phosphate played a role in these leaks, but again, it is highly suspect. Procedural changes requiring the installation of caps or plugs on demated QD halves have been instituted. When this is not possible, the QD is cycled once before de-mating in the hopes of dislodging precipitate. One of the leaking QDs will be returned for failure analysis with a flexhose on flight LF-1.

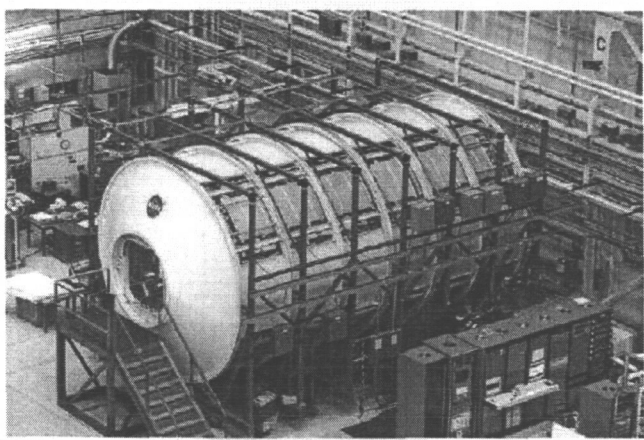
Figure 14. US Lab module simulator at Marshall Space Flight Center

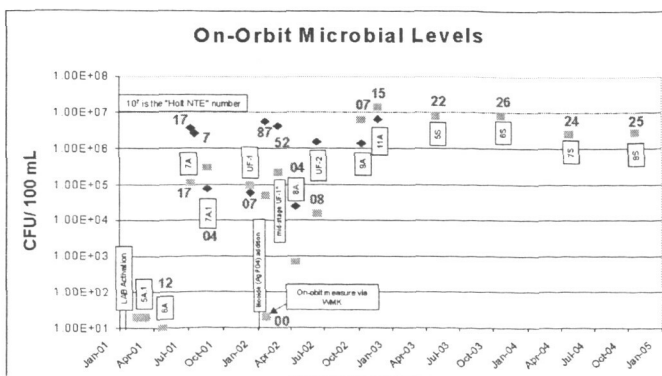
Figure 15. Microbial data through June 2004 showing sample hold times (red numbers, days) before analysis

Hold times for samples through mid-2004 are illustrated in Figure 15. In this figure it appears that longer hold times tend to be associated with higher microbial population measurements, although there are some inconsistencies. While this casts doubt on the accuracy of the microbial measurements, it suggests that they are at least conservative, and it is the general policy of the ISS program to use worst-case scenarios to drive decisions.

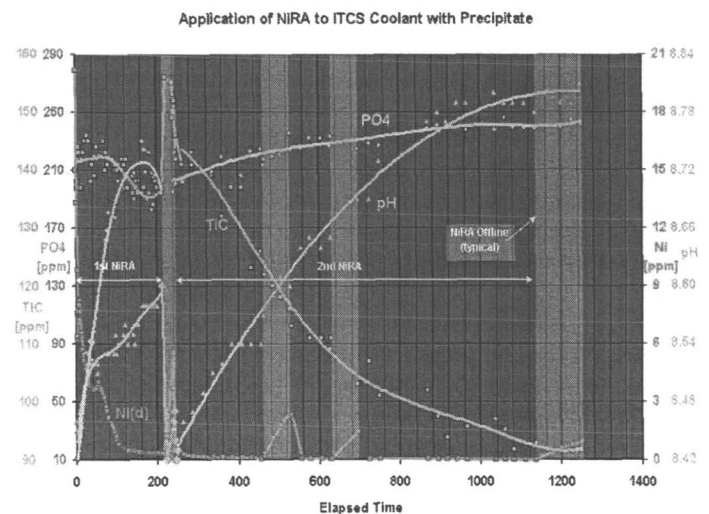
Figure 16. Recirculating bench test results of NiRA showing nickel removal (green) and phosphate redissolution (orange)

Nickel Removal Assembly (NiRA) – The IATCS coolant working group has performed extensive experimentation and perfected the application of a chelating resin produced by DOW Chemical for the removal of nickel ions from the IATCS coolant. A recirculating bench test of the NiRA performed in 2004 demonstrated its effectiveness at reducing nickel concentration, Figure 16. As the nickel concentration drops, nickel phosphate crystals distributed throughout the test bed were observed to re-dissolve and phosphate concentrations returned to their pre-precipitated levels. Subsequent bench testing proved the effectiveness of additional resin treatments for maintaining a constant pH during NiRA implementation. Ground NiRA units have been produced for experimentation and to support nickel ion removal from the Node 2 cooling systems while it is processed at the NASA Kennedy Space Center. Flight units are being manufactured and will be delivered to NASA by April 2005.

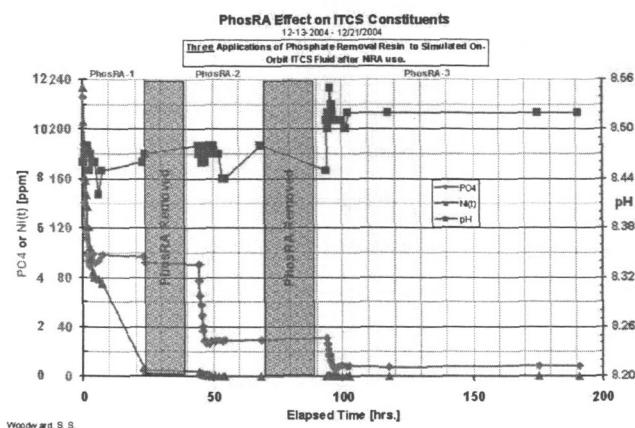
Figure 17. Beaker scale testing of PhosRA resin showing phosphate removal effectiveness and ability to maintain a relatively constant pH

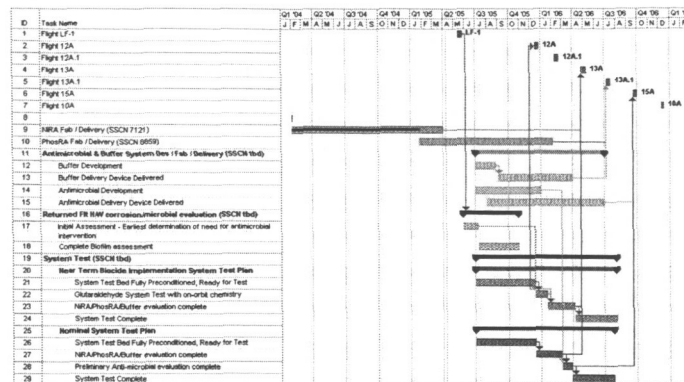
Figure 18. Coolant Remediation Plan

Implementation Schedule – An overview of the coolant remediation plan and implementation schedule is shown in Figure 18. This shows that flight LF-1 will yield key data that may initiate a rapid antimicrobial development effort. This would entail a re-prioritization of full-scale system test objectives and change the approach to the full-scale system test. The intent would be to deliver an early antimicrobial by flight 12A in December 2005. Absent a rush on the antimicrobial development, then the coolant remediation plan calls for a full scale system test in the MSFC US Lab Module Simulator beginning with NiRA testing in October 2005. This test is intended to mimic the on-orbit implementation with accelerations where stable equilibrium conditions allow.
