NASA/TM-2006-214321

Test and Analysis of Foam Impacting a 6x6 Inch RCC Flat Panel

Wendy B. Lessard
Langley Research Center, Hampton, Virginia

June 2006

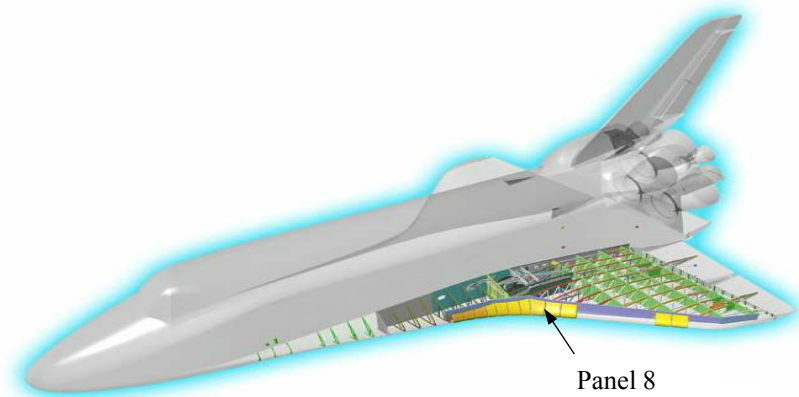
Figure 1. Location of panel 8 on the left wing of the Shuttle Orbiter

Compelling evidence obtained from still photographs and video of the STS-107 Columbia launch clearly showed that a piece of external tank insulating foam separated from the left bipod ramp and struck the bottom part of wing panel 8 (Figure 1). Immediately following the accident, the Columbia Accident Investigation Board (CAIB) was quickly formed to identify the root cause of the accident and recommend corrective action to return the Shuttle fleet to flight. The CAIB identified that the technical failure was due to the foam impact that caused a breach to form, thereby exposing the aluminum sub-structure to the surrounding superheated gases. Once breached, the wing's inner structure began to melt, rendering the Shuttle unable to withstand the high temperatures or loads, which led to its eventual breakup.

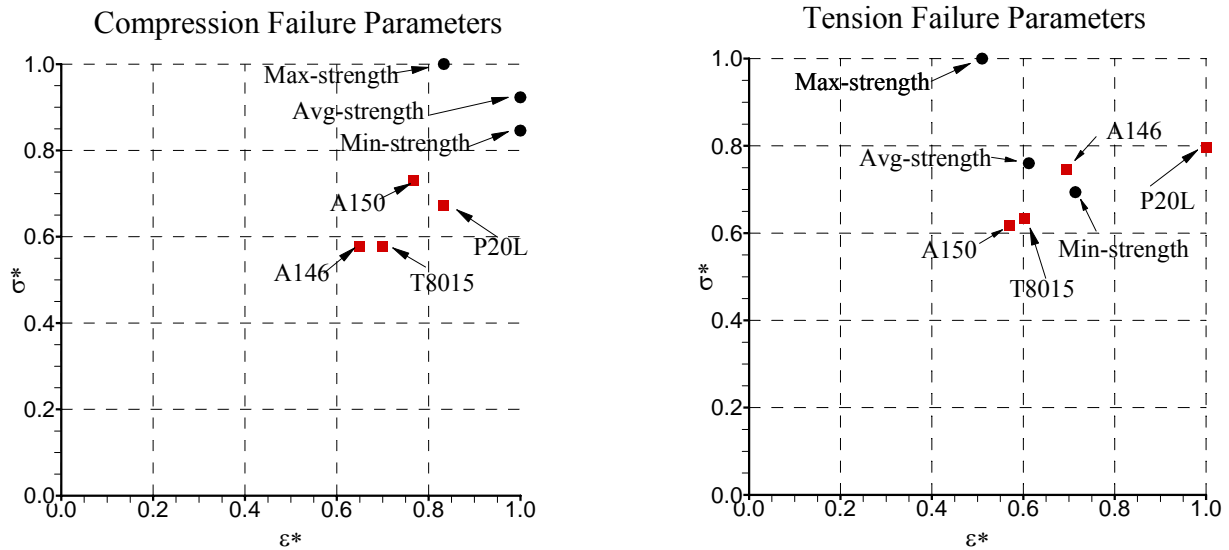
Figure 2. Normalized compression and tension parameters for the RCC material obtained from the Loral Report (black data points) and the 6x6 flat panel test (red data points).

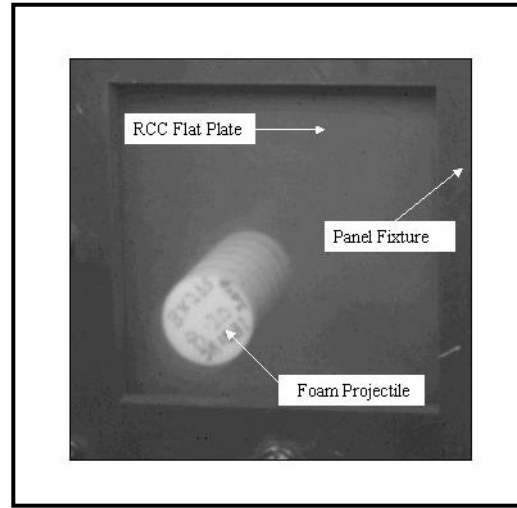
Figure 3. Test set-up showing the BX-265 foam projectile impacting the RCC panel.

The results from GRC's 6x6 inch RCC panel tests at a 90° angle of incidence are summarized in this paper; details of these tests and the results can be found in references 5 and 6. Thirteen tests were performed on four different RCC plates, which were left over from a previous Shuttle configuration. The panels were composed of a 19-layered RCC substrate which had a laminate coating and a nominal thickness of 0.233 inches. Each of the four plates were cut into smaller plates and labeled with a different prefix, which was used to identify what larger plate it was cut from. Although the plates were all made of the RCC material, the variability of material properties among the panels required that each panel be identified; hence, each panel group was identified via prefix labeling. The panel prefixes were designated as T8015, A146, P20L, and A150 (see Table 1). The BX-265 (named to represent the material model used in LS-DYNA®) foam projectile was shot from an air gun at various speeds into a vacuum box containing a panel that was restrained by the framed fixture as shown in Figure 3. The diameter and length of the projectile was 1.25 in. and 3.0 in., respectively, and had a nominal mass of 2.0 grams. Each panel was restrained approximately 0.16 in. from the outer sides by half-round aluminum rods to uniformly clamp the outer edges of the panel firmly in place. Table 1 lists the 13 tests along with their normalized material descriptions, physical property characteristics, and test conditions. Note that all the panels in each prefixed group had the same thicknesses and material properties. Pre- and post-test still

photographs, NDE such as ultrasound and thermography, and Aramis displacement data were obtained for each panel, which was impacted by a foam projectile at different velocities.

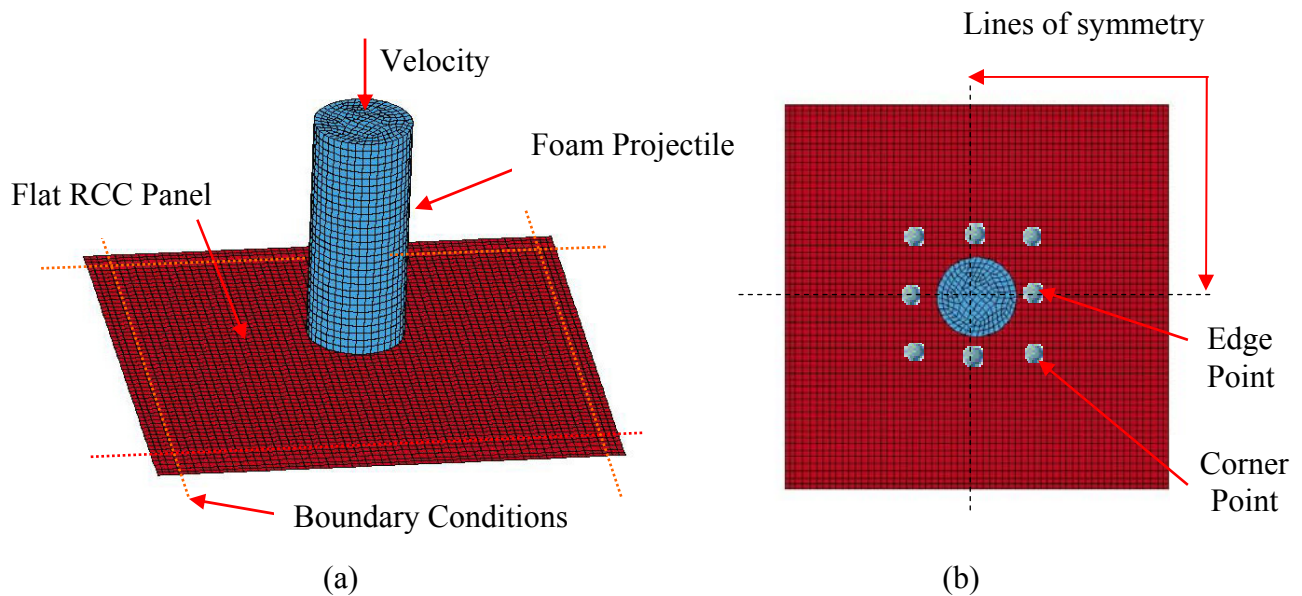
Figure 4. Finite element model of flat RCC panel with the BX-265 cylindrical foam set up to impact normal onto the panel is shown in Figure 4a. Measurements are taken at nine correlation points shown in Figure 4b.

The impact tests performed by GRC were simulated by LaRC using LS-DYNA[®]. The finite-element model, depicted in Figure 4, was composed of a 6x6 inch flat panel containing 3600 quadrilateral shells (with element edge length of 0.1) and a foam projectile, which consisted of 5250 solid elements. The foam, which impacted the center of the plate at 90° (normal to the plate), was 1.25 inches in diameter and 3.0 inches long. The analytic dynamic response of the panel was symmetric; hence, all corner and edge displacements produced the same dynamic behavior. Each edge and corner point was approximately 0.9 inches in the x and y direction from the center point of the panel (shown notionally in Figure 4b). The simulated displacement values were extracted from the four corner points, four edge points, and one center point and compared to test data. This basic model was replicated to create a series of models to capture the exact RCC panel thickness and the proper mass of each foam projectile for each of the GRC tests (see Table 1).

For the GRC experiments, the RCC flat panel specimens were constrained on all four sides by a frame composed of aluminum half-rounds. For the simulation, the RCC panels were constrained along the outer boundary shell edges 0.16 inches from the outer panel (shown notionally in Figure 4a). The edges were constrained in the normal out-of-plane (z-direction), and were free to rotate in all directions. The modeling of the frame's boundary constraints significantly influenced the

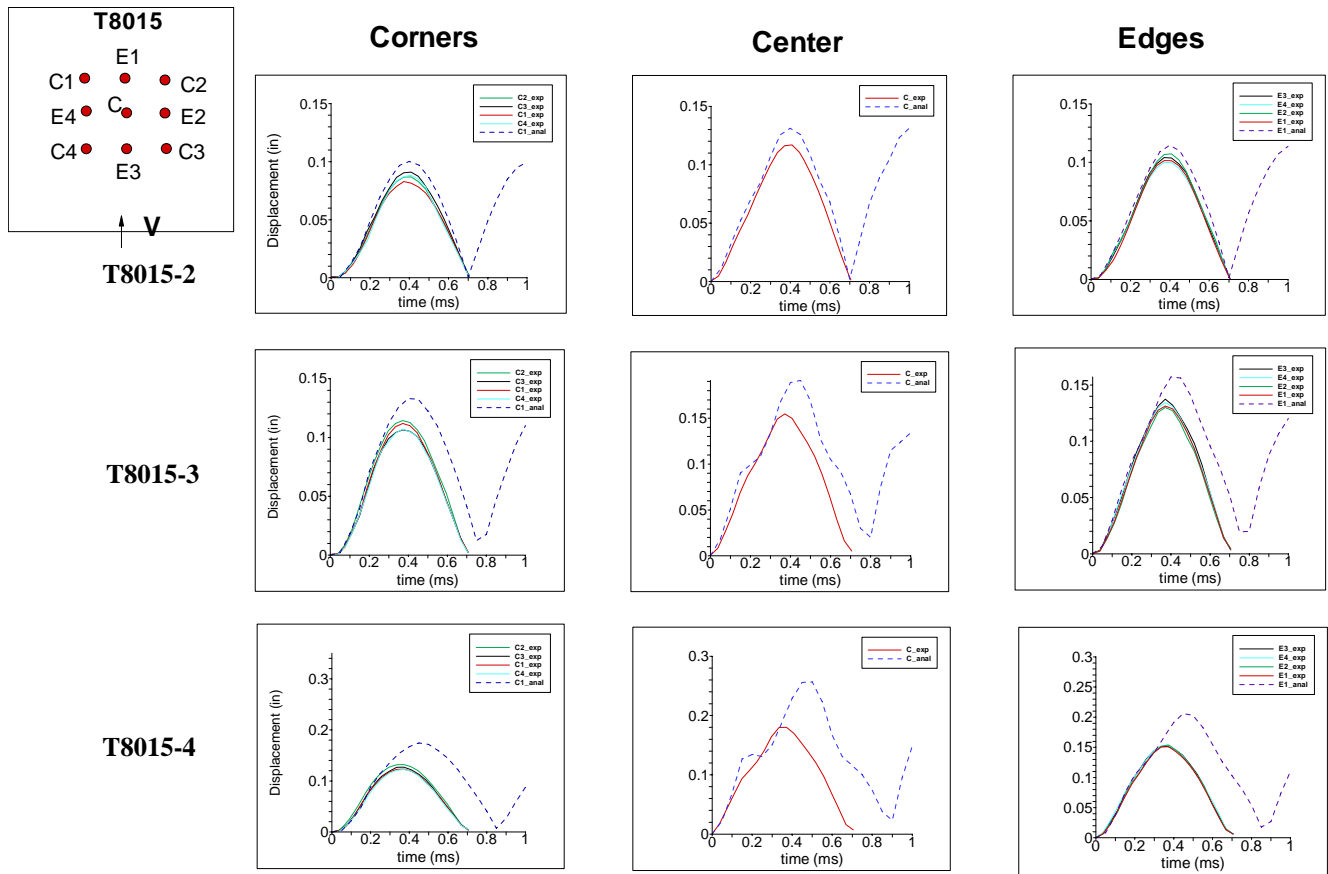
Figure 5. Predicted displacement time histories compared to the flat panel test results.

The predicted displacement time history curves for the T8015 panels at the corner, center and edge locations are shown in Figure 5 (analytical curves are dotted). The deflection results shown are representative of the time displacement curves obtained for the other panels. Due to the horizontal and vertical planes of symmetry in the LS-DYNA[®] models, only one analytic curve is needed per test to represent all the corner and edge response behavior while all four experimental curves are plotted. Predicted time histories for T8015-2 and T8015-3 compared reasonably well with the test data, and the predicted peak deflections are within 20% of the measured values, as shown in Figure 6. There is a 26% error between test and analysis at the maximum peak displacement for the center point of the T8015-4 panel. This test case had the highest impact velocity (22,884 in/sec) for that particular panel type. Factors which may have contributed to the displacement discrepancies are: 1) the post-processing of the Aramis displacement test data, 2) the small size of the panels, 3) pre-test RCC plate and coupon anomalies, which were evident in the A146 panel, 4) incorrect simulation of the panel stiffness at its center, and 5) no damping parameters were used in LS-DYNA[®].

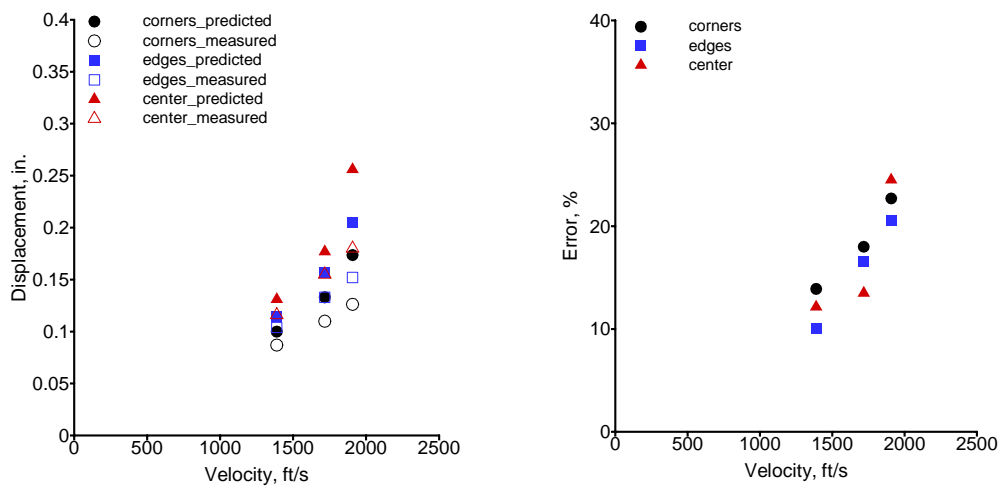
Figure 6. The maximum displacements and percent error of all the correlated data points.

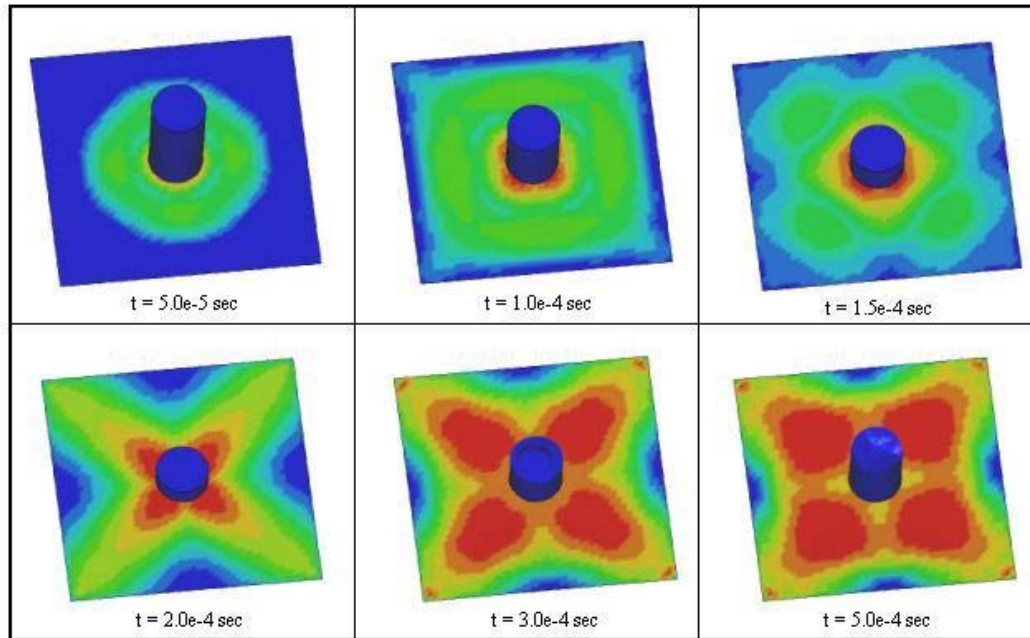
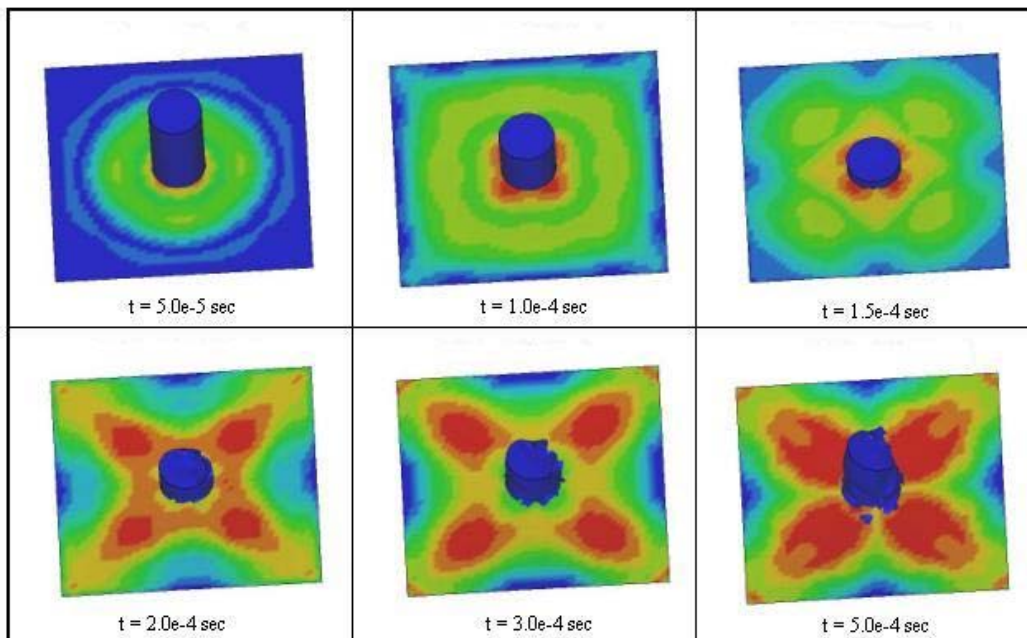
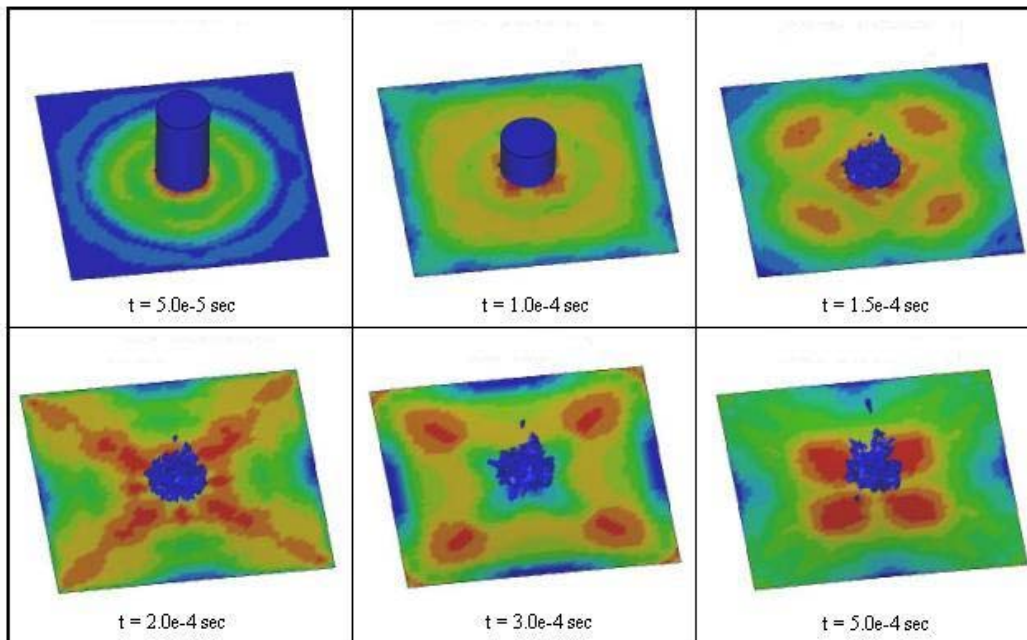
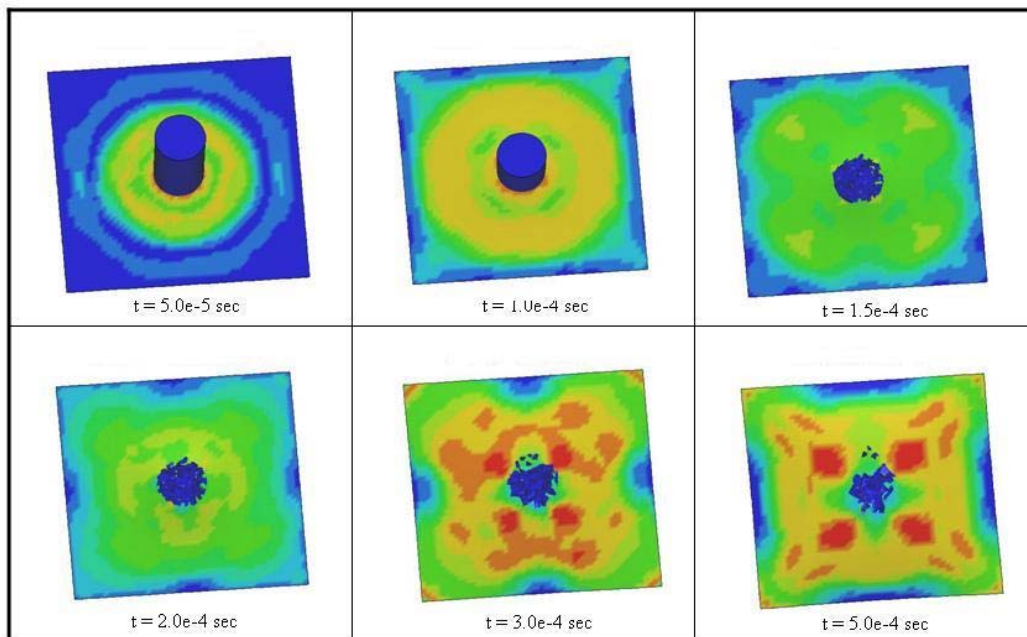
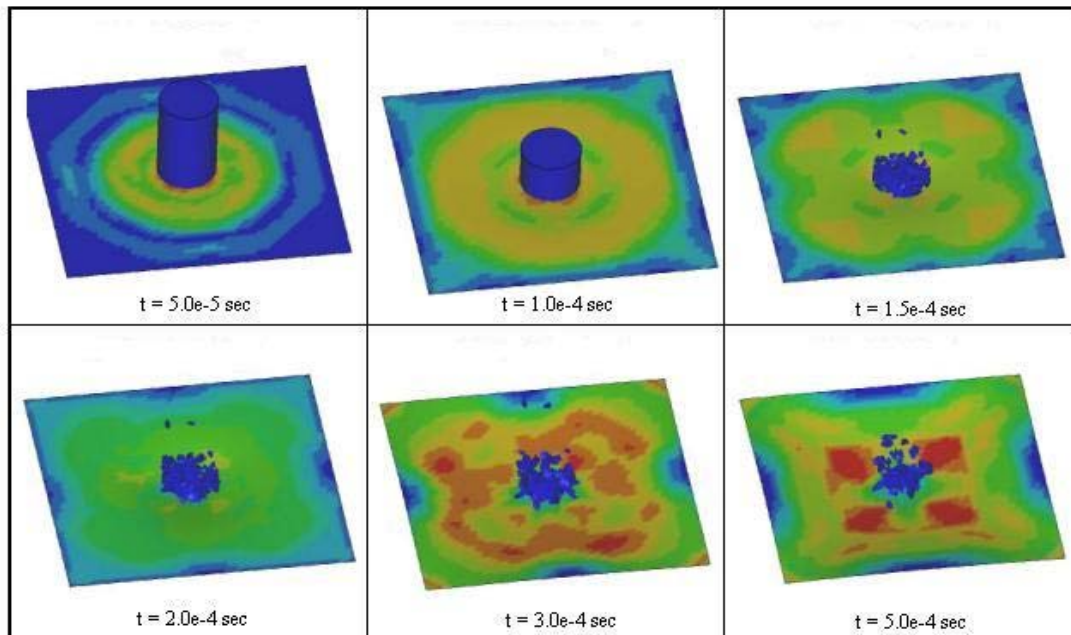
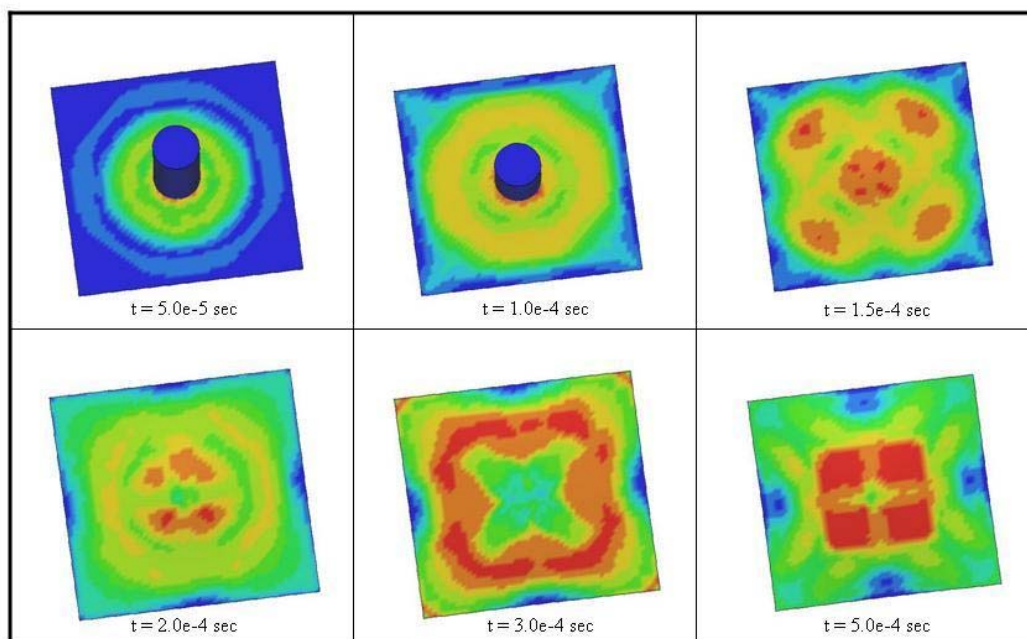
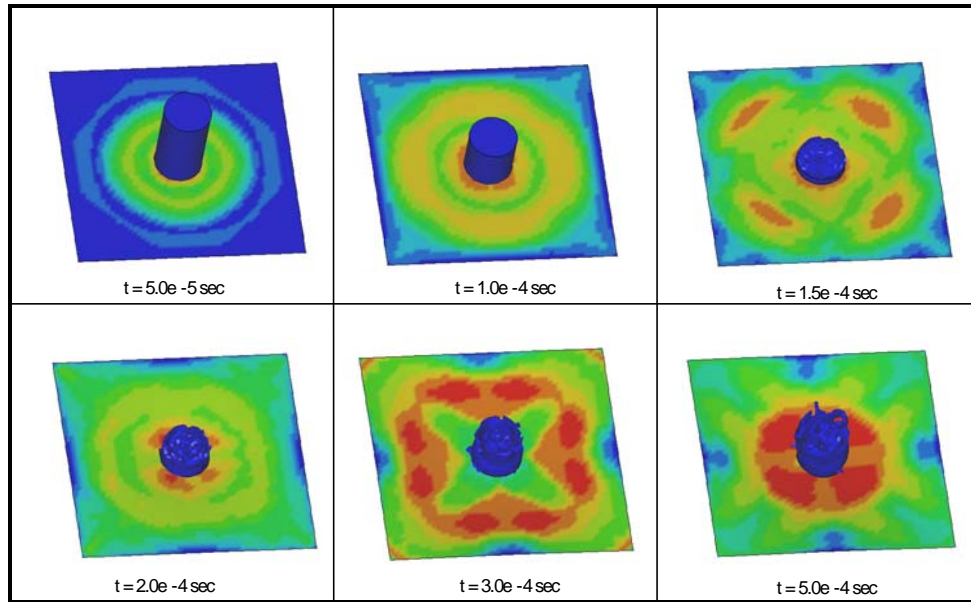
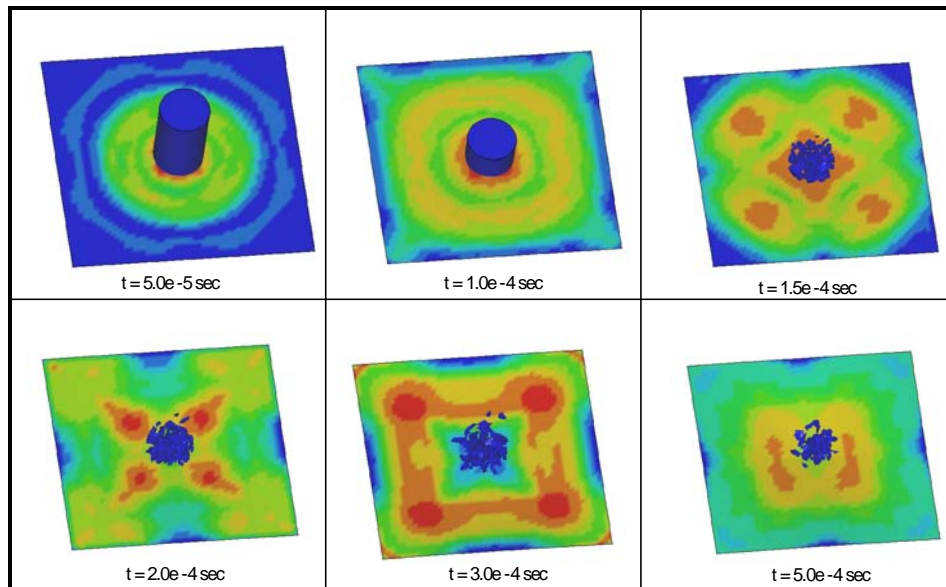
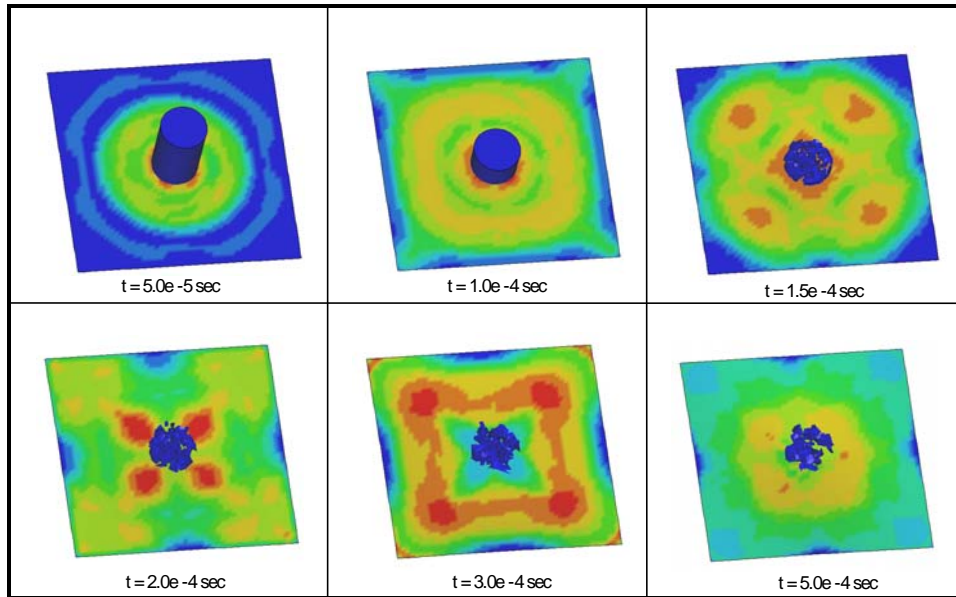
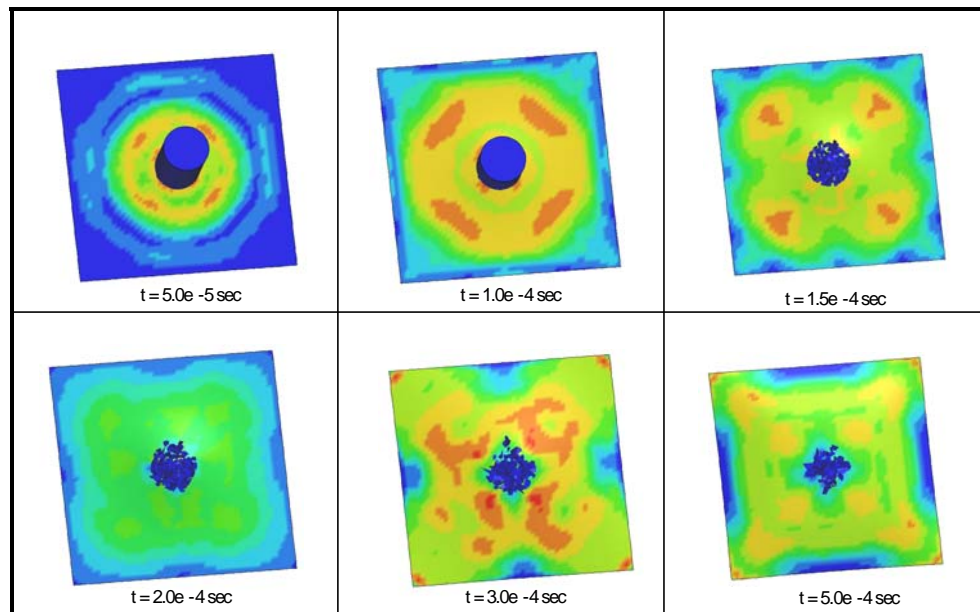
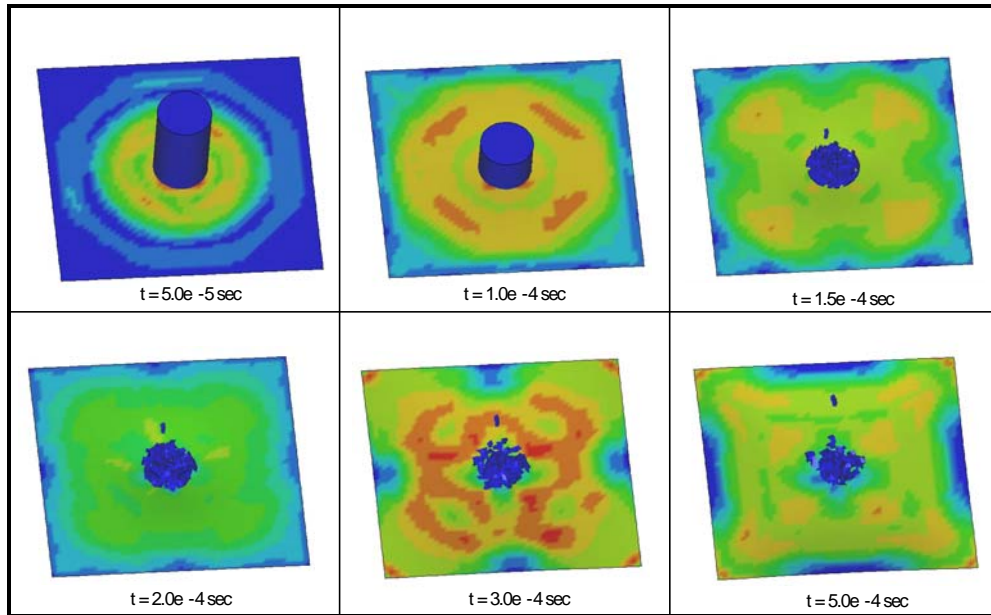
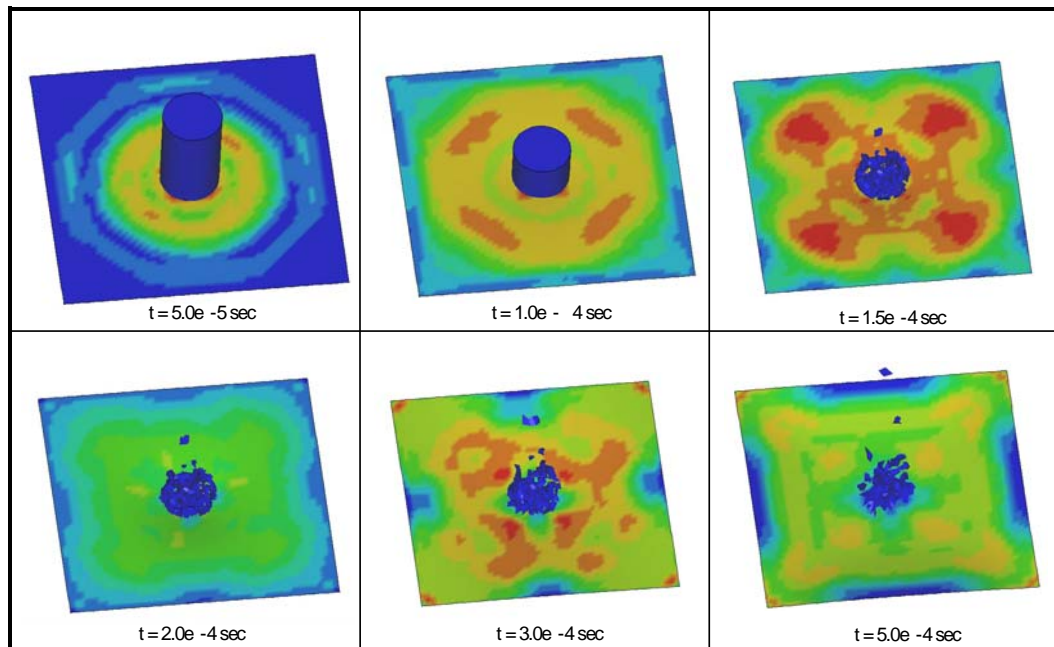
Figure 7. Colored contours of the first-principal stresses at different time intervals for the T8015-2 flat panel. The impact velocity of the foam is 16,656 in/sec.

Figure 8. Colored contours of the first-principal stresses at different time intervals for the T8015-3 flat panel. The impact velocity of the foam is 20,604 in/sec.

Figure 9. Colored contours of the first-principal stresses at different time intervals for the T8015-4 flat panel. The impact velocity of the foam is 22,884 in/sec.

Figure 10. Colored contours of the first-principal stresses at different time intervals for the A146-1 flat panel. The impact velocity of the foam is 24,180 in/sec.

Figure 11. Colored contours of the first-principal stresses at different time intervals for the A146-2 flat panel. The impact velocity of the foam is 24,024 in/sec.

Figure 12. Colored contours of the first-principal stresses at different time intervals for the A146-3 panel. Then impact velocity of the foam is 22,140 in/sec.

Figure 13. Colored contours of the first-principal stresses at different time intervals for the A146-4 flat panel. The impact velocity of the foam is 20,892 in/sec.

Figure 14. Colored contours of the first-principal stresses at different impact time intervals for the P20L-23 flat panel. The impact velocity of the foam is 24,924 in/s.

Figure 15. Colored contours of first-principal stresses at different time intervals for the P20L-24 flat panel. The impact velocity of the foam is 25,308 in/sec.

Figure 16. Colored contours of first-principal stresses at different time intervals for the A150-17 flat panel. The impact velocity of the foam is 24,000 in/sec.

Figure 17. Colored contours of first-principal stresses at different time intervals for the A150-18 flat panel. The impact velocity of the foam is 23,424 in/sec.

Figure 18. Colored contours of first-principal stresses at different time intervals for the A150-19 panel. The foam impact velocity is 23,736 in/sec.

Colored contour plots of the analytical predictions for the first principal stresses at different impact time intervals for the 12 RCC panel tests (there was no test data available for T8015-1) are shown in Figures 7–18. Each figure depicts 6 different “snap-shots” in time. The stress predictions for panels T8015-2, T8015-3, and T8015-4 are shown in Figures 7, 8 and 9, respectively. The highest analytical stress contours among the T8015 group occurs for the T8015-4 panel at $t = 0.2$ ms (Figure 9). This finding is consistent with the displacement trends in Figure 5, which show that the T8015-4 panel has the highest test and analysis displacement values for the corner, edge and center locations. A small bump in the displacement curve at the center point appears at $t \sim 0.18$ ms for all the T8015 cases shown in Figure 5. The magnitude of the bump increases with velocity. The LS-DYNA[®] code appears to treat the center of the plate different from the corners and edges and produces a softer dynamic response in the panel center, while the tests show this region to be much stiffer. Stresses depicted as colored contours are shown for panels A146 (Figures 10–13), P20L (Figures 14 and 15), and A150 (Figures 16–18). For the most part, the stress color contours are symmetrical; however, there are some asymmetries that occur after the foam has fully impacted the panel ($t \geq 2.0$ ms).

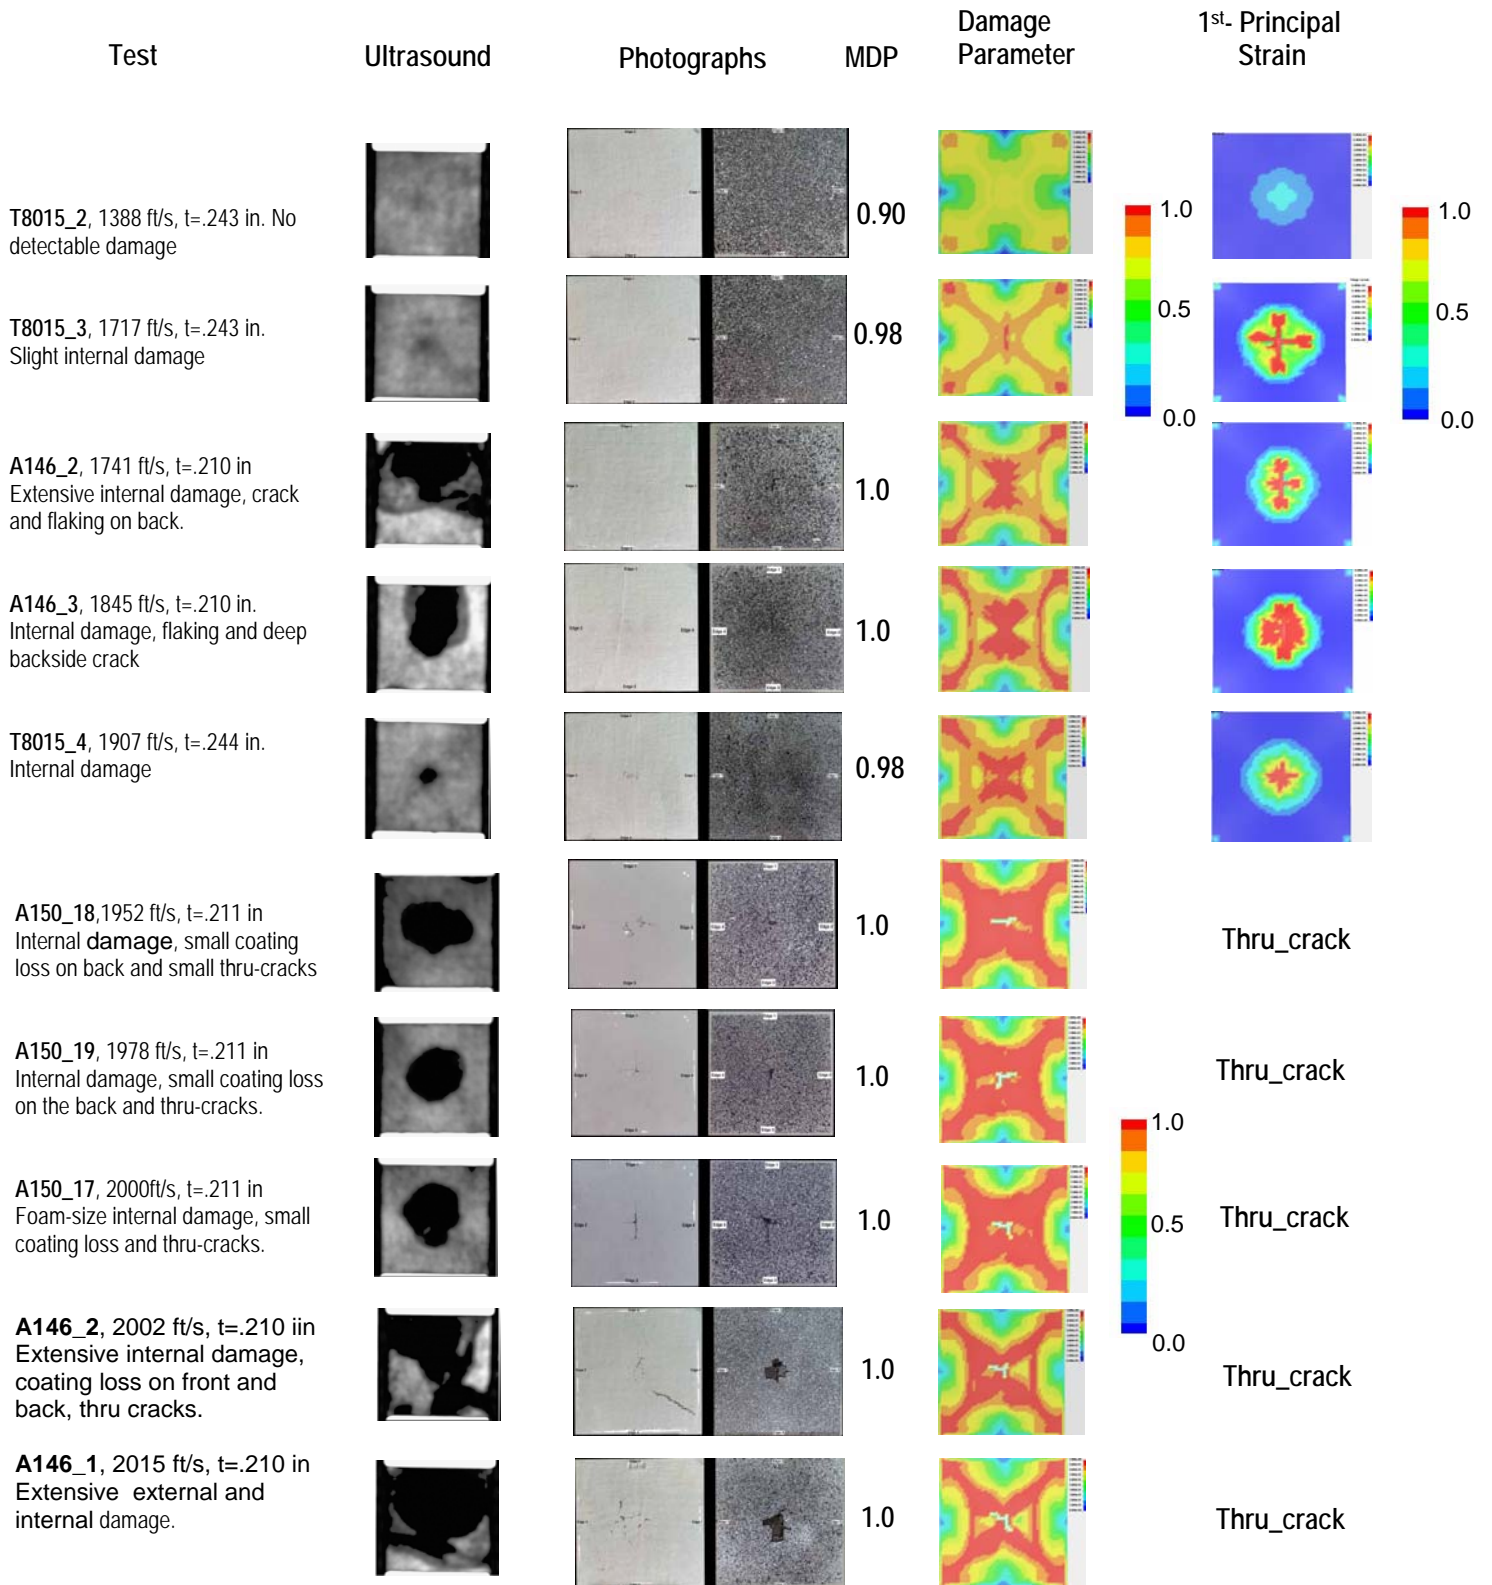
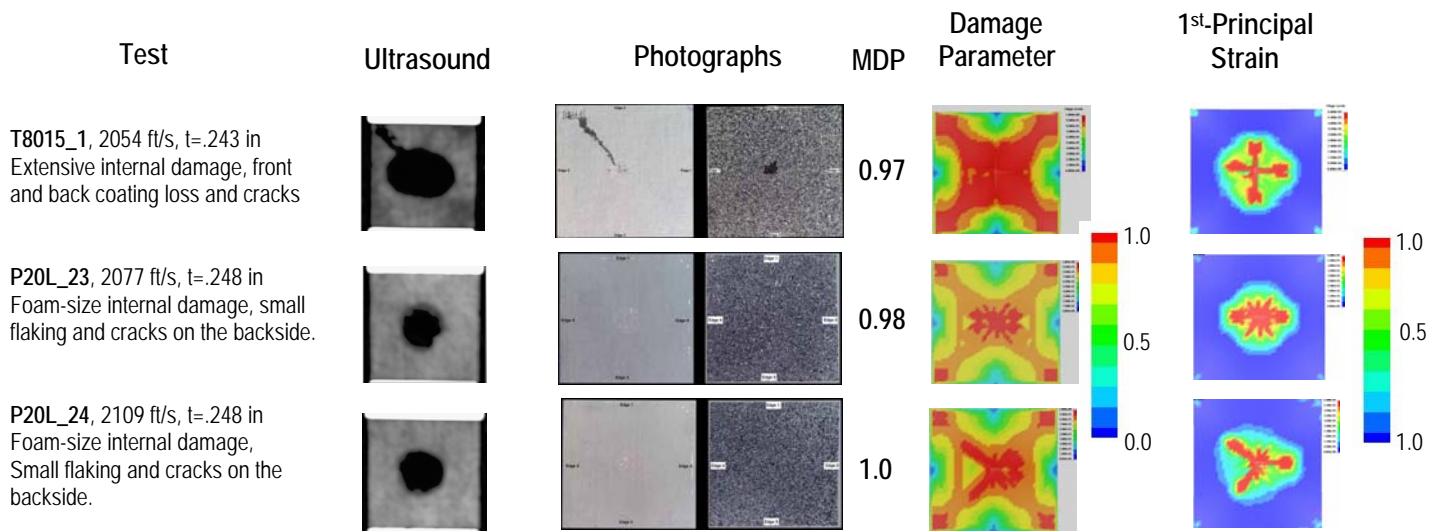
Figure 19. Continued

Figure 19. Post-impact test and computational qualitative results. MDP is the maximum damage parameter.

The predicted maximum damage parameter and principal strain are plotted as colored contours and compared to post-impact photographs of the top and bottom surfaces (Figure 19). Overall, the breaches and coating cracks, which resulted after impact, proved to be a good indicator of the NDE images, except for the A146 panel, which had anomalies. Usually, as more damage was inflicted to the panel surface after impact, more internal damage was noted. This was not the case for the A146 panel group, which showed massive internal damage without any significant external cracks or ablations. Both the test and analyses indicated through cracks for the following panels: T8015_1, P20L-23, P20L-24, A150-17, A150-18, A150-19 (Figure 19). It appears that the greatest internal damage (detected by ultrasound) occurred in the T8015_1 panel, the A150 panels, and the P20L panels. Again panel A146 is not included due its probable pre-test anomalies.

The threshold of damage parameter represents any external or internal visible RCC damage detectable by NDE techniques. According to the computational damage parameter shown in Figure 19, the threshold of damage is between 0.92 and 0.98. Therefore, thresholds below 0.92 should not result in any internal or external damage. As the threshold damage increases from 0.92 to 0.98, (at 1.0, the panel is completely damaged), the amount of internal and external damage increases.
