Apollo Seals: A Basis for the Crew Exploration Vehicle Seals

Prepared for the
42nd Joint Propulsion Conference and Exhibit
cosponsored by the AIAA, ASME, SAE, and ASEE
Sacramento, California, July 9–12, 2006

The National Aeronautics and Space Administration is currently designing the Crew Exploration Vehicle (CEV) as a replacement for the Space Shuttle for manned missions to the International Space Station, as a command module for returning astronauts to the moon, and as an earth reentry vehicle for the final leg of manned missions to the moon and Mars. The CEV resembles a scaled-up version of the heritage Apollo vehicle; however, the CEV seal requirements are different than those from Apollo because of its different mission requirements. A review is presented of some of the seals used on the Apollo spacecraft for the gap between the heat shield and backshell and for penetrations through the heat shield, docking hatches, windows, and the capsule pressure hull.

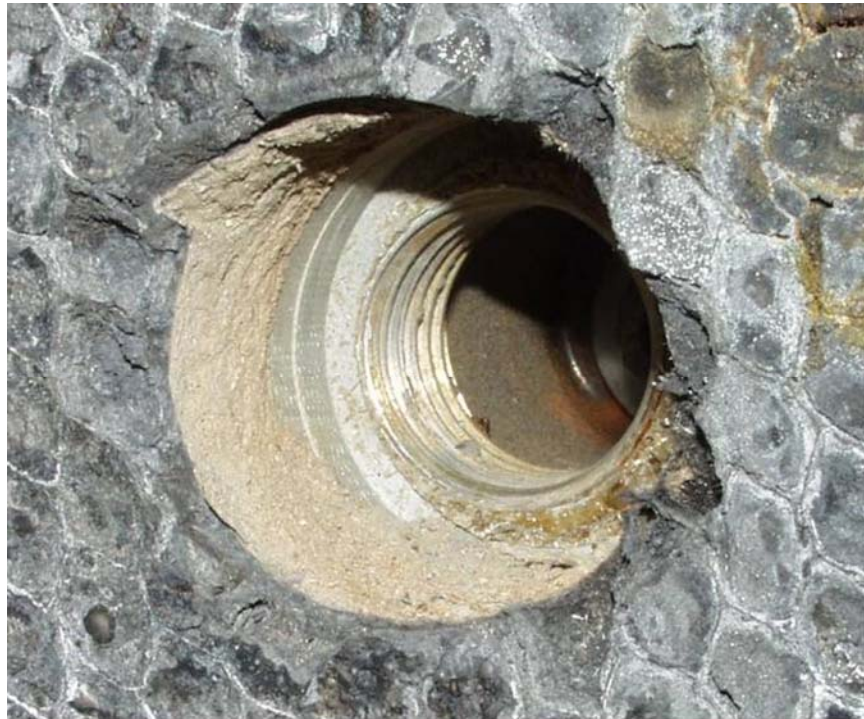
CD-06-82888-9

Figure 9. Photograph of ablator plug hole on Apollo/Skylab 3 aft heat shield.

Figure 7 shows the plug covering the oxidizer dump port on the Apollo 11 command module, and Fig. 10 shows the plug covering the fuel dump port on the Apollo/Skylab 3 command module. The gaps introduced into the aft heat shield by these plugs were sealed with high temperature GE RTV 560¹². During an abort within the first 42 seconds after liftoff, the oxidizer and fuel dump plugs would be jettisoned using small pyrotechnic charges.¹¹ The RCS monomethylhydrazine fuel and nitrogen tetroxide oxidizer would then be dumped through the ports to ensure that they would not pose a fire or chemical hazard to the astronauts and recovery crews.^{13,14} Note that the seals shown in the two figures show strong evidence of ablative mass loss at their outer surfaces.

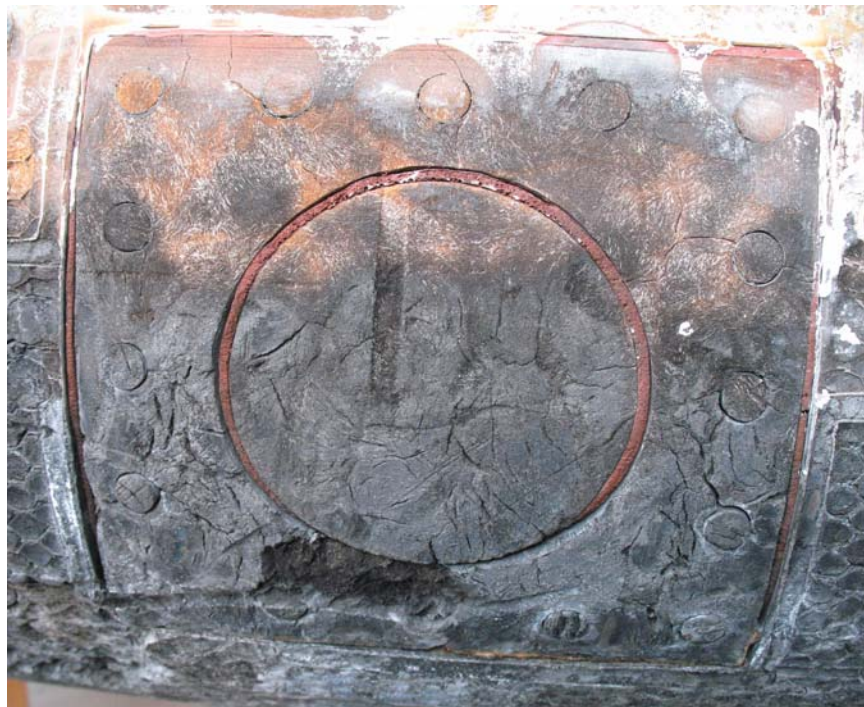
CD-06-82888-10

Figure 10. Photograph of RCS fuel dump plug on Apollo/Skylab 3 command module.

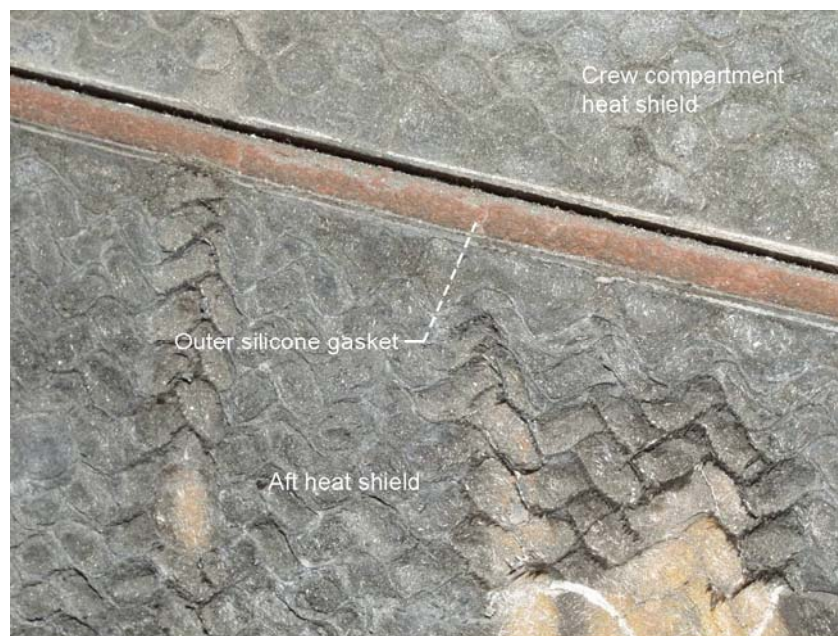
Figure 13. Photograph of Apollo/Skylab 3 aft heat shield-to-crew compartment heat shield interface region including the outer silicone gasket seal.
