Low Velocity Airdrop Tests of an X-38 Backup Parachute Design

The NASA Johnson Space Center's X-38 program designed a new backup parachute system to recover the 25,000 lb X-38 prototype for the Crew Return Vehicle spacecraft. Due to weight and cost constraints, the main backup parachute design incorporated rapid and low cost fabrication techniques using off-the-shelf materials. Near the vent, the canopy was constructed of continuous ribbons, to provide more damage tolerance. The remainder of the canopy was constructed with a continuous ringslot design. After cancellation of the X-38 program, the parachute design was resized, built, and drop tested for Natick Soldiers Center's Low Velocity Air Drop (LVAD) program to deliver cargo loads up to 22,000 lbs from altitudes as low as 500 feet above the ground. Drop tests results showed that the 500-foot LVAD parachute deployment conditions cause severe skirt inversion and inflation problems for large parachutes. The bag strip occurred at a high angle of attack, causing skirt inversion before the parachute could inflate. The addition of a short reefing line prevented the skirt inversion. Using a lower porosity in the vent area, than is nor

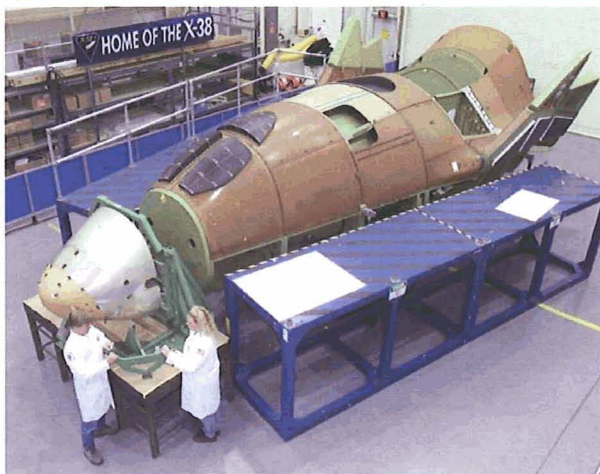
The X-38 program was building a prototype called V-201, shown in Fig. 1. For the orbital test flight of V-201, the Space Shuttle was going to carry the vehicle into orbit and release it into space. After a short time in orbit, V-201 was going to de-orbit and land on earth. Initially, the backup parachute system base-lined for V-201 was the one flown on all eight of the atmospheric test flights conducted at Edwards Air Force Base¹. However, V-201 weighed 25,000 lbs and the atmospheric test vehicle was only 15,000 lbs. The backup parachute system had sufficient margin to handle the drogue high dynamic pressure deployment conditions of 430 psf, but it was sized to land a 15,000 lb vehicle at 35 feet per second. With its higher weight, V-201 would land with a vertical velocity of 46 feet per second, resulting in damage to the structure.

Figure 1: X-38 V-201 in fabrication

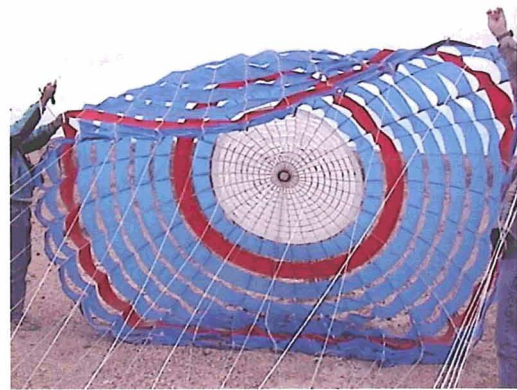
Prior to the cancellation of the X-38 project, drop testing was conducted to evaluate the use of hot-cut coated nylon fabric for the parachute rings to further reduce manufacturing costs. Results indicated that the hot-cut edges did not hold up under a high dynamic pressure flutter environment. A 16-ft subscale version of the parachute was built for these tests. The normal ribbons were replaced in selected areas with ribbons made from hot-cut fabric strips. A lightweight bomb-type vehicle, referred to as a drogue test vehicle (DTV), was dropped from a Huey helicopter and allowed to free-fall to achieve the required dynamic pressure at parachute deployment. United Space Alliance (USA) packed the parachutes, and Pioneer Aerospace rigged the DTV and provided field support. Two drop tests, P2D21 and P2D22, were conducted. For each test, the DTV was ballasted to 1,000 lbs and dropped from 10,000 ft MSL. The parachute was deployed at a dynamic pressure of 76 psf. Although most of the hot-cut ribbons survived with no damage, some ribbons showed fraying damage adjacent to radials. The hot-cut fabric ring method of fabricating the continuous panel ringslot parachutes was rejected based upon the test data.

Figure 2. Post-drop inspection of subscale parachute

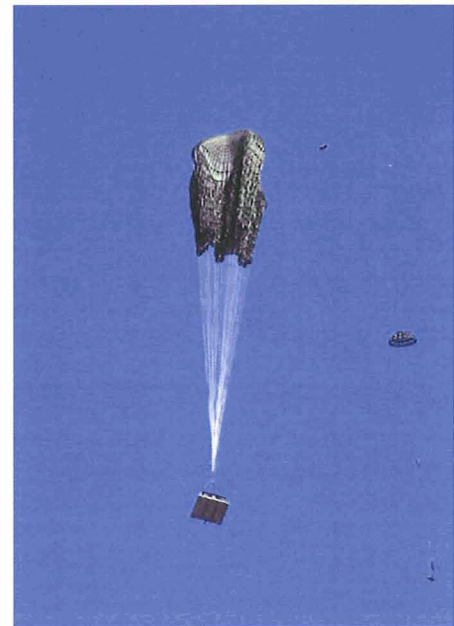
There was no skirt inversion, however, the parachute failed to inflate to full open. A very large infold, as shown in Fig. 6, was observed on the windward side of the canopy. The infold persisted throughout the flight and prevented enough air from flowing into the canopy to cause inflation. It was now clear that there were two failure modes, both caused by the same phenomenon. A cross-flow at the parachute skirt during deployment closed the skirt opening and, if not controlled, caused an inversion. An attempt to improve the parachute inflation characteristics was made by lining the vent area with low porosity cloth.

Figure 6. Canopy infold on test 4

While the skirt inversion did not occur on drop test 4, large infolds at the skirt still provided enough blockage to prevent inflation of the parachute. At this point it became clear that a vent porosity that works well for a normal parachute application, such as vehicle recovery, would not be adequate for the 500-foot LVAD application. The large amount of skirt blockage was preventing most of the normal amount of air from being captured inside of the canopy. It became clear that to pressurize the canopy vent area with even a small amount of inflow at the skirt, the vent would have to be made completely imporous. A low porosity liner was inserted in the vent region of all three parachutes. The liner extended down to the top of the uppermost large ring of the ringslot section of the canopy, where it could be attached to a lateral reinforcement that already existed at that location. A larger liner was desired but could not be incorporated in the short time available to finish the modifications because no other lateral reinforcements existed farther down the canopy to provide attachments for the liner. Some significant packing changes were also made at this point. The canopy skirt was spread open at the canopy compartment mouth to maximize inward airflow, and additional canopy ties were added to keep the parachute stretched out.

A single parachute modified to include a liner was flown in the fifth test. A cluster of 3 of the parachutes, each modified with a liner, was deployed in the fifth test. All parachutes that were modified to include the short reefing line and liner fully inflated. There was no evidence of skirt inversion or its associated damage on any of the parachutes. This once again showed that the temporary reefing line was preventing skirt inversion as intended and provided evidence that the reduced porosity in the vent area due to the presence of the liner improved the inflation performance.

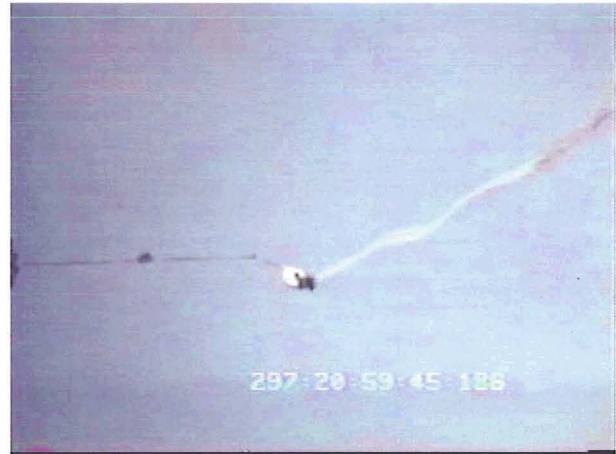
angle of attack as the parachute is being deployed, as shown in Fig. 7, which is not typical for large parachutes used in other applications such as vehicle recovery.

The crossflow due to the angle of attack blows the canopy fabric on the windward side toward the opposite side (infoling) and under the skirt band. The skirt band inflates outside the main canopy, closing the air inlet at the skirt.

Figure 7. Large angle of attack at bag strip on test 2

The conclusion was reached that to prevent skirt inversion entanglement, the skirt needs to be controlled and kept at a small diameter until the canopy vent is pressurized, which occurs about two seconds after line stretch. The G-11 parachute uses a reefing line with a two second reefing cutter, indicating the G-11 may have experienced similar deployment problems during their development. The reefing line for a G-11 parachute uses a reefing line length of two inches per gore. Therefore, a fix was incorporated into the X-38 parachute to add a reefing line that has a length of 2.5 inches per gore and a two second reefing cutter. Drop test 4 successfully demonstrated that the addition of the reefing line prevented the occurrence of the skirt inversion and its associated damage.

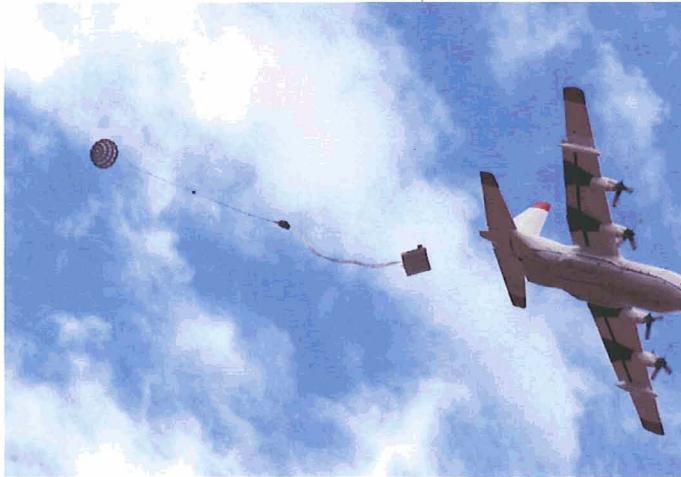
A frame-by-frame study of the video tapes of the pallet and deploying parachute was initiated to investigate the 500-ft LVAD parachute deployment problems. Although the results are somewhat speculative at this point, they are present here for consideration. The videos show that after the pallet leaves the aircraft ramp and extraction line load is transferred from the pallet to the parachute deployment bag, significant dynamics are induced into the deploying riser and suspension lines. Some transverse waves of significant amplitude are generated by the load transfer and the dropping pallet that travel between the pallet and the deployment bag through the riser and suspension lines. When a wave reflects off the deployment bag with a downward amplitude, a large (greater than 45 degrees) local angle can develop. This large angle causes significant cross-flow drag on the risers and suspension lines. The wave motion probably also creates large inertial loads on the material exiting the deployment bag. The combination of the aerodynamic and inertial loads likely overpowers the fairly weak line ties used on this type of parachute. A type of line sail results that only makes the situation worse. A more careful study of this phenomenon is obviously needed. A wide angle view of the deploying line motion is shown in Fig. 8, and a close up view is shown in Fig. 9.

Figure 8. Deploying line motion on test 5.

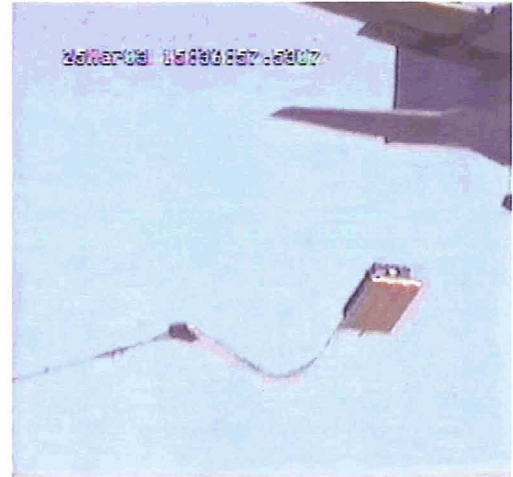
Figure 9. Deploying line motion on test 4
