Free Enterprise: Contributions of the Approach and Landing Test (ALT) Program to the Development of the Space Shuttle Orbiter

Peter W. Merlin*

Analytical Services and Materials, Inc., NASA Dryden Flight Research Center, Edwards, CA, 93523

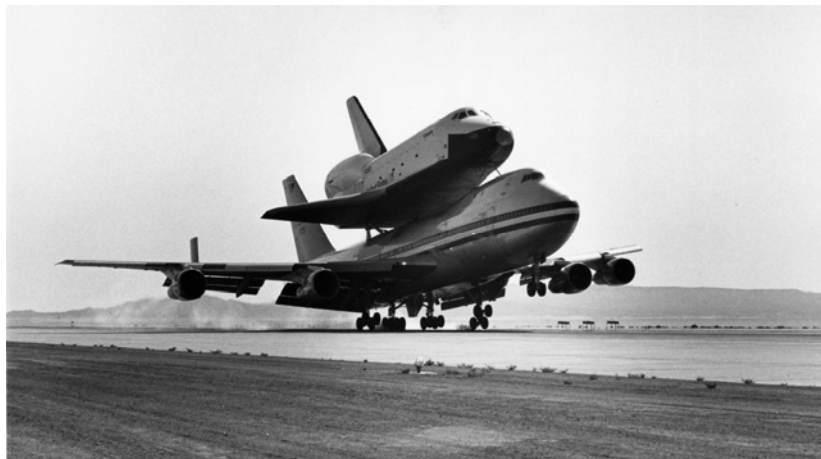
Figure 1. Shuttle Carrier Aircraft and orbiter in mated configuration.

A Boeing 747 was modified as a Shuttle Carrier Aircraft (SCA) to carry Enterprise to altitude for the captive and free-flight tests (Fig. 1). Most of the passenger accommodations were removed and parts of the fuselage underwent structural reinforcement to support the weight of the orbiter. Tip fins were added to the horizontal stabilizers. An emergency escape system slideway was provided for the 747 crew (OV-101 was equipped with ejection seats) along with pyrotechnics to open an escape hatch in the side of the fuselage. Support struts (two aft and one forward) were installed atop the 747's fuselage to hold the orbiter. At the beginning of each free-flight, explosive bolts released the orbiter from the SCA.

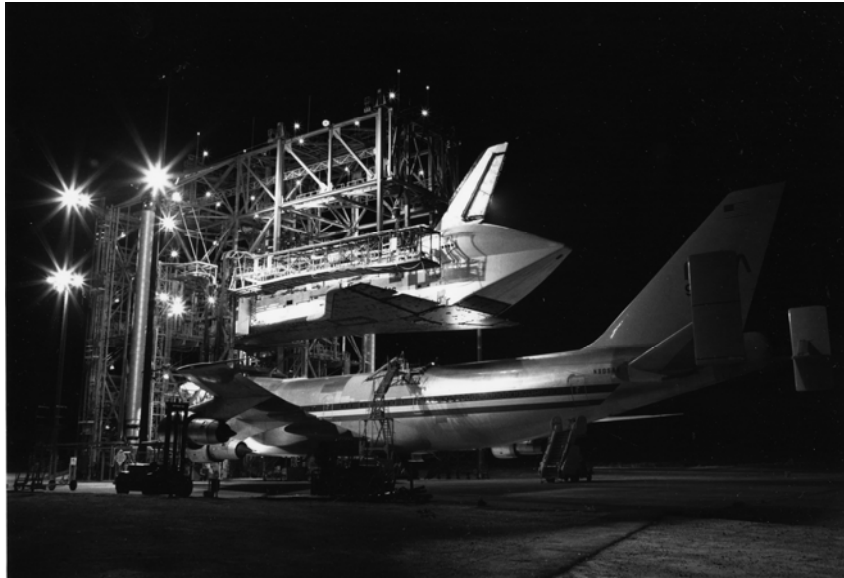
Figure 2. The orbiter is lowered onto the SCA in the Mate/Demate Device.

OV-101 was placed atop the SCA at DFRC using a specialized crane called the Mate/Demate Device (MDD) (Fig. 2). On February 15, 1977, three taxi runs were accomplished at maximum speeds of 78, 122 and 137 knots. The SCA test team evaluated techniques for setting takeoff thrust, directional stability and control, elevator effectiveness, pitch response, thrust-reverser effectiveness, and airframe buffet. They found no areas of concern that would prevent proceeding with flight tests.⁷

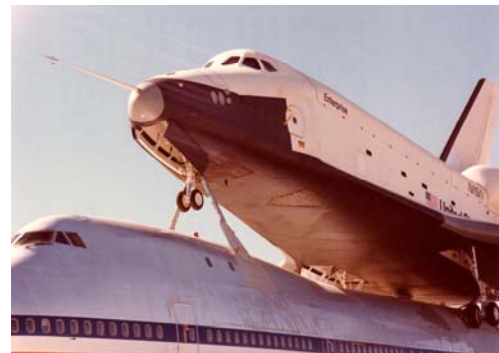
Figure 3. The orbiter's landing gear was lowered during the final captive-active flight.

In the captive-active phase the orbiter was powered up and manned while mated to the SCA. In consideration of the crew's safety, provisions were made for separation of the orbiter in the event of emergency. Three flights were conducted, to verify the separation profile as well as orbiter stability and performance in the mated configuration with combined operation of the primary flight control system, auxiliary power units, hydraulics and structure. Orbiter vertical-tail buffet data obtained during speed brake and rudder operation at 180 kn indicated no significant adverse oscillations. Flutter clearance tests, performed during the second flight at speeds up to 270 kn, revealed no sustained vibrations. The orbiter's dynamic response to rapid control inputs from both the orbiter and SCA was highly damped and considered satisfactory. Tail buffet was measured at incremental speed brake settings and various rudder deflections resulting in structural responses that were well within limits. An autoland fly-through allowed the orbiter crew to verify that the attitude indicator and horizontal situation indicator displayed accurate indications. The landing gear was lowered to verify that it functioned properly (Fig. 3).

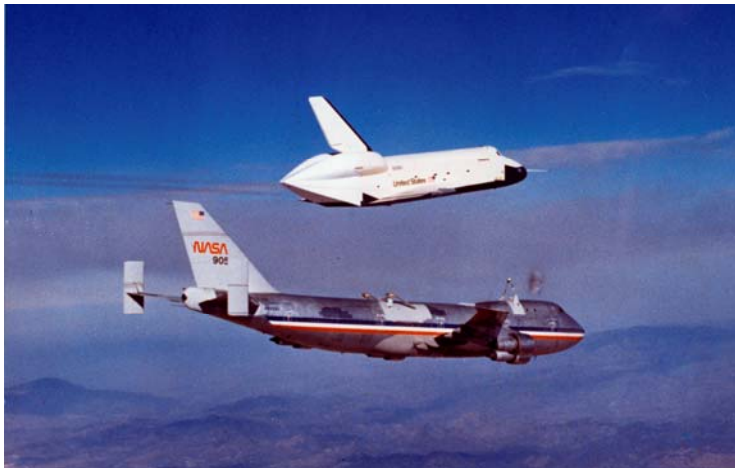
Figure 4. The orbiter separates from the SCA during the first free-flight.

The first free flight, on August 12, 1977, began with orbiter separation from the SCA at an altitude of about 22,800 ft above ground level at 270 knots equivalent airspeed (KEAS) (Fig. 4). Haise and Fullerton executed two 90 percent left turns during descent (Fig. 5) and landed on lakebed runway 17 five minutes and 22 seconds after separation. Touchdown was approximately a mile beyond the predicted landing point. The crew performed steering, braking, and coasting tests during the 11,000-ft rollout.

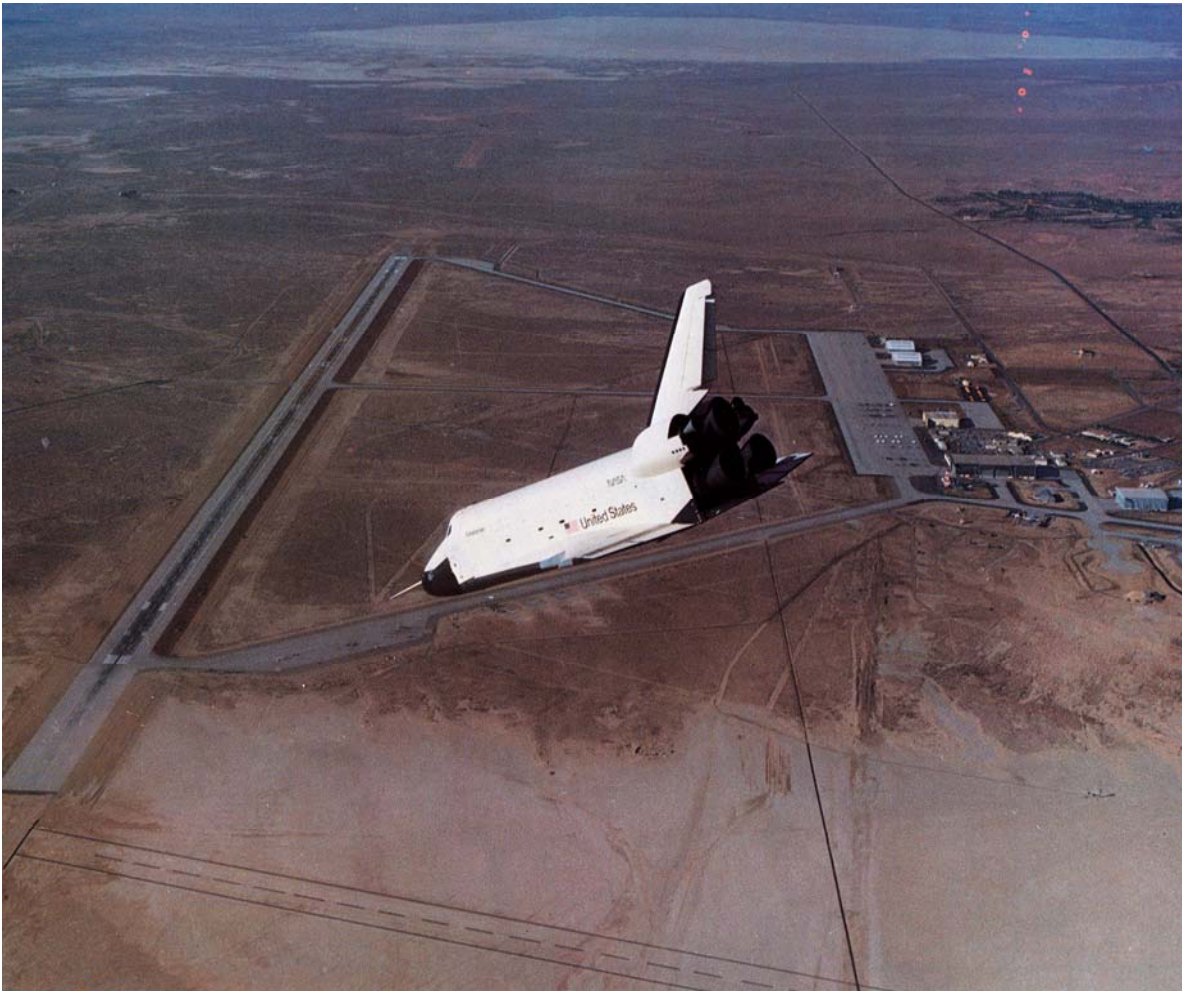
Figure 7. The orbiter during the first tailcone-off free-flight, with the Edwards main runway in the background.

FF-4 was the first tailcone-off flight (Fig. 7). The SCA crew flew two circuits of a racetrack pattern, extending about 70 mi from Edwards, in order to gather flightworthiness and buffet data. The special-rated-thrust modification was engaged to gain additional altitude for separation. The orbiter was separated at a speed of 245 KEAS and an altitude of 17,700 feet. During the two-minute-and-35-second glide flight the orbiter crew performed an angle-of-attack sweep and aerodynamic stick inputs to collect data on performance, stability and control, and flight handling qualities. Only two turns of 10 deg each were made for the purpose of aligning with runway 17. Enterprise touched down 510 ft beyond its planned landing point and rolled 5,725 feet. The crew performed braking and nose wheel steering tests during the landing roll and encountered no brake chatter.

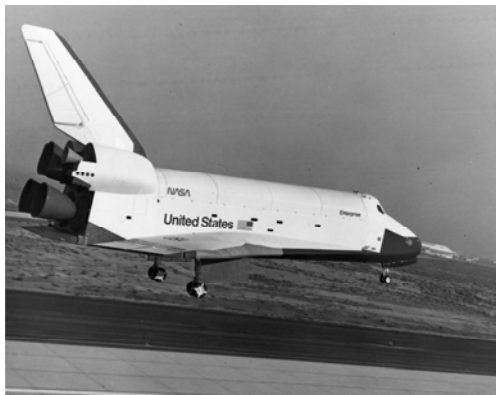
Figure 9. Enterprise approaches the concrete runway as the crew adjusts the approach attitude.

As Enterprise approached the Edwards main runway (Fig. 9), the pilot adjusted the vehicle's attitude in order to increase airspeed to 290 knots. Meanwhile the commander made left rudder and roll inputs prior to speed brake deployment to complete a set of aerodynamic data requirements. Enterprise intercepted the glideslope at 9,600 ft above ground level while the crew maintained alignment with the surface aim point and correlated instrument readings. In a smooth transition, as the orbiter dropped through 7,000 ft, the commander assumed control of the speed brake. When Enterprise was 4,000 ft above ground level, the crew noticed that they had drifted above the glideslope. To reacquire the aimpoint and prevent overspeed, the commander pitched the nose over and deployed speed brakes to 80 percent. He responded to a momentary 10-kn airspeed decrease by reducing speed brakes slightly. The pilot then noted an airspeed decrease to 275 kn followed by a rapid increase to 290 knots.

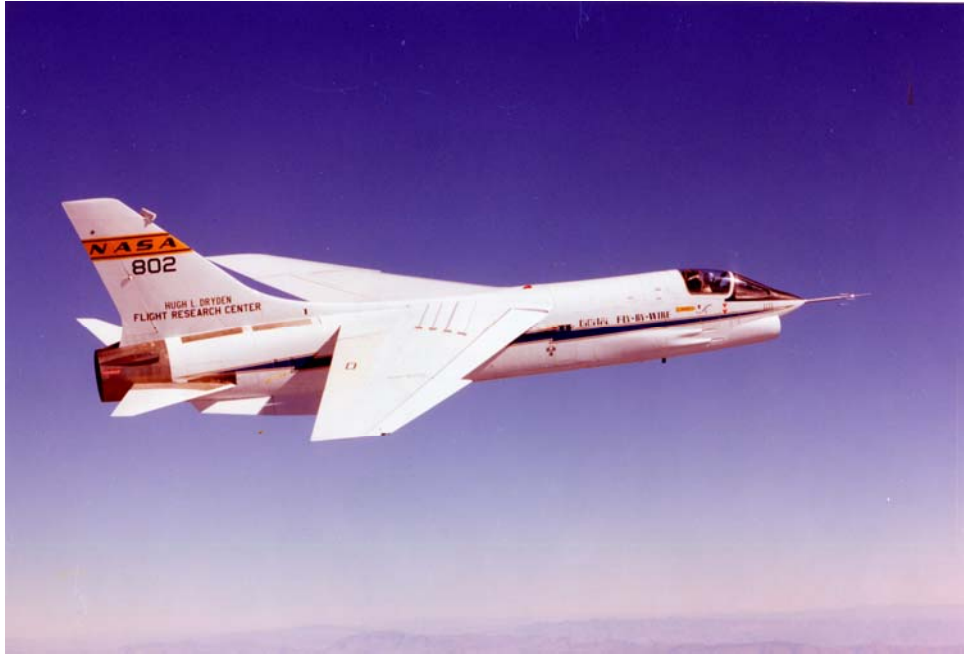
Figure 10. F-8 Digital Fly-By-Wire testbed.

The F-8 DFBW aircraft (Fig. 10) had been modified in the 1970s with a digital flight control system. The pilot could select predetermined values for various flight parameters using an input keypad linked to an AP-101 computer that had been used on one of the Apollo lunar missions. The airplane was not inherently prone to PIO so in order to evaluate a PIO suppression filter, it was necessary to implement a programmed time delay in the control system. The pilot was given the ability to activate and deactivate the control delay as necessary.¹⁴

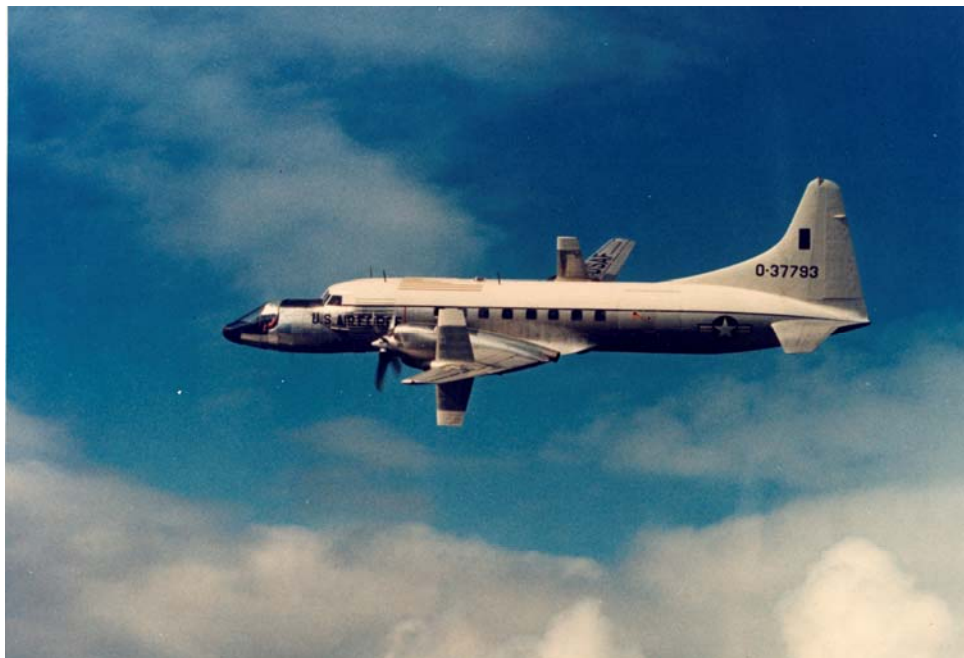
Figure 11. NC-131H Total In-Flight Simulator.

Additional studies were carried out in 1978 using the Air Force's Calspan Total In-Flight Simulator (TIFS) (Fig.11), a highly modified C-131H transport aircraft. The results characterized deficiencies in the orbiter's low-altitude longitudinal handling qualities contributing to the pilot's inability to precisely control flight-path angle and altitude change rate, predict aircraft response to control inputs, and adequately control the vehicle in disturbances due to external forces such as wind gusts.¹⁷

The objective of the TIFS flight research was to evaluate orbiter handling qualities with various proposed mechanizations of the FCS. The flight-test program was designed to replicate the ALT FF-5 flight control problem and develop control system modifications for incorporation into the OFT orbiter Columbia (OV-102). A series of flights was planned to first replicate the ALT FF-5 conditions then simulate a nominal OFT-1 baseline configuration and variations of OFT-1 with alternative transport lag, surface rate limit, and forward-loop pitch gain. Other variables included use of a conventional stick controller and simulation of a cockpit moved 40 ft further forward.¹⁸
