## NASA Experience with Pogo in Human Spaceflight Vehicles

**Dr. Curtis E. Larsen**

NASA Engineering and Safety Center

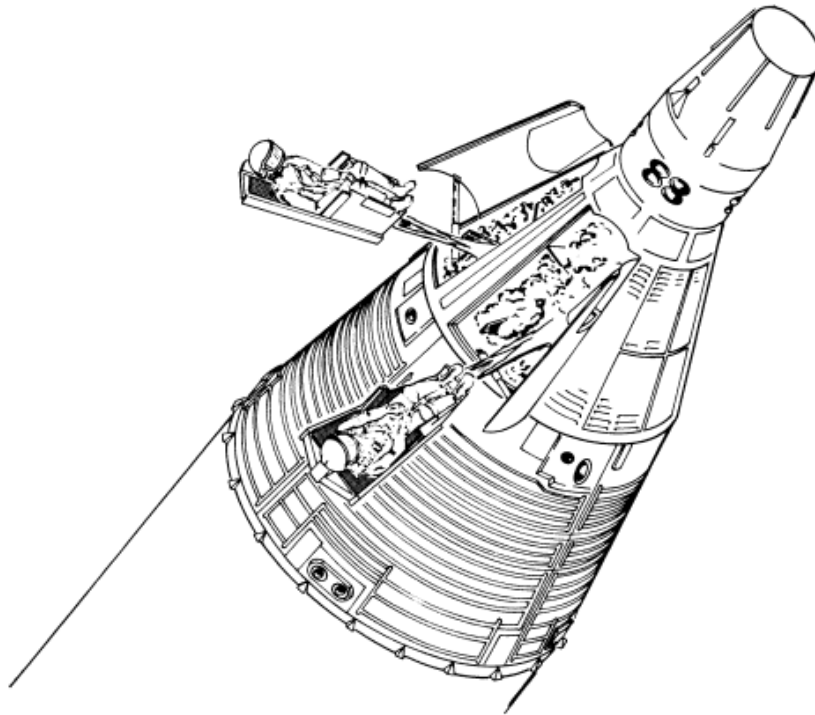
**Figure 2. Gemini Spacecraft and Ejection Seats<sup>1</sup>**

**Artist's sketch of ejection seats propelling the astronauts to escape distance from a launch failure. They would be used in emergencies before launch (pad-abort) and in flight to about 18,000 meters altitude.**

NASA first identified pogo as a threat to spaceflight vehicles and their crews in the early 1960's during the Gemini-Titan II program. The Gemini spacecraft was to be a two-person vehicle with significant improvements in spacecraft design over that of the Mercury spacecraft, principally for simplified systems check-out and operations, and increased crew piloting functions. In particular, the Gemini project manager considered the event sequencing for the Mercury escape system as "...one of the major problem areas in Mercury in all its aspects - its mechanical aspects in the first part of the program, and the electronic aspects later." Thus the new design of the Gemini spacecraft eliminated the escape rocket tower used in Mercury and put the crew in ejection seats.<sup>1</sup>

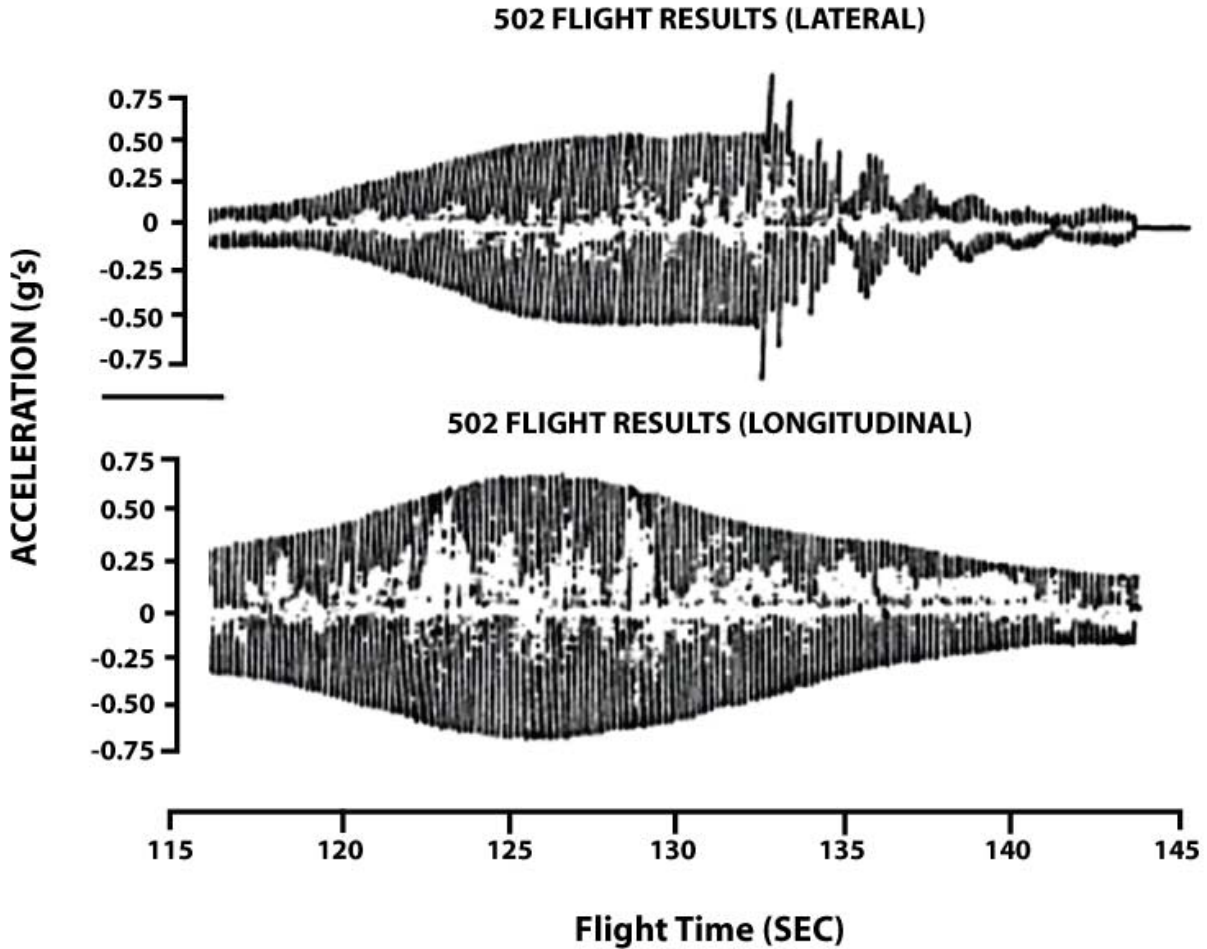
Figure 5. Pogo oscillation as measured at the LM simulator<sup>10</sup>

The second unmanned Saturn V, designated as AS-502 or Apollo 6, launched on April 4, 1968, but unexpectedly experienced pogo at 5 Hz between 105-140 seconds during first stage (S-IC) boost with 0.60 g maximum acceleration at the command module and 0.33 g at the aft of the vehicle.<sup>3</sup> The second and third stages of flight also experienced problems with failures of the J-2 engines unrelated to the first stage pogo.<sup>9</sup> The acceleration response recorded at the lunar module simulator during the first stage pogo event is illustrated in Figure 5.<sup>10</sup>

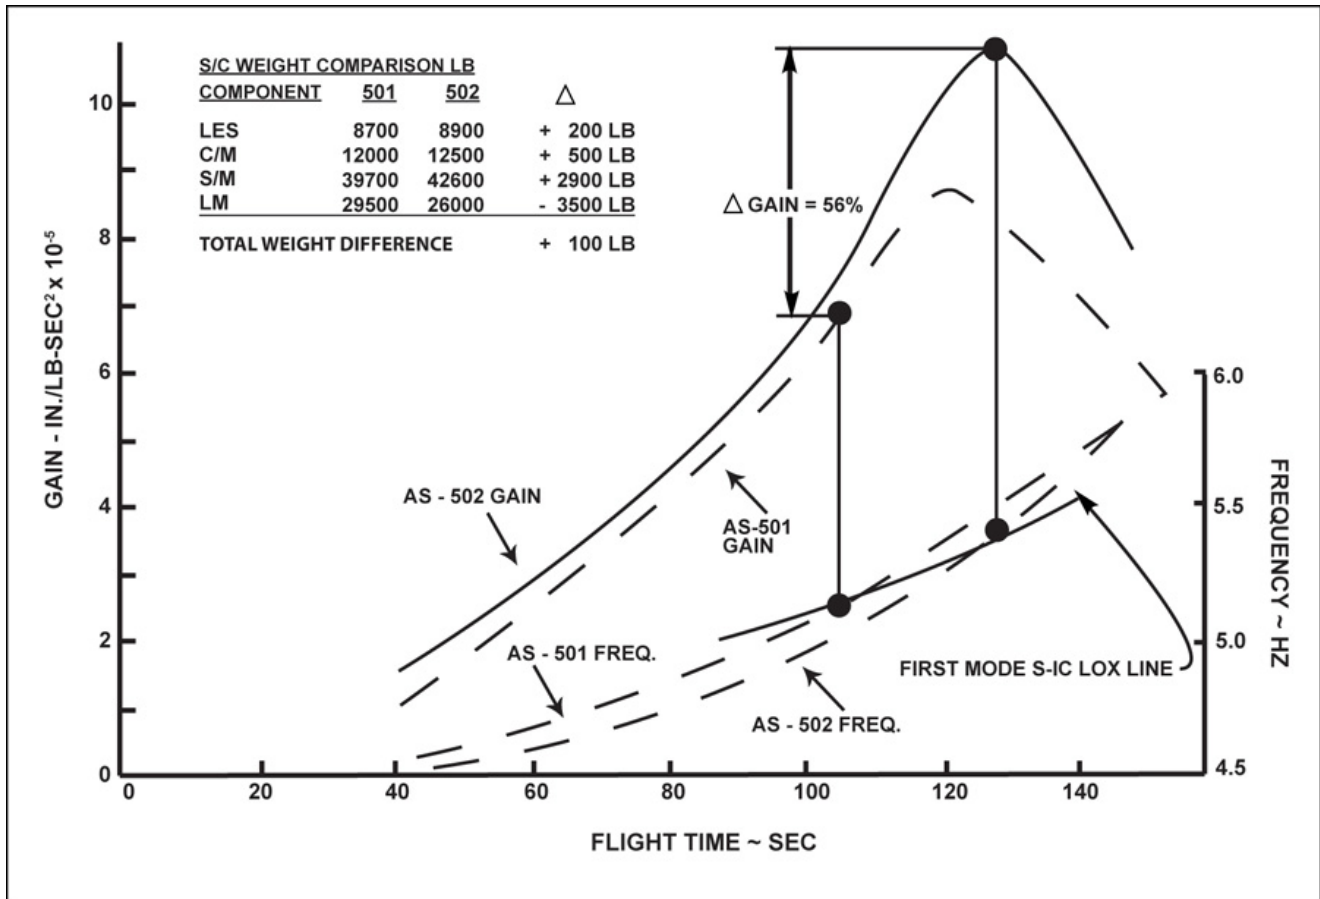
Figure 7. Illustration of Sensitivity to Small Changes: Comparison of AS-501 and AS-502<sup>10</sup>

sensitivity of pogo to what may have been thought to be inconsequential changes to the Apollo spacecraft. The Apollo 4 (AS-501) flight had a low fidelity mass simulator of the lunar module, while Apollo 6 (AS-502) had a much more realistic model of the expected LM spacecraft. Mass changes from Apollo 4 also occurred in the escape system, command module and service module of the Apollo 6 spacecraft, but the total net weight difference was only 100 pounds.<sup>12</sup> As shown in Figure 7, these slight changes accounted for a small shift in the time at which the first oxidizer line mode crossed an AS-502 structural mode as compared to the same AS-501 mode, but the closed loop system gain from the change was increased by over 50 percent.<sup>10</sup>

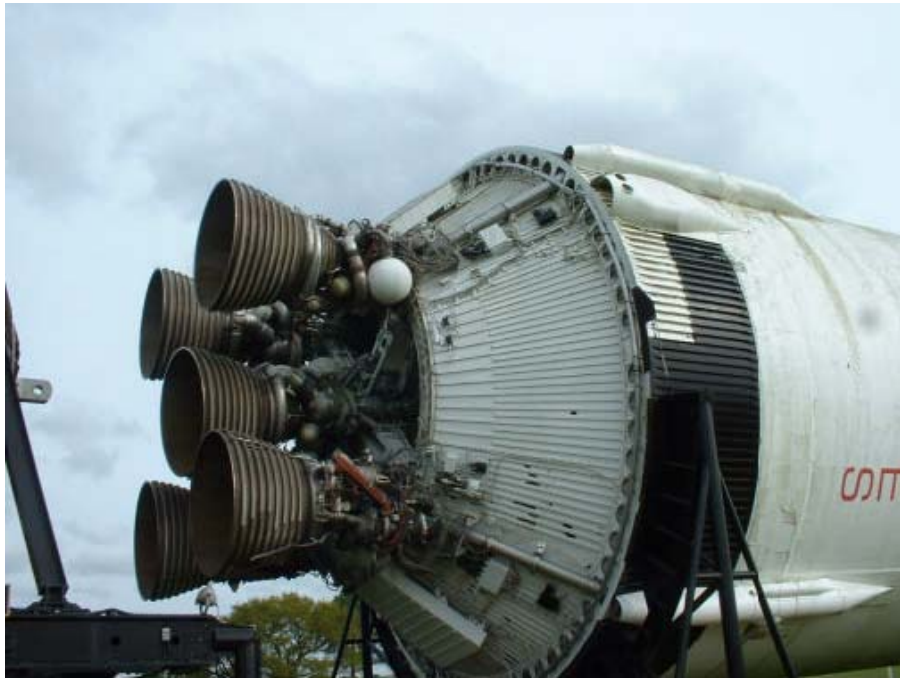
**Figure 8. Saturn V Second Stage S-II Close up, J-2 Engine Cluster<sup>15</sup>**

Apollo 8 (AS-503), the third Saturn V and first manned flight (Apollo 7 flew on a Saturn IB), successfully demonstrated the effectiveness of this pogo mitigation for the S-IC first stage. However, perhaps even more unexpectedly than the first stage pogo, on this mission the S-II second stage experienced pogo as reported by the command pilot at about 50 seconds before engine cut-off. Data analysis revealed an 18 Hz vibration of the center engine of the five engine J-2 cluster. Mounted on a crossbeam structure, the center engine was vibrating with the liquid oxygen (LOX) tank bottom. The magnitude at the crew cabin was actually quite small and no threat, but the local amplitude at the engine mount posed a threat the supporting cross beam structure.<sup>3,10</sup>
