SPECIAL REPORT # 80

N.A.C.A. STALL-WARNING DEVICE

By F. L. Thompson  
Langley Memorial Aeronautical Laboratory

February 1938

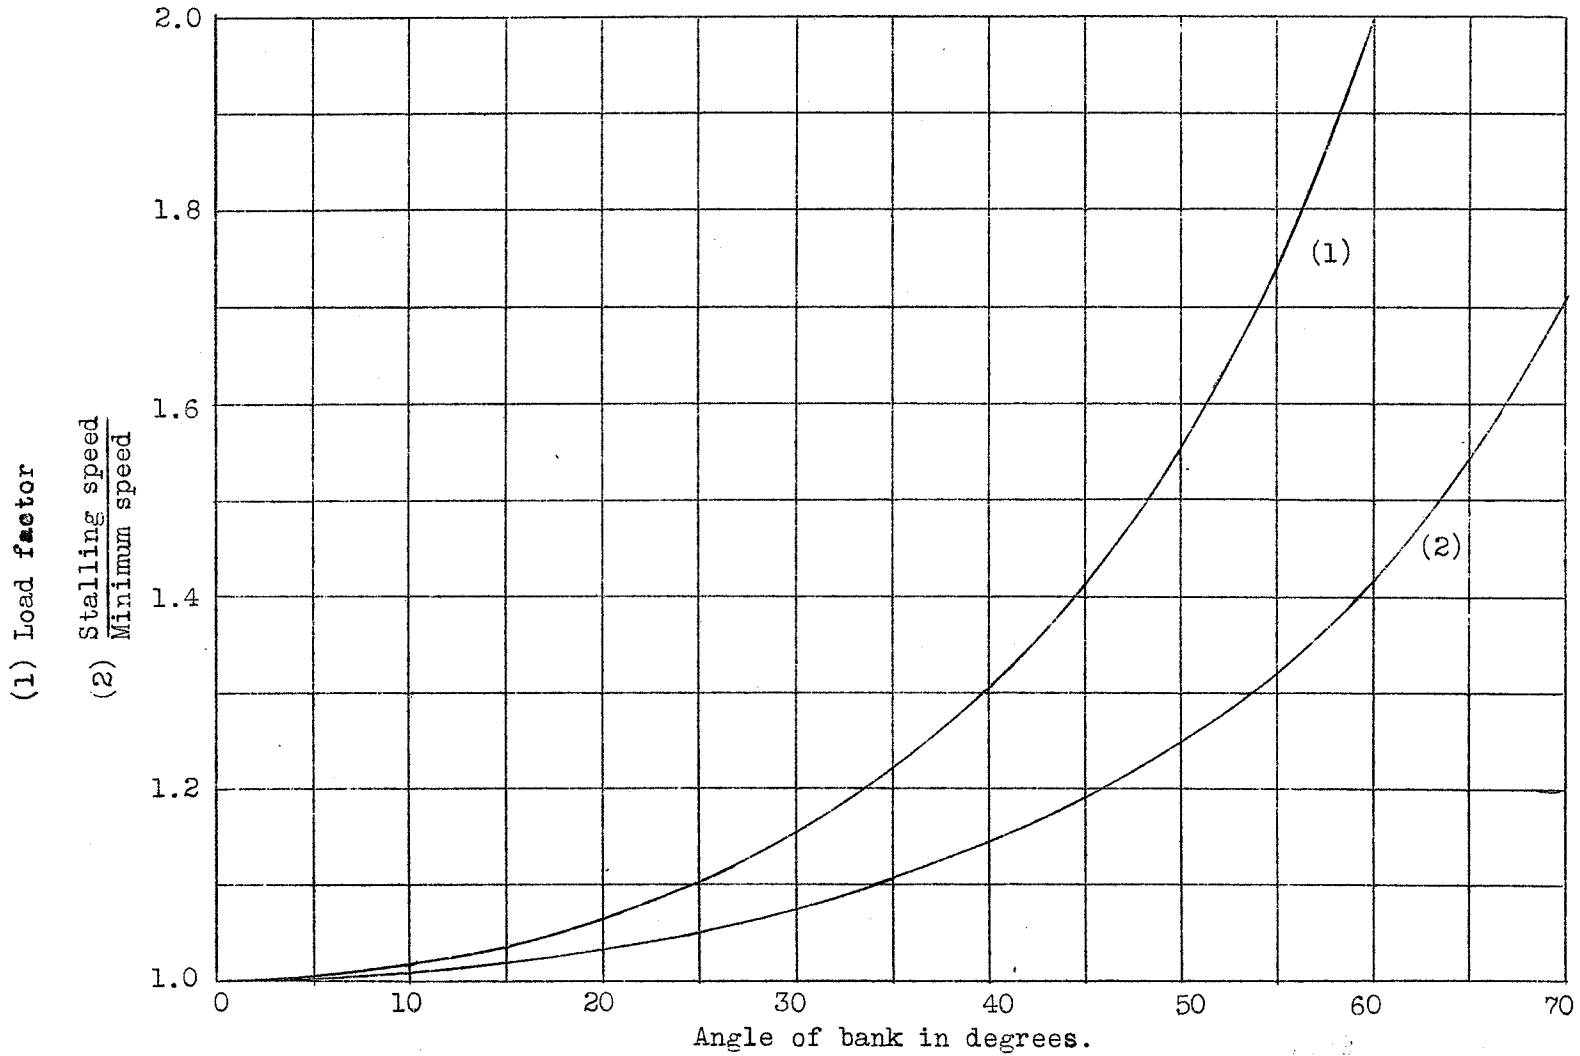
Figure 1.- Variation of load factor and ratio of stalling speed to minimum speed with angle of bank in horizontal turns.

The load factor and the ratio of  $V_{\text{stall}}$  to  $V_{\text{min}}$  in turns are plotted in figure 1 to show how these quantities vary with angle of bank. The curve of stalling speed is an ideal one that does not take into account the influence of errors in the air-speed meter reading. In general, such errors will further complicate the situation because calibrations made in steady flight will not apply in accelerated flight unless the correction for position error of the air-speed head is negligible. If an instrument is to be used to give a warning of the stall, therefore, it appears desirable that its functioning should be dependent on angle of attack rather than air speed. Furthermore, it seems desirable in order to avoid the necessity for watching the instrument continuously that it be arranged to give a warning signal when a safe limit has been reached.

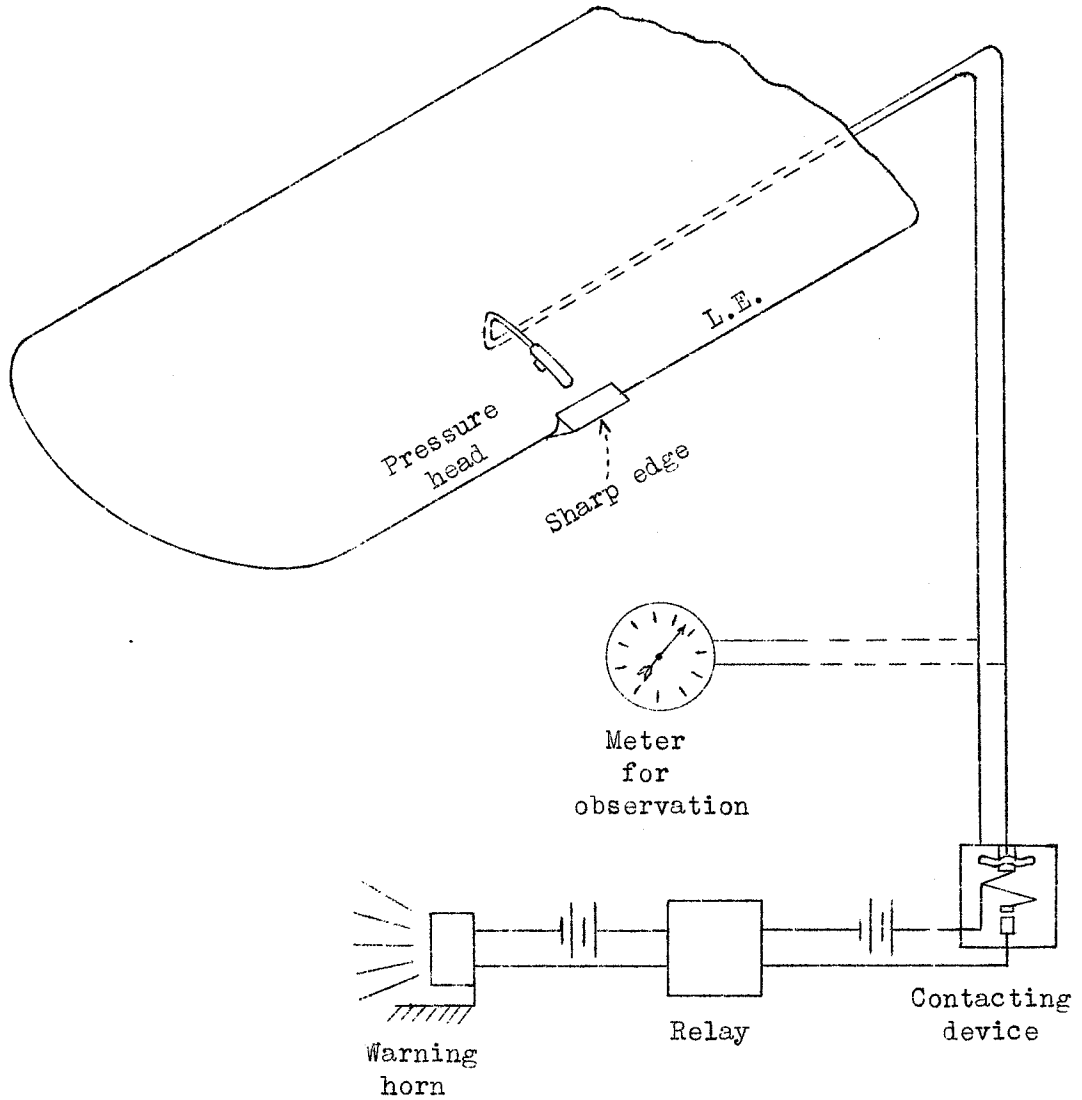
Figure 2.- Diagram of stall warning device.

A stall-warning device developed by the National Advisory Committee for Aeronautics is shown diagrammatically in figure 2. It makes use of a modified type of pitot-static head set close to the wing surface in a region wherein stalling occurs (or is made to occur) at an angle of attack considerably below that at which the main portion of the wing stalls. This head is connected to a pressure cell fitted with electrical contacts and for observations during tests it may also be connected to a conventional air-speed meter. When the air flow in the region in which the head is located breaks away from the wing surface, that is to say, when local stalling occurs, the pressure indicated by the head drops sharply to zero. When this occurs the electrical contacts close a circuit that operates a warning signal. The signal as used in flight tests of this device was a horn such as that used with retractable landing gears, but of course any suitable type of warning may be used.

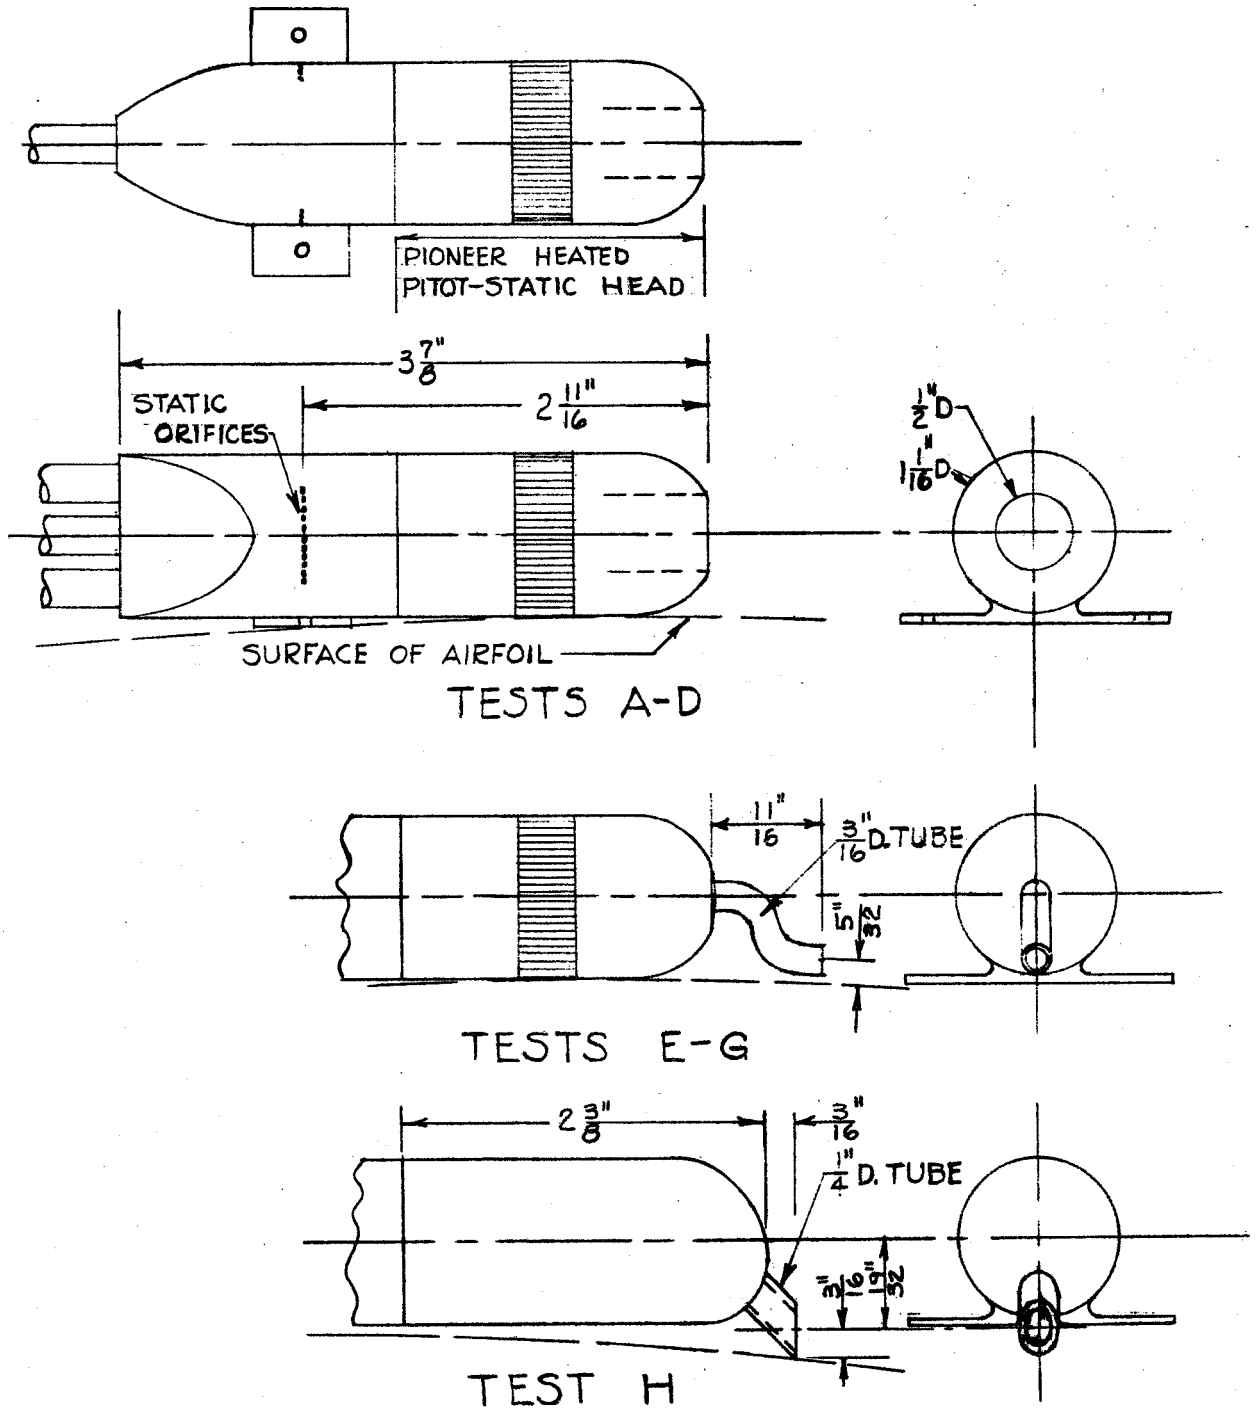
FIGURE 3.- PRESSURE HEADS USED WITH STALL WARNING DEVICE.

The head used in the experiments with different nose pieces is shown in figure 3. Table I shows the various arrangements of sharp edge and head that were tested and figure 4 shows photographs of combination H. For the tests the contacting device was set to operate when the local air speed as indicated by the stall-warning device dropped below 70 miles per hour. As will be shown later, this setting was appreciably below what would normally be the local velocity over the curved portion of the leading edge of the wing at the minimum speed of the airplane on which the tests were made. A considerable variation of this setting, however, would not have altered the results appreciably.

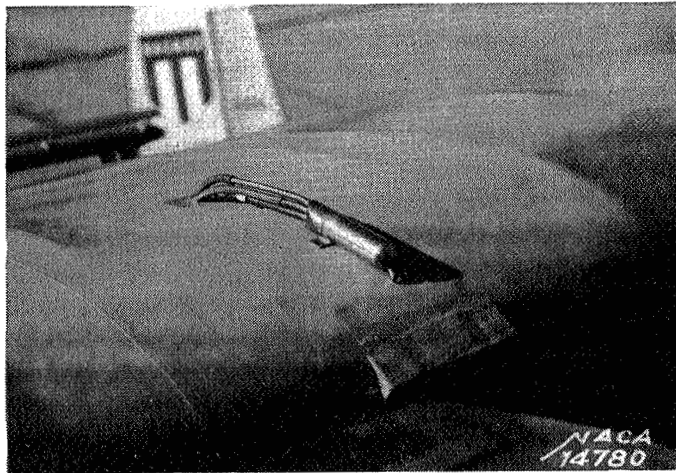
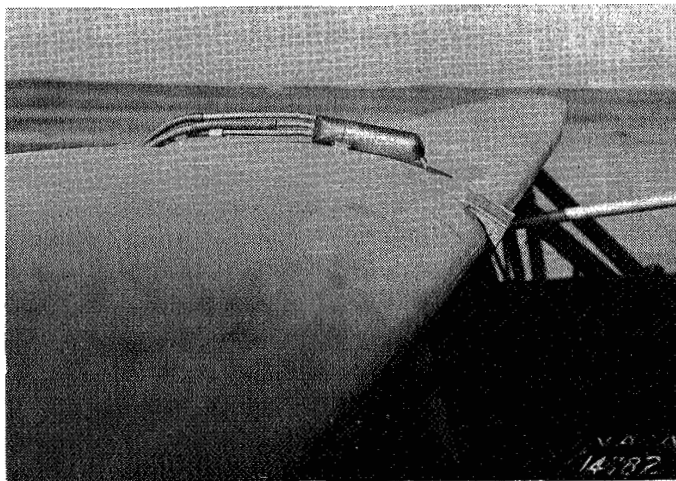
Figure 4.- Stall-warning device installed on wing of Fairchild 22 airplane.

The airplane used in the tests was a Fairchild 22 fitted with a wing of rectangular plan form, having a chord of 66 inches and an N-22 section. This wing was equipped with full-span Zap flaps. The head of the stall-warning device was placed outboard from the center a distance equal to about two-thirds the semispan where early stalling did not normally occur. Throughout the tests an air-speed meter was connected in the line of the stall-warning device so as to obtain more complete information concerning the functioning of the device than could be obtained by use of the warning signal alone.

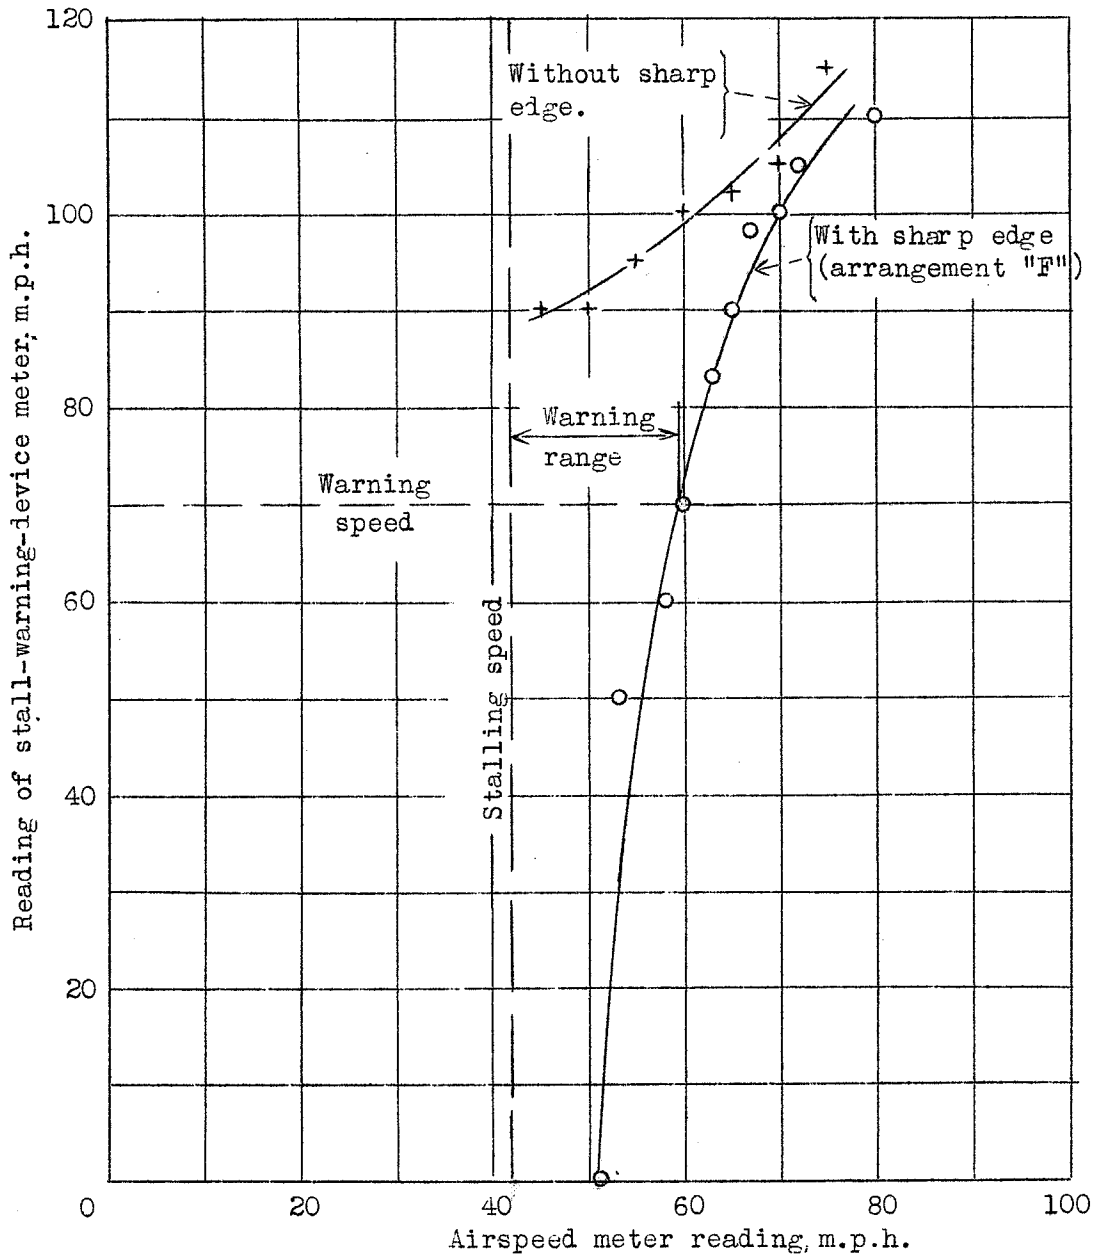
Figure 5.- Characteristics of stall-warning device for typical case.

Before a comparison is made of the results obtained with different arrangements, it seems advisable to describe the general characteristics of the behavior of the device by reference to figure 5. This figure shows the readings of the meter connected to the stall-warning head plotted against the readings of the air-speed meter of the airplane with arrangement F and also with the sharp edge removed. The results shown in this figure for arrangement F are typical of arrangements considered to be satisfactory. It will be noted that whereas the reading of the air-speed meter of the airplane at minimum speed is 42 miles per hour, the warning is obtained at about 59 miles per hour, the speed at which the local velocity falls below 70 miles per hour. Without the sharp edge the local velocity over the leading edge of the wing does not fall below 90 miles per hour. It may also be noted that, although the device was set to warn when the local velocity reached 70 miles per hour, a change of setting of several miles per hour in either direction would not have greatly altered the airplane speed at which the warning occurred. In other words, the adjustment of the contacting device was not critical. One other point of practical interest brought out by figure 5 is that in the normal flight range the local velocity is considerably greater than the air

speed of the airplane, so that the pressure unit used in the contacting device must be rugged enough to withstand pressures much larger than the dynamic pressure corresponding to the maximum speed of the airplane relative to undisturbed air.
