SOURCES OF AND REMEDIES FOR REMOVING UNWANTED REFLECTIONS IN MILLIMETER WAVE IMAGES OF COMPLEX SOFI-COVERED SPACE SHUTTLE STRUCTURES

S. Kharkovsky¹, R. Zoughi¹, and F.L. Hepburn²

¹Electrical and Computer Engineering Department
Applied Microwave Nondestructive Testing Laboratory (*amntl*)
University of Missouri-Rolla
Rolla, MO 65409

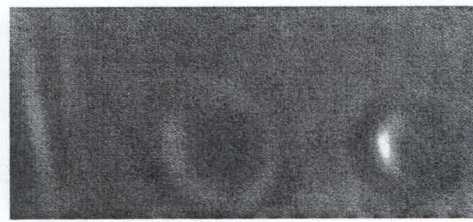
FIGURE 5. (a) Raw and (b) processed images of the portion (200 mm by 90 mm) of the tilted SOFI wedge sample obtained with a small horn antenna at 36 GHz.

It should be noted that only the largest voids in the SOFI wedge sample at different positions were detected using the small horn antenna. Better results were obtained with lens antennas at higher frequencies. For instance, Figure 6 shows image of the entire not tilted (i.e., substrate orientation orthogonal to the direction of propagation) SOFI wedge sample obtained at 100 GHz using the lens antenna with the short depth-of-field when the lens was focused at the substrate (Figure 6a) and 64 mm above the substrate (Figure 6b), respectively. The results show that, with the exception of a few voids the majority of the voids are clearly detected. In addition, the relative size and shapes of the voids are also clearly shown in the images. These images also show additional several small indications that are most likely due to the presence of excess adhesive during the manufacturing process. The most important that the interference pattern is significantly reduced since in this case the reflection from the substrate is constant while that from the SOFI surface (which is much weaker) changes across the scan resulting in gradual change of the intensity in the images from left to right.
