Human Habitation in a Lunar Electric Rover During a 14-Day Field Trial

Harry Litaker, Jr.¹, Shelby Thompson¹, and Robert Howard, Jr.²

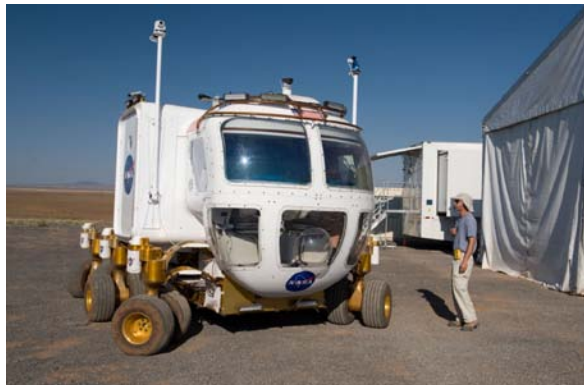
Figure 1. LER Cabin 1B at field trail.

The LER is a high fidelity functional vehicle which provides the crew a safe haven from the hazardous environment of the lunar surface, a living area for multiple day missions away from the lunar outpost, and a rapid EVA deployment system for scientific exploration of the surface (see Figure 1). Total interior volume of the vehicle was calculated at 10.8 cubic meters with a net habitable volume (NHV) of approximately 8.6 cubic meters, resulting in about 79% functional volume. Net habitable volume is defined as the total remaining volume available to crew after accounting for the loss of volume due to equipment, stowage, and any other structural inefficiencies which decrease functional volume.

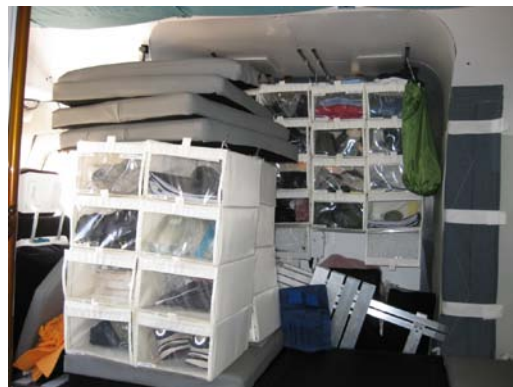
Figure 2. LER cabin after a reconfiguration for EVA.

For internal volume and stowage, seven elements were studied. Volume, accessibility, clearance, and overall design of the personal soft lockers were rated by the crew as totally acceptable. The crew reported the soft locker volume was great for a 14-day mission as well as the accessibility to the lockers (see Table 3). They liked the flipped down front flaps and locker depth to hold personal items. The crew liked the overall design and concept of the soft locker system; however, reconfiguration of the system became a major issue. Reconfiguration time was a factor with the crew observing approximately 5 minutes per reconfigure per EVA with 4 EVAs per day for 14 days times 4 crewmembers would equal 18 hours and 40 minutes per mission. With the crew having to relocate the lockers, space within the vehicle started to become cramped and crowded (see Figure 2).

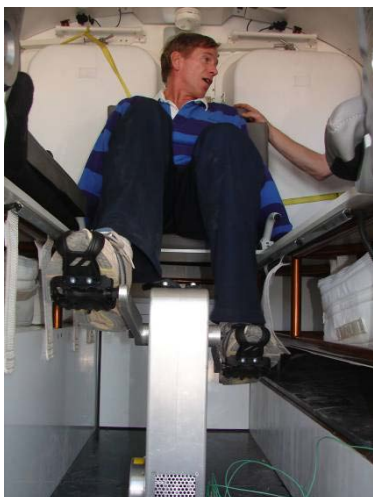
Figure 3. Crewmember doing aerobic exercise with ergometer. Note the spacing between the pedals and the aisle way.

However, the crew did express some issues with the system. The ability of a crew to perform aerobic exercise while the vehicle was moving was the highest rated concern among the crewmembers ($GM = 6.1$). The crew reported it depended on the terrain in which the LER was traveling. If the terrain was flat and smooth, they did not have an issue with exercising; however, if the terrain was bumpy and rough, exercise was not possible. Just walking from the aft cabin to the cockpit of

the LER while on rough terrain was difficult according to the crew. This also held true for resistive exercise as well (see Figure 3).

Accessibility of the non-exercising crewmember to other stations within the vehicle while a crewmember was performing either aerobic or resistive exercise was also rated high. The crew indicated they tried to make sure certain items were stationed up in the cockpit area. With the ergometer in the aft section aisle way of the LER, the pedals of the device do not allow for any space to pass for the non-exercising crewmember. The crew also observed this limited aisle space as well during setup.

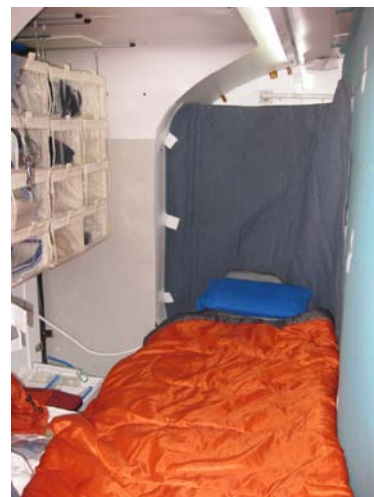
Figure 4. Fully deployed sleep station inside LER.

They noted with the two soft lockers hanging in the side hatch and the high ceiling height, it gave them the perception of a spacious volume within the station (see Figure 4).

Egressing out of the station when the curtains were deployed was considered somewhat acceptable. The crew noted with the curtains down, there was limited access to the WCS and the noise from the Velcro was a concern for the other sleeping crewmember. As for the sleep quality, the crew stated they like the large side curtain for its sound and light dampening qualities which made sleeping a lot quieter. However, they reported the bench cushions by the front seats were awkward to lay on and some time was spent adjusting the pads for the right comfort. The LER’s lighting controls were outside the sleep station which causes an issue. The crew reported there was no easy access to the controls.
