Propulsion Health Monitoring of a Turbine Engine Disk Using Spin Test Data

Prepared for the
Smart Structures and Materials and Nondestructive Evaluation and Health Monitoring 2010
sponsored by the International Society for Optical Engineering (SPIE)
San Diego, California, March 7–11, 2010

Abstract

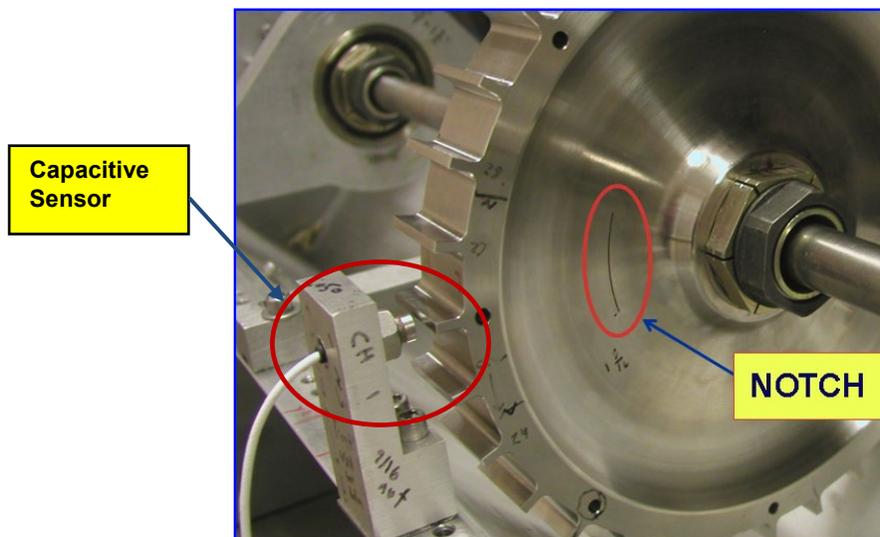
Figure 1 shows the disk specimen and the induced crack-notch along with the tip clearance probes. The test specimen disk has an outside diameter of 23.495 cm (9.25 in.) respectively; a bore and an outside rim thickness of 2.54 cm (1 in.) and 3.175 cm (1.25 in.); the thickness of the web is 0.254 cm (0.10 in.), and the cross section and height of the blades are 3.175- by 0.330-cm (1.25- by 0.13 in.) and 0.838 cm (0.33 in.), respectively. It has rotor like blades, total of 32, evenly spaced around the circumference. Eight holes, 0.508 cm (0.20 in.) diameter each, were drilled through the disk half-way in the rim. The holes were spaced every 45° and they were designed for future studies as possible mass add-on points or notch initiation sites.

Figure 1.—Test disk with a notch.

The controlled speed applied during the current testing ranged from a minimum of 1,000 up to a maximum of 10,000 rpm with acceleration-deceleration rates of 60 rpm/second. This insured surpassing the critical speed of 2,610 rpm and leading to post critical state. Experiments covered base line runs with undamaged disk and with damaged disk via artificially induced notch, shown in Figure 1.

The notch had a width of 0.381 mm (0.015 in.) as per wire thickness and burn area of the electric discharge machining (EDM) process. The notch region was intentionally selected to be in the rim area due to the fact that the finite element results revealed that this section encounters the highest stress level in the disk during the spin operation (Refs. 1 and 2). Systemic considerations were emphasized to preserve consistency of the operating parameters and other experimental conditions during the removal-reinstallation process of the disk specimen in both situations, baseline no-notch and notch state.

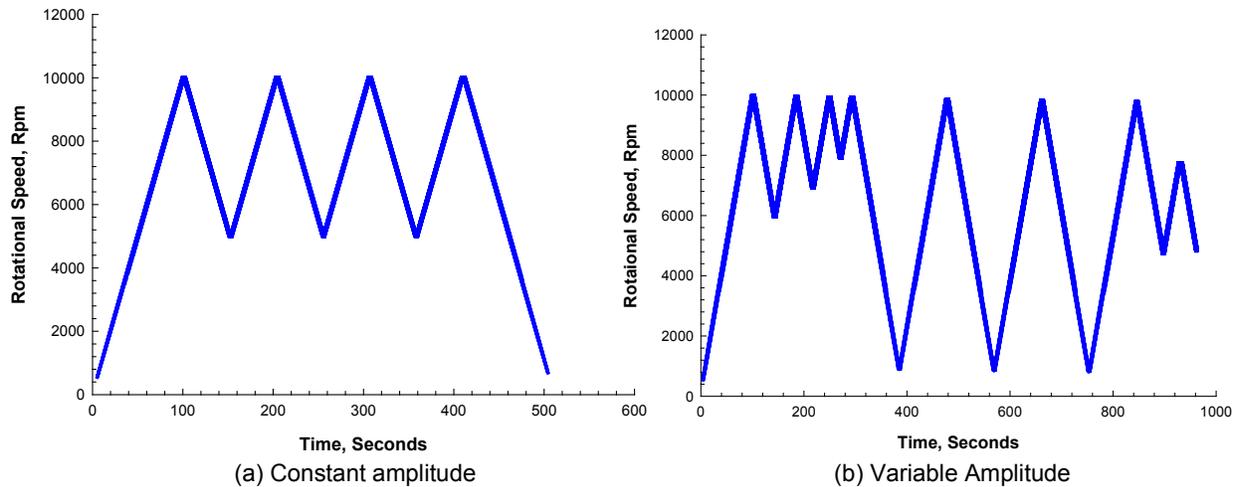
Figure 2.—Simulated engine mission history profiles.

Figure 2 shows the mission history profiles applied in this experimental work for the disks, the baseline unnotched and the notched disk. These profiles were derived on the basis of revolutions per minute data obtained on different flights comprising different flight maneuvers (Ref. 15). Figure 2(a) shows the constant amplitude portion which is one of the test mission profiles applied in the experiment. It clearly demonstrated less aggressive and smoother profile compared to the variable amplitude profile shown in Figure 2 (b), starting with a minimum of 200 rpm up to a maximum of 10,000 and a shutdown to 0 rpm. Meanwhile, Figure 2(b) represents the variable amplitude engine history which reflects steep and sharp changes in the rotational speed across the entire cycle, subjecting the disk to high and complex loading conditions in an attempt to fatigue the disk with the expectation that all existing anomalies would appear in the test data. The speed was varied sharply from a minimum of 200 rpm up to 10,000 rpm at various intervals. Testing the rotor under these conditions provided a good simulation to collect data under various loading conditions which the disk may experience during nontypical operating environment. Furthermore, these experiments supplied valuable assessments for both, the crack detection scheme and the structural durability of the disk materials.

For the constant amplitude cycle (Fig. 2(a)) data analysis, the data was recorded in two sets: “normal” and “notched”. The rotational speed for the disk continuously varied from 5,000 to 10,000 rpm for both normal and notched runs. In this analysis, only the 32 gap measurements were considered. Orca, Inductive Monitoring System (IMS) and One-Class Support Vector Machines (OCSVM) were chosen to evaluate this data. The normal run’s data was randomly divided in half. One half was used for training and the remainder half was used for validation. The means and standard deviations for all 32 channels are calculated for the training data and used to z-score normalize (normalize each channel to have zero mean and unit standard deviation) both the training and testing data sets. The plots, Figures 5 to 8, are the global anomaly scores for each of the algorithms on both the validation normal and the notched runs over time.

An additional data set had rotational speed varying from 1,000 to 10,000 rpm; Figure 2(b) was evaluated using all three algorithms. For the analysis of 1,000 to 10,000 rpm data, the algorithms performed comparably to the 5,000 to 10,000 rpm analysis. However, in the category of false alarm rates when fixing the correct detection at 90 percent IMS appears to have trouble, with a false alarm rate of 100 percent. It also appears that Orca has an edge in this category with a false alarm rate of 1.99 percent where OCSVM is slightly higher at 4.57 percent.

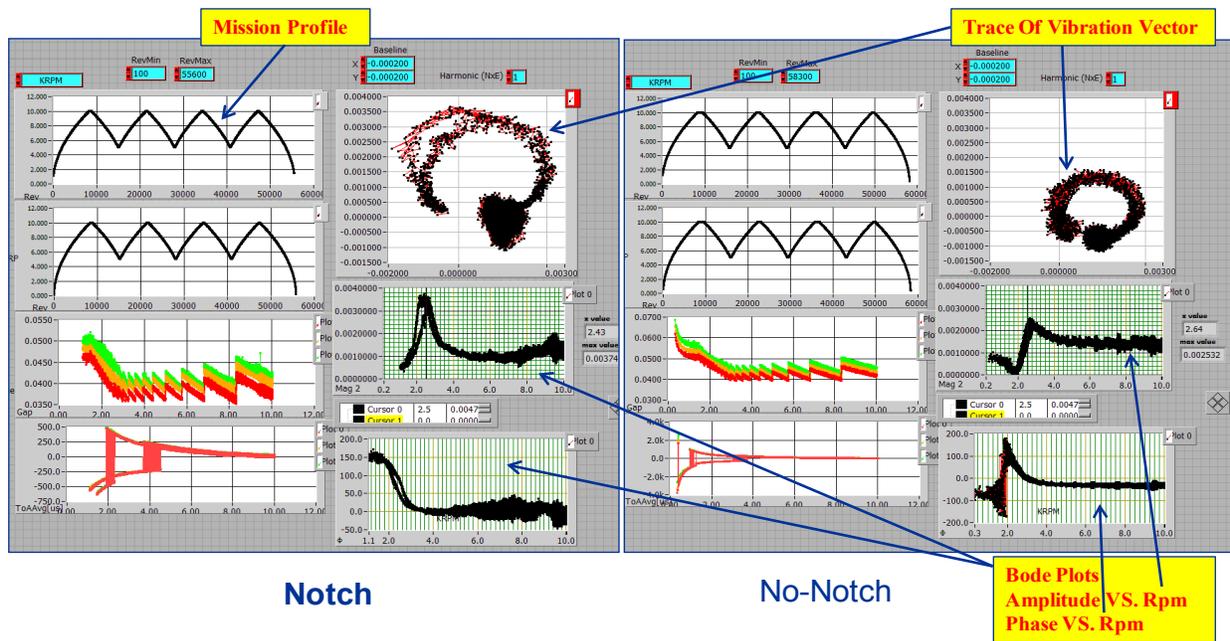
Experimental data under both applied mission profiles are represented in Figures 3 and 4. The data in Figure 3 are produced under the constant amplitude mission for both the baseline no-notch and the notched disks. The mission history is shown along with the trace vibration vector and bode plots for the phase and amplitude response. A clear observation is noted for both, the baseline and the notched disk; a closed loop representation for the trace of vibration vector is seen for the baseline disk while a gap in the loop is present for the notched disk. This behavior offers the first hint that we have a difference in the vibration response for the two structures indicating the presence of some type of anomaly. Such observation has been reported in Reference 7, where a crack in the rotor disk is documented via the presence of distorted trace of the vibration vector distribution and a rise in the phase and amplitude response upon surpassing the critical speed stage.

Figure 3.—Bode Plots—9 minutes comparison test for the disk with and without notch, constant amplitude mission profile.

This conduct is obvious in Figure 3 for the notched disk. A rise in the phase and amplitude response is clearly noted. While a flat and steady decrease in these parameters is shown for the baseline rotor which implies that it is a healthy rotor. Again, similar remarks for the variable amplitude mission history profile are seen in Figure 4. A rise is reported in the phase and amplitude response as soon as the disk crosses the 5,000 rpm level up to the 9,000 rpm where a notable no changes response is apparent. The difference between the data reported for the variable and the constant amplitude profile is confined to a higher blade tip clearance for the variable amplitude (nearly about 22 percent higher). Therefore, examination of the above data verified that the detection scheme applied in the experiment seemed to deliver a reasonable set of results indicating the presence of a defect in the rotor disk. However, this confirmation has to be further documented by conducting more tests for different rotors under similar operating conditions to authenticate that this behavior in the data is strictly due to existing structural defects in the rotor and not due to a system related unbalance.

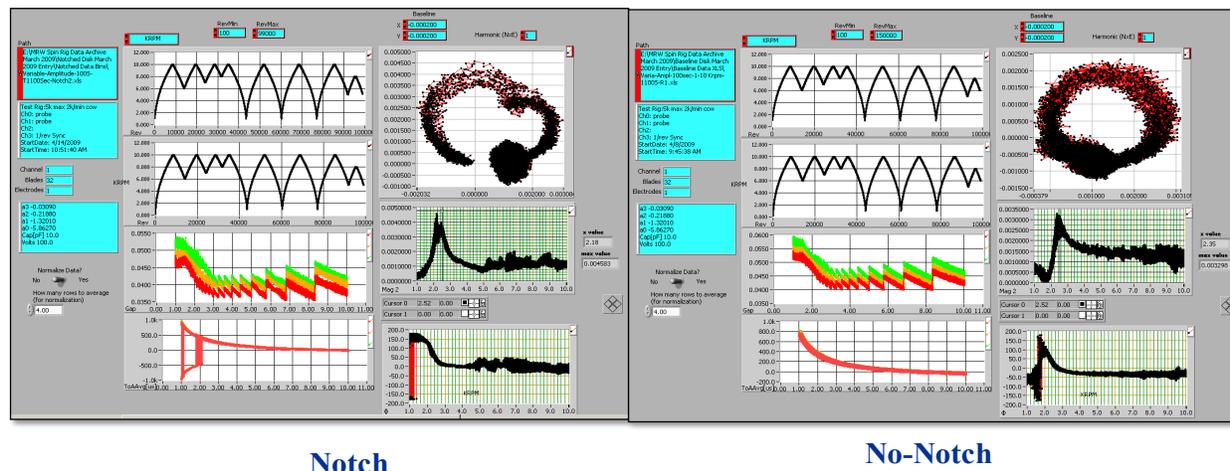
Figure 4.—Bode Plots—9 minutes comparison test for the disk with and without notch, variable amplitude mission profile.

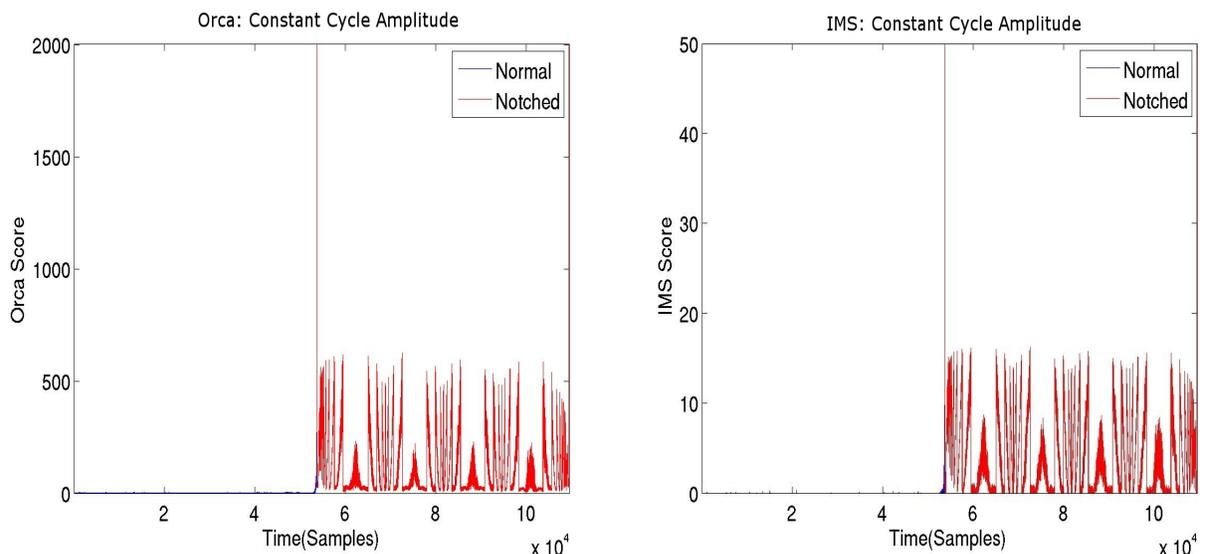
Figure 5 through 8 provides the scores for the three different techniques. In Figures 6 and 8 the anomaly scores are portrayed as positive values and any nominal points are represented as zero. This was done to allow for similar comparison across the algorithms. It is important to note that OCSVM allows some nominal sample points in the training set to be classified as anomalous. This percentage is governed by the Nu parameter, which is set by the user, but for which we set currently at the default value of 10 percent. Due to this characteristic of the algorithm, 10 percent of all nominal data tested may result in anomalous classification. In Tables 1 and 2 the choice for fixing correct classification to 90 percent was to make the comparisons fair between all three algorithms, since OCSVM, in this case, was optimized for a correct classification of 90 percent.

Figure 5.—Results of Data Driven Anomaly Detection Technique; ORCA and Inductive monitoring system (IMS).

Therefore, based on the information reported in Figures 5 to 8, it can be concluded that the detection techniques performed as expected and indications of malfunctions are seen in the scored representations of highly spiked distributions for the notched disk, while no spikes are noted for the baseline no notch disk. This applies to the data reported in Figures 5 to 8. The evaluation of the data reported from these techniques is also tied to the scores produced as a result of the simulation. For instance, the higher the score, the more anomalous is the structure.

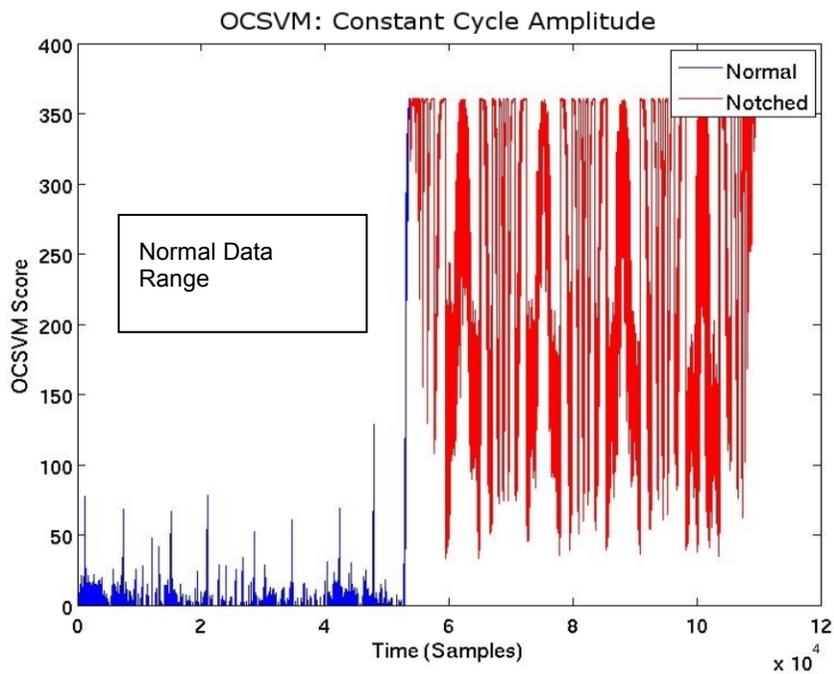
Figure 6.—Results of Data Driven Anomaly Detection Technique; OCSVM Algorithm.

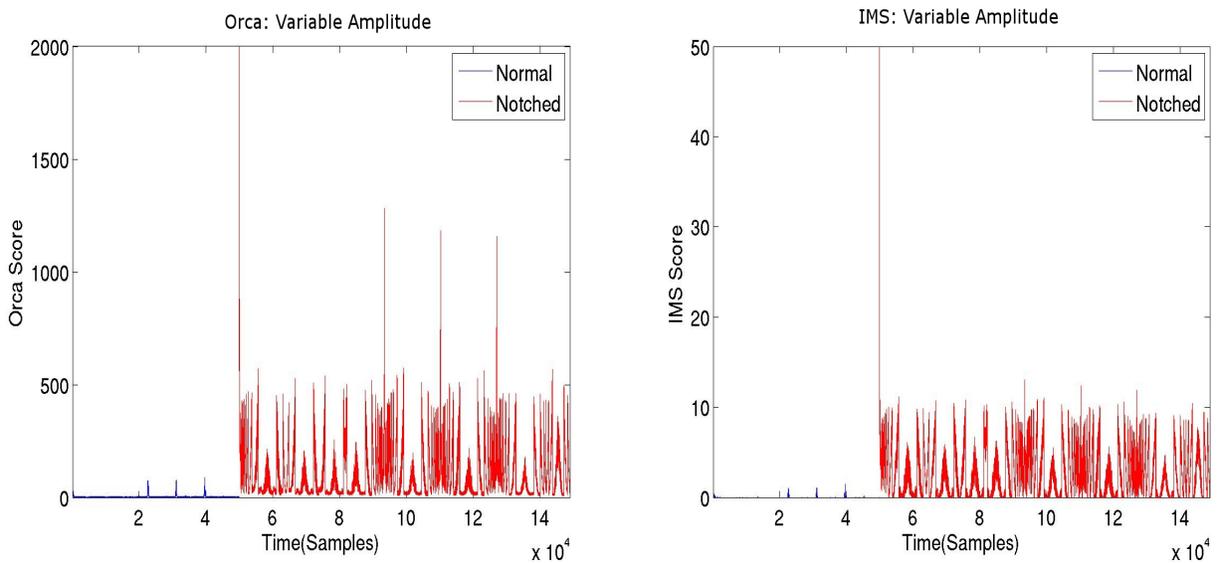
Figure 7.—Results of Data Driven Anomaly Detection Technique; ORCA and Inductive monitoring system (IMS).

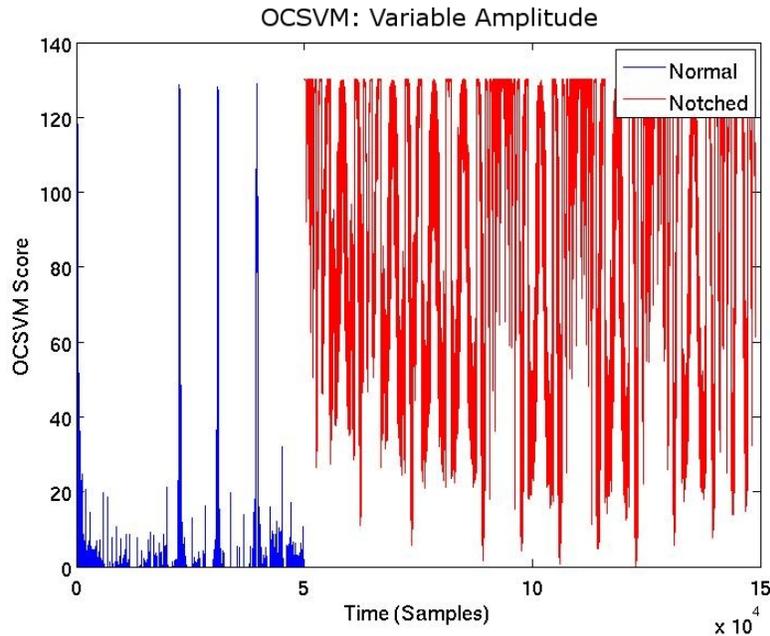
Figure 8.—Results of Data Driven Anomaly Detection Technique; One-Class Support Vector Machines (OCSVM).
