A Comparison of the Capability of Sensitivity Level 3 and Sensitivity Level 4 Fluorescent Penetrants to Detect Fatigue Cracks in Various Metals

Bradford H. Parker
Goddard Space Flight Center, Greenbelt, MD

Under the auspices of the NASA Nondestructive Evaluation (NDE) Program, the Goddard Space Flight Center (GSFC) Materials Engineering Branch initiated a task in October 2008 to investigate the effect of liquid penetrant sensitivity level on probability of crack detection. The purpose of the task was to address the requirement in NASA-STD-5009¹, “Nondestructive Evaluation Requirements for Fracture Critical Metallic Components,” which was released in April 2008, that states only sensitivity level 4 penetrants could be used for NASA Standard Level liquid penetrant inspections.

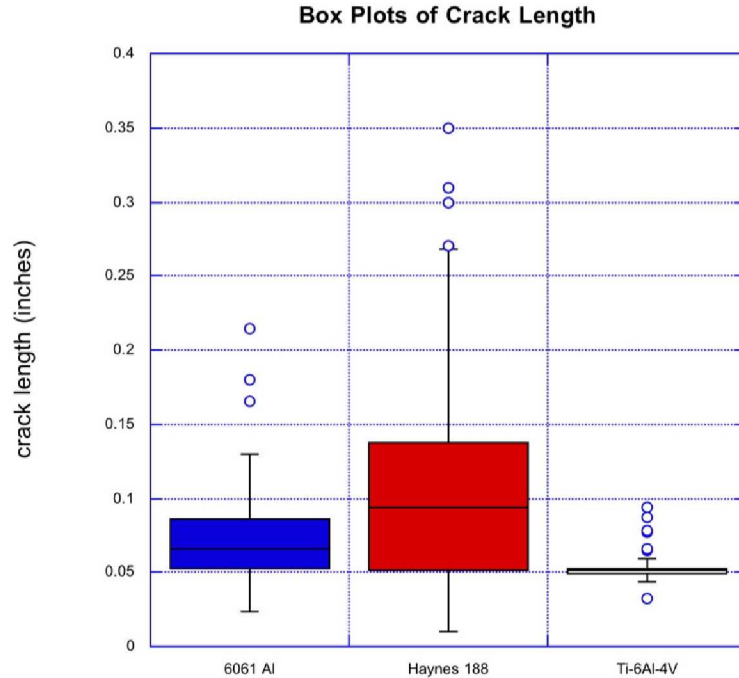
Figure 1 shows statistical box plots of the crack length distributions for each panel set. There is a sharp contrast between the distribution in the Ti-6Al-4V set and the other two metals. The Ti-6Al-4V set was designed for point estimate POD demonstration testing at a crack length of 0.050 inches. Hence, 45 of the 54 cracks in the set have lengths between 0.045 and 0.055 inches. For the Haynes 188 and 6061-Al sets there is broader distribution

Figure 1: Box plots of crack length distribution for each of the crack panel sets.

of crack lengths and these two sets are better suited for the curve fitting POD data analysis technique.

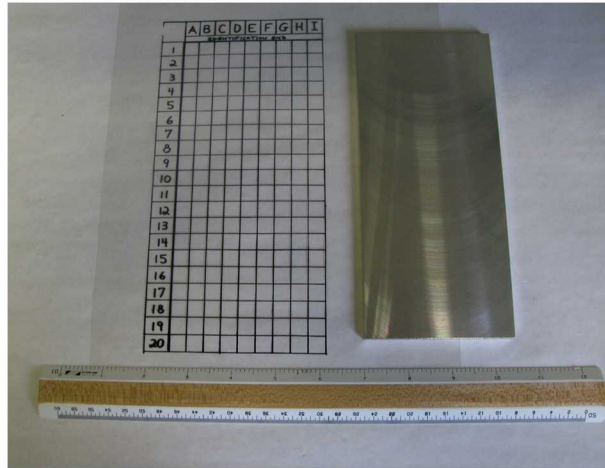
For all three panels sets, a grid was used for identification of crack locations. Figure 2 is an optical photograph of a 6061-Al panel with the corresponding inspection grid. Similar grids were used for the Haynes 188 and Ti-6Al-4V panel inspections. All inspections were of the hit-miss type. In addition to hits and misses, the number of false calls was also recorded.

Figure 2: Optical photograph of an aluminum crack panel and the grid used to identify the detected crack locations.

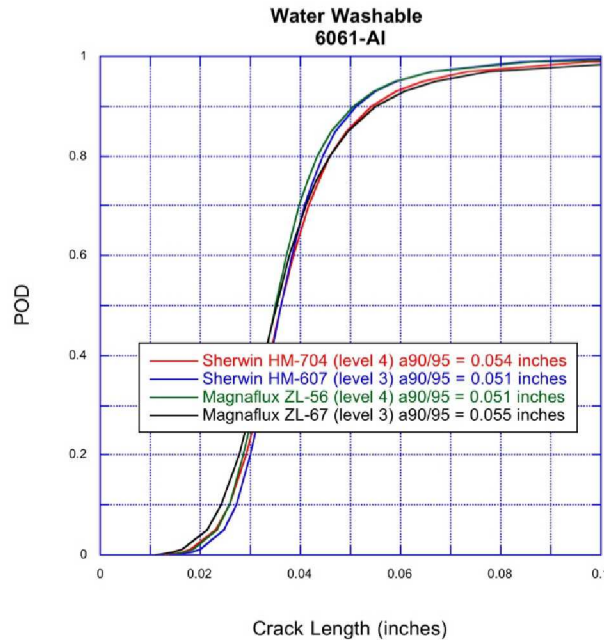
In order to compare the individual inspectors and the individual penetrants, hit-miss results from individual trials were combined and analyzed using the Logit curve fit technique. Figure 3 shows the a90/95 curve fits for the four different Method A penetrants. Each curve fit was performed on the combined hit-miss data from the five

Figure 3: Logit curve fit a90/95 results as a function of Method A penetrant for 6061-A1 POD demonstration tests.

trials (one trial for each of the five inspectors) performed using the penetrant. The a90/95 values for the penetrants range from 0.051 to 0.055 inches.

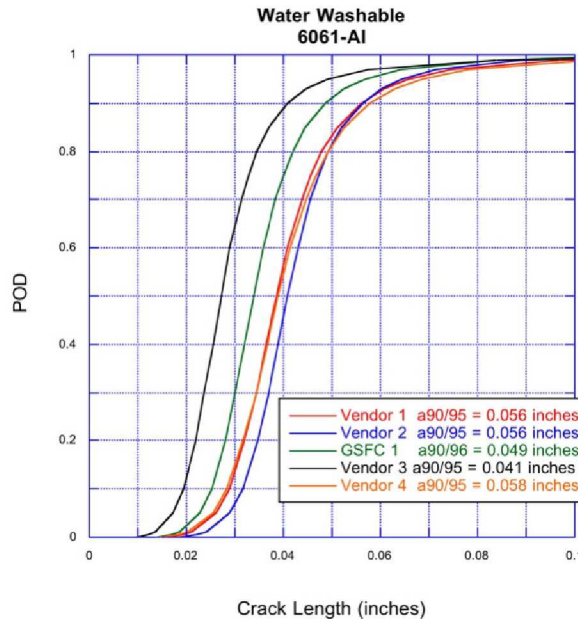
In a similar fashion, all of the hit-miss results for each inspector (four trials, two with sensitivity level 3 and two with sensitivity level 4 penetrants) were combined and analyzed using the Logit curve fit technique. These results, which are plotted in Figure 4, show that the demonstrated a90/95 is a stronger function of the inspector than of the penetrant. Here, the a90/95 values varied between 0.041 and 0.058 inches.

Figure 4: Logit curve fit a90/95 results as a function of Method A inspector for the 6060-AI demonstration tests.

For the Method A inspections, the largest variable in the process was the application of the nonaqueous Sherwin D-100 developer. One inspector (Vendor 1) applied a heavy coating of the developer (there was no evidence of the aluminum beneath the developer), whereas the remaining inspectors applied lighter coatings. One inspector (Vendor 3) inspected the panels completely before developing and then inspected the panels again during the development process, i.e., the developer was applied to one crack panel and the panel was immediately observed under the black light. After recording all crack locations, the inspector proceeded to the next panel. This inspector had the lowest number of misses. The remaining inspectors developed batches of panels and waited at least 10 minutes before beginning the crack identification process.

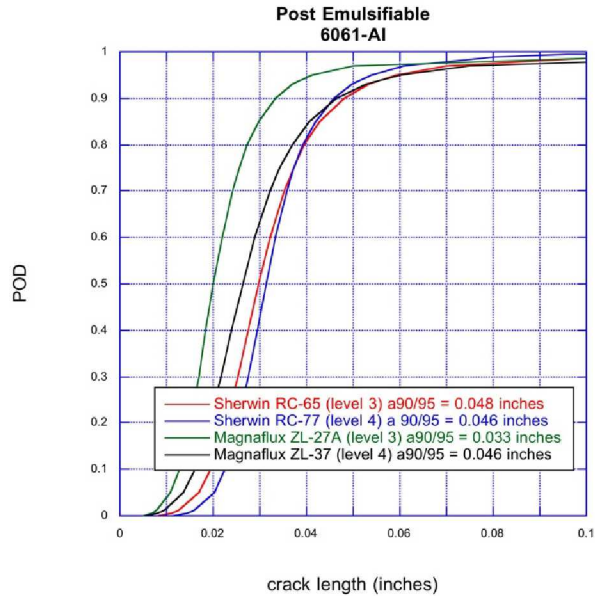
In order to compare the different penetrants and inspectors, hit-miss results from individual trials were combined and analyzed using the Logit curve fit technique. Figure 7 shows the a90/95 curve fits for the four different Method D penetrants. Each curve fit was performed on the combined hit-miss data from the six trials (one trial for each of the six inspectors) performed using the penetrant. The plots show that one penetrant, Magnaflux ZL-27A, performed better than the remaining three penetrants. Interestingly, this penetrant is sensitivity level 3. This result is not unprecedented. In a report by John Lively,⁸ four of six inspectors who performed penetrant demonstrations tests on Inconel 718 panels using Magnaflux ZL-37 (sensitivity level 4) and Magnaflux ZL-27A (sensitivity level 3) performed better with ZL-27A.

Figure 7: Logit curve fit a90/95 results as a function of Method D penetrant for 6061-A1 demonstration tests.

Table 6 provides summary results for all four Method D penetrants. This data again shows that the inspectors performed better with ZL-27A and that the remaining three penetrants performed similarly. There was no characteristic of ZL-27A that surfaced during the inspections that would lead one to believe that this penetrant would perform better.

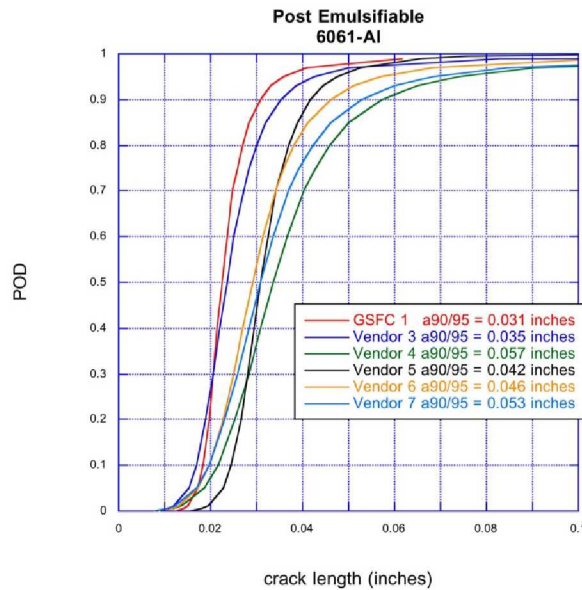
Again, all of the hit-miss results for each inspector (four trials, two with sensitivity level 3 and two with sensitivity level 4 penetrants) were combined and analyzed using the Logit curve fit technique. These results, which are plotted in Figure 8, show that the demonstrated a90/95 is again a stronger function of the inspector than of the penetrant. Here, the a90/95 values varied between 0.031 and 0.057 inches, which is similar to the range for the Method A inspectors (0.041 to 0.058 inches). It should also be noted, that the inspector with the largest overall demonstrated a90/95 for Method A, also had the largest a90/95 for Method D.

Figure 8: Logit curve fit a90/95 results as a function of Method D inspector for 6061-AI demonstration tests.

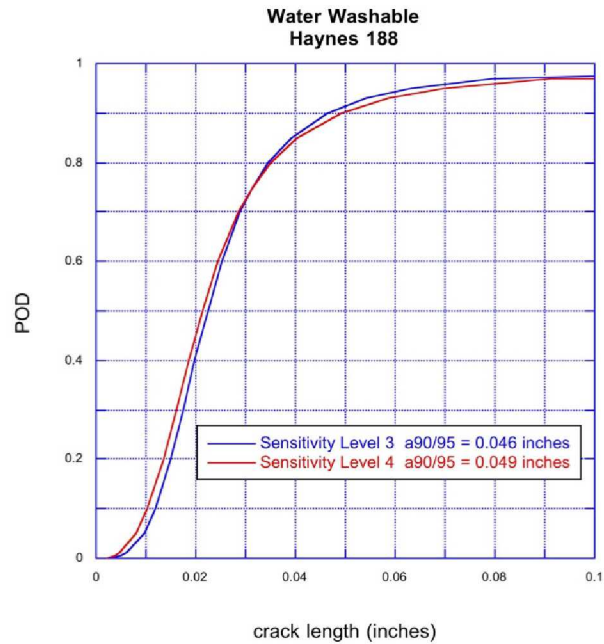
The values in the final column of Table 7, which were obtained by performing Logit curve fits on the combination of all 6 sensitivity level 3 hit-miss data sets and all six of the level 4 sets, show the a90/95 values for the two levels of penetrants differ by 0.003 inches. These results are shown graphically in Figure 9.

Figure 9: Logit curve fit a90/95 results as a function of Method A penetrant sensitivity level for Haynes 188 demonstration tests.

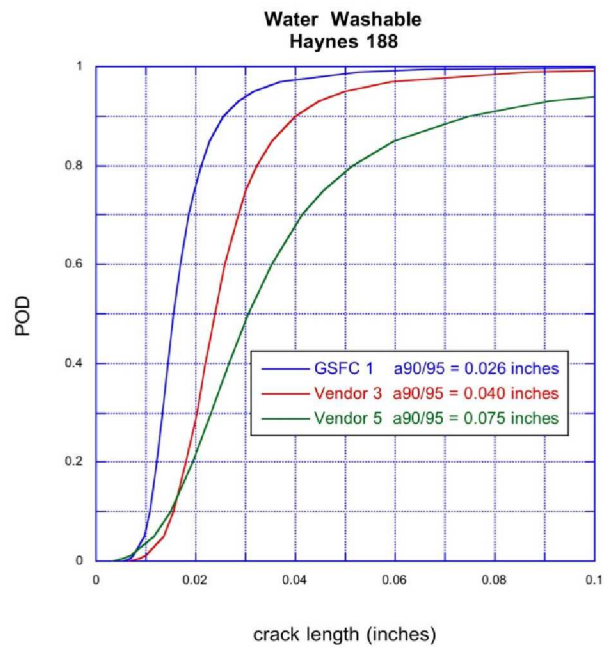
All of the hit-miss results for each inspector (four trials, two with sensitivity Level 3 and two with sensitivity Level 4 penetrants) were also combined and analyzed using the Logit curve fit technique. These results, which are plotted in Figure 10, show that the demonstrated a90/95 is again a stronger function of the inspector than of the penetrant. Here, the a90/95 values varied between 0.026 and 0.075 inches. Note that the range of a90/95 values as a function of inspector is much broader for the Haynes 188 compared to the 6061-A1 using the same inspection method and materials. This larger range of values was attributed to variations in the application of the D-100 developer.

Figure 10: Logit curve fit a90/95 results as a function of Method A inspector for Haynes 188 demonstration tests.

During his first trial, the GSFC inspector noticed that for some of the longer cracks, the indications were intermittent, almost as if the crack was partially clogged with debris. Upon low magnification (10 to 20 times) microscopic examination, he observed that the intermittent indications were a result of the non-uniform and sparse nature of his developer application. As a consequence, this inspector applied an unusually heavy coating of the developer and the indications became stronger and continuous. This technique was then adopted for all his inspections. The Vendor 3 inspector to some extent discovered the same thing. In his case, the discovery occurred during the checking of some flaw indications. The inspector was witnessed wiping potential flaw indications with a alcohol dampened swab and then re-developing the area with a concentrated developer application, i.e., a much heavier application than was initially applied to the entire panel. The Vendor 5 inspector consistently gave the panels a light dusting of developer and never discovered the strong influence of the development process on the crack detection in Haynes 188. The strong influence of developer application for detection of cracks in Haynes 188 was previously noted by Ward Rummel in his 1998 paper⁹. In this paper, the POD for Haynes 188 panels before and after developing was compared. Rummel gives the example of an inspector detecting only 86 of 284 cracks without developer with no a90/95 achieved. With developer, the same inspector found 277 of 311 cracks with an a90/95 of 0.077 inches.

As previously noted, for the Method A 6061-Al demonstration tests, inspectors also displayed extreme variations in the amount of D-100 developer applied, but the resultant variation in POD was much less. Observations in this study showed that the increase in indication brightness after developer application was much greater for the Haynes 188 panels as compared to the 6061-Al and Ti-6Al-4V panels. It was also noted that the majority of the cracks in the 6061-Al and Ti-6Al-4V panels could be detected prior to developer application, but this was not the case for the Haynes 188 panels.

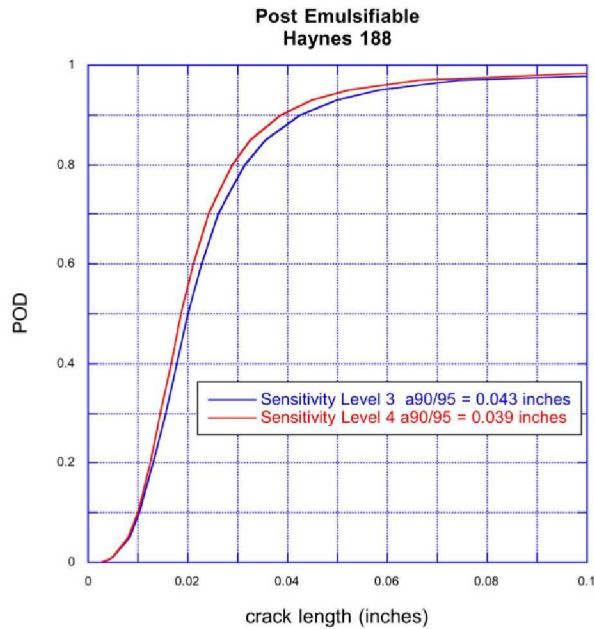
Table 4-A in Appendix A contains the results from all the Method D inspections performed on the Haynes 188 panel set. Point estimate and curve fit solutions were found for all 12 trials. Table 8 summarizes the sensitivity level 3 results versus level 4 results for all the trials. This table shows that the Method D sensitivity level 4 penetrants performed better on the Haynes 188 panels. The overall percentages of cracks detected were 95.6 and 96.7 percent for the sensitivity level 3 and level 4 penetrants, respectively. The final column of Table 8, which was obtained by performing Logit curve fits on the combination of all 6 sensitivity level 3 hit-miss data sets and all six of the level 4 sets, show the a90/95 values for the two levels of penetrants differ by 0.004 inches. These results are shown graphically in Figure 11.

Figure 11: Logit curve fit a90/95 results as a function of Method D penetrant sensitivity level for Haynes 188 demonstration tests.

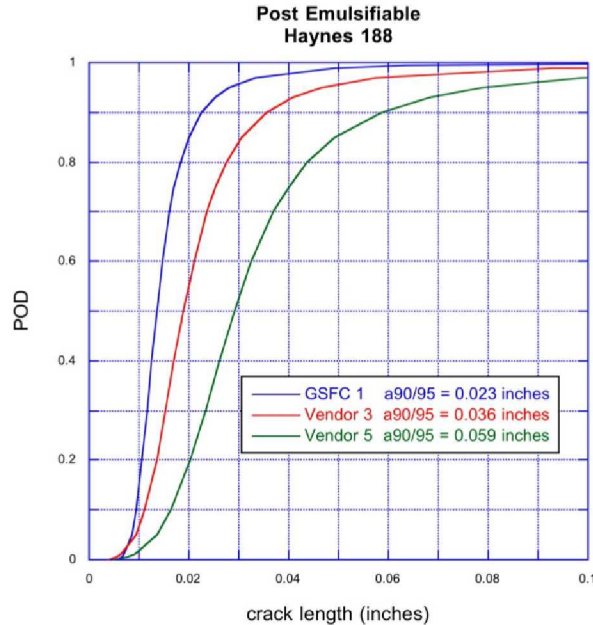
Again, all of the hit-miss results for each inspector (four trials, two with sensitivity level 3 and two with sensitivity level 4 penetrants) were combined and analyzed using the Logit curve fit technique. These results, which are plotted in Figure 12, show that the demonstrated a90/95 is again a stronger function of the inspector than of the penetrant. The range of variation for the three inspectors, which were the same three that performed the Method A inspections on this panels set, is smaller (0.026 to 0.075 inches for Method A and 0.023 to 0.059 inches for Method D). The biggest change was with Vendor 5 inspector. This may be due to the fact that the dry powder developer, by its nature of

application (dip and drag), will completely coat the surface, whereas this may not be the case for a light dusting with the D-100 developer. This appears more critical for the Haynes 188, where crack detection is strongly influenced by the development process.

Figure 12: Logit curve fit a90/95 results as a function of Method D inspector for Haynes 188 demonstration tests.

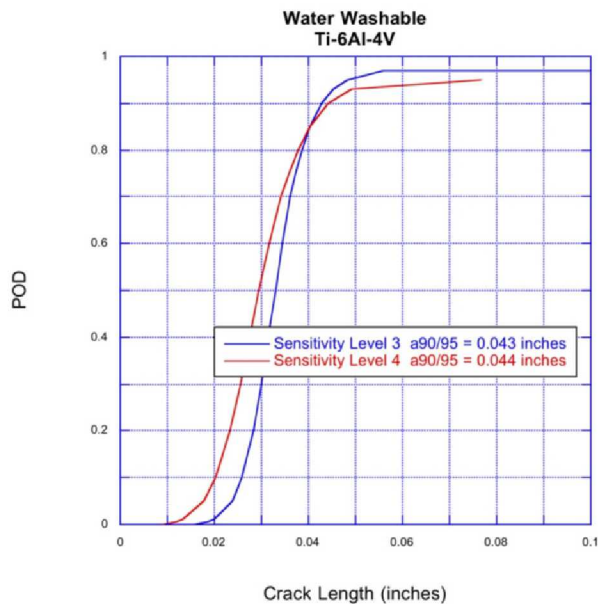
All of the individual inspector demonstration test results for the inspections of the Ti-6Al-4V panels set using the Method A penetrants is shown in Table 5-A in Appendix A. The table shows that in 5 of the 12 trials there was no point estimate solution. This is a consequence of the small number of cracks in this panel set; as few as two missed cracks can result in no point estimate solution. In addition, there were two trials with no Logit curve fit solution. Table 9 shows that the overall average number of cracks detected for the sensitivity level 3 trials (97.8 percent) was higher than for the level 4 trials (96.2 percent). The Logit curve fit a90/95 values obtained by combining all six level 3 trials (0.043 inches) is within 0.001 inches of the a90/95 obtained by combining the six level 4 trials (0.044 inches). These results are shown graphically in Figure 13.

Figure 13: Logit curve fit a90/95 results as a function of Method A penetrant sensitivity level for Ti-6Al-4V demonstration tests.

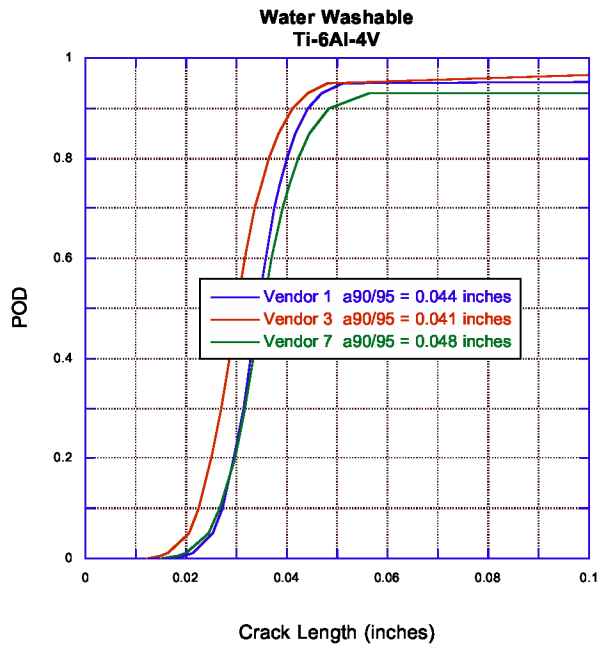
Again, all of the hit-miss results for each inspector (four trials, two with sensitivity level 3 and two with sensitivity level 4 penetrants) were combined and analyzed using the Logit curve fit technique. These results, which are plotted in Figure 14, show that the demonstrated a90/95 varies little between the three inspectors (0.041-0.048 inches). Having observed all the inspections for the three panel sets, this may be attributed to the very low background found on the Ti-6Al-4V panels. In addition, the cracks in the Ti-6Al-

4V set produced relatively bright indications before developing, which minimizes the variability created by variations in development technique.

Figure 14: Logit curve fit a90/95 results as a function of Method A inspector for Ti-6Al-4V demonstration tests.

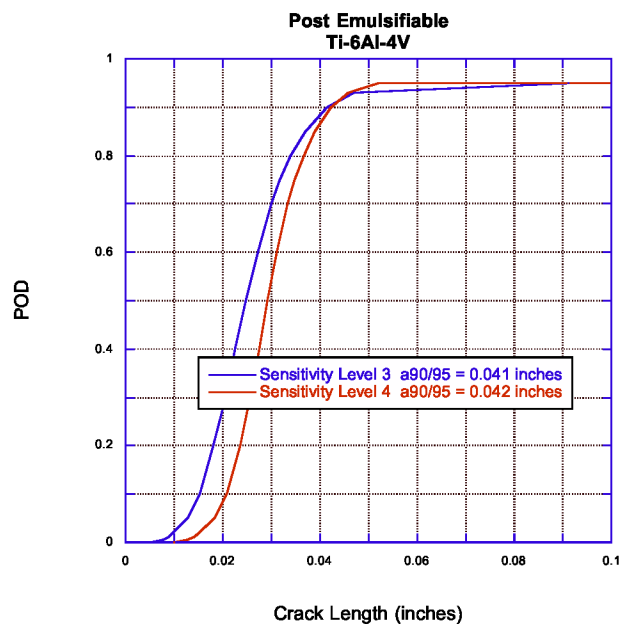
All of the individual inspector demonstration test results for the inspections of the Ti-6Al-4V panels set using the Method D penetrants is shown in Table 6-A in Appendix A. The table shows that there was no point estimate solution in eight of the 12 trials. This is again a consequence of the small number of cracks in this panel set. In addition, there were four trials with no Logit curve fit solution. Table 10 shows that the overall average number of cracks detected for the sensitivity level 4 trials (97.2 percent) was higher than for the level 3 trials (96.4 percent). The Logit curve fit a90/95 values obtained by combining all six level 3 trials (0.041 inches) is within 0.001 inches of the a90/95 obtained by combining the six level 4 trials (0.042 inches). These results are shown graphically in Figure 15.

Figure 15: Logit curve fit a90/95 results as a function of Method D penetrant sensitivity level for Ti-6Al-4V demonstration tests.

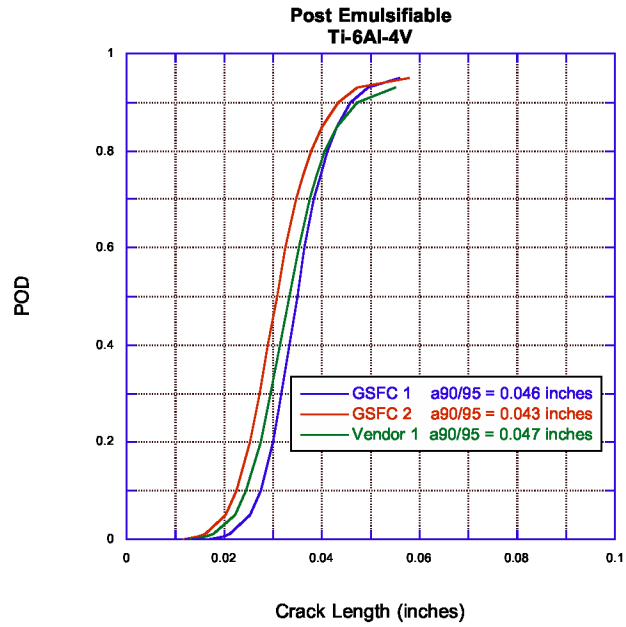
Again, all of the hit-miss results for each inspector (four trials, two with sensitivity level 3 and two with sensitivity level 4 penetrants) were combined and analyzed using the Logit curve fit technique. These results, which are plotted in Figure 16, show that the demonstrated a90/95 varies little between the three inspectors (0.043-0.047 inches).

Figure 16: Logit curve fit a90/95 results as a function of Method D inspector for Ti-6Al-4V demonstration tests.

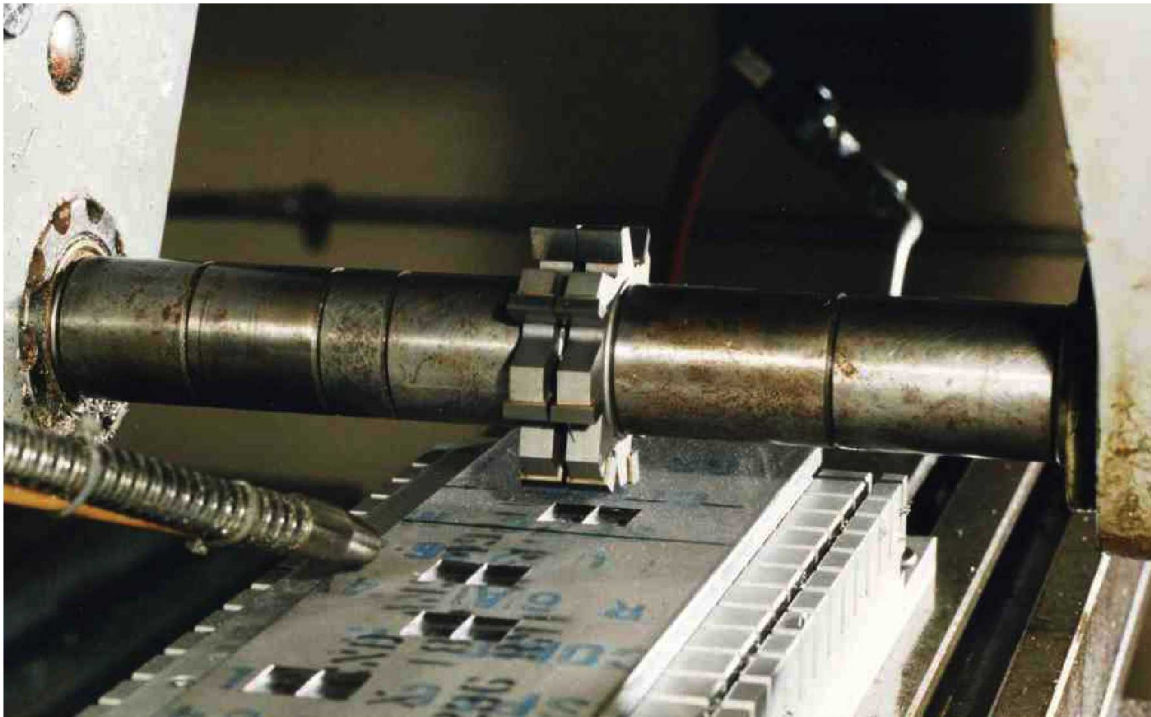
The cracks were introduced into panels that were initially 18 inches long by 3.9 inches wide by 0.250 inches thick. Seven electric-discharge machine (EDM) fatigue crack starter notches were randomly introduced along the 18-inch length on one side of the panel. The intended crack sites were first prepared with a pair of slotting cutters that were used to scoop metal out at each site. The scooped out area was approximately one inch square and was cut to a depth of 0.050 inches. The closely spaced slotting cutters, shown in Figure B-1, left a thin (0.010 inches) upstanding, lengthwise rib centered in the cut. The rib was subsequently EDM-notched to a depth of 0.020 inches. This scoop-rib method of initiating cracking was performed to facilitate producing short fatigue cracks with aspect ratios near 0.5.

Figure B-1. Slotting Cutters and resulting Scoop-Rib Areas on a Test Panel

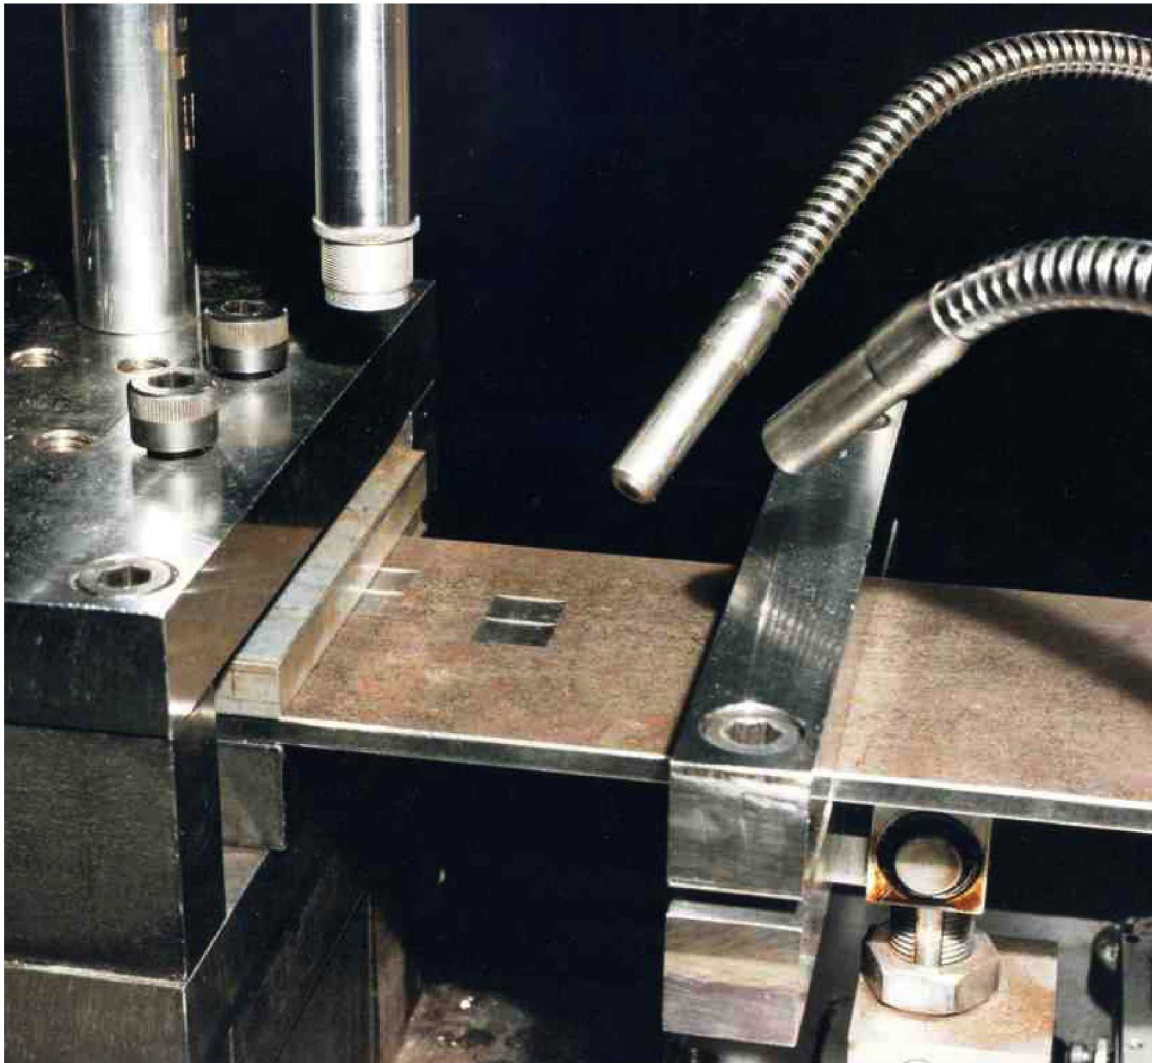
Fatigue cracking was accomplished in cantilever bending using a Vishay fatigue machine. Growing fatigue cracks in bending with conventional EDM notches tended toward low aspect ratio cracks. The scoop-rib method allowed short, 0.5 aspect ratio cracks to be produced relatively easily where the crack initiated in the notched rib and

grew into the base metal at a high aspect ratio. Each crack was grown separately by clamping the scooped out site such that the notch in the rib was at the point of maximum stress in bending (i.e., just beyond the end of the clamp). A moment arm of four inches was used during cycling and the displacement was controlled so as not to exceed 50 percent of the material's yield strength. A typical test set up is shown in Figure B-2. As each crack was grown to the desired length, the panel was re-clamped at the next scoop-rib site and the completed crack was moved under the clamps so that no additional crack growth occurred. This process of fatigue cycling a scoop-rib site to the desired crack length and moving the finished crack under the clamps was continued until all seven cracks were completed.

Figure B-2. Typical Fatigue Test Set Up Showing Loading Arrangement

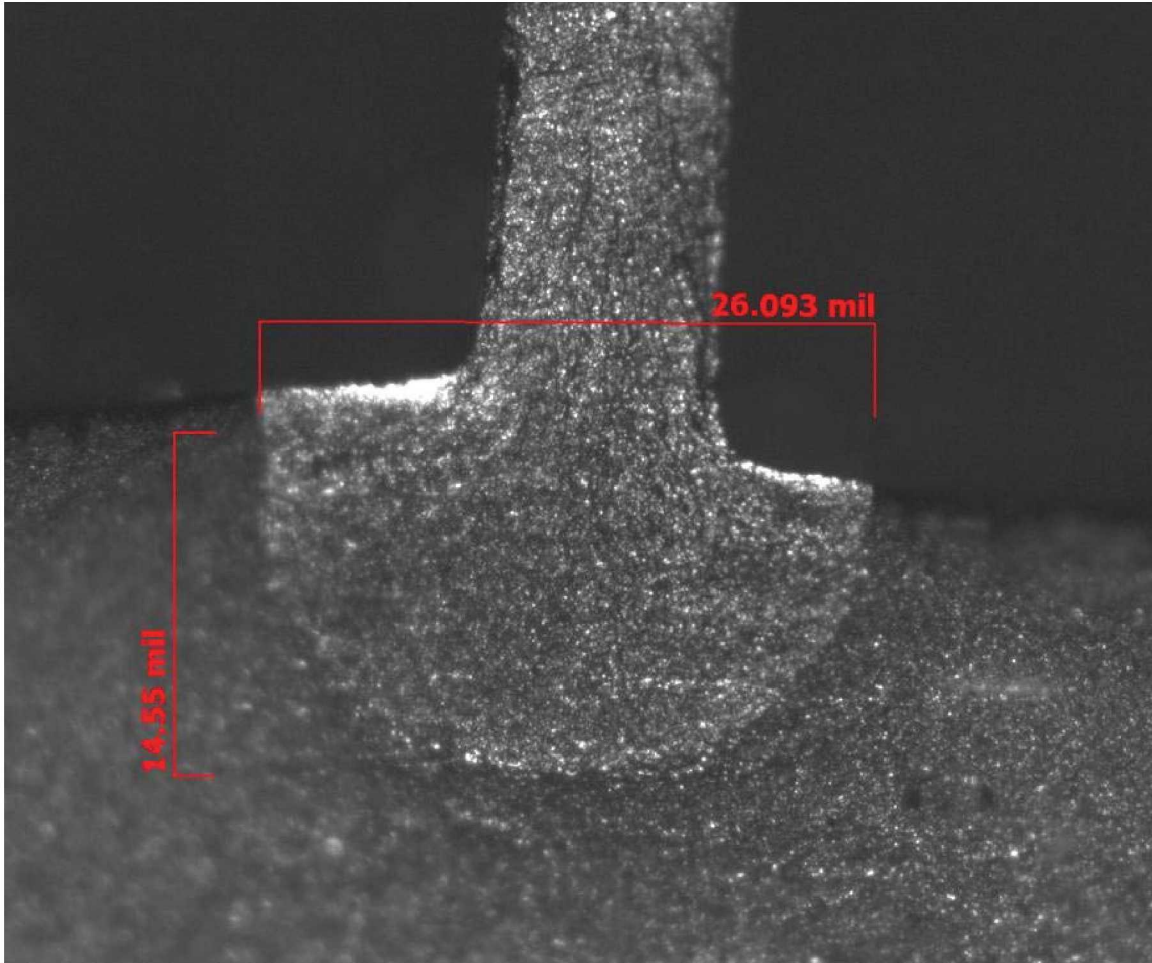
To validate the cracking process, a number of the cracks were broken open. Breaking open the cracks allowed the crack depths to be measured and the crack aspect ratios to be determined. Four cracks were broken open before any machining occurred and six cracks were opened after the machining and etching were completed. The pre-machined cracks did have high aspect ratios and ranged from 0.48 to 0.57. The post-machined and etched cracks had aspect ratios ranging from 0.36 to 0.46. The lower than intended aspect ratios of the finished cracks was due to the shallowness of the crack depths and the need to insure the complete removal of any evidence of the scoop machined surfaces by removing a few ten-thousandths of an inch past the scooped surface. The end result was that the cracks in the final specimen set had aspect ratios closer to 0.4 than to 0.5. Several broken open crack surfaces from a similarly manufactured set of 0.025 inch long cracks are shown in Figures B-3 and B-4.

Figure B-3. Pre-machined Crack Surface with Rib. Mag: 70x

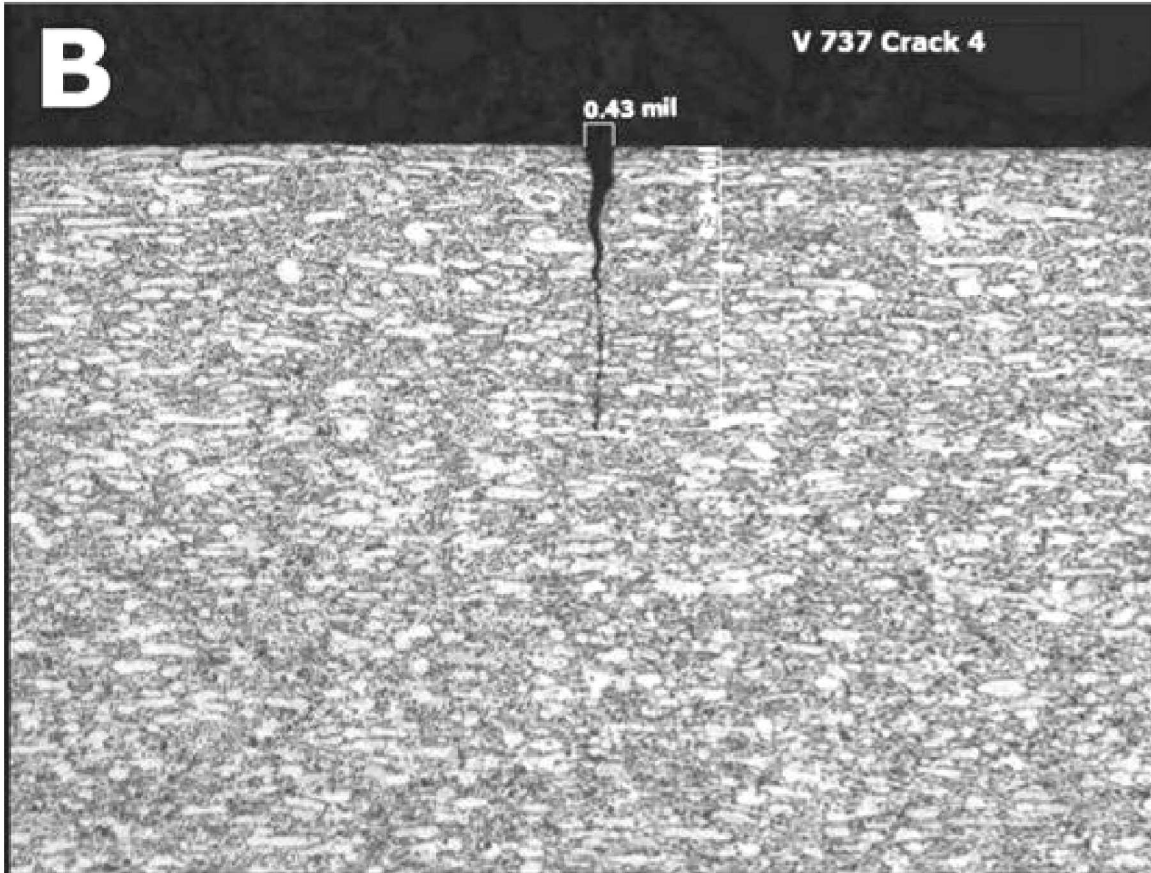
Figure B-5. Metallographic Cross Section of a Crack. Mag: 200x
